REPORT NUMBER: 301F-MGA-03-004

**SAFETY COMPLIANCE TESTING FOR
FMVSS NO. 301F
FUEL SYSTEM INTEGRITY**

2003 Liberty Freedom
School Bus
NHTSA No.: C30901

PREPARED BY:
MGA RESEARCH CORPORATION
5000 WARREN ROAD
BURLINGTON, WI 53105

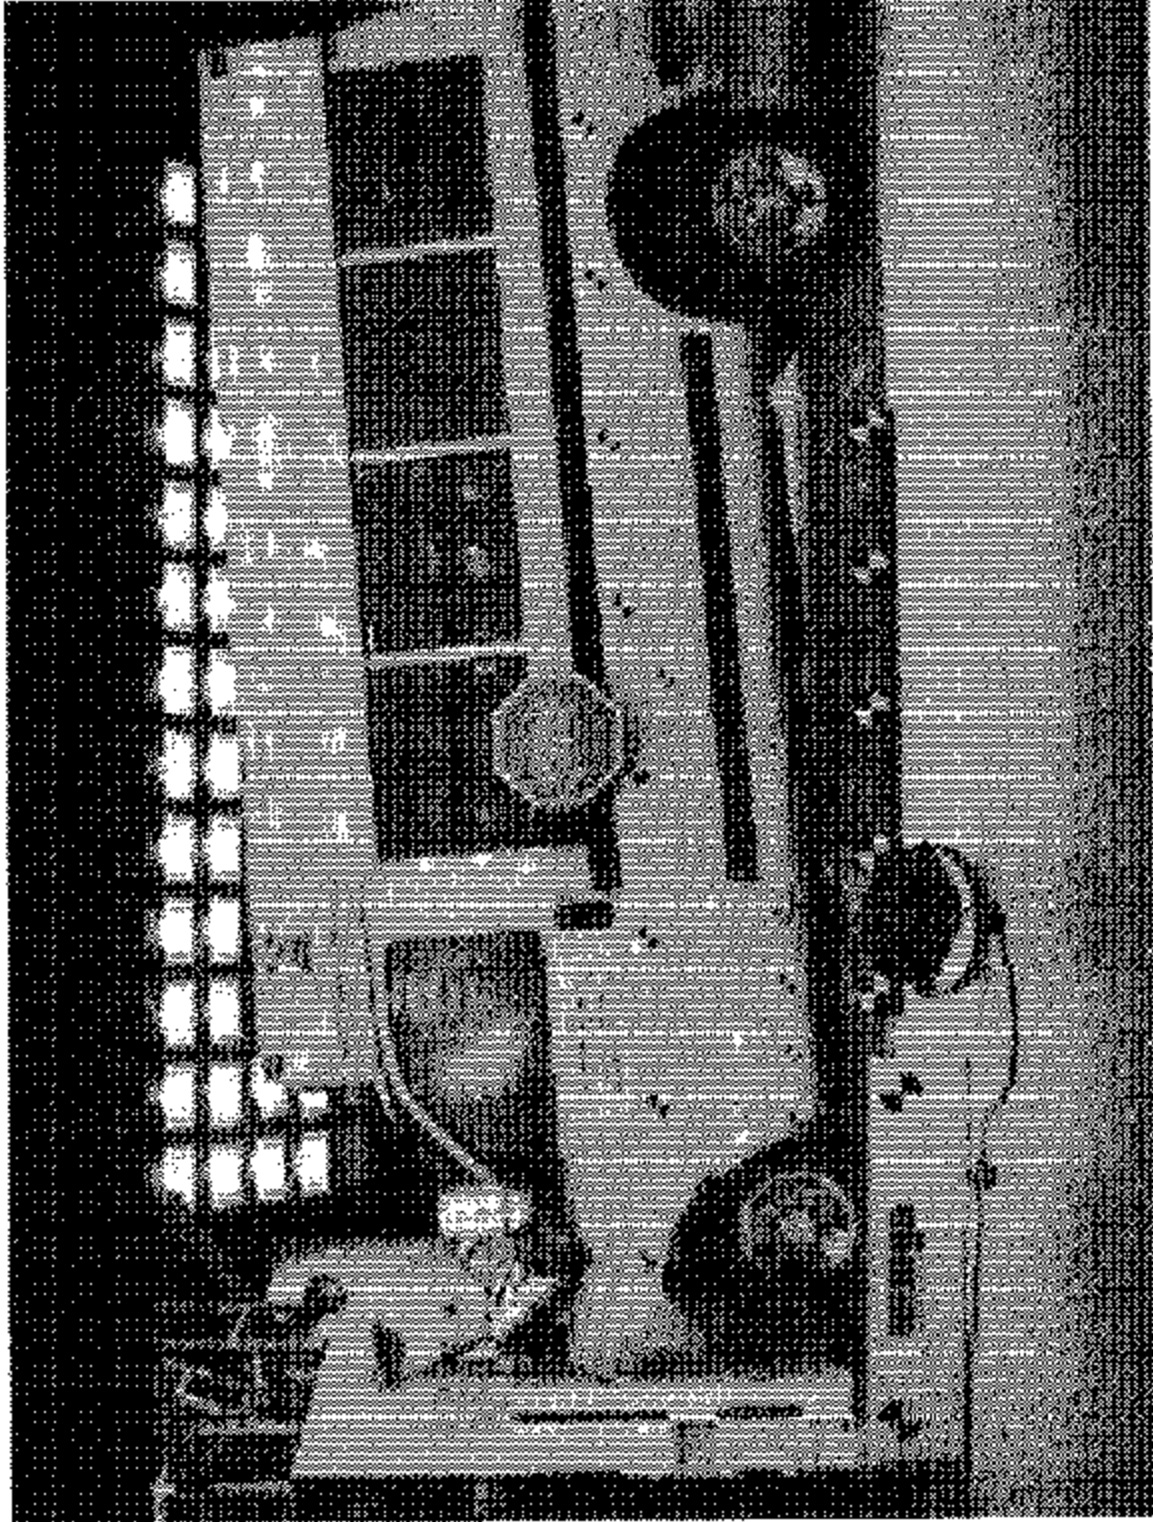
Impact

The vehicle was subjected to a 47.3 kph (29.4 mph) frontal impact.
