REPORT NUMBER: 221-MGA-03-003

**SAFETY COMPLIANCE TESTING FOR
FMVSS NO. 221
SCHOOL BUS BODY JOINT STRENGTH**

**Liberty Bus
2003 Liberty Freedom School Bus
NHTSA No.: C30901**

**PREPARED BY:
MGA RESEARCH CORPORATION
6000 WARREN ROAD
BURLINGTON, WI 53105**

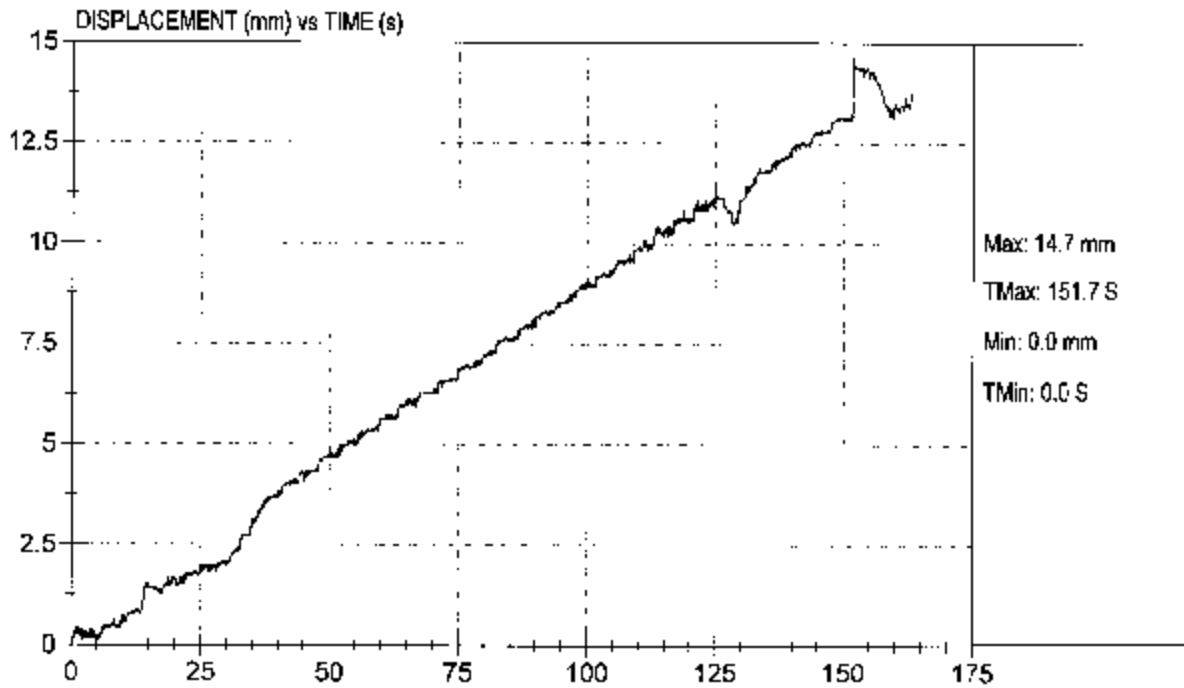
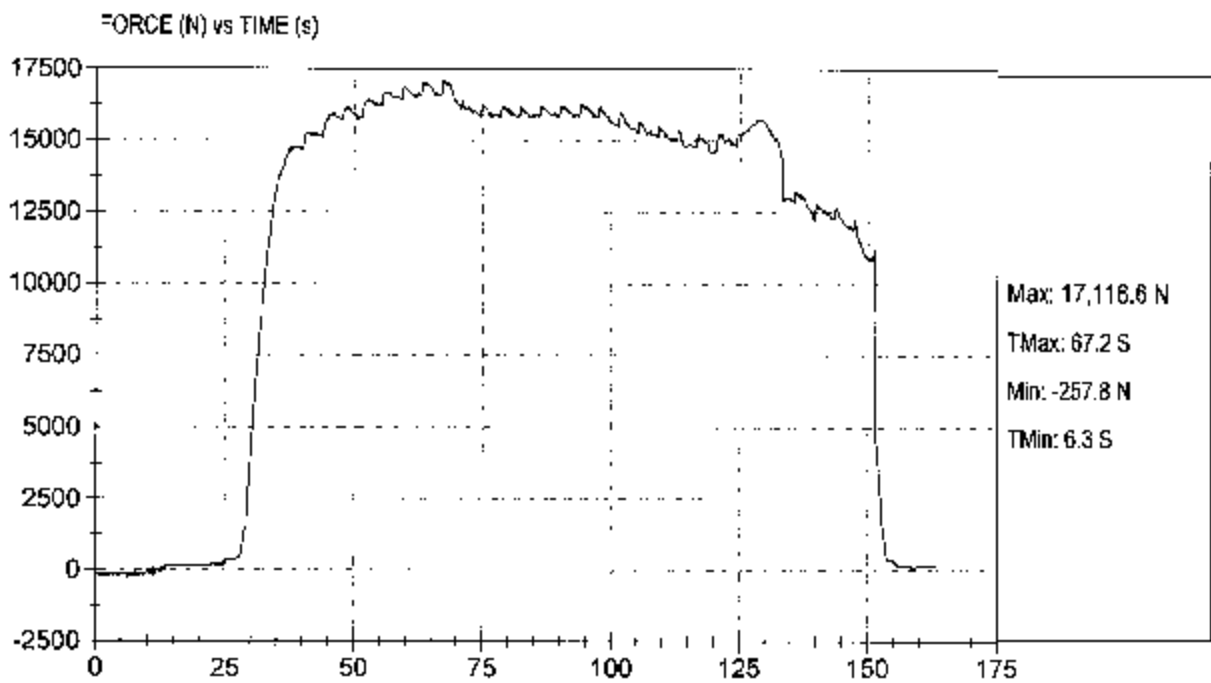
Test Desc: LSRRME1B4BRV (Right Roof Ext) (1)
Component ID: Liberty

Test Date: 8/26/03
NHTSA #: C30901

Interior side panel LSRRME184BRV failed to meet load requirement of 44,307.8 newtons when tensile tested as described in 49 CFR 571.221. Actual load was 17,118.4 newtons.

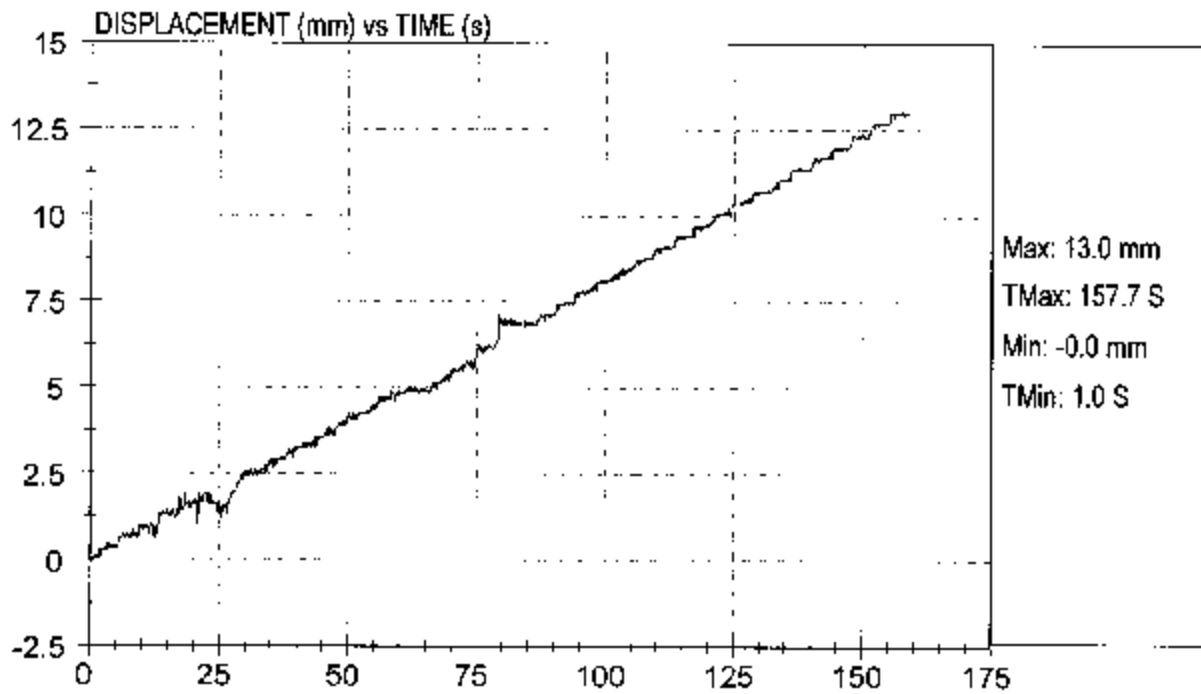
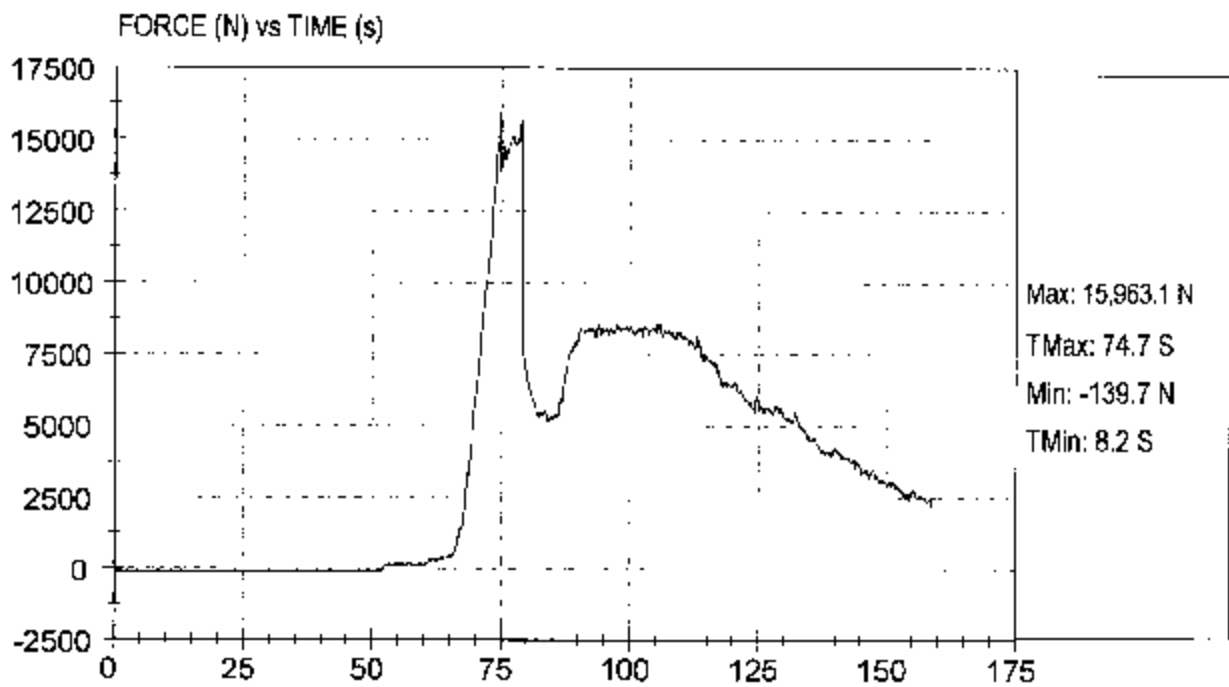
Test Desc: LSSRRI285BAV (Left Roof Int) (2)
Component ID: Liberty

Test Date: 8/26/03
NHTSA #: C30901

Interior side panel LSSRR1285BAV failed to meet load requirement of 24,279.7 newtons when tensile tested as described in 49 CFR 571.221. Actual load was 15,963.8 newtons

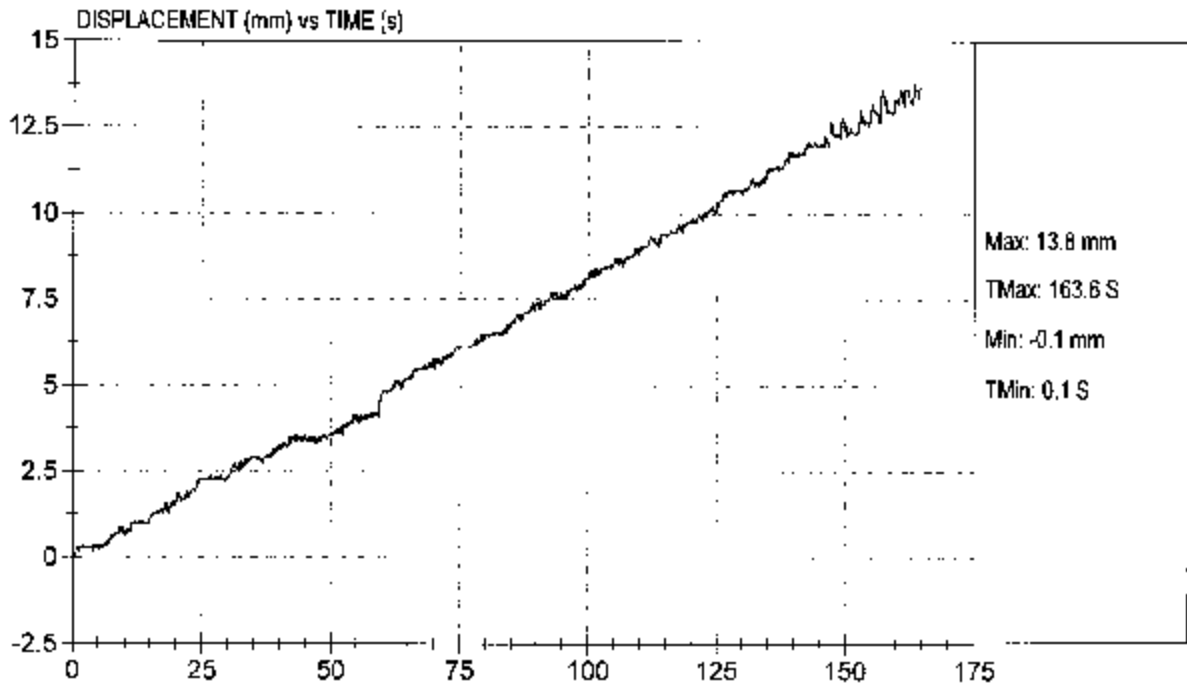
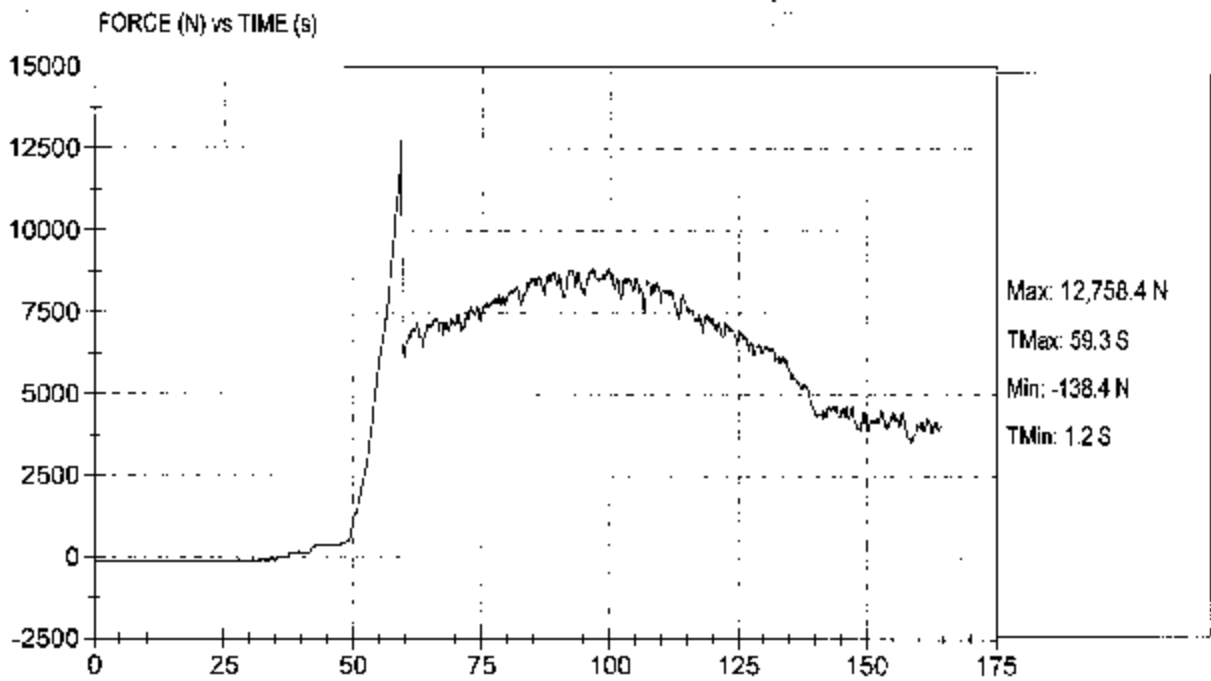
Test Desc: LSRRRI483BRH (Right Roof In.) (4)
Component ID: Liberty

Test Date: 8/26/03
NHTSA #: C30901

Interior side panel LSRRRI483BRH failed to meet load requirement of 24,928 newtons when tensile tested as described in 49 CFR 571.221. Actual load was 12,758.8 newtons
