REPORT NUMBER: 221-MGA-03-002

**SAFETY COMPLIANCE TESTING FOR
FMVSS NO. 221
SCHOOL BUS BODY JOINT STRENGTH**

**American Transportation Corporation
2003 ATC IC3S530 School Bus
NHTSA No.: C30902**

**PREPARED BY:
MGA RESEARCH CORPORATION
5000 WARREN ROAD
BURLINGTON, WI 53105**

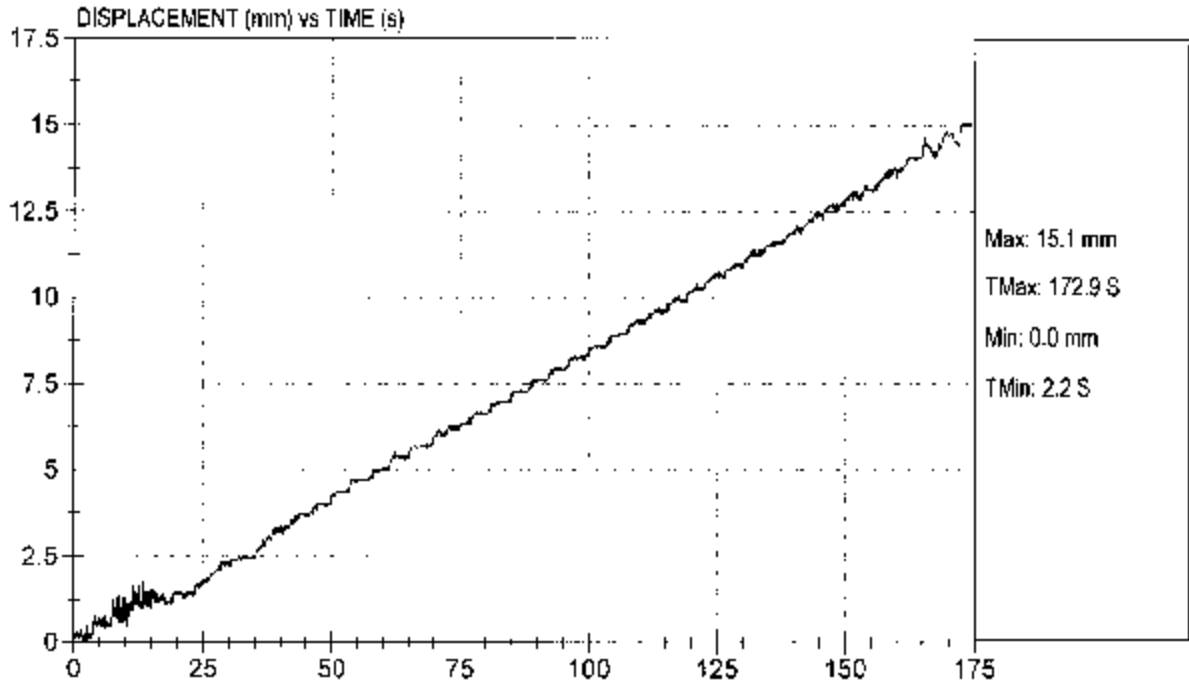
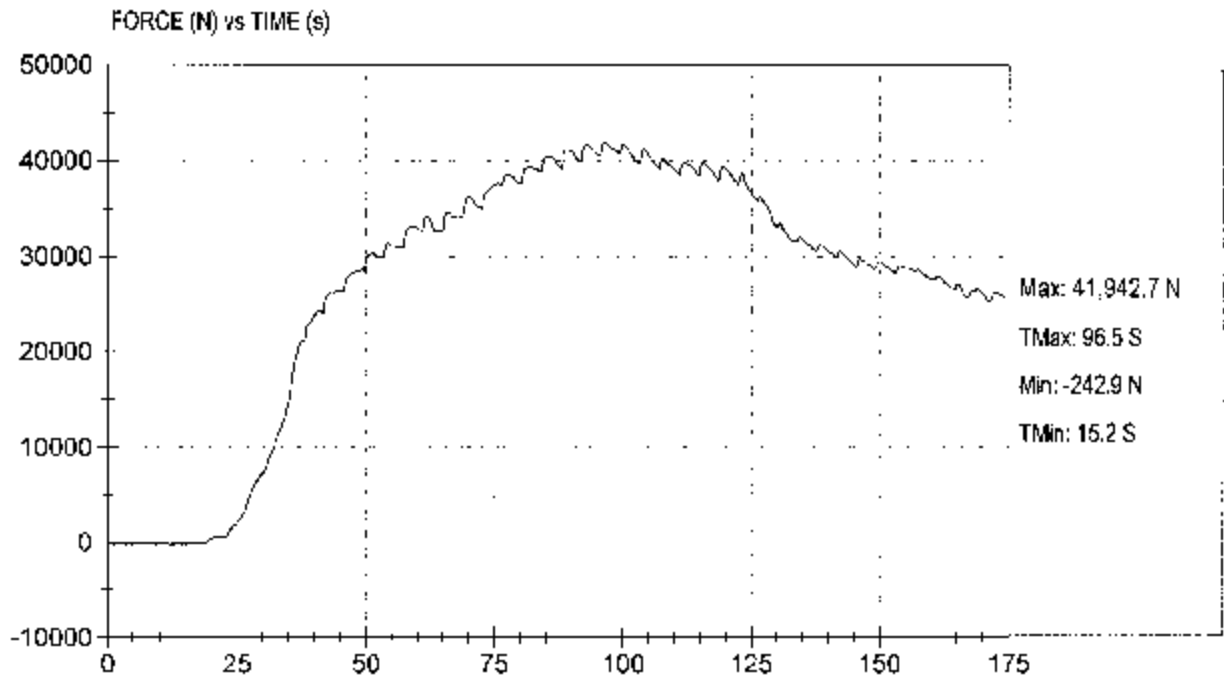
Test Desc: ALSRM1287BSV (Right Int. Side) (2)
Component ID: ATC

Test Date: 8/15/03
NHTSA #: C30902

Weaker Member	Stronger Member
Material	—	---
Tensile Strength (MPa)	310.2	---
Gage/Thickness (mm)	22 / .759	---
Fastener Holes (No./Diameter – mm.)	6 / 4.089	---
Net Area (Sq. mm.)	135.5	---
Material Strength (N)	42,098.7	---
60% of Material Strength (N)	25,259.1	---
Maximum Load From Tensile Test of Joint (N)	41,942.0	---
PASS/FAIL	PASS	---

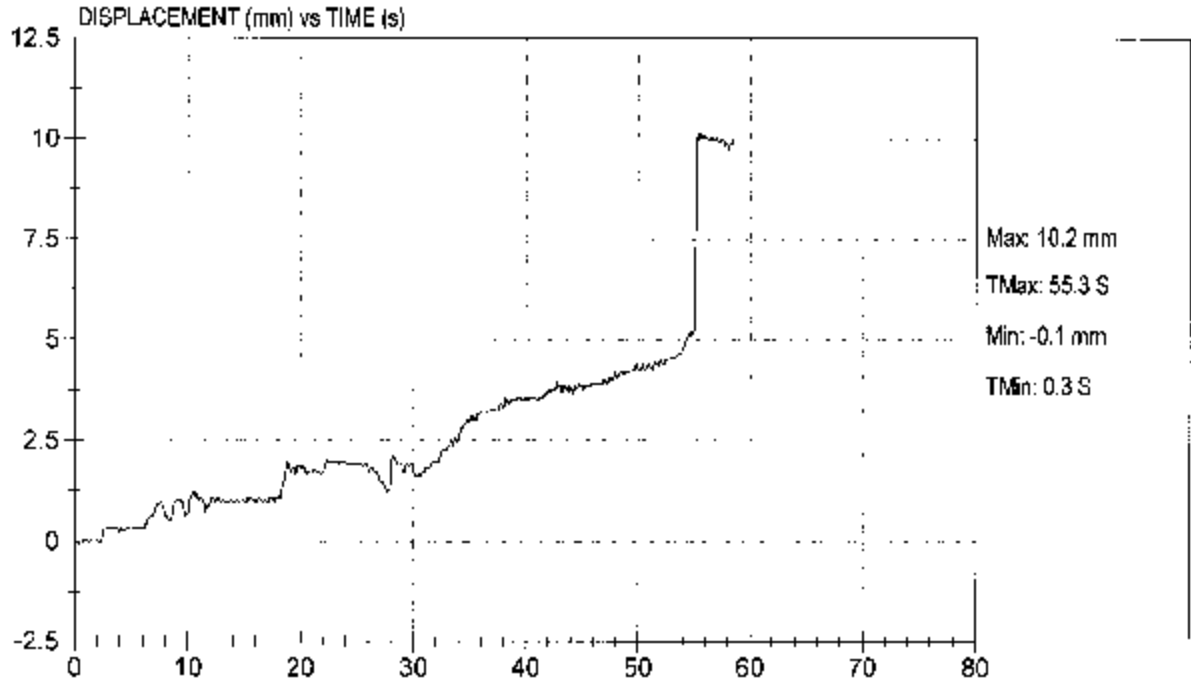
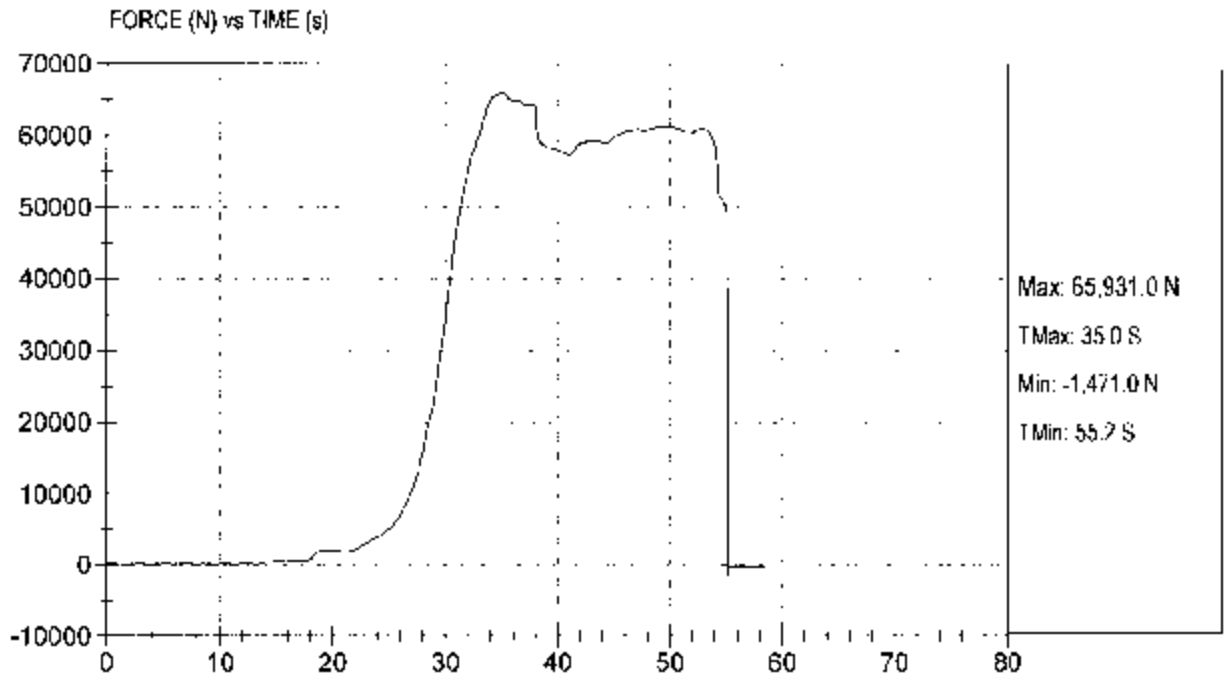
Test Desc: ALSME387BAV (Left Ext.Side) (3)
Component ID: ATC

Test Date: 8/15/03
NHTSA #: C30902

Weaker Member	Stronger Member
Material	—	---
Tensile Strength (MPa)	310.2	---
Gage/Thickness (mm)	16 / 1.448	---
Fastener Holes (No./Diameter - mm.)	7 / 4.902	---
Net Area (Sq. mm.)	244.5	---
Material Strength (N)	75,862.7	---
80% of Material Strength (N)	45,517.5	---
Maximum Load From Tensile Test of Joint (N)	65,931.0	---
PASS/FAIL	PASS	---

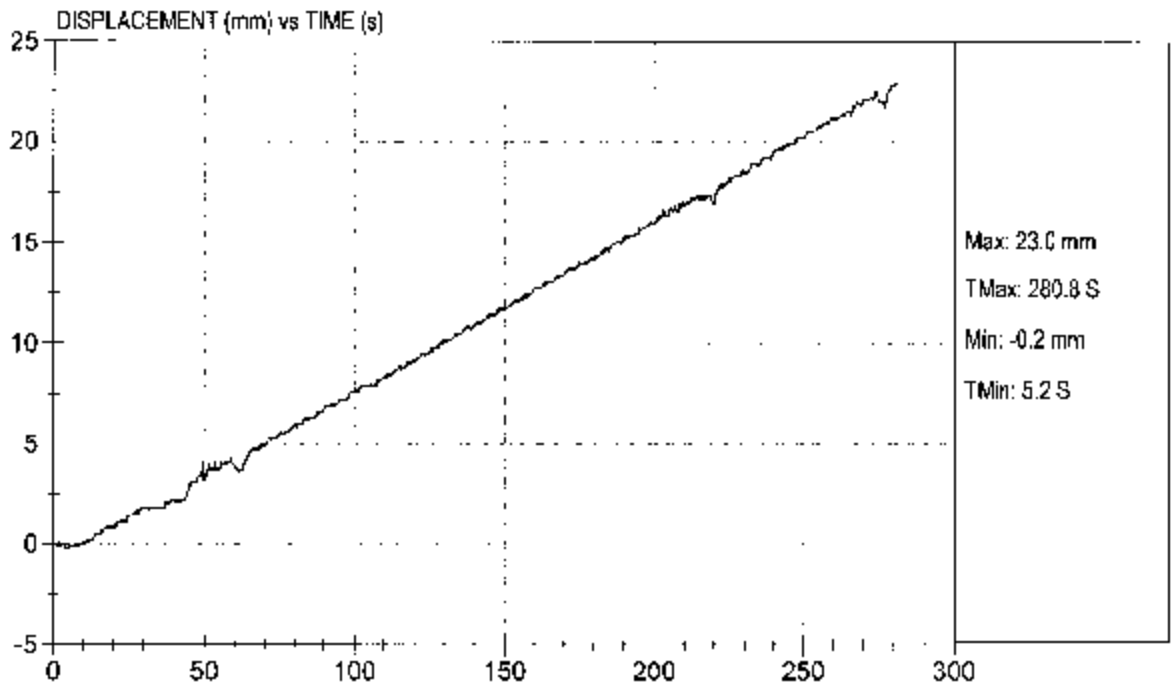
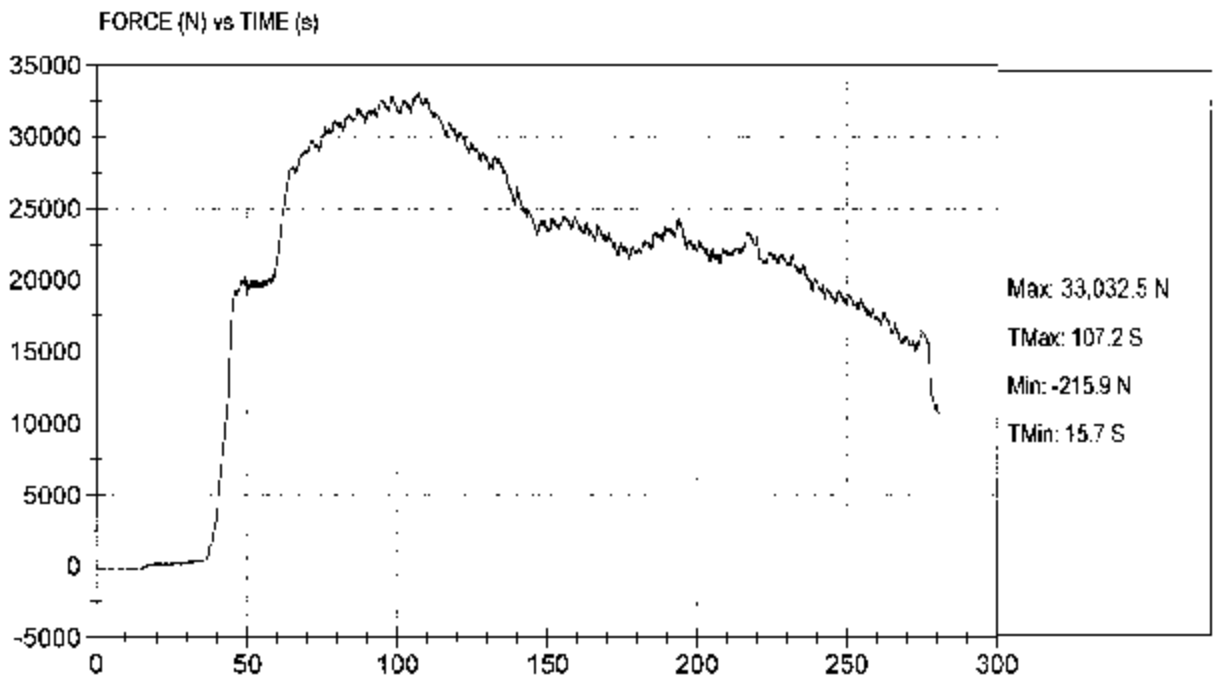
Test Desc: ALSM1485BSV (Left Int Side) (4)
Component ID: ATC

Test Date: 8/15/03
NHTSA #: C30902

Weaker Member	Stronger Member
Material	---	---
Tensile Strength (MPa)	310.2	---
Gage/Thickness (mm)	22 / .759	---
Fastener Holes (No./Diameter - mm.)	6 / 4.089	---
Net Area (Sq. mm.)	135.5	---
Material Strength (N)	42,098.7	---
60% of Material Strength (N)	25,259.1	---
Maximum Load From Tensile Test of Joint (N)	33,032.5	---
PASS/FAIL	PASS	---

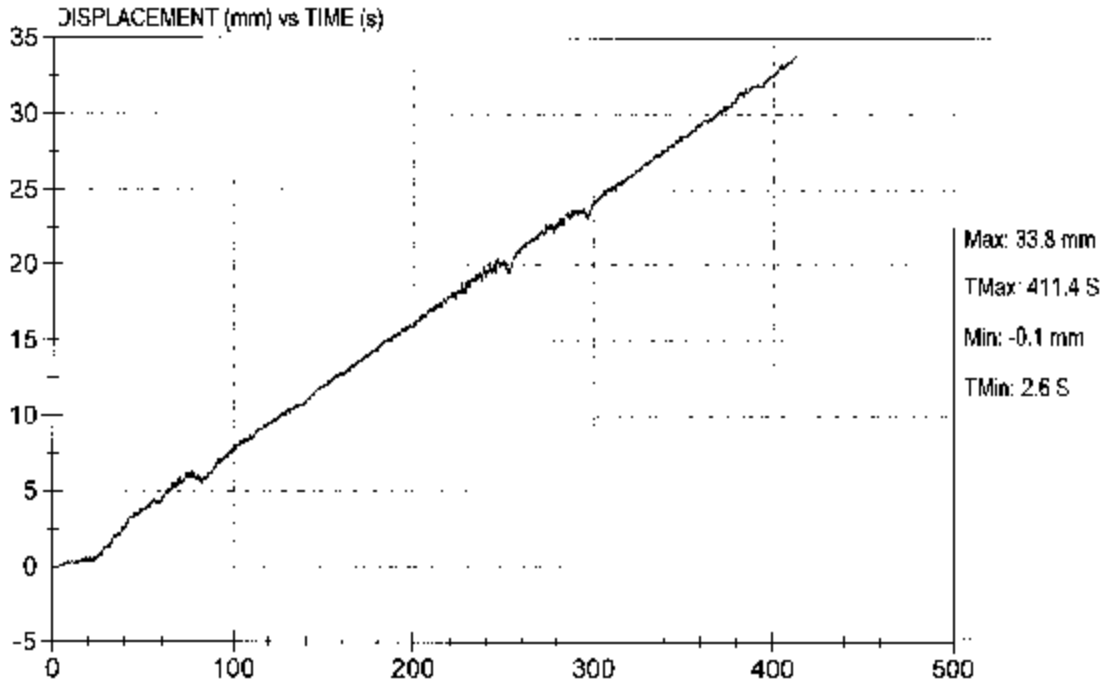
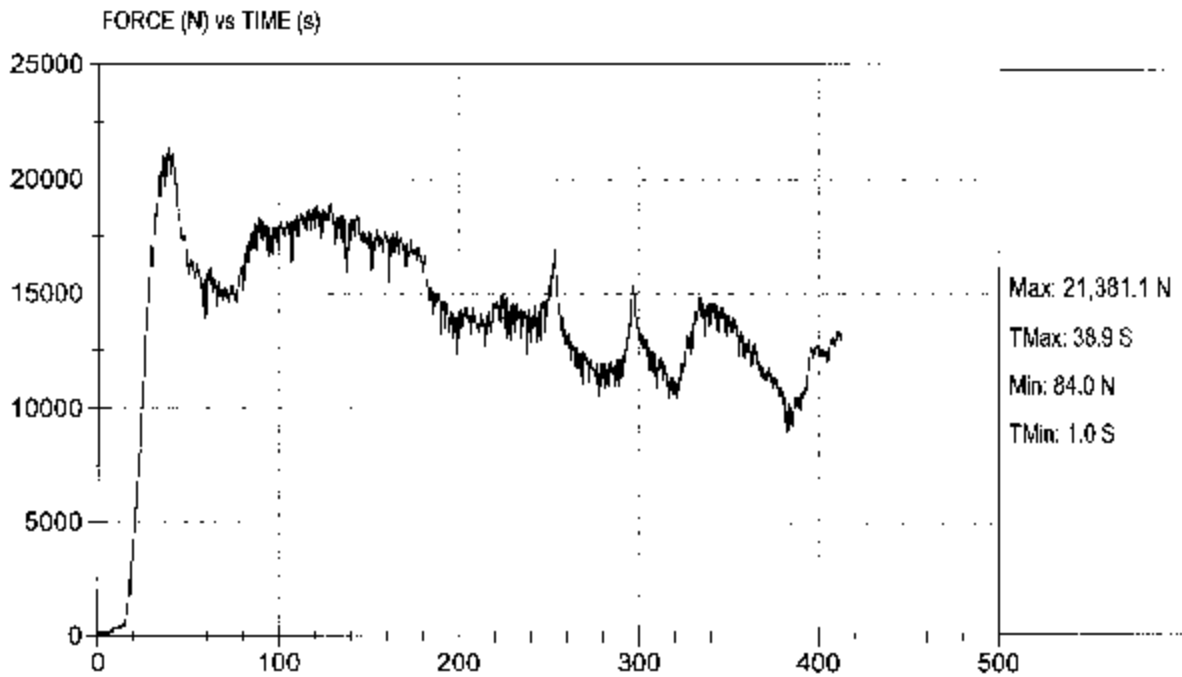
Test Desc: ALSCM587BAV (Roof Ext) (5)
Component ID: ATC

Test Date: 8/15/03
NHTSA #: C30902

Roof panel ALSCME587BAV failed to meet load requirement of 28,668 newtons when tensile tested as described in 49 CFR 571.221. Actual load was 21,382 newtons.

Weaker Member	Stronger Member
Material	---	---
Tensile Strength (MPa)	310.2	---
Gage/Thickness (mm)	20 / .912	---
Fastener Holes (No./Diameter – mm.)	7 / 4.902	---
Net Area (Sq. mm.)	154	---
Material Strength (N)	47,780.3	---
60% of Material Strength (N)	28,668.2	---
Maximum Load From Tensile Test of Joint (N)	21,381.1	---
PASS/FAIL	FAIL	---

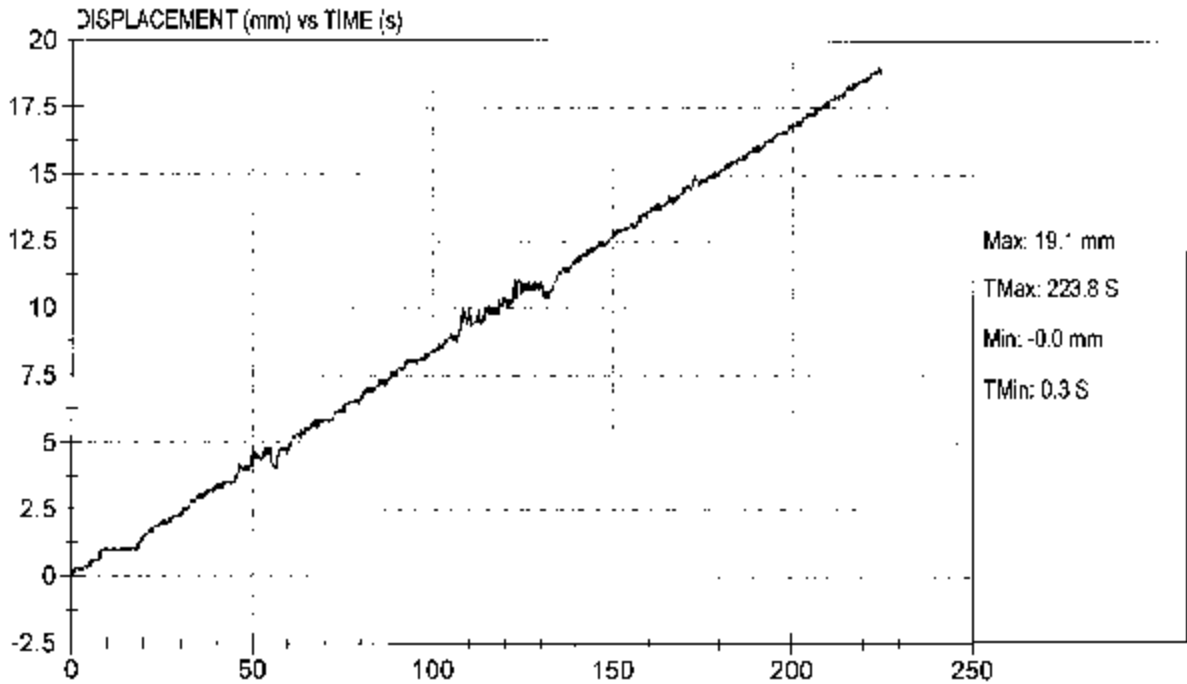
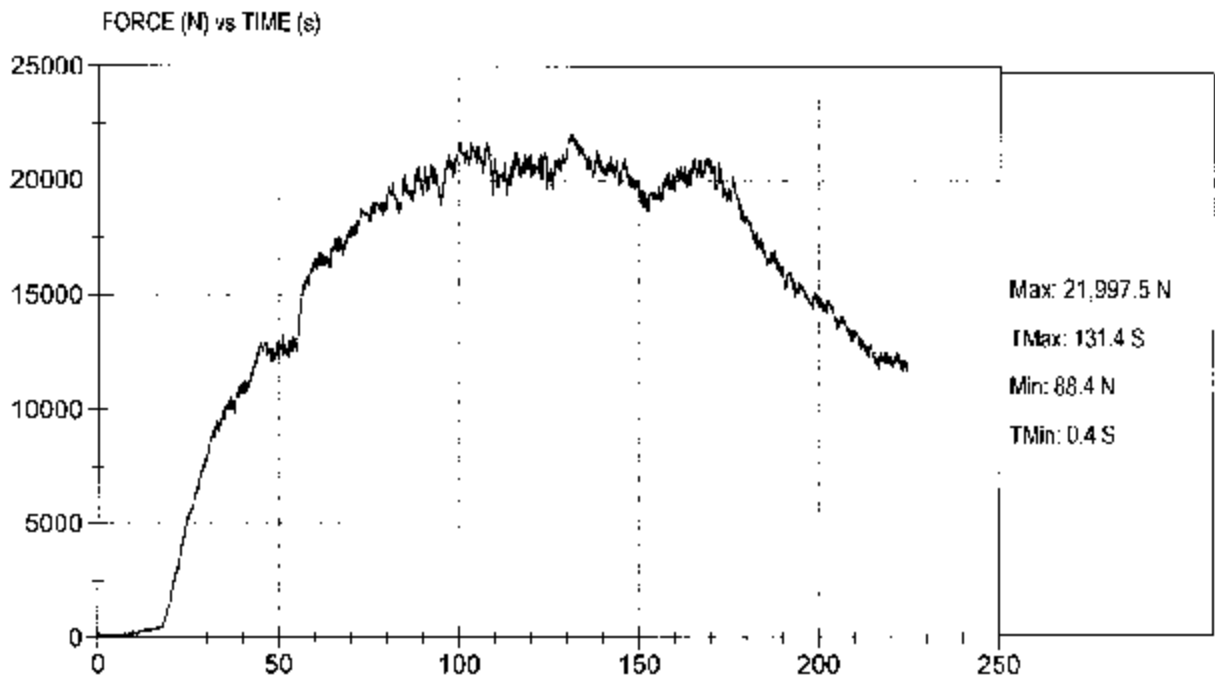
Test Desc: ALSC1685BSV (Roof Int) (6)
Component ID: ATC

Test Date: 8/15/03
NHTSA #: C30902

Roof panel ALSCMI685BSV failed to meet load requirement of 25067.9 newtons when tensile tested as described in 49 CFR 571.221.

Weaker Member	Stronger Member
Material	---	---
Tensile Strength (MPa)	310.2	---
Gage/Thickness (mm)	22 / .759	---
Fastener Holes (No./Diameter - mm.)	5 / 4.089	---
Net Area (Sq. mm.)	138.7	---
Material Strength (N)	41,779.8	---
60% of Material Strength (N)	25,067.9	---
Maximum Load From Tensile Test of Joint (N)	21,997.5	---
PASS/FAIL	FAIL	---

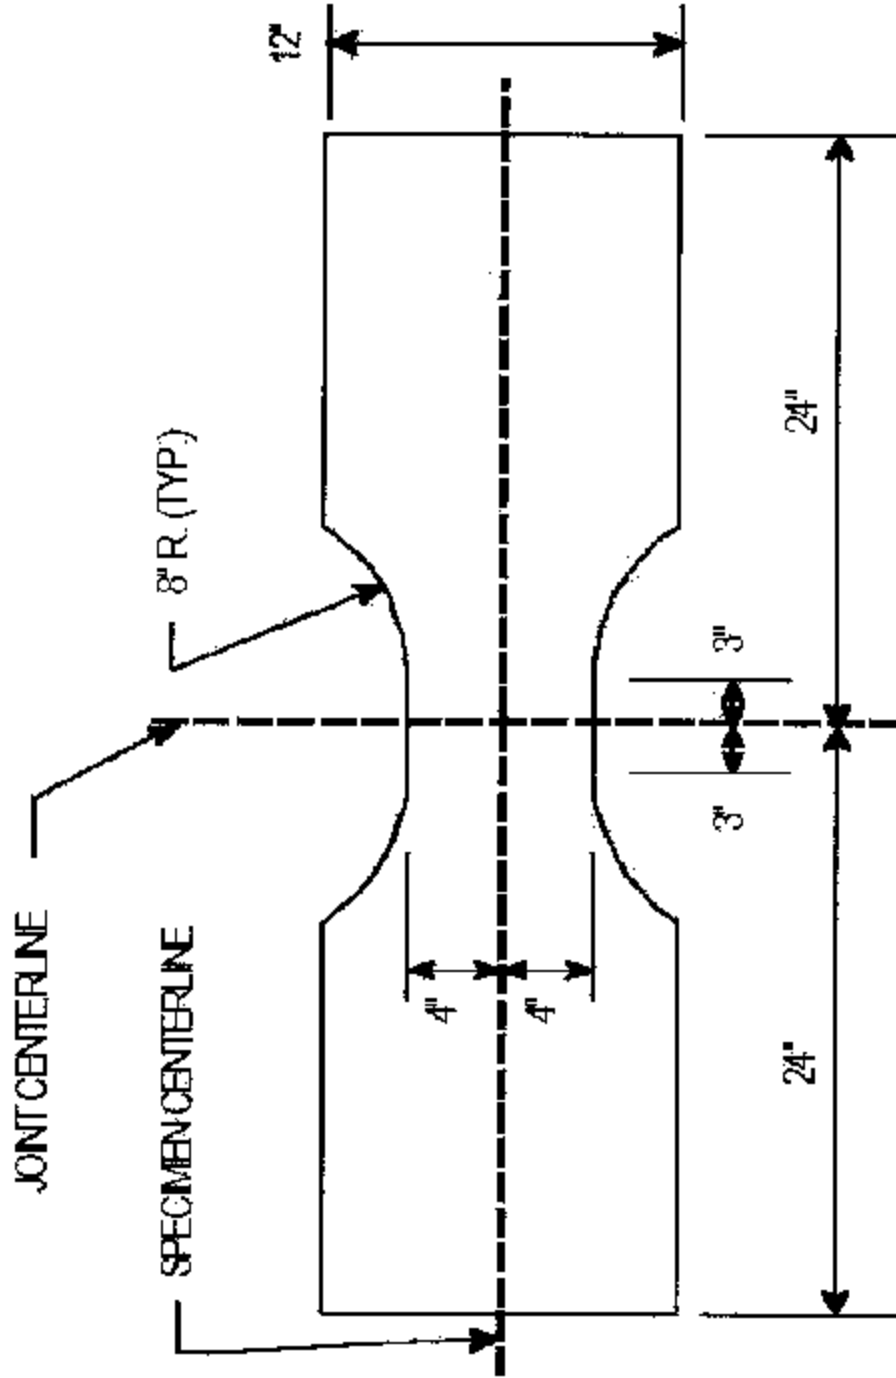
**DIMENSION REQUIREMENTS OF BODY PANEL SPECIMEN
WHOSE JOINT SEGMENT IS 8 INCHES LONG**
