REPORT NUMBER: 222-MGA-03-004

**SAFETY COMPLIANCE TESTING FOR  
FMVSS NO. 222  
SCHOOL BUS PASSENGER SEATING AND CRASH PROTECTION**

**2003 Liberty Freedom School Bus  
NHTSA No.: C30901**

**FINAL REPORT**

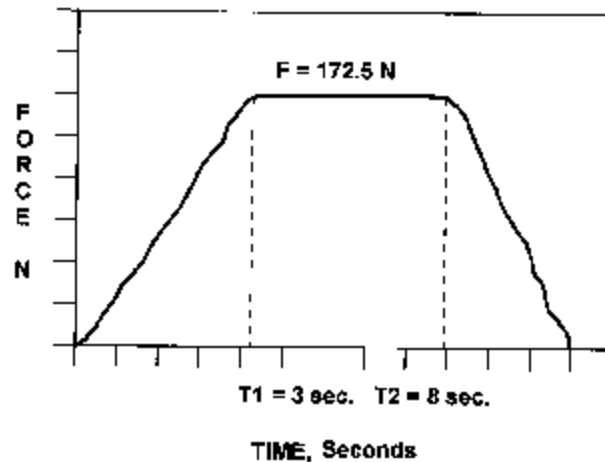
**SEAT NUMBER: S4**

1. Cushion Weight/Mass = 3.5 kg
2. Cushion Weight x 5 = F = 172.5 N (S5.1.5)
3. Complete the following force/time graph:

F must be 5 x Cushion Weight; t1 and t2 must be according to the following expressions:  
 $T1 \Rightarrow 1 \text{ sec.}, < 5 \text{ sec.}, t2 = t1 + 5 \text{ sec.}, + 0 \text{ sec. and } -0.10 \text{ sec.}$

PASS/FAIL
4.	Did seat cushion separate from the seat structure at any attachment point? (S5.1.5)	PASS

Seat Nos. S4 and S5 were tested in accordance with Section 12.3 of OVSC TP-222-03. Seat cushion weight was 3.5 kg. The maximum force reached for both seats was 173 N. The lower time limit boundary (t1) was approximately 3 seconds with an approximate load duration of 5 seconds. As shown in Data Sheet 3, the seat cushions tested complied with all requirements.

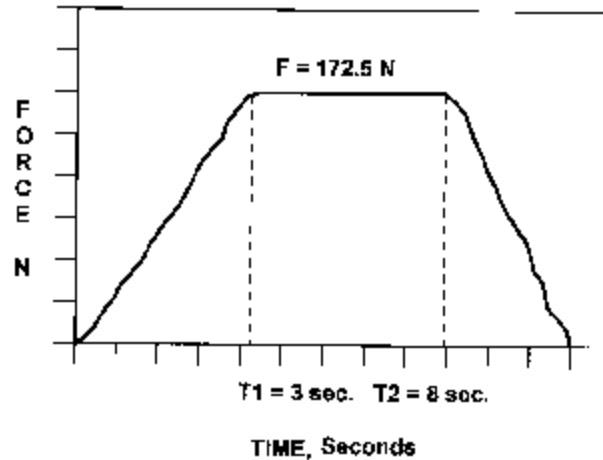
**SEAT NUMBER: S5**

4. Cushion Weight/Mass = 3.5 kg
5. Cushion Weight x 5 = F = 172.5 N (S5.1.5)
6. Complete the following force/time graph:

F must be 5 x Cushion Weight; t1 and t2 must be according to the following expressions:  
 $T1 \Rightarrow 1 \text{ sec.}, < 5 \text{ sec.}, t2 = t1 + 5 \text{ sec.}, + 0 \text{ sec. and } -0.10 \text{ sec.}$

PASS/FAIL
4.	Did seat cushion separate from the seat structure at any attachment point? (S5.1.5)	PASS

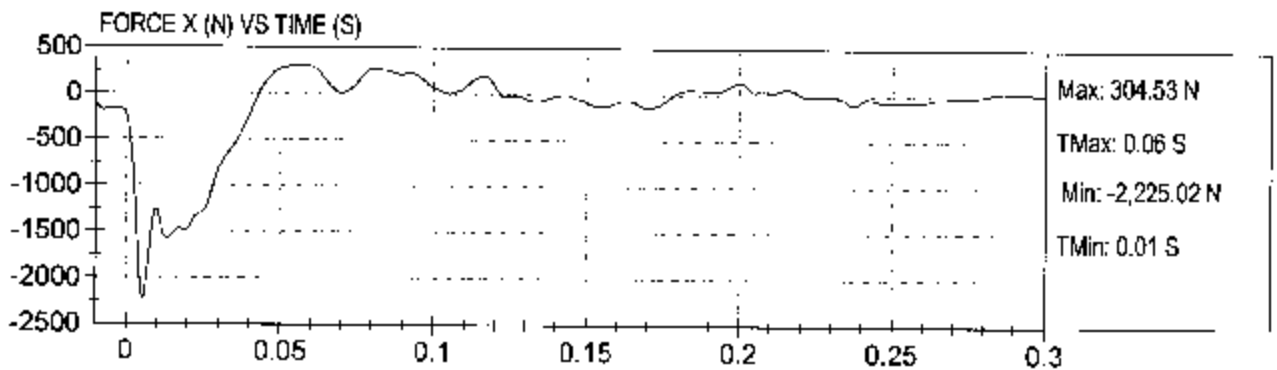
Test Date: 7-15-03  
Location: H7

(1) Head impact & Test #	(2) Location			(3) Speed Trap Impact Velocity ** mps	(4)* Derived Velocity ** mps	(5) Max HIC	(6) Engy Reqd Joules	(7)		(8)	
	X	Y	Angle					Column 5 < 1000		Column 6 > 4.5 joules	
								Yes- Pass	No- Fail	Yes- Pass	No- Fail
H7	209	330	0	6.84 (b)	6.40	116.4	3.9	X			X
H8	107	330	0	6.66	6.40	110.8	5.0	X		X	
H9	75	330	0	6.63	6.51	107.1	5.8	X		X	
H10	209	406	0	6.57 (a)	6.30	105.1	12.4	X		X	
H11	107	406	0	6.53 (a)	6.19	88.1	14.3	X		X	
H12	75	406	0	6.64	6.48	143.6	4.4	X			X

Seat No. S1 was tested in accordance with Section 12.6 of OVSC TP-222-03. The mass of the head form was 5.20 kg. All head form contact area criteria was met for the seat. The impact energy criteria of 4.5 joules for locations H7 and H12 were not met. See Plots 17 and 22.

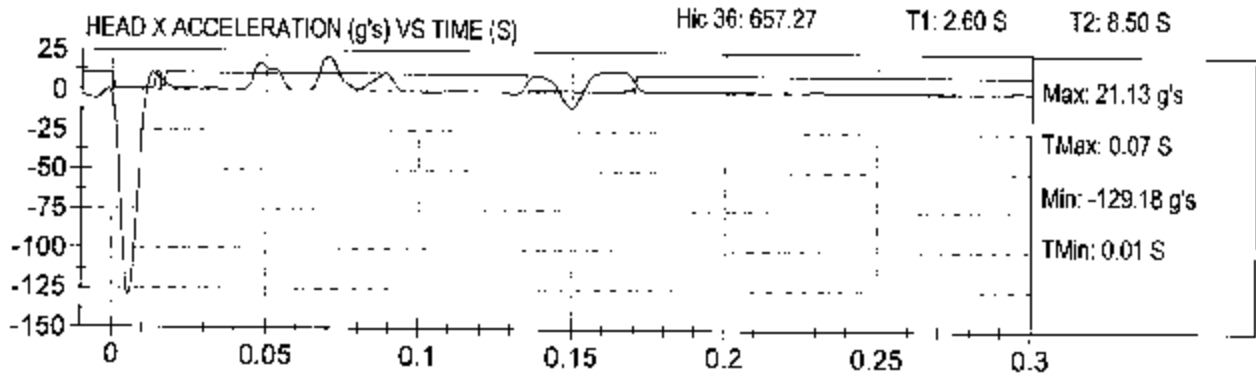
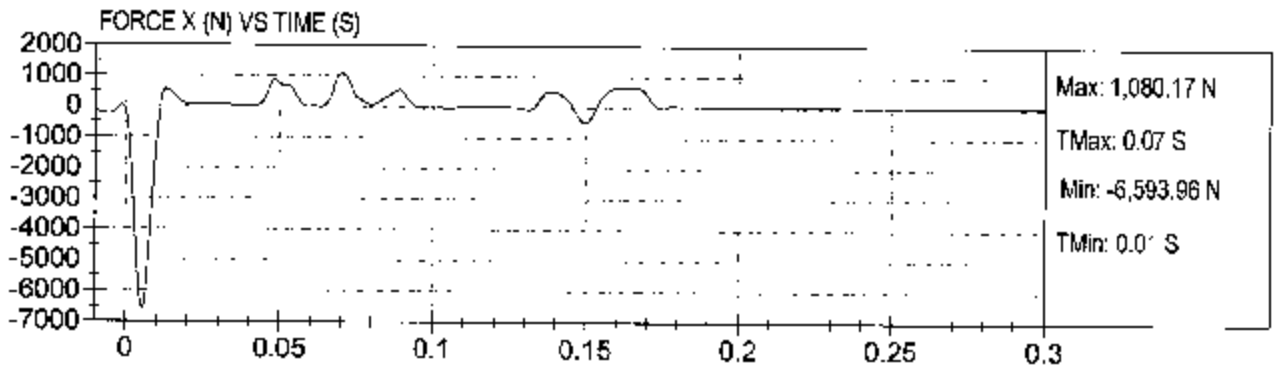
Test Date: 7-15-03  
Location: H14

(1) Head impact & Test #	(2) Location			(3) Speed Trap Impact Velocity ** mps	(4)* Derived Velocity ** mps	(5) Max HIC	(6) Engy Reqd Joules	(7) Column 5 < 1000		(8) Column 6 > 4.5 joules	
	X	Y	Angle					Yes- Pass	No- Fail	Yes- Pass	No- Fail
H14	413	983	0	6.69	5.72	657.3	1.74	X			X
H15 (a)	413	876	0	6.65	5.84	704.8	2.21	X			X

Wall barrier (above and behind front door) on right side of vehicle failed to meet impact energy criteria of 4.5 joules for locations H14 and H15. See Plots 23 and 24.

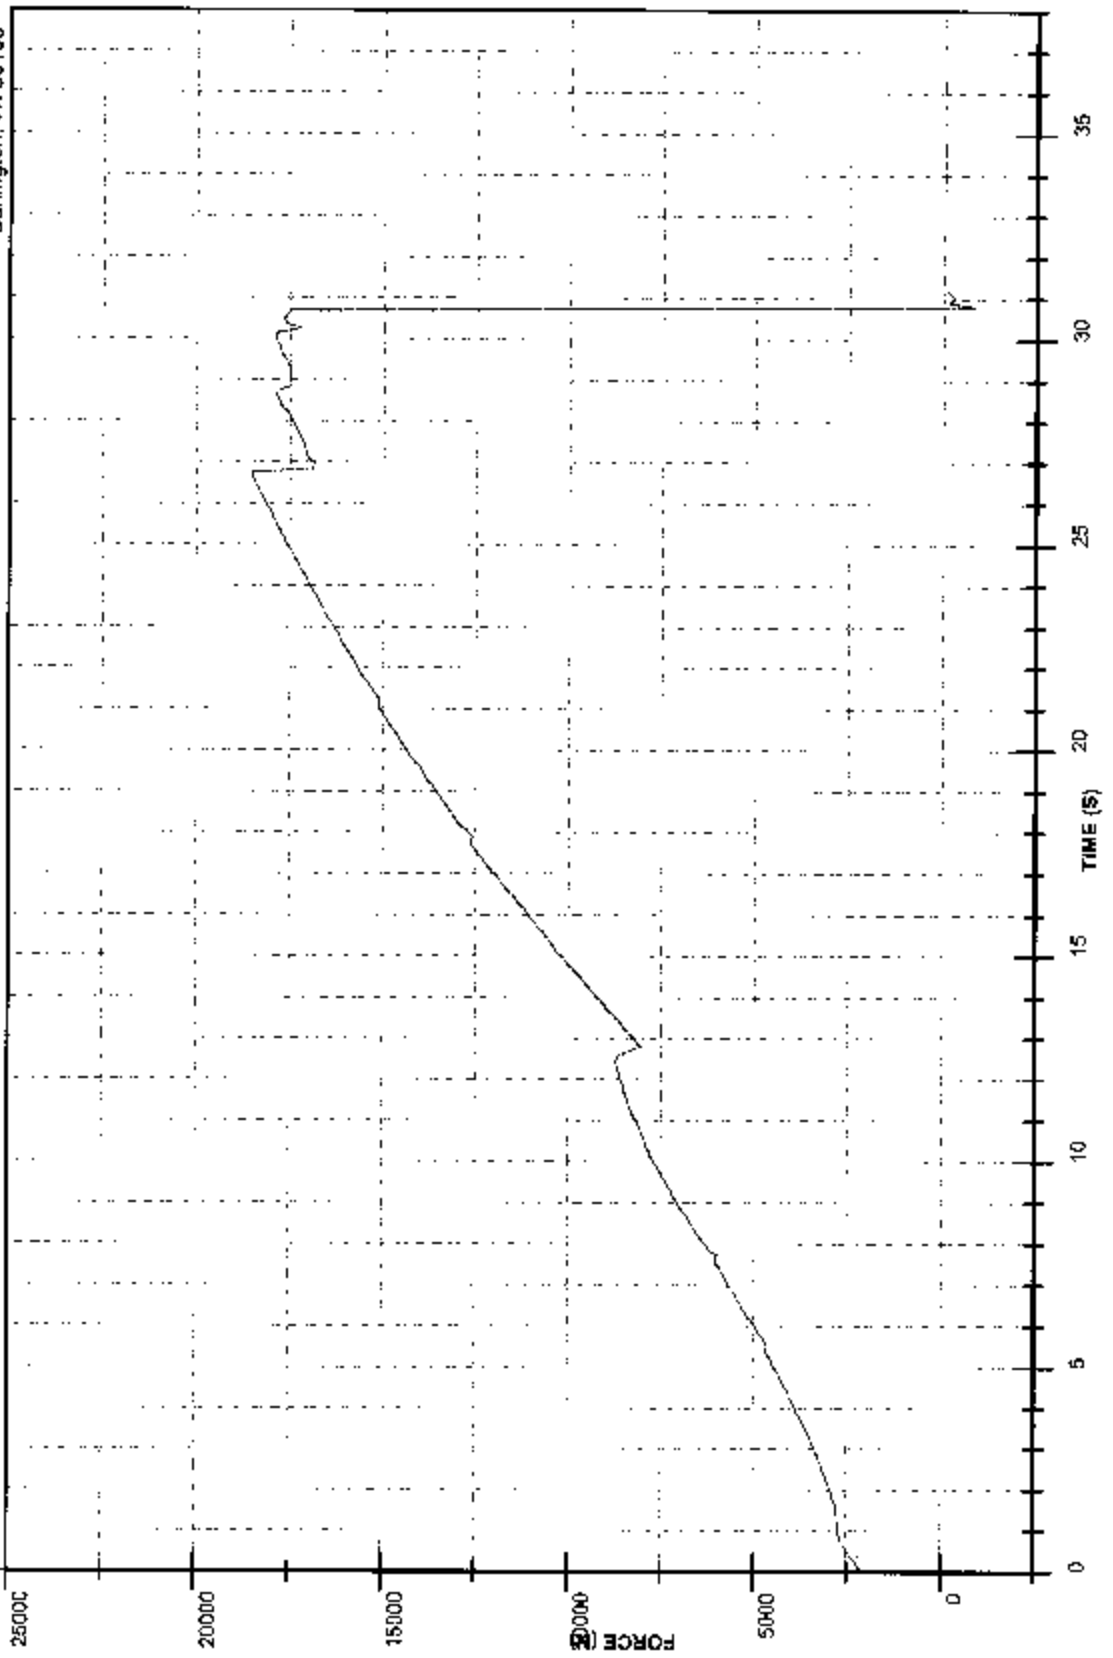
Test Desc: Seat Belt Assy. Anchorage Inboard  
Component ID: Liberty Freedom Bus

Seat Location	Seating Location	Required Load (N)	Actual Max. Test Load (N)	Pass/Fail	Comment
S5	Left Inner	22,241	18539.2	Fail	(a)
	Right Outer	22,241	20098.7	Fail	(a)

The force application, for the seat belt assembly anchorages, in the S5 location did not reach the specified force before the failure of the floor and wall mount anchor structure. The force requirement as specified in 49 CFR 571.210 is 22,000 N. The actual force reached 20,098.7 N before failure of the floor and wall mount anchor structure.

Seat belt anchorages and specially made high strength webbing straps were used to conduct the test. The seat belt anchor points failed to meet the required load of 22,241 N for each due to failure of seat to bus anchor points at an achieved load of 18,318 N and 20,098 N for the two (2) seating positions being tested. See Plots 33 and 34.

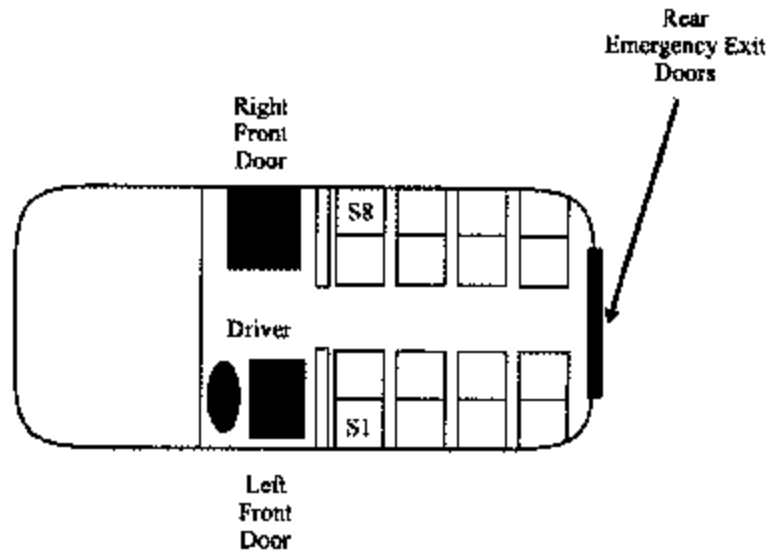
**SECTION 8  
BUS FLOOR PLAN**

Seat belt anchorage for seat location S5 was tested in accordance with Appendix A of OVSC TP-222-03. Seat location S5 is located as shown in seating diagram in Section 8.
