REPORT NO. 111-KAR-04-004

**SAFETY COMPLIANCE TESTING  
FOR FMVSS 111**

**REARVIEW MIRRORS  
(Other Than School Buses)**

2004 CHEVROLET MALIBU  
4 DOOR SEDAN

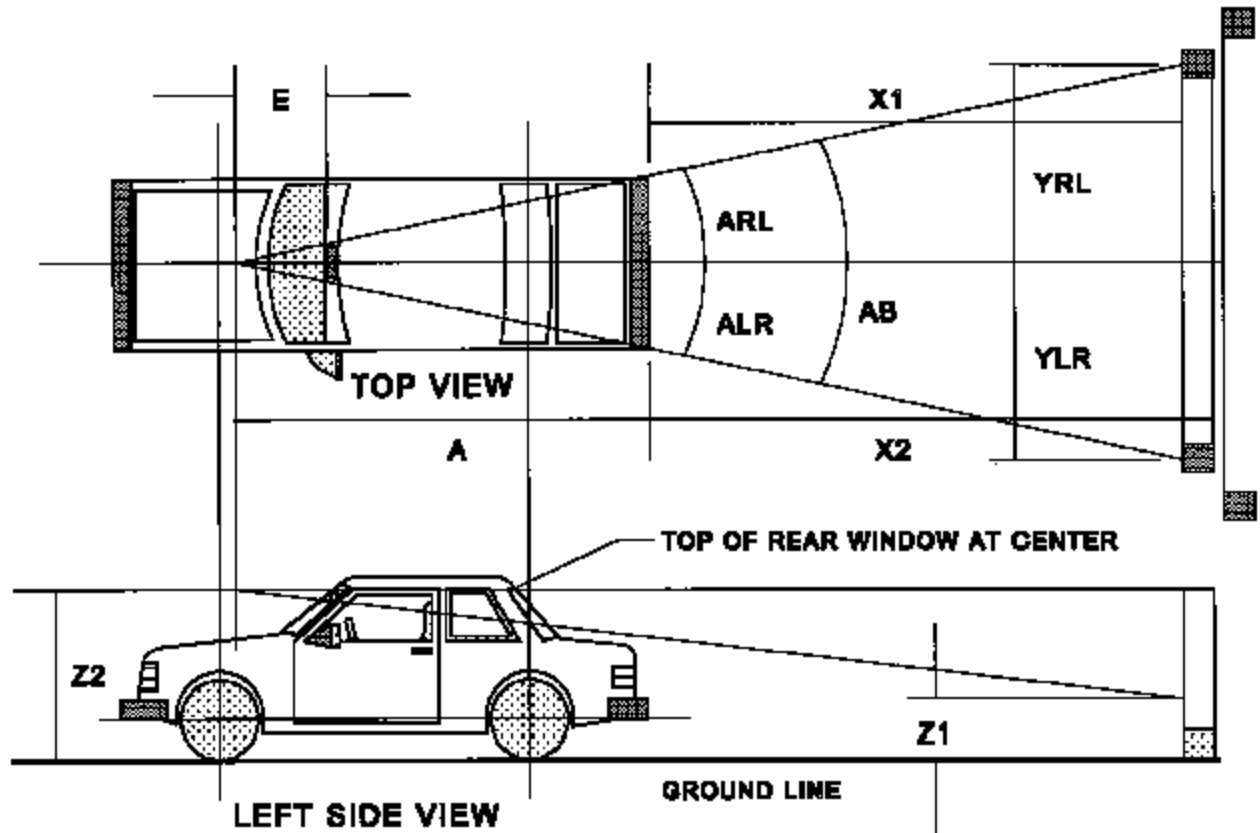
### INSIDE REARVIEW MIRROR FIELD OF VIEW TEST GRID AND MARKER SETUP

- E Distance from center of mirror to projected eye point location = 595.0 mm
- A Distance from rear of vehicle to projected eye point location = 3520.0 mm
- X1 Distance from rear of vehicle to field of view grid = 6280.4 mm
- Z1 Vertical distance to lowest point of field of view at distance X1 439.0 mm
- Z2 Height of center of mirror = 1320.0 mm
- X2 Distance from rear of vehicle where the road surface is first visible  
 $X2 = [(Z2 \times X1) + (Z1 \times A)] / (Z2 - Z1) =$   
 (S111 REQUIREMENT = 61m maximum) 14160.50 mm (14.50 m)

EYE LOCATION	MONOCULAR DATA (ALR & ARL ARE ANGLES)			
	YL (mm)	YR (mm)	ALR (°)	ARL (°)
LEFT EYE POINT	YLL = 1772	YRL = 2650		12.80
RIGHT EYE POINT	YLR = 2695	YRR = 1667	13.03

ANGLE AB = 25.83 (S111 REQUIREMENT = 20 degrees minimum)

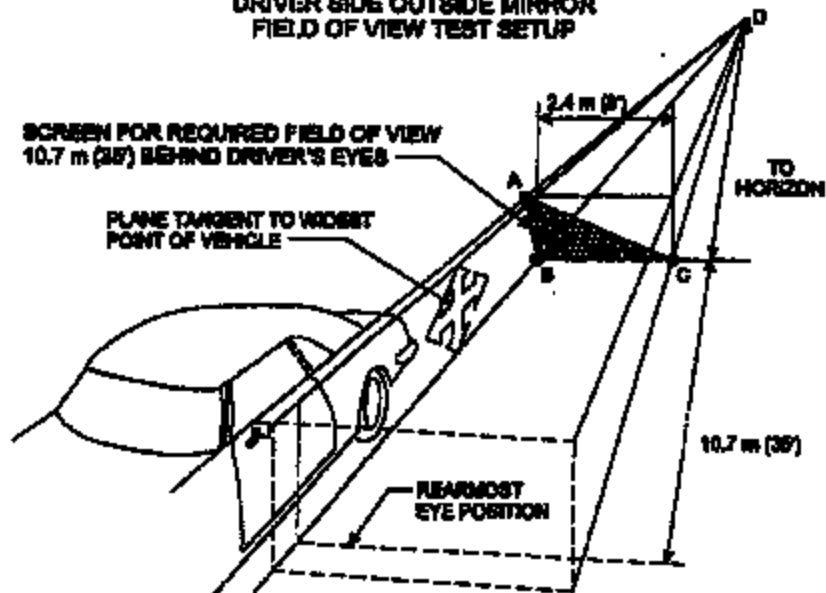
DRIVER SIDE OUTSIDE MIRROR  
FIELD OF VIEW TEST SETUP

HEIGHT OF TARGET DISC ON MIRROR 1040 mm

DISTANCE OF TARGET DISC ON MIRROR FROM VEHICLE TANGENT PLANE 37 mm

ENTIRE TRIANGULAR TEST TARGET AREA ON SCREEN VISIBLE YES X NO \_\_\_

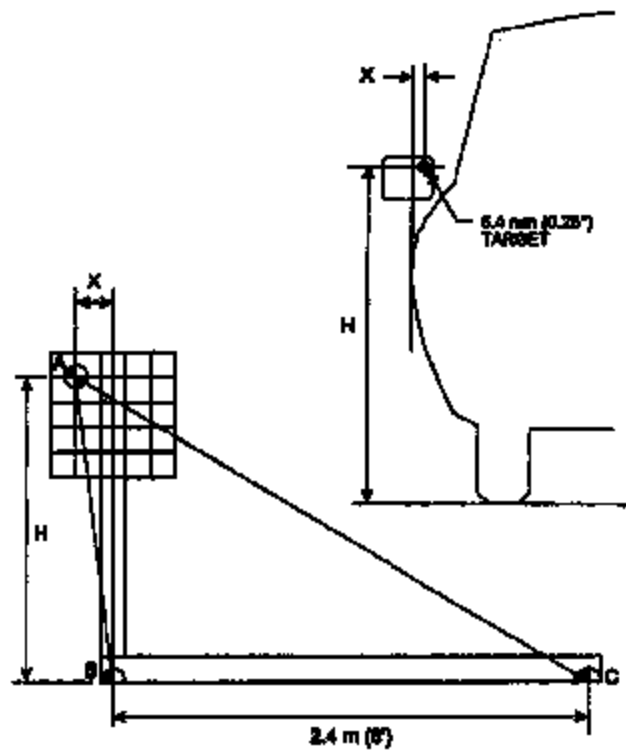
**DRIVER SIDE OUTSIDE MIRROR TARGET DISC LOCATION WITH X AND H DIMENSIONS**

TARGET DISC LOCATION RELATIVE TO VEHICLE TANGENT PLANE INBOARD  
(Inboard or Outboard)

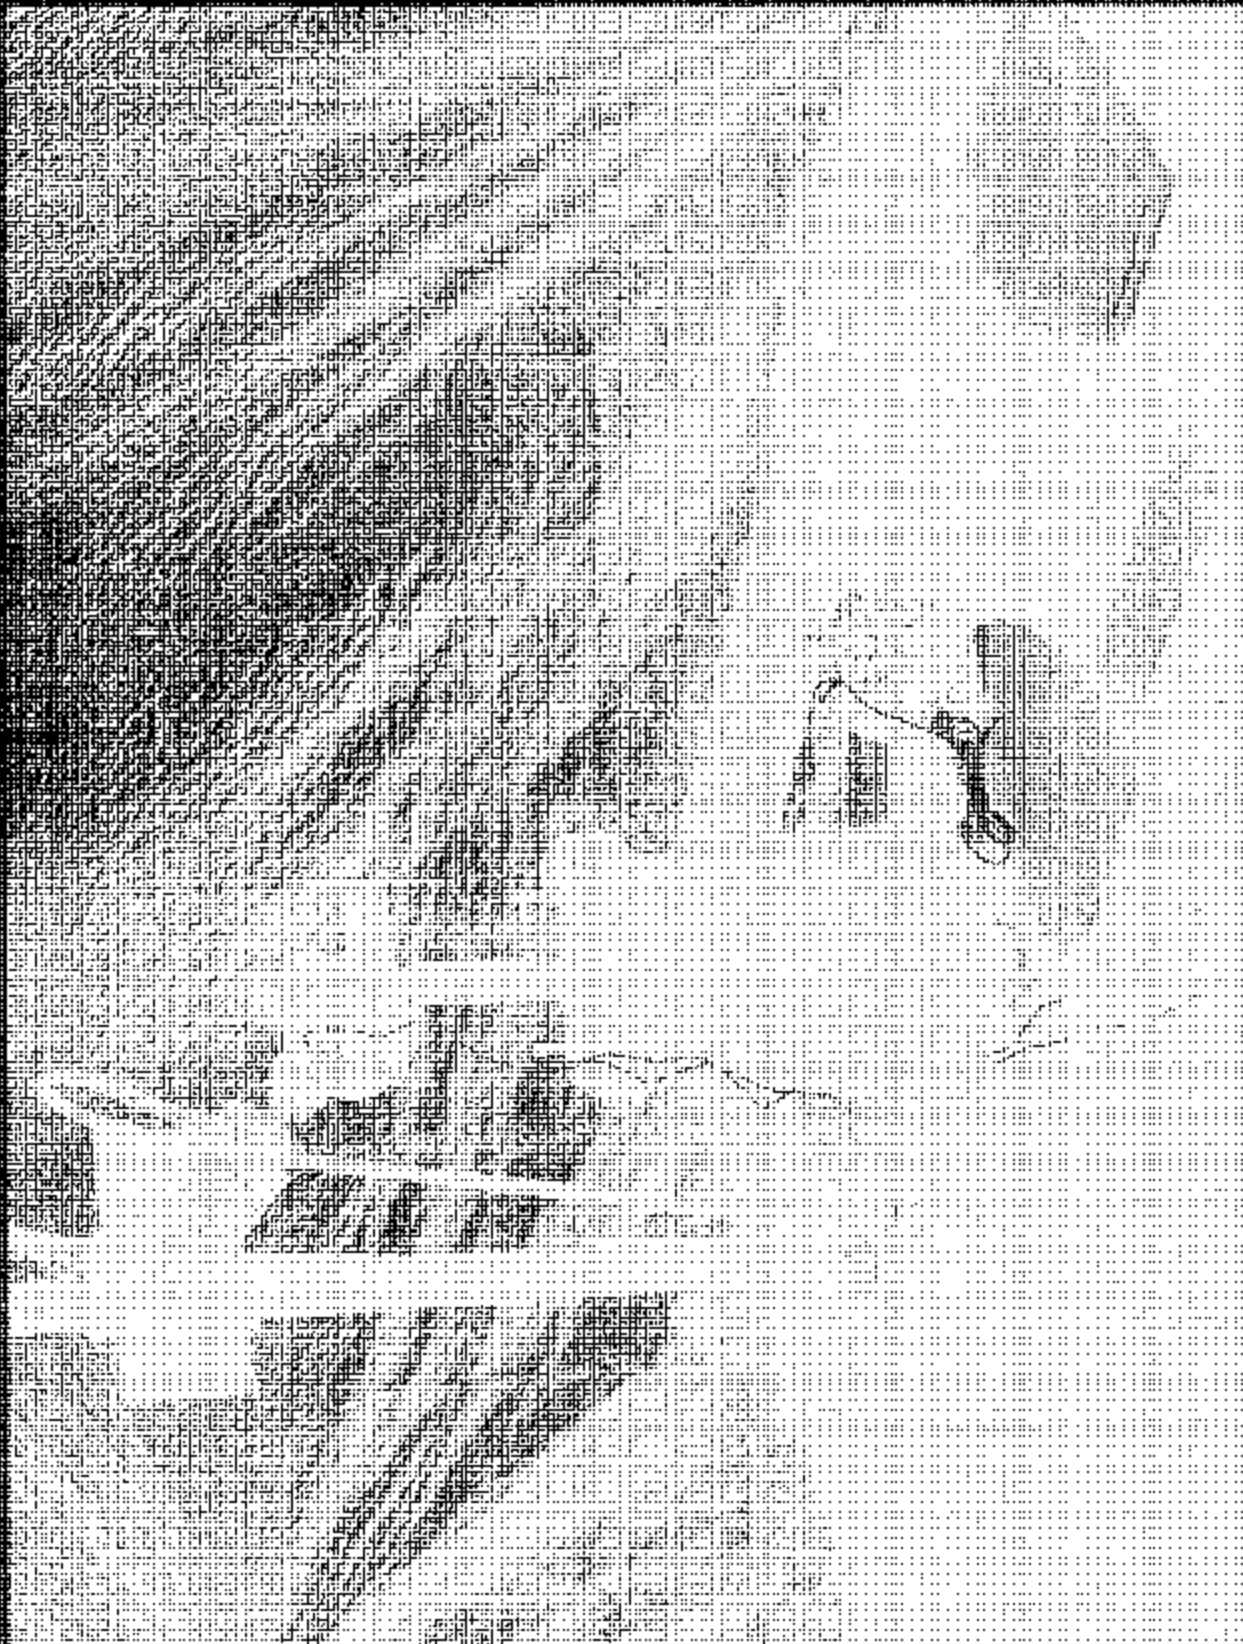
204 CHEVROLET MALIBU FIBER & OVERALL SET-UP FOR MIRROR BREAK AWAY TEST

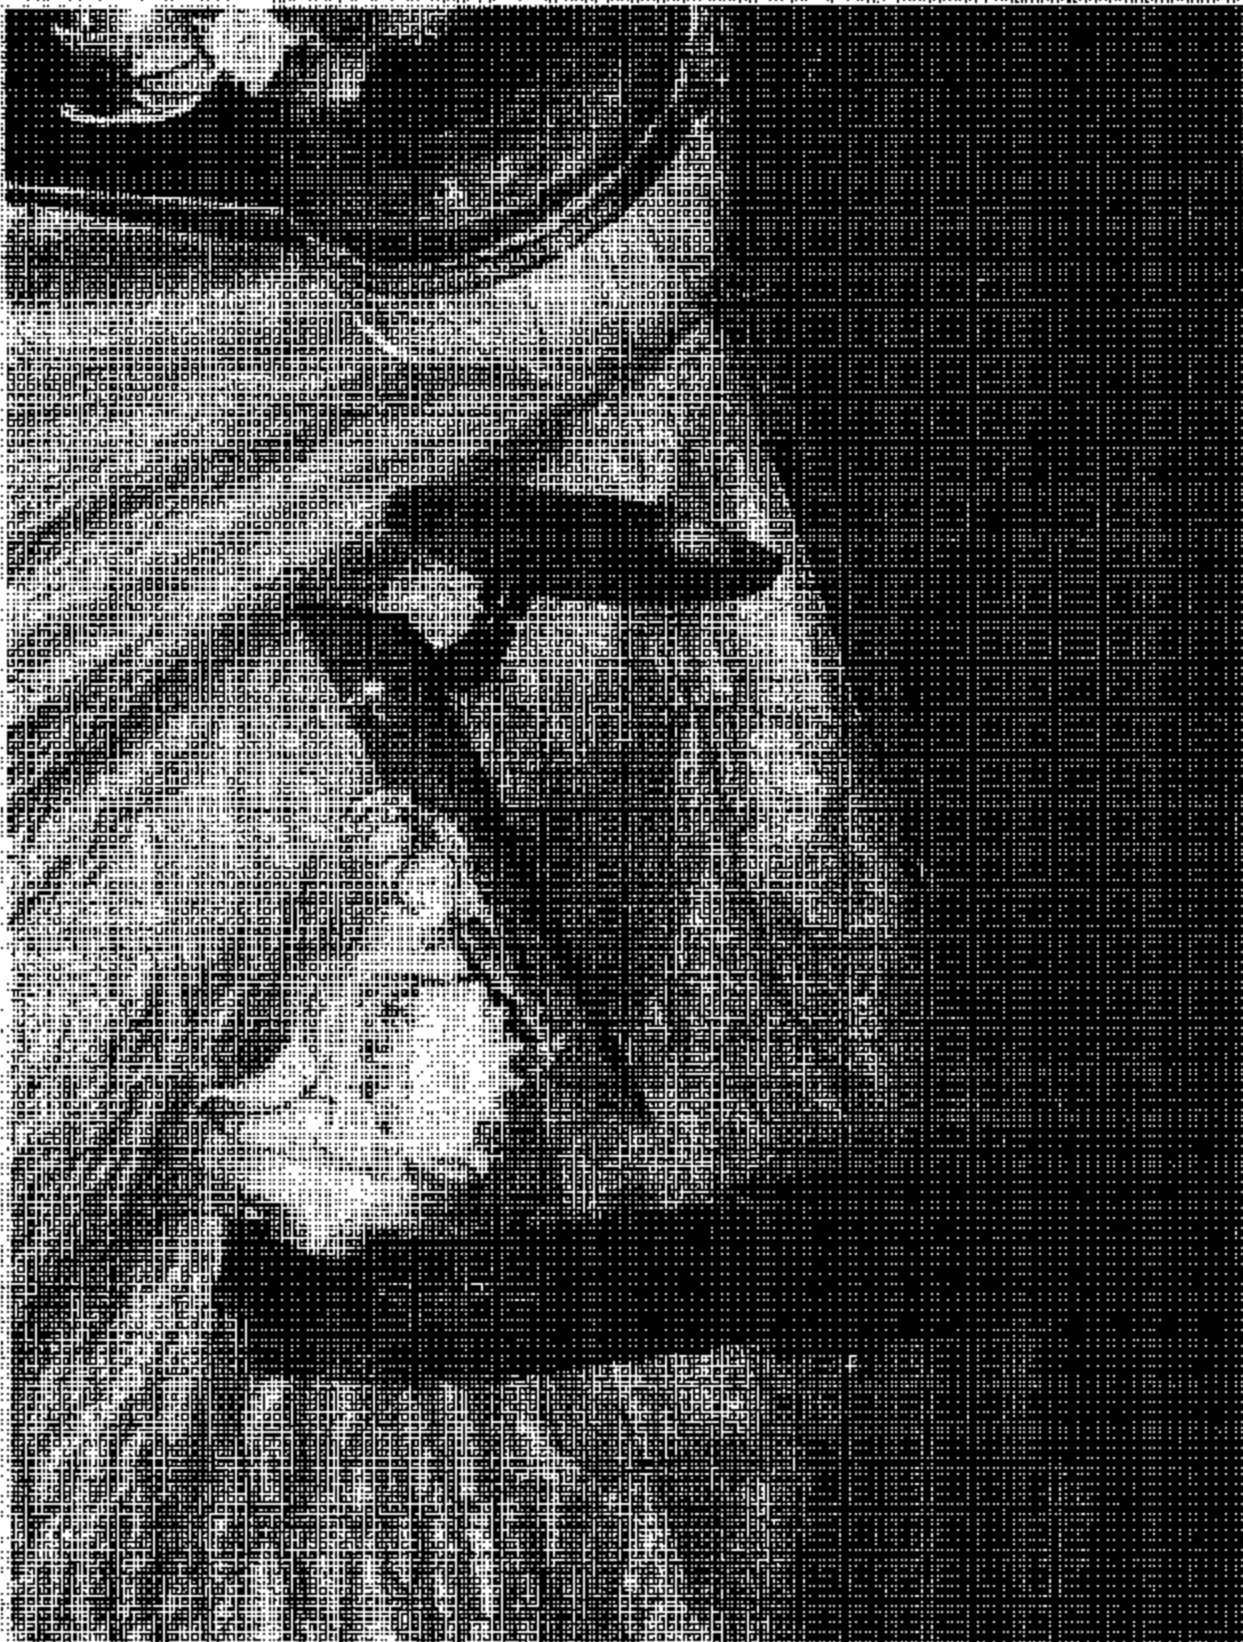
FIGURE 13: CLOSE-UP OF MIRROR BREAKAWAY TEST

**BREAKAWAY TEST - INSIDE REARVIEW MIRROR FAILURE TYPE - DESCRIPTION:**

**NONE**

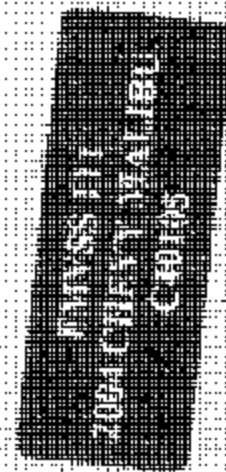
FIGURE 16. MIRROR SETUP FOR AREA MEASUREMENT

MIRRORS	AREA (cm <sup>2</sup> )	REQUIREMENT		RESULTS	
		GVWR < 4536 kg	GVWR > 4536 kg	PASS	FAIL
Outside Driver's Side	187.09 cm <sup>2</sup>	126 cm <sup>2</sup>	323cm <sup>2</sup>	X	
Outside Passenger Side	164.83 cm <sup>2</sup>	126 cm <sup>2</sup>	323 cm <sup>2</sup>	X

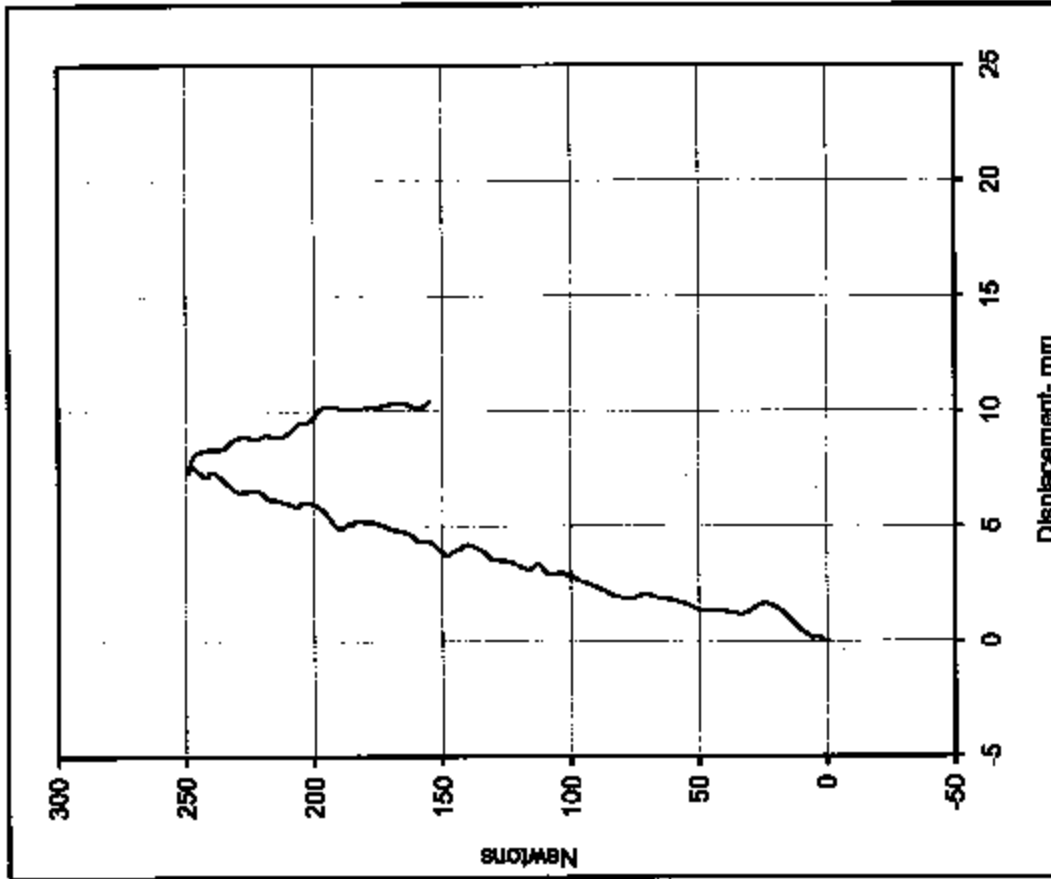
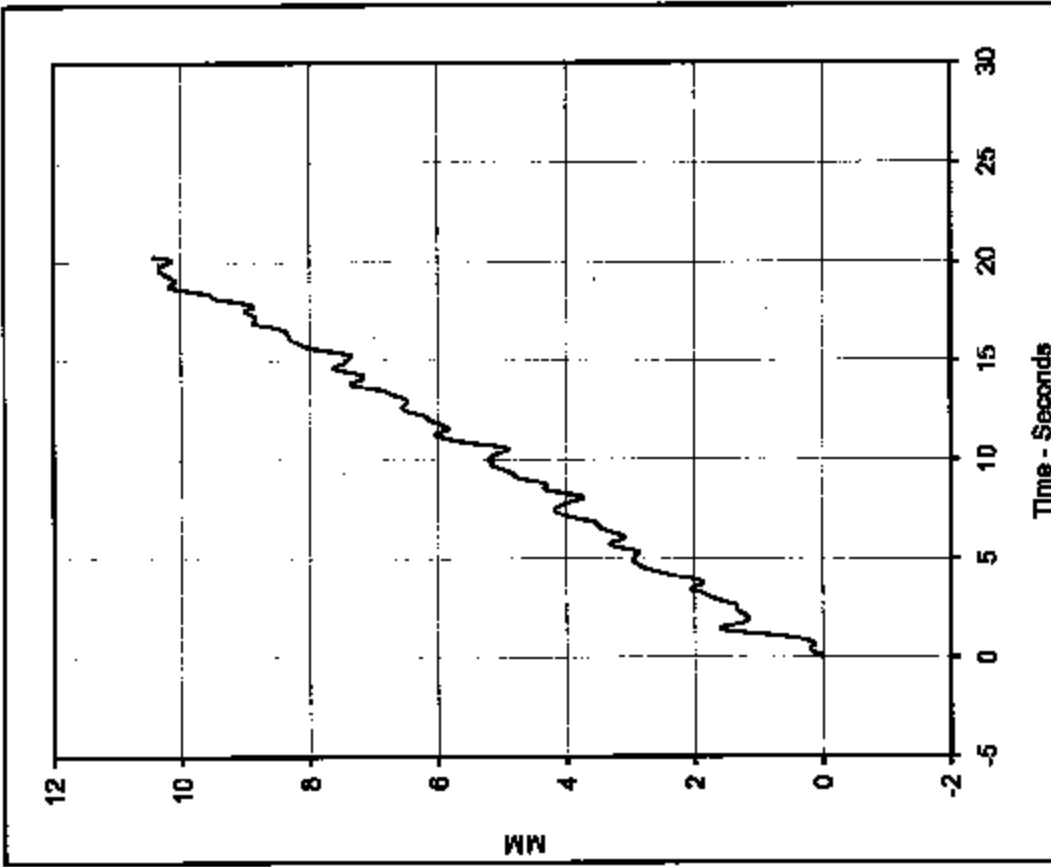
Units	Peak Force	Displacement	Filter (Hz)
Newtons	249.7	7.4	1

Units	Max	Time	Displ. Rate (mm/min.)	Filter (Hz)
MM	10.4	20.3	32.3	1

Load Direction: 0 / 90  
 Test Date: 5/7/04

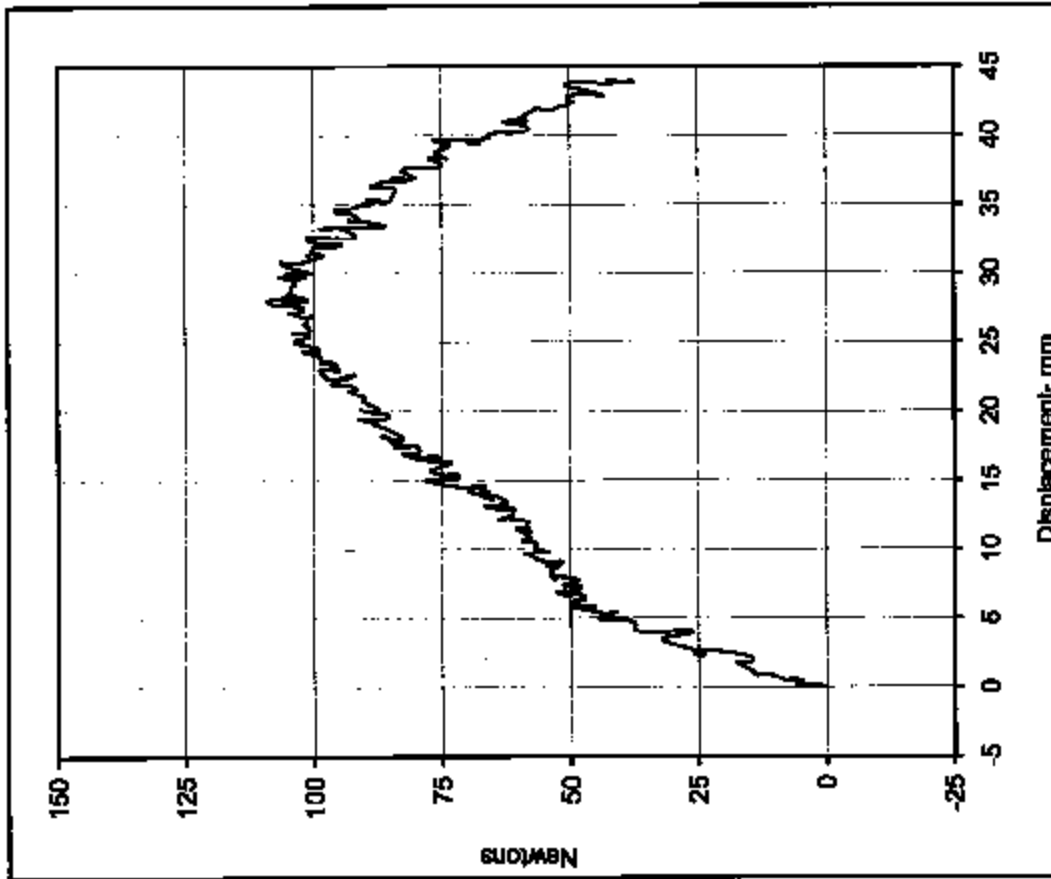
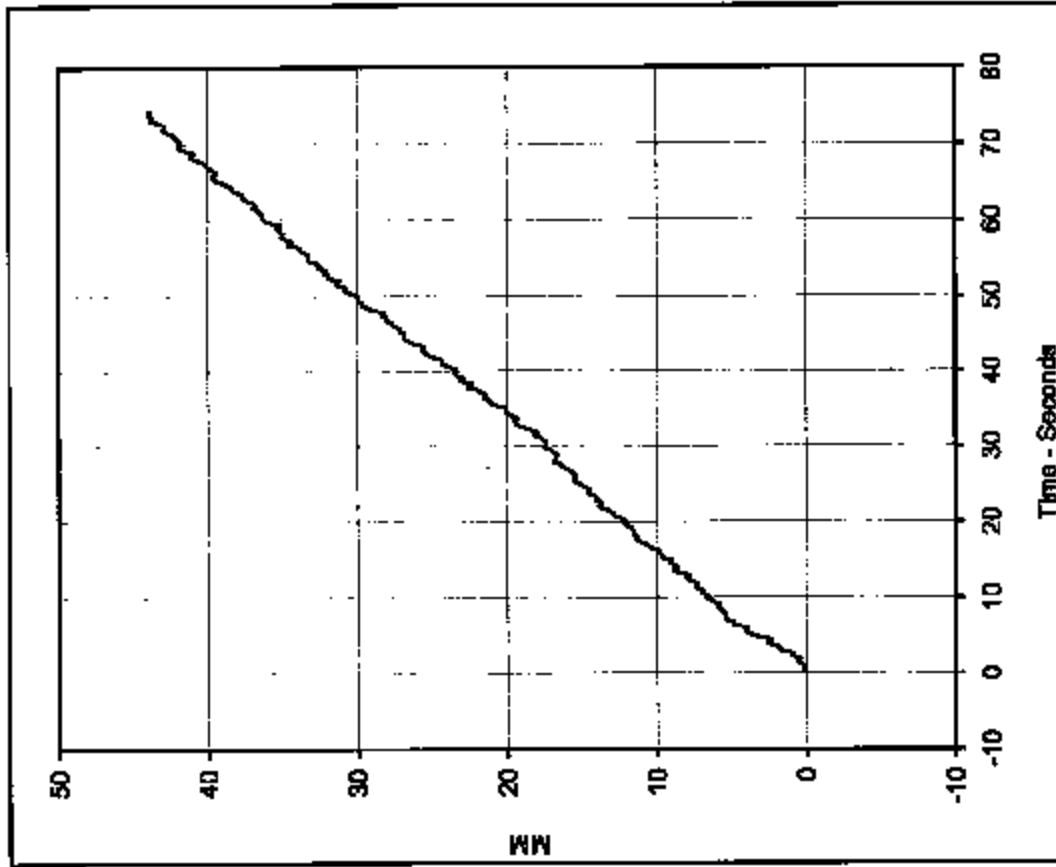
Units	Peak Force	Displacement	Filter (Hz)
Newtons	108.0	28.0	1

Units	Max	Time	Displ. Rate (mm/min.)	Filter (Hz)
MM	44.0	73.9	35.6	1

Load Direction: -45 / +45  
 Test Date: 5/10/04

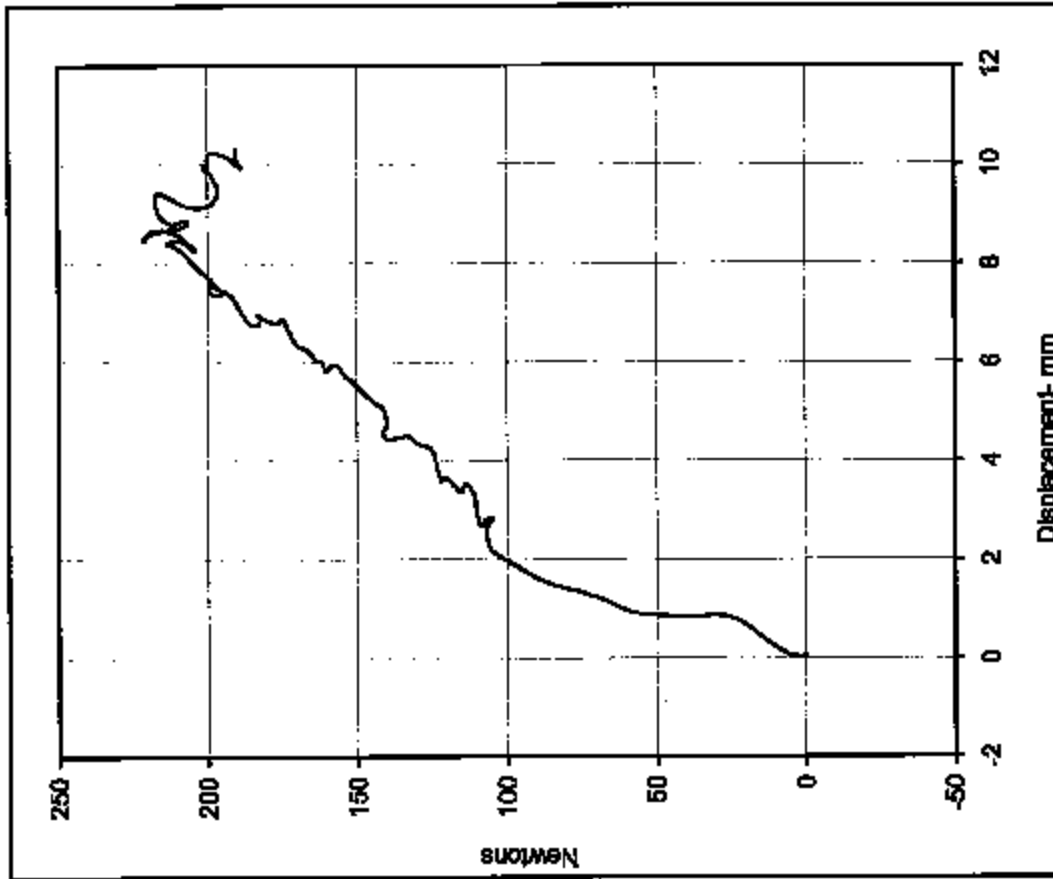
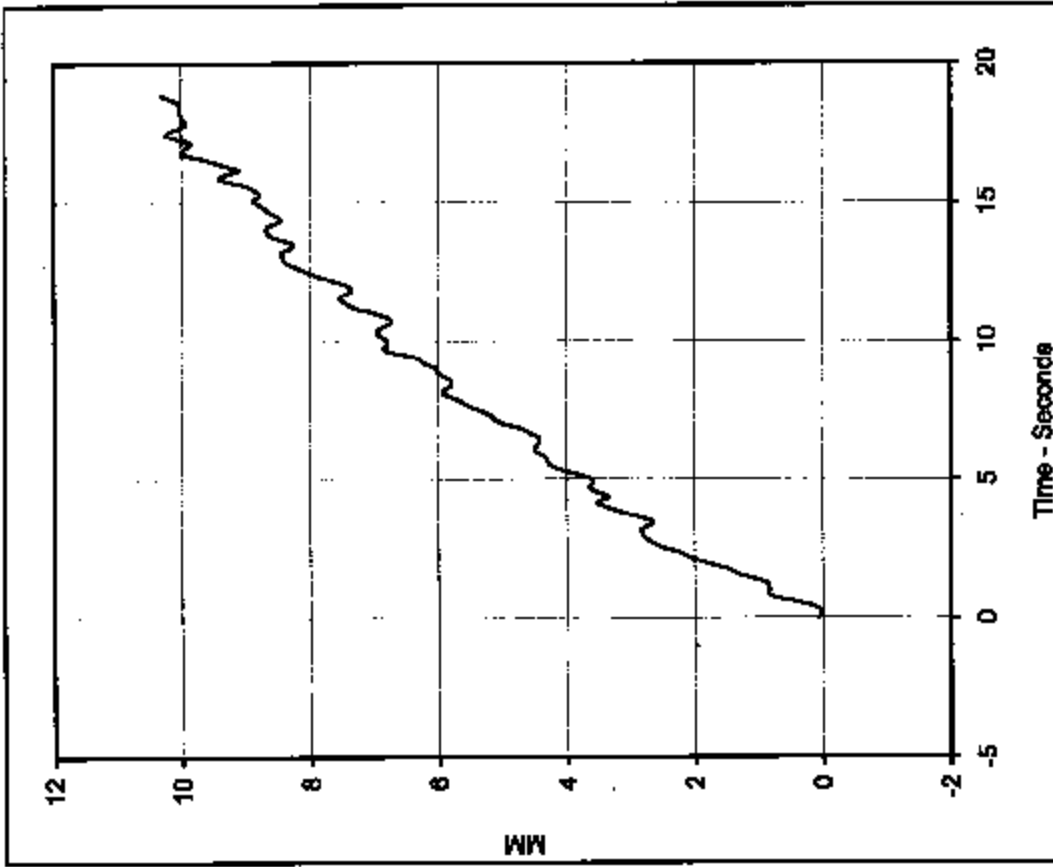
Units	Peak Force	Displacement	Filter (Hz)
Newtons	221.8	8.5	1

Units	Max	Time	Displ. Rate (mm/min.)	Filter (Hz)
MM	10.3	18.9	33.2	1

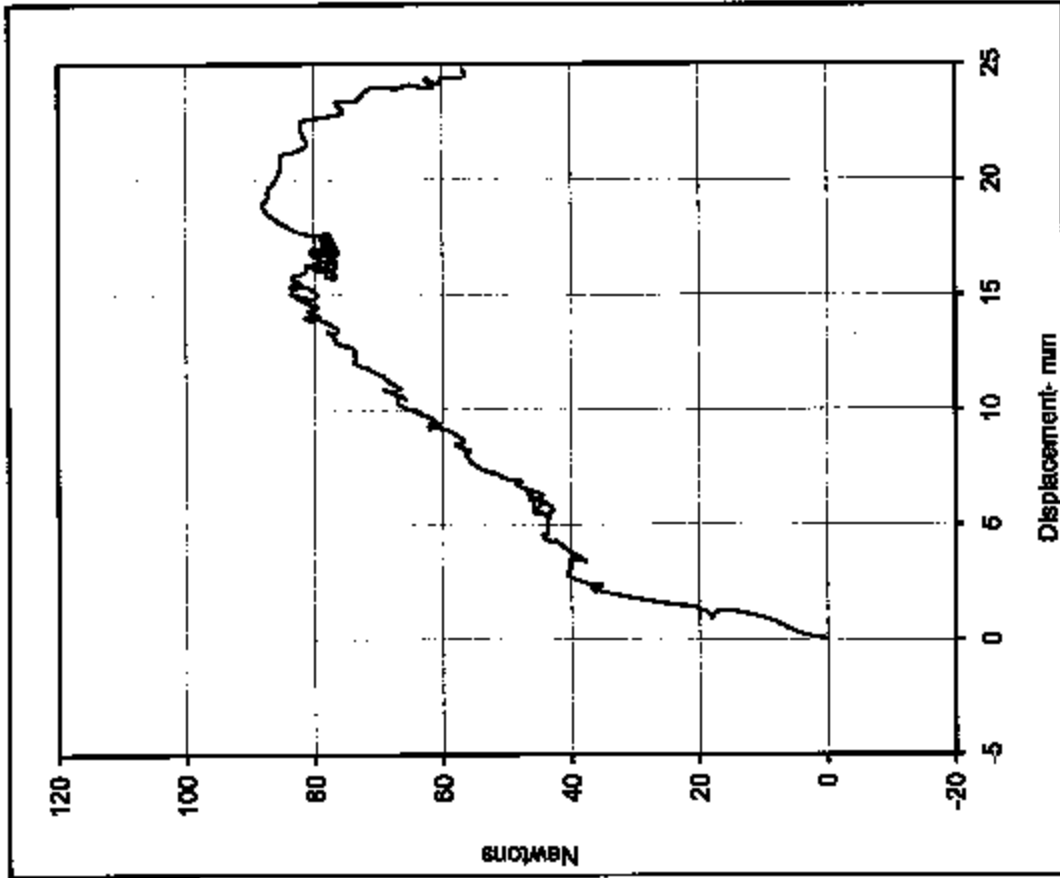
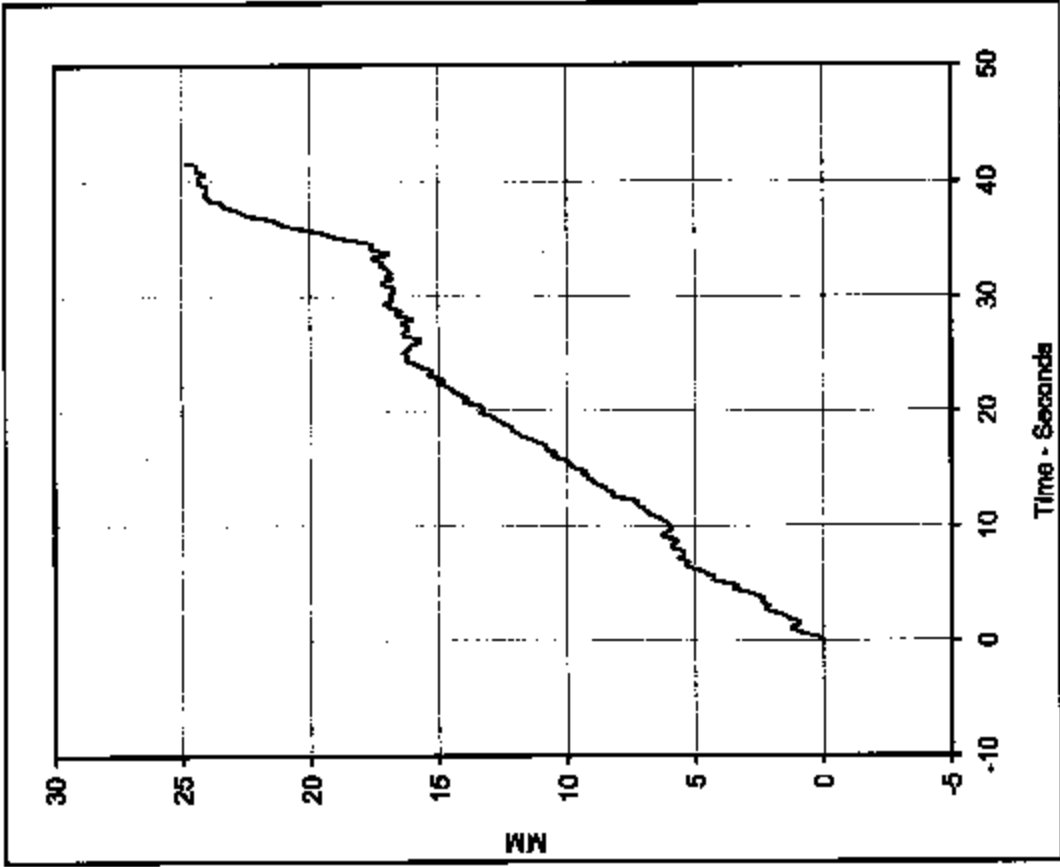
Units	Peak Force	Displacement	Filter (Hz)
Newtons	88.0	18.9	1

Units	Max	Time	Displ. Rate (mm/min.)	Filter (Hz)
MM	24.8	41.6	37.2	1

Load Direction: -45 / 90  
 Test Date: 5/10/04

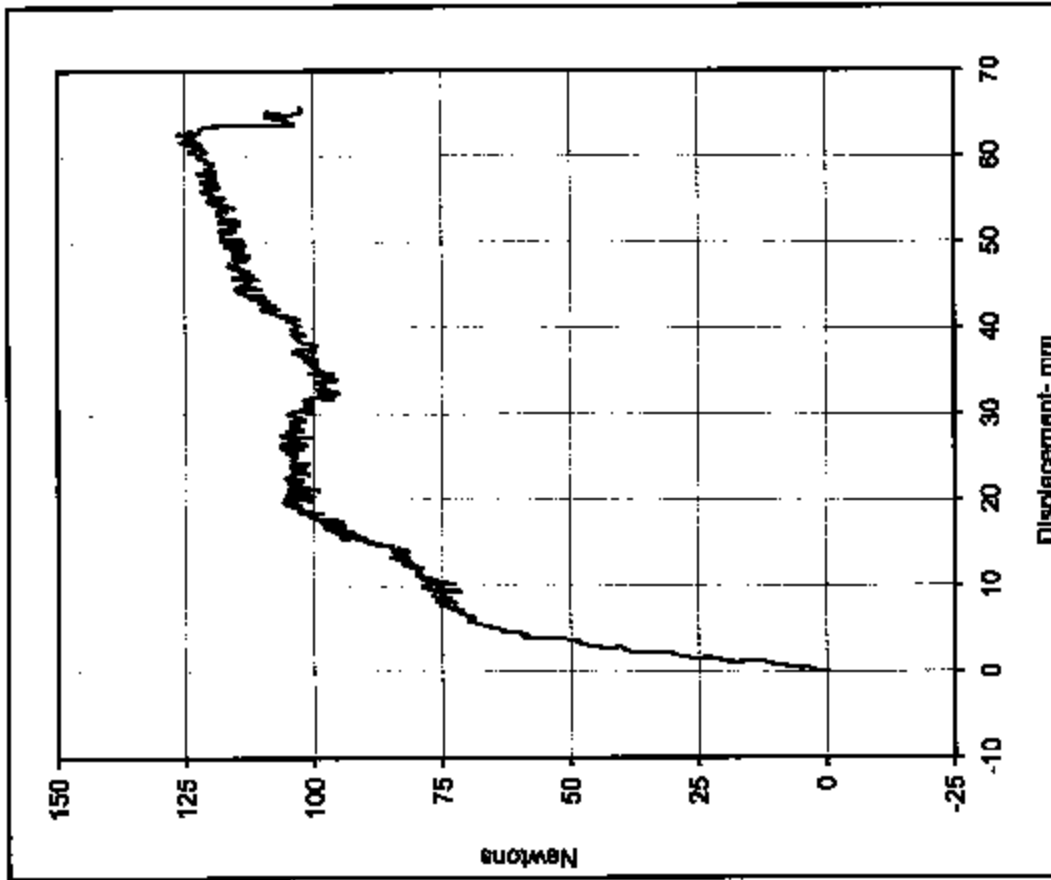
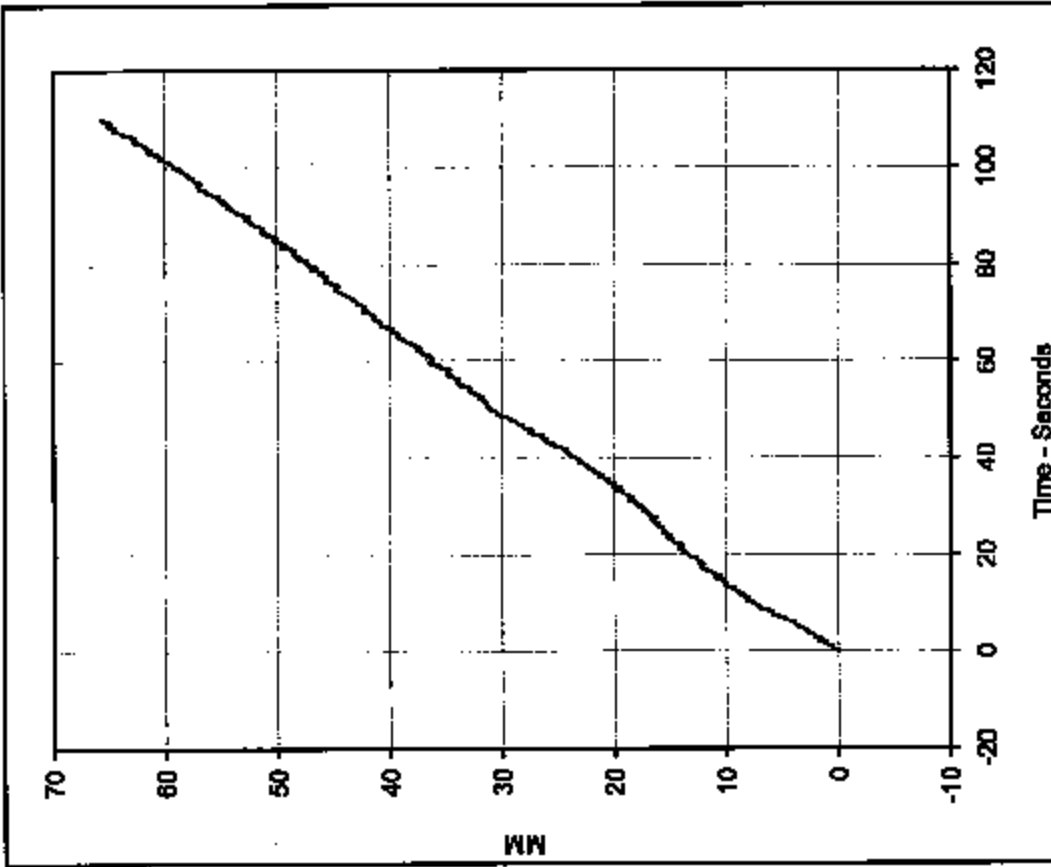
Units	Peak Force	Displacement	Filter (Hz)
Newtons	126.4	62.6	1

Units	Max	Time	Displ. Rate (mm/min.)	Filter (Hz)
MM	65.7	108.9	35.8	1

Load Direction: +45 / +45  
 Test Date: 6/10/04

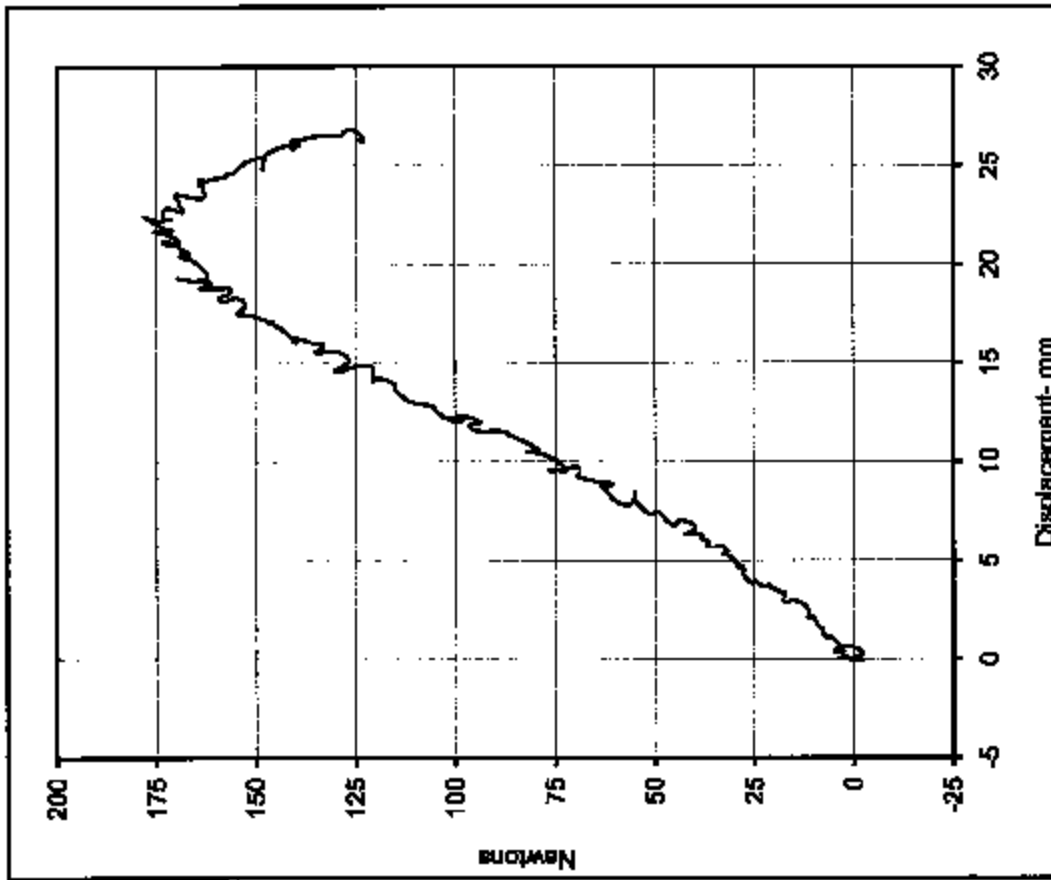
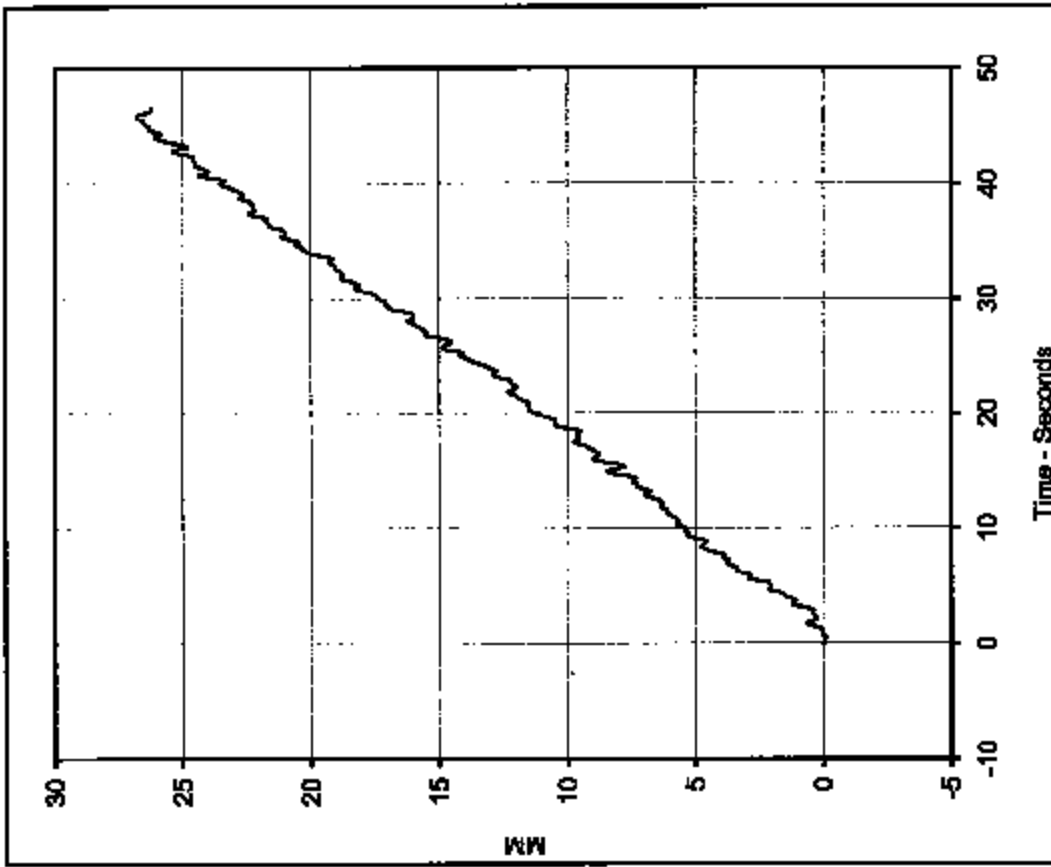
Units	Peak Force	Displacement	Filter (Hz)
Newtons	178.1	22.4	1

Units	Max	Time	Displ. Rate (mm/min.)	Filter (Hz)
MM	26.8	45.9	35.1	1

Load Direction: +45 / -45  
 Test Data: 5/17/04

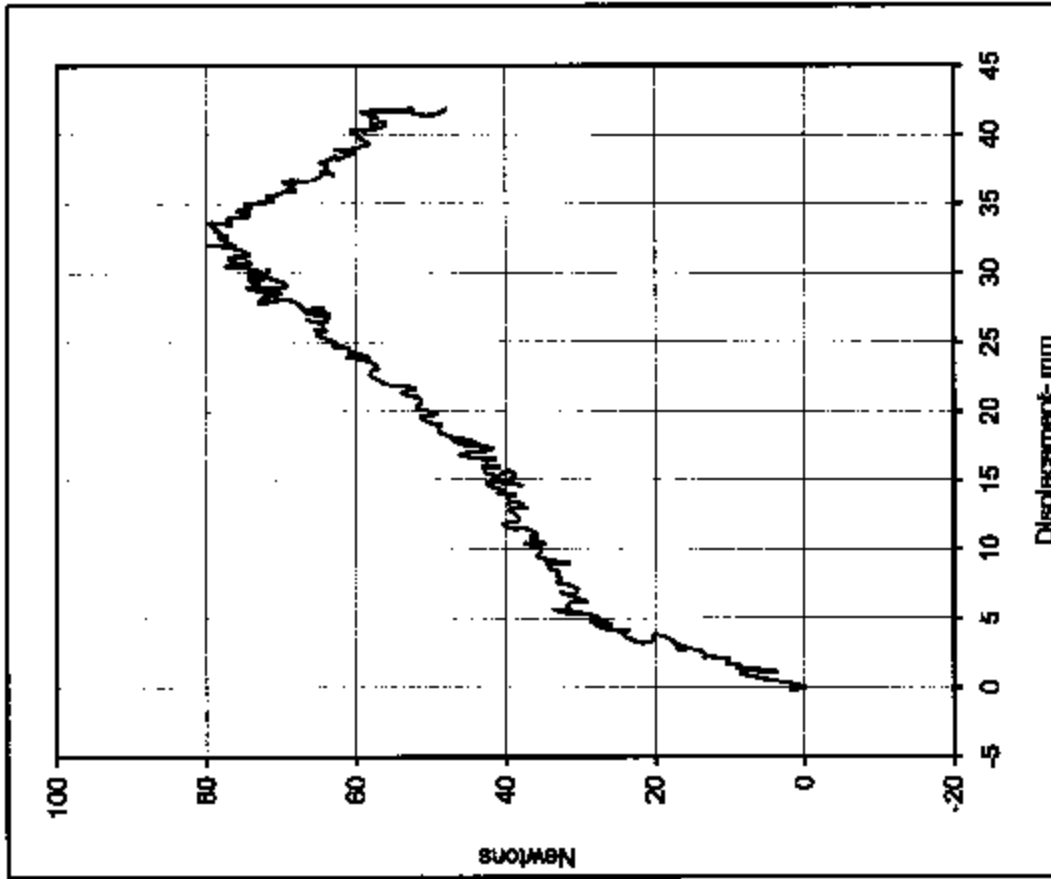
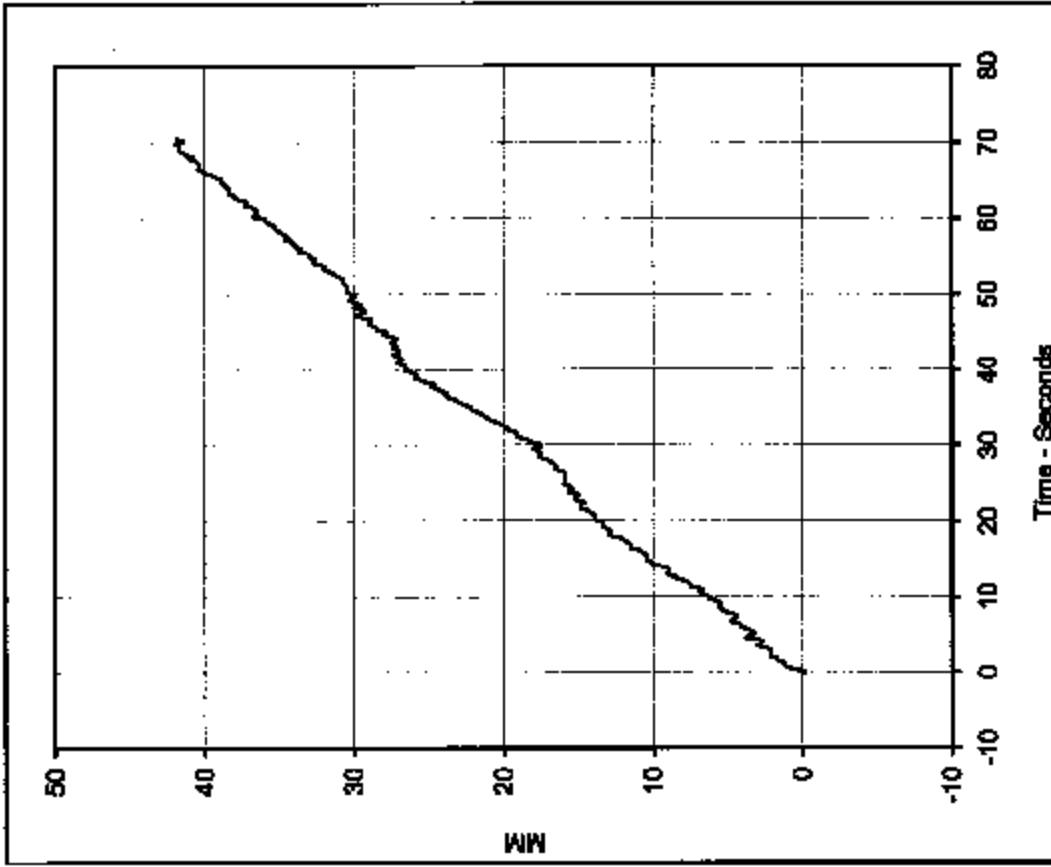
Units	Max	Time	Displ. Rate (mm/min.)	Filter (Hz)
MM	41.9	69.9	36.3	1
