REPORT NUMBER 110-GTL-04-004

**SAFETY COMPLIANCE TESTING FOR
FMVSS NO. 110
TIRE SELECTION AND RIMS**

**GENERAL MOTORS CORPORATION
2004 CHEVROLET MALIBU, PASSENGER CAR
NHTSA NO. C40102**

**GENERAL TESTING LABORATORIES, INC.
1623 LEEDSTOWN ROAD
COLONIAL BEACH, VIRGINIA 22443**

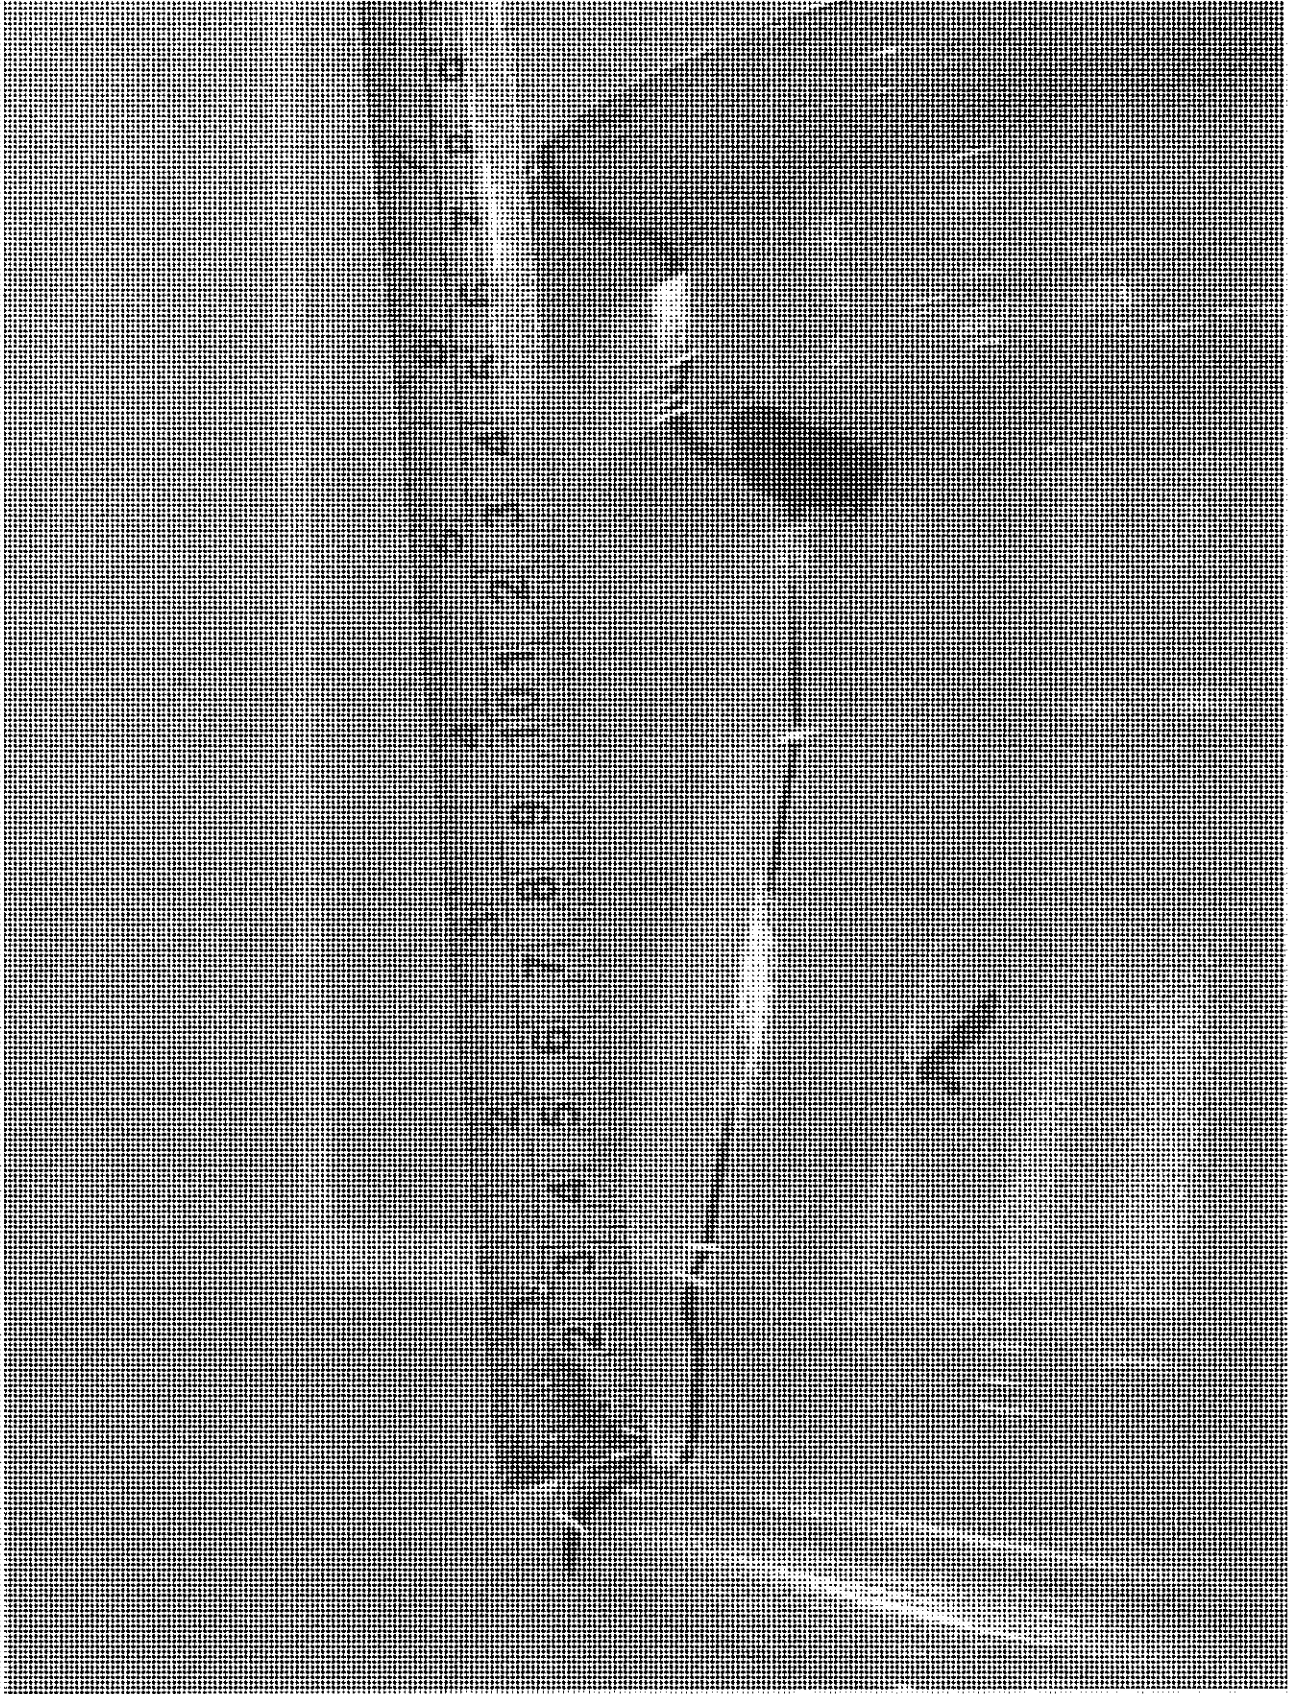
Tire Size	Specfd. Rims	Measured Width of Rims	Measured Height of Rims	PASS/ FAIL
Right Front:	<u>P205/65R15</u>	<u>5.5 to 7.5 J x 15</u>	<u>6.5"</u>	<u>15"</u>	<u>Pass</u>
Left Rear:	<u>P205/65R15</u>	<u>5.5 to 7.5 J x 15</u>	<u>6.5"</u>	<u>15"</u>	<u>Pass</u>

FIGURE 5.12
VIEW OF RIM CONTOUR

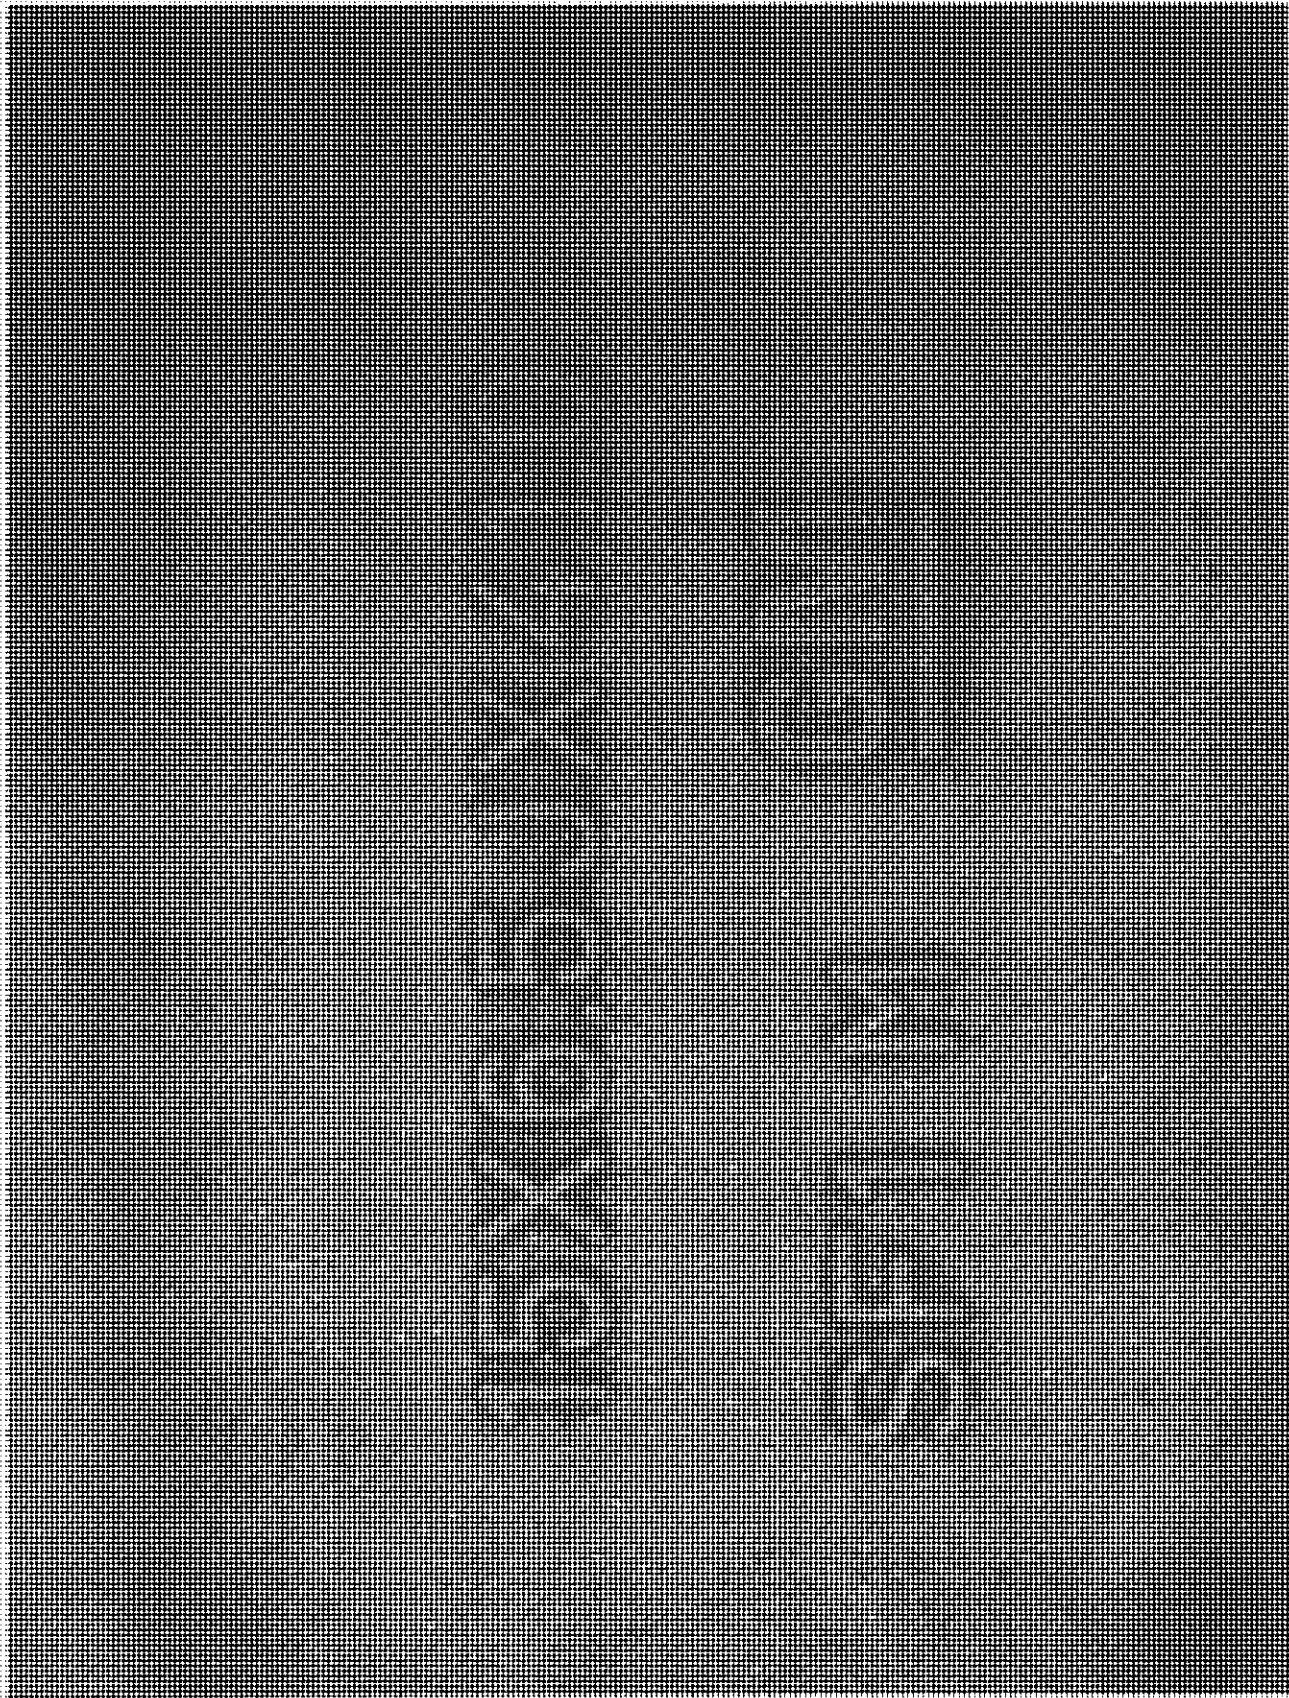
Other Rim/Wheel Marking: 15 x 6.5 JX 41.0, SF1M, DOT-T,

FIGURE 5.13
RIM MARKING (SIZE & MANUFACTURER)

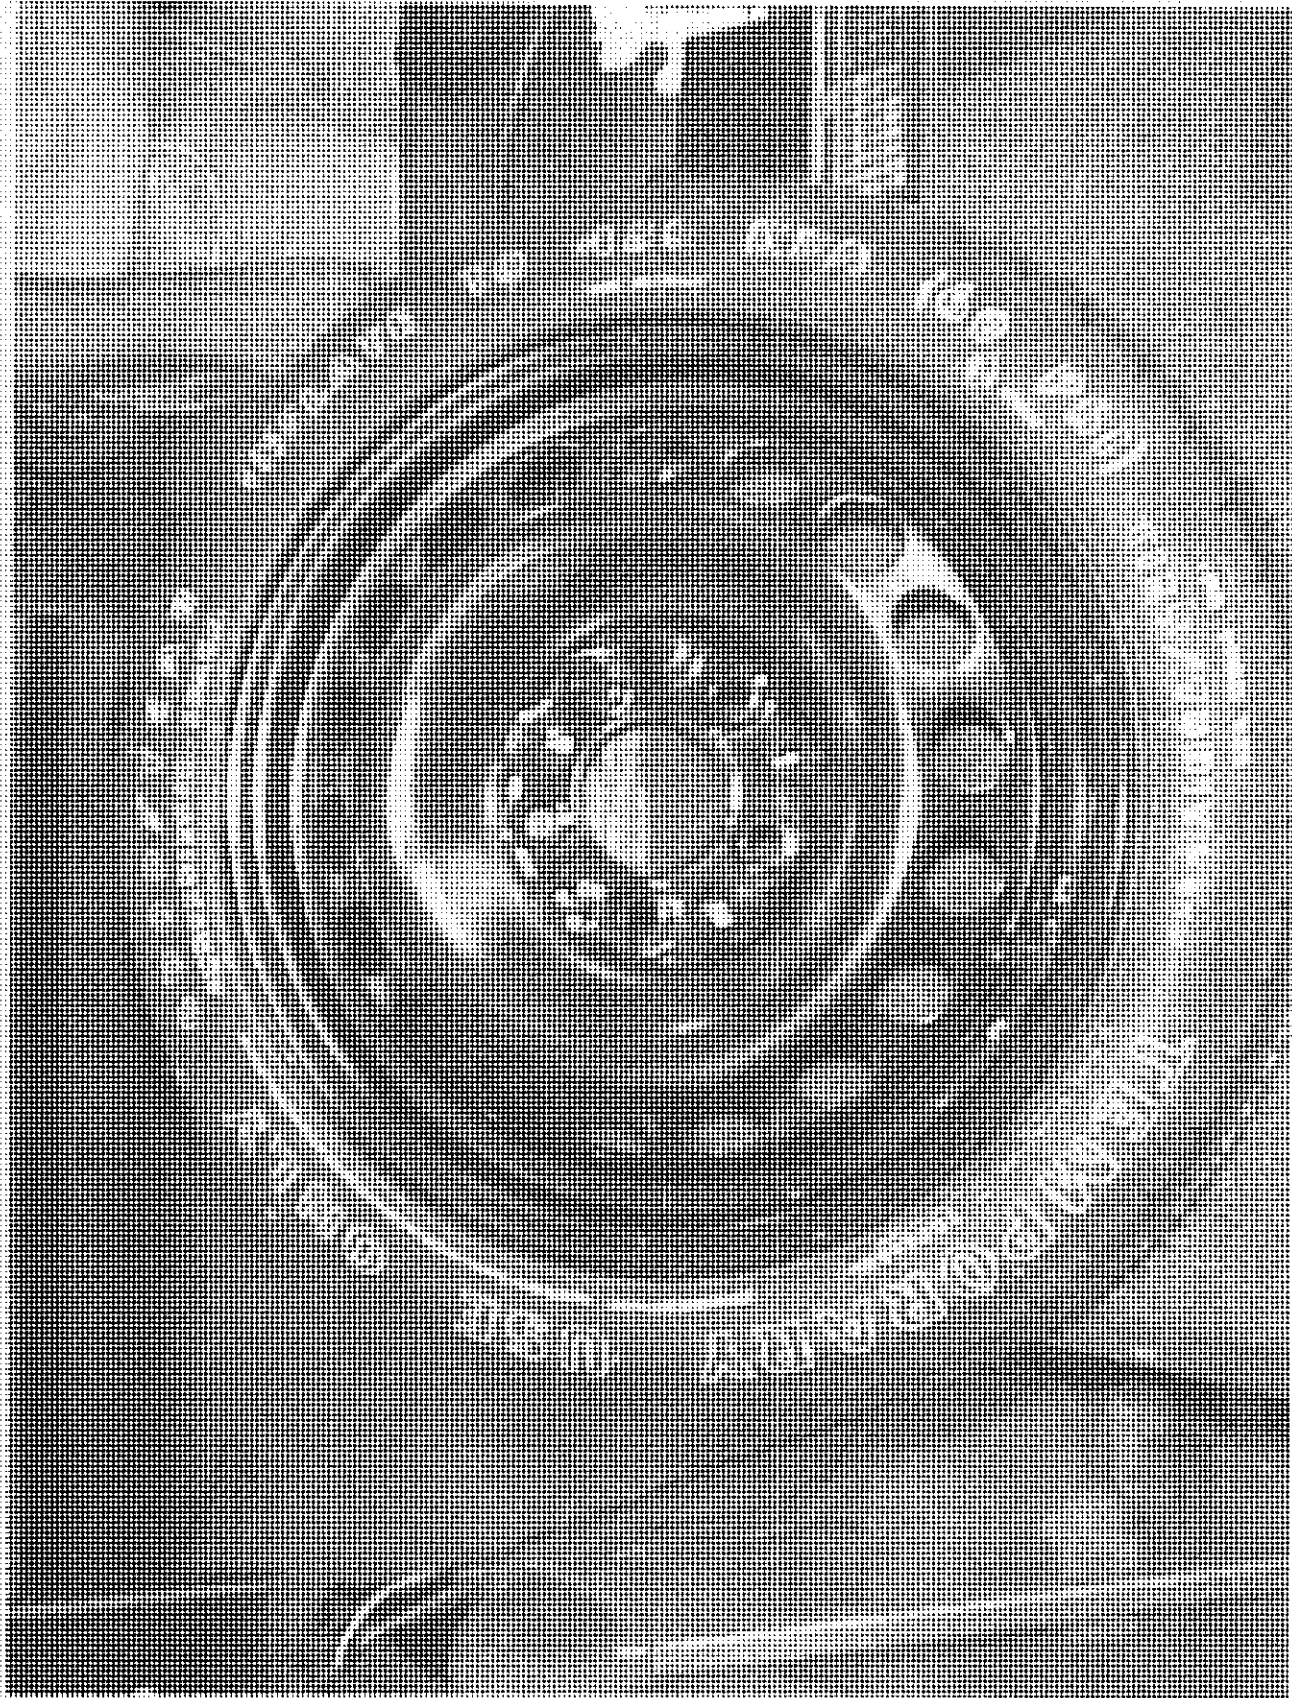
FIGURE 5.18
SPARE TIRE AND MARKINGS

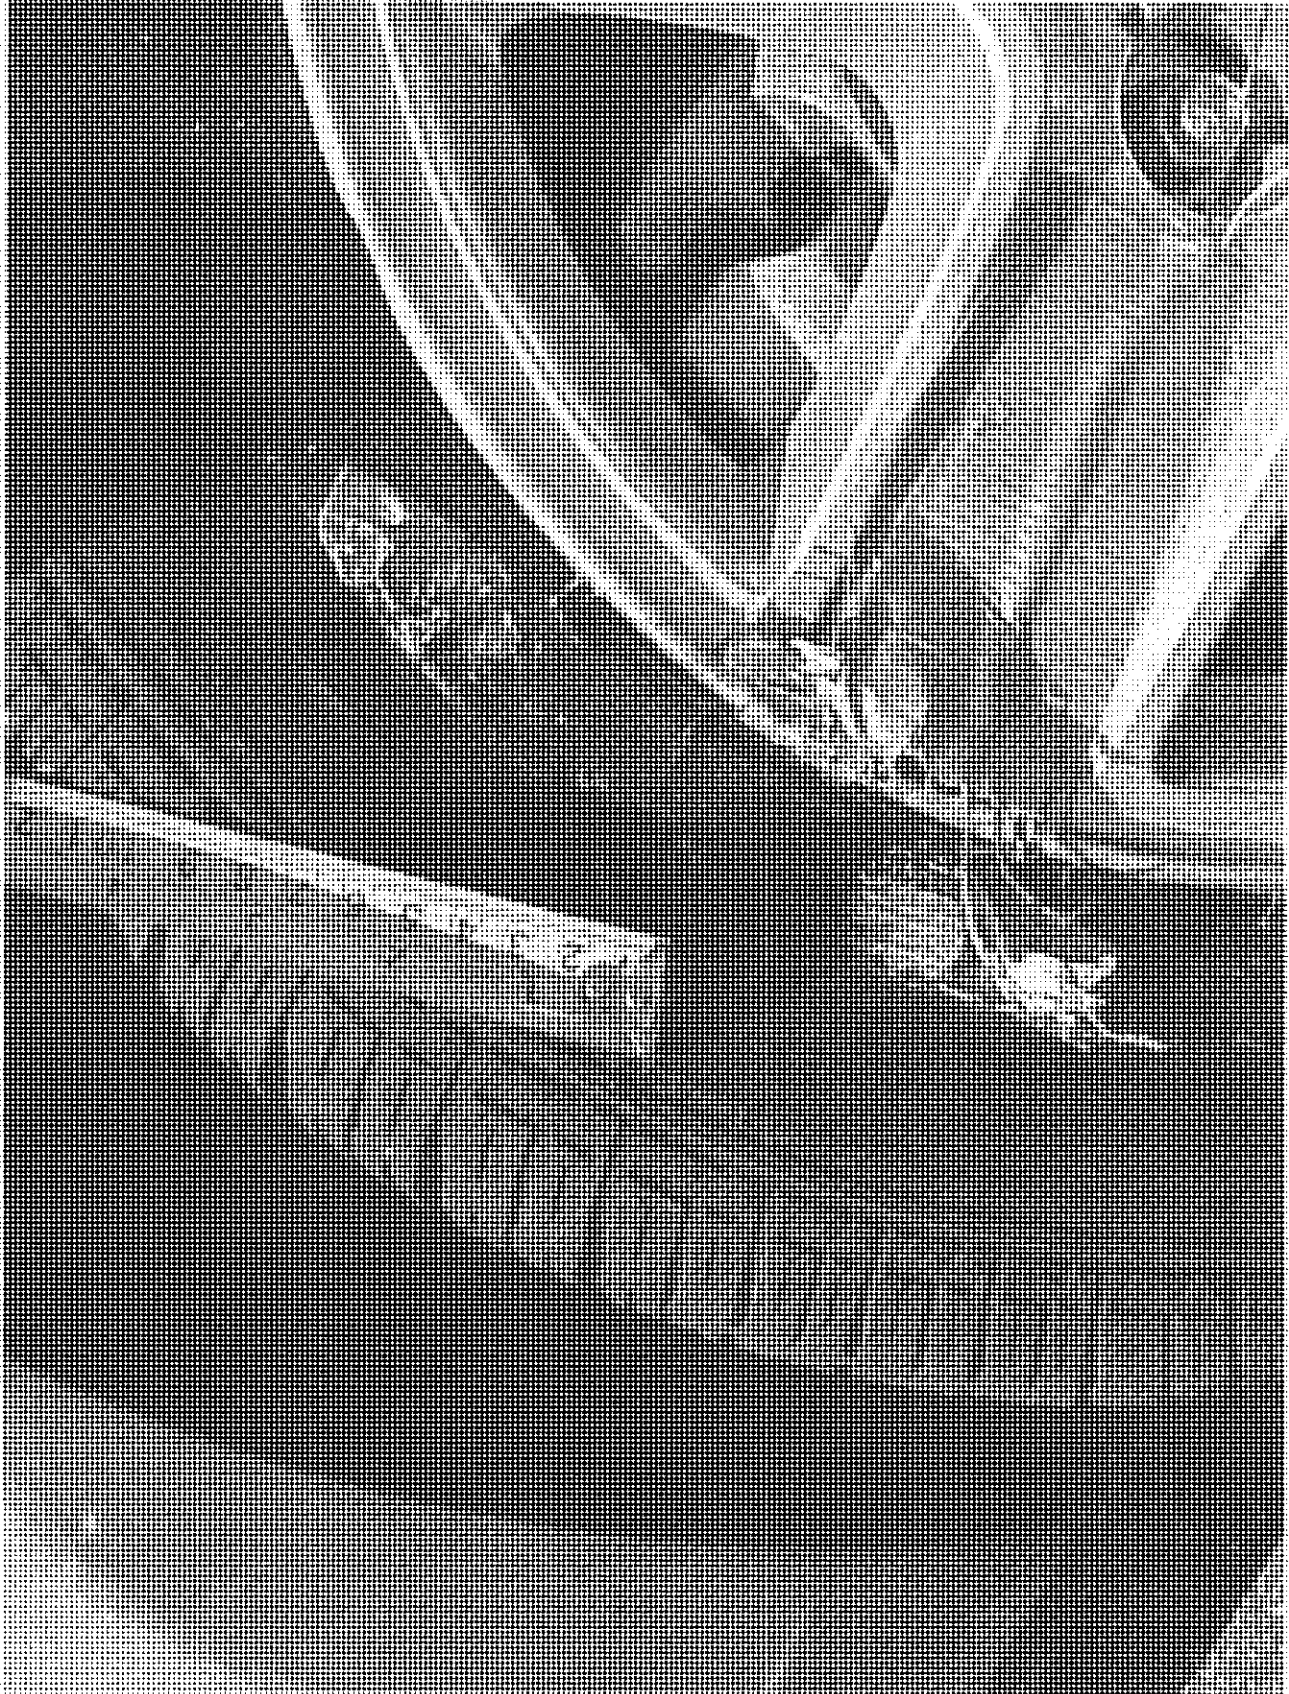
FIGURE 5.19
LEFT FRONT TIRE AFTER BLOW-OUT
WITH RULER NEXT TO HOLE

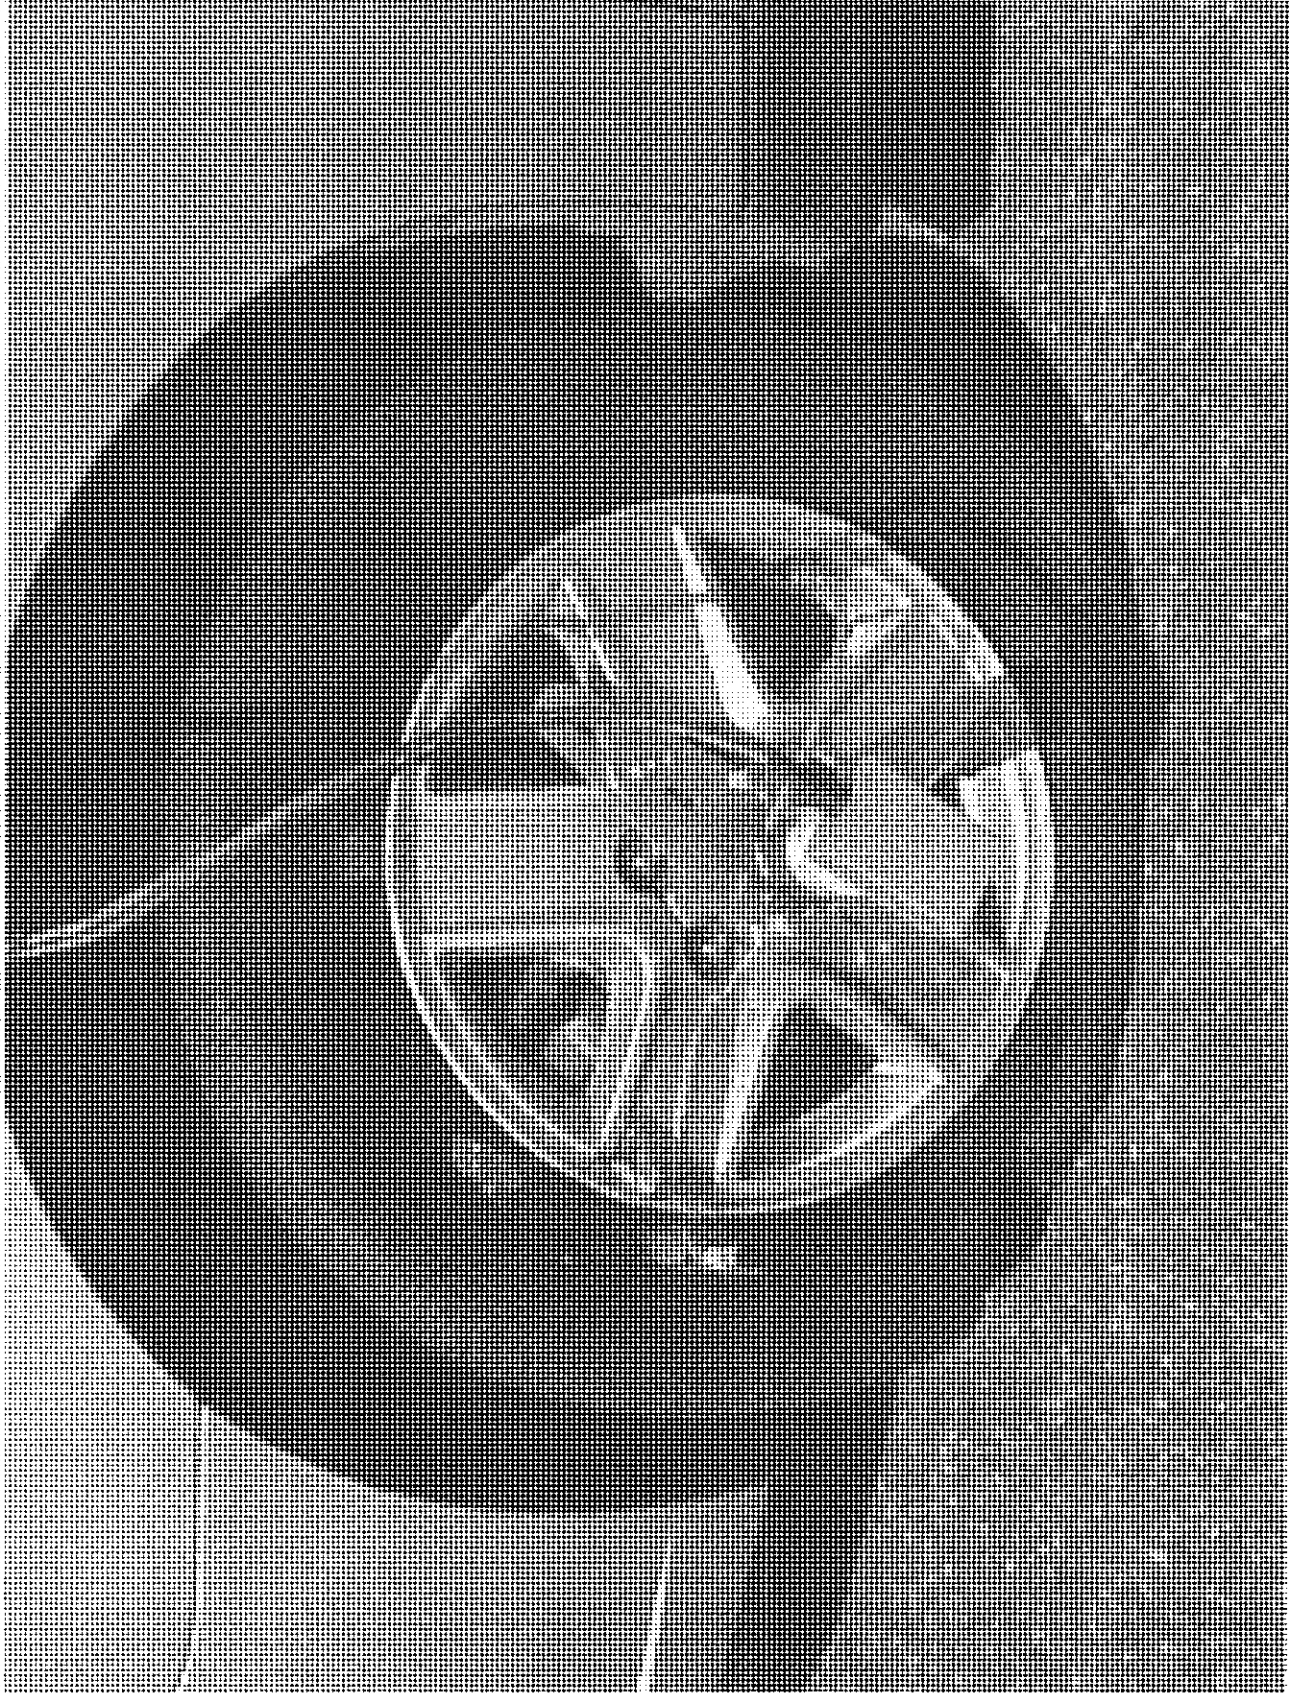
Description of Bead Separation, Outboard: None

FIGURE 5.20
OUTSIDE VIEW OF LEFT FRONT TIRE
AFTER BLOW-OUT

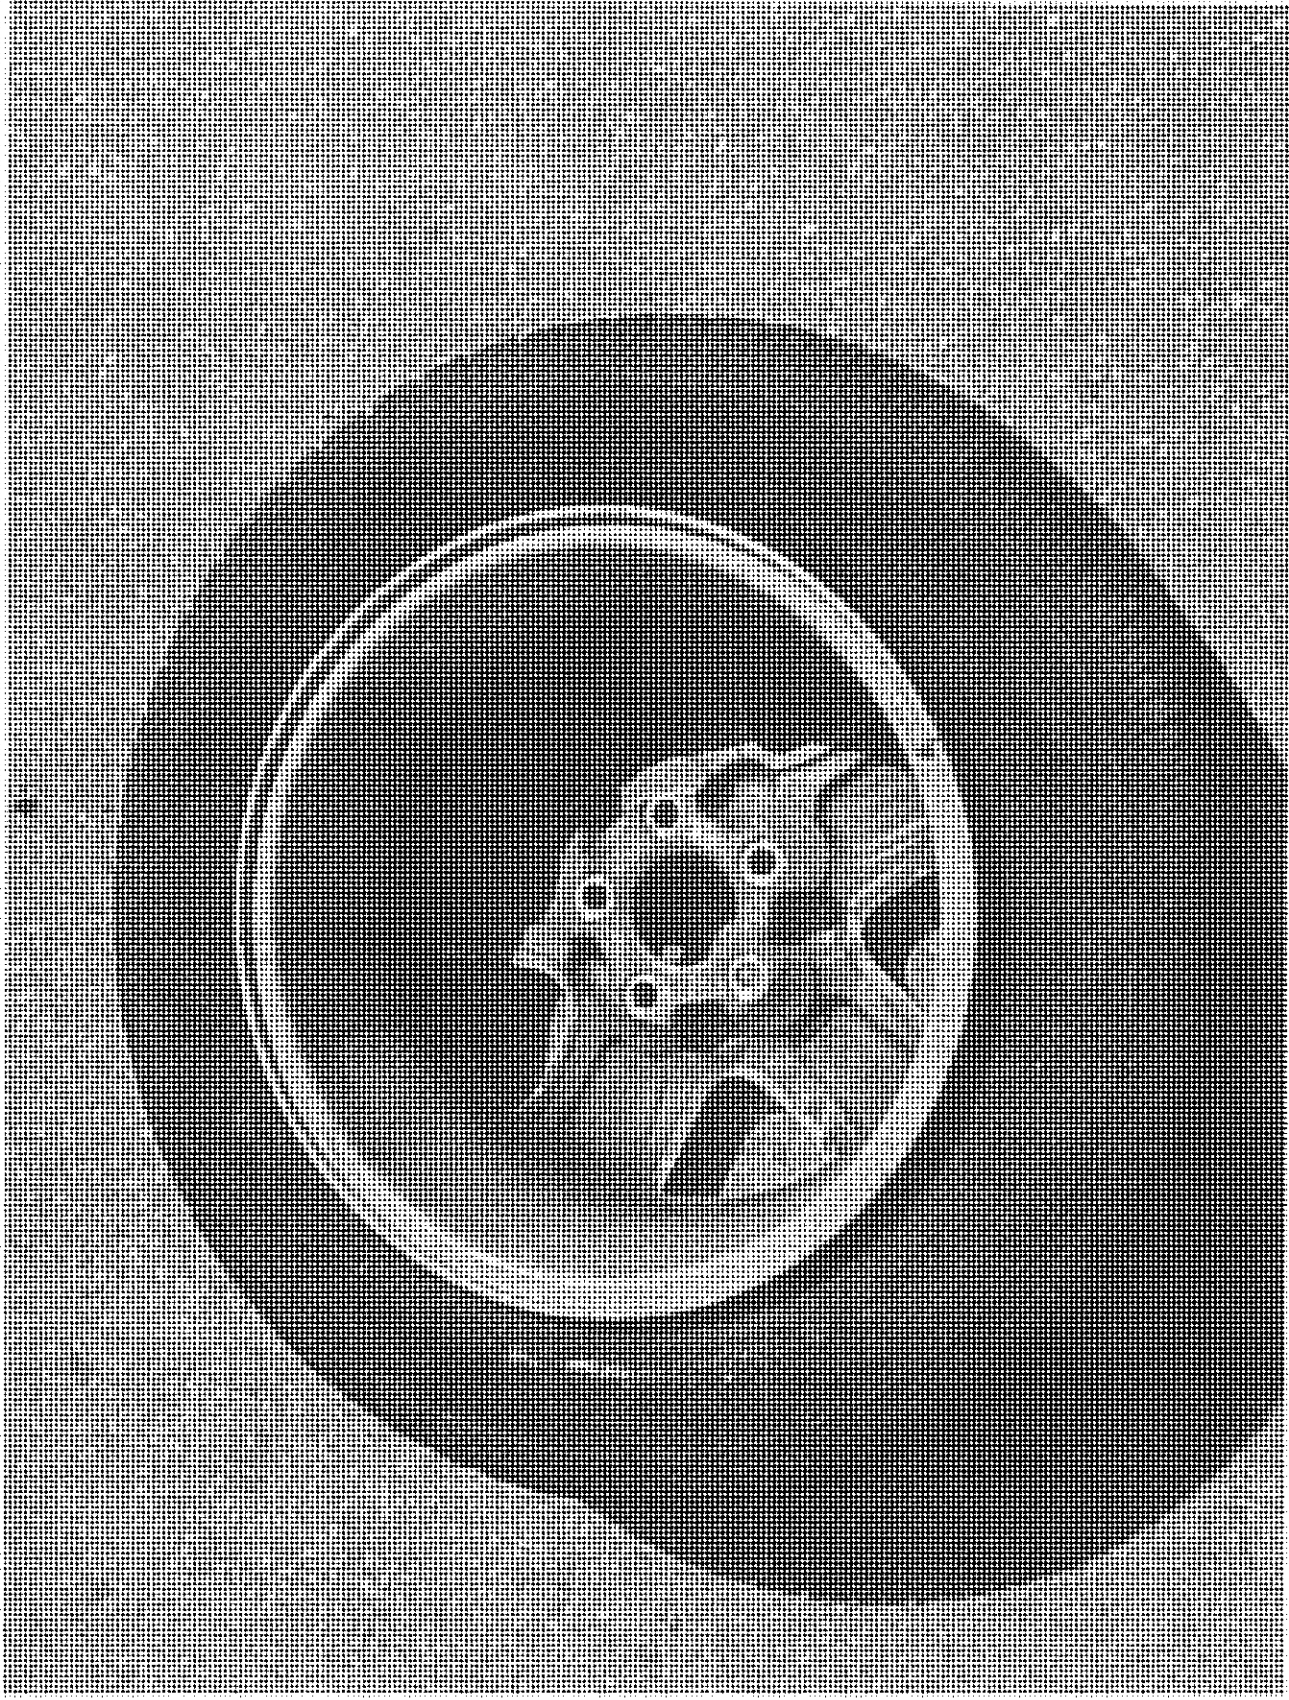
Description of Bead Separation, Inboard: Inboard bead came loose and moved in on rim but tire did not rotate on rim.

FIGURE 5 21
INSIDE VIEW OF LEFT FRONT TIRE
AFTER BLOW-OUT

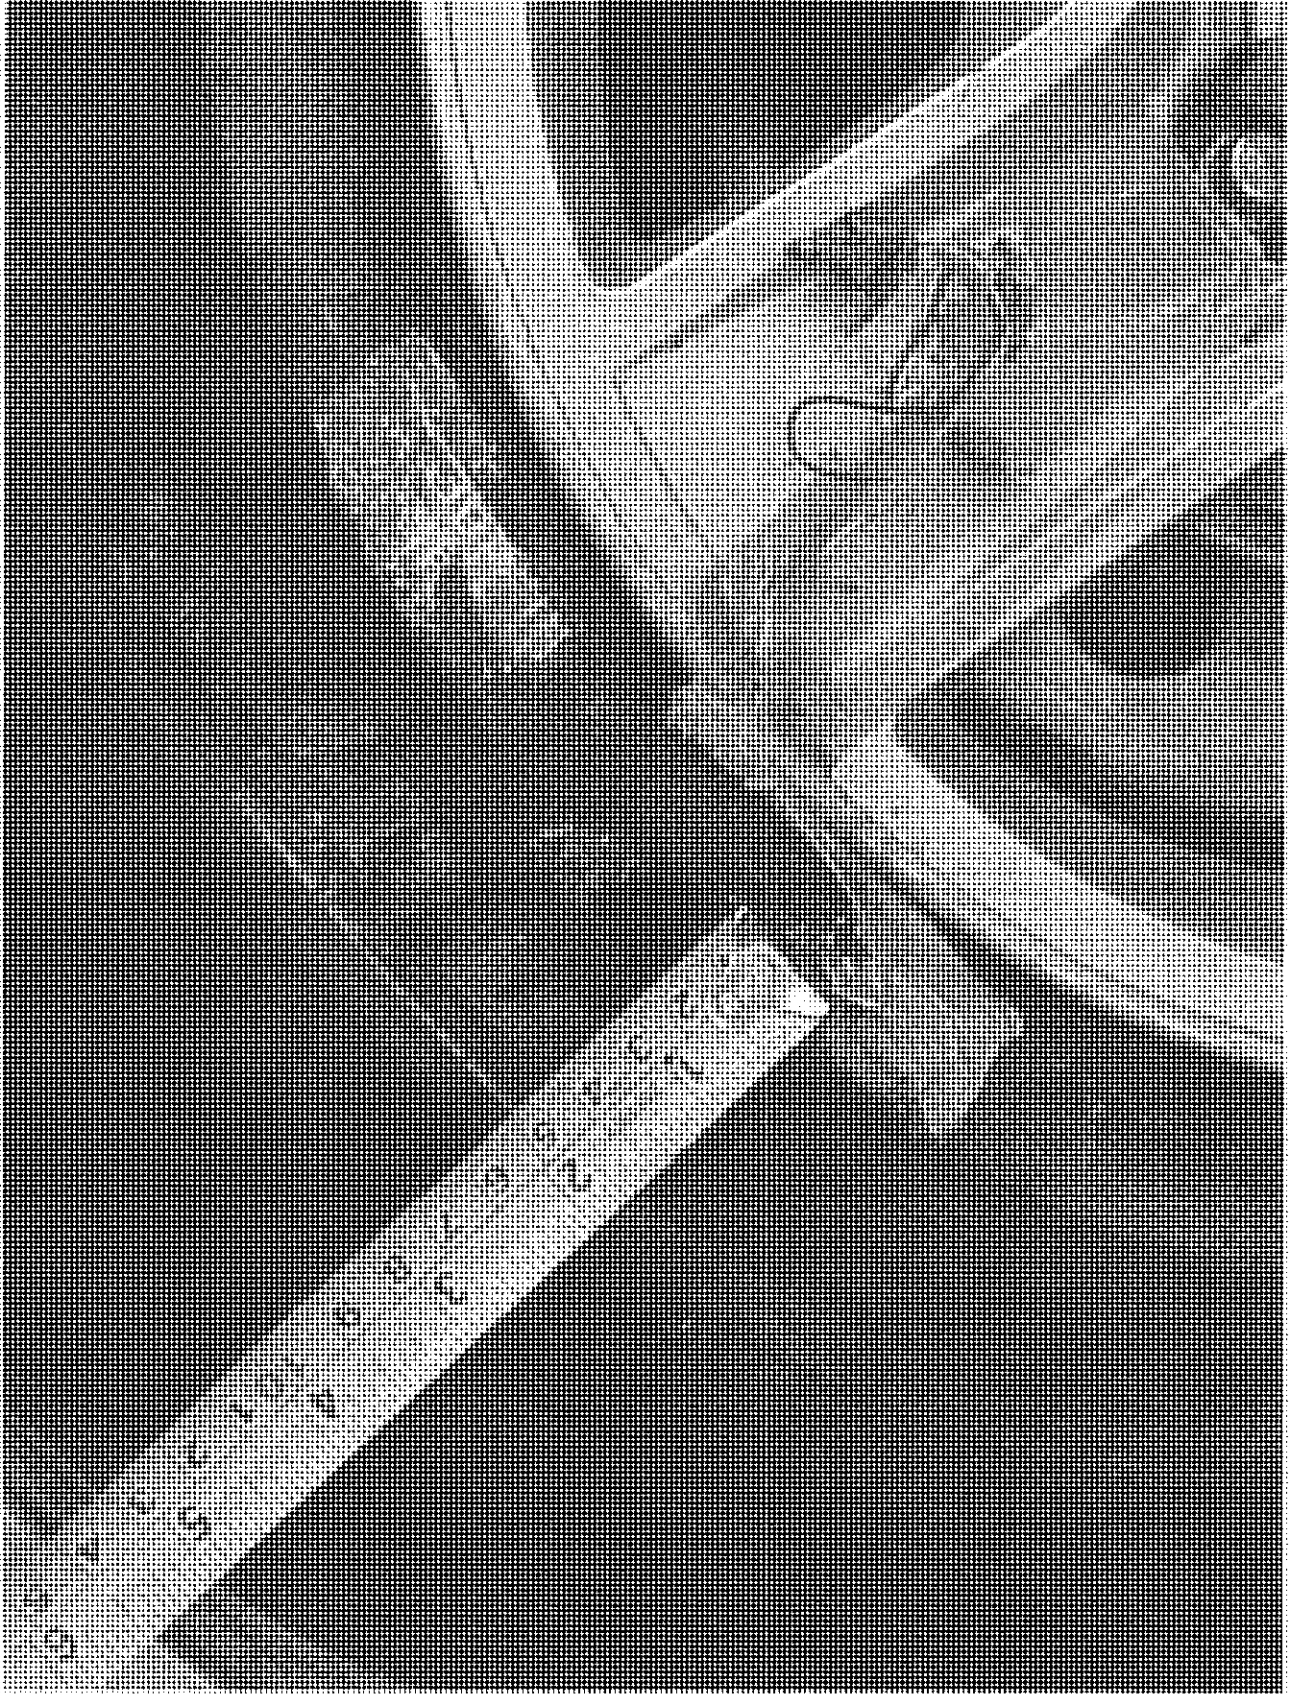
FIGURE 5.22
RIGHT REAR TIRE AFTER BLOW-OUT
WITH RULER NEXT TO HOLE

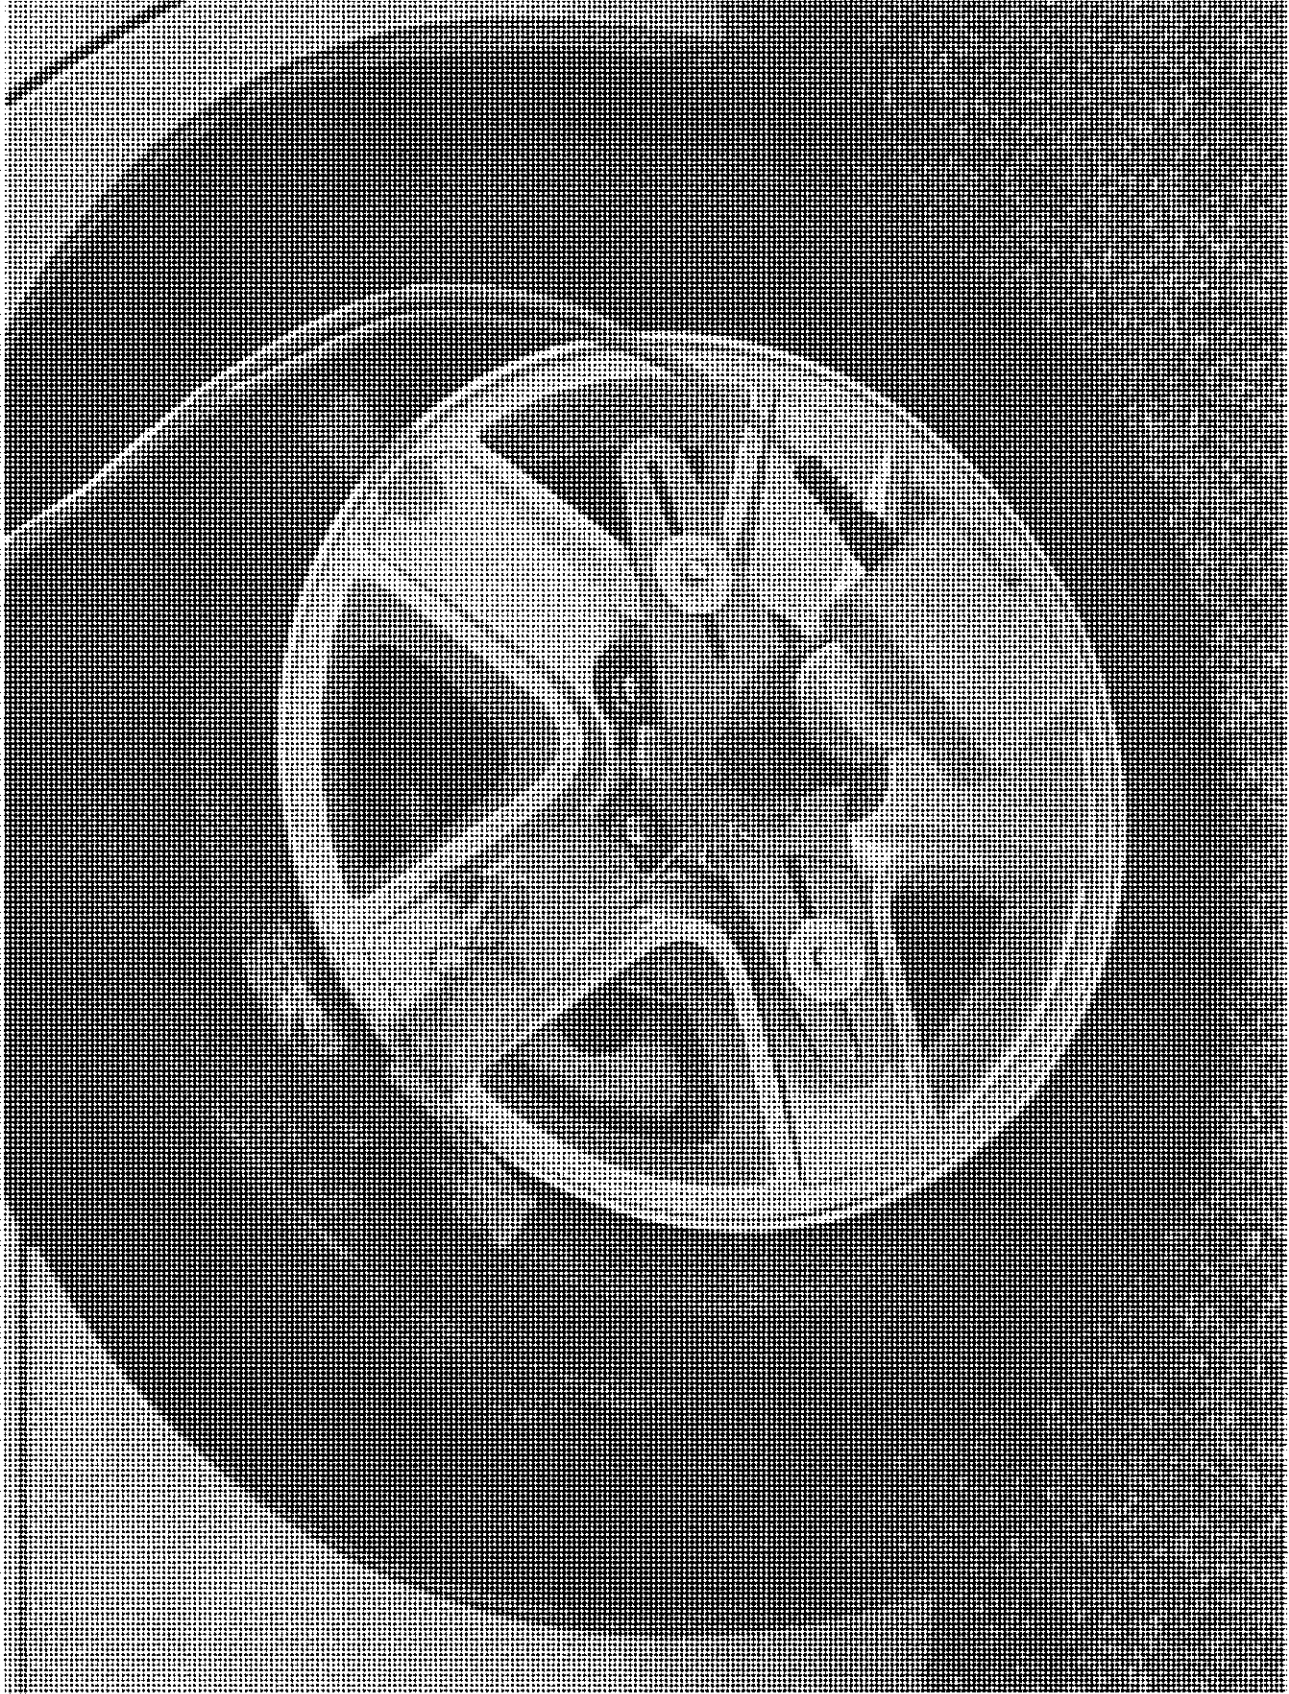
Description of Bead Separation, Outboard: None

FIGURE 5.23
OUTSIDE VIEW OF RIGHT REAR TIRE
AFTER BLOW-OUT

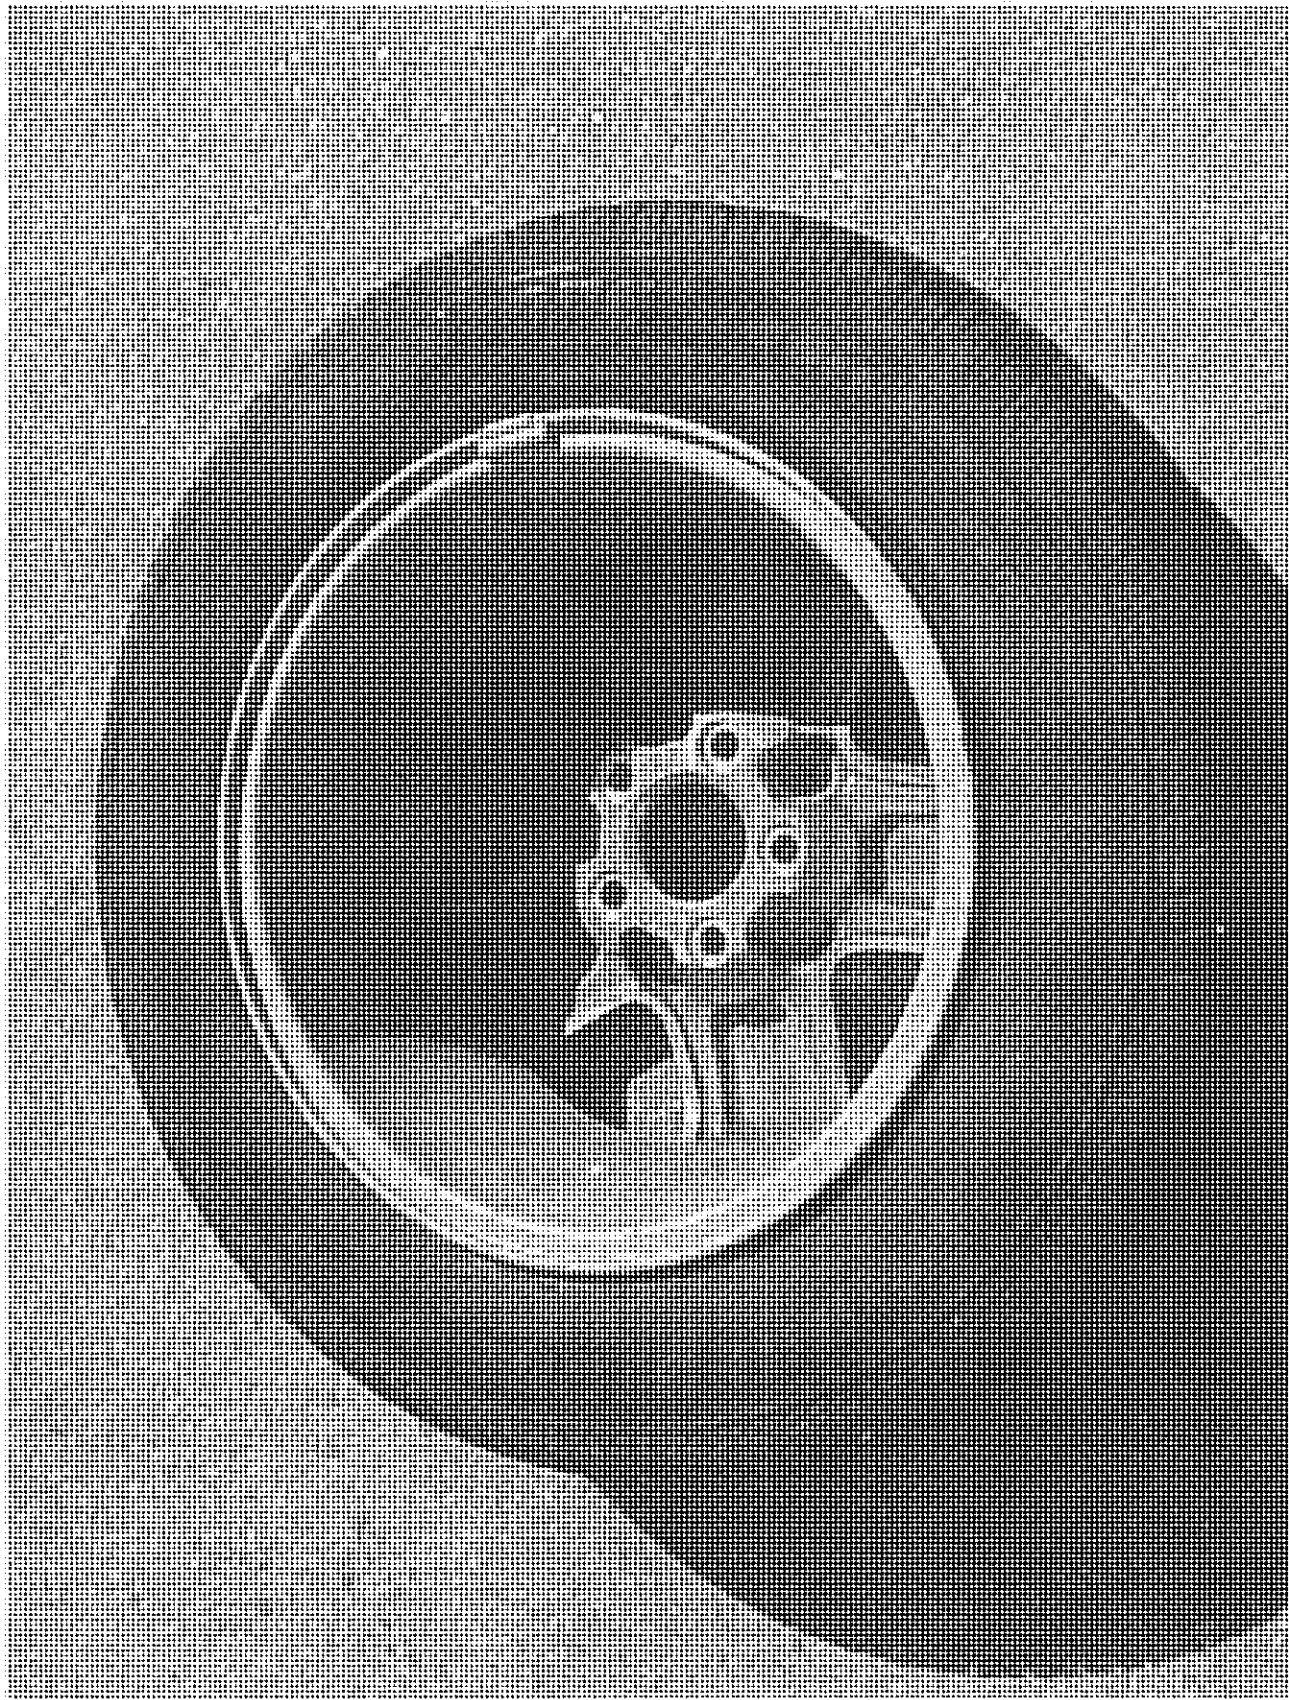
Description of Bead Separation, Inboard: None

NOTE: No rotation of tire on rim

FIGURE 5.24
INSIDE VIEW OF RIGHT REAR TIRE
AFTER BLOW-OUT

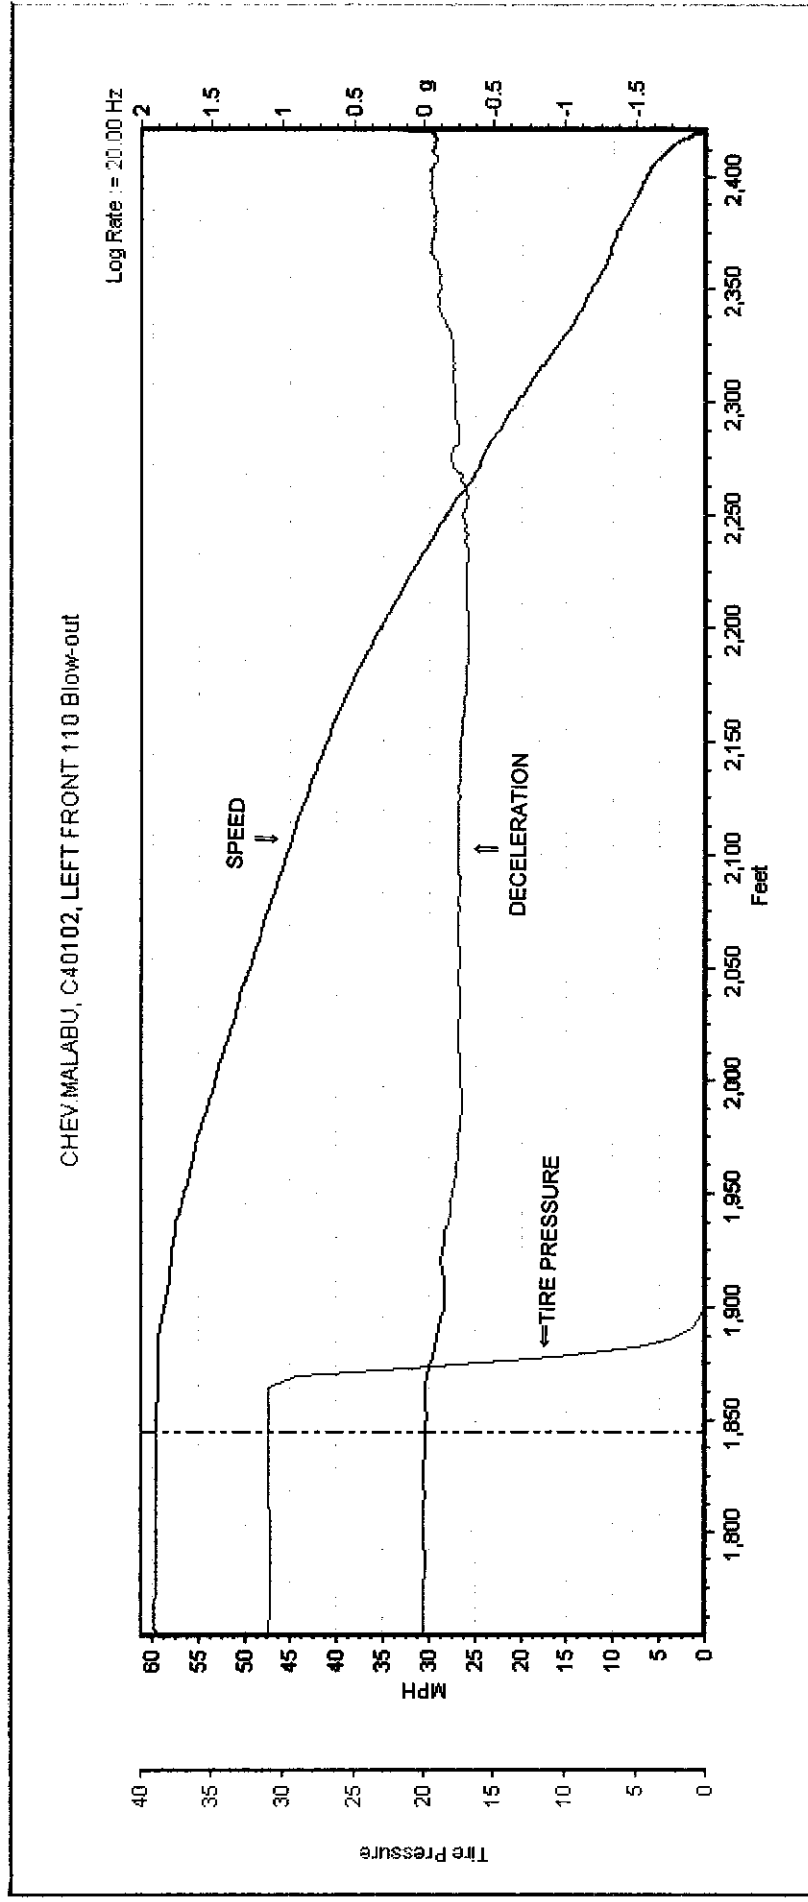
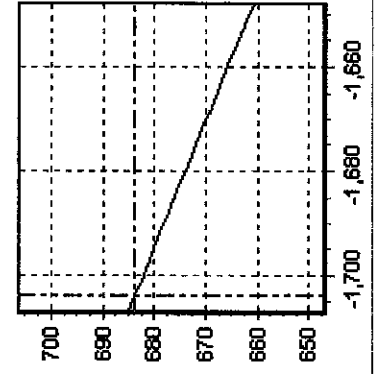
MALABU, WBO (run 1)	
Run Time	2 minute 31.20 secs
Cursor (Feet)	1844.51
Speed (MPH)	59.56
Tire_Press (PSI)	30.945
Longitudinal Acceleration (g)	-0.015
Lateral Acceleration (g)	-0.013
Height (Feet)	-114.586
Vertical Velocity (MPH)	0.000
Satellites (Number of)	7
