REPORT NUMBER 110-GTL-04-004

**SAFETY COMPLIANCE TESTING FOR
FMVSS NO. 110
TIRE SELECTION AND RIMS**

**GENERAL MOTORS CORPORATION
2004 CHEVROLET MALIBU, PASSENGER CAR
NHTSA NO. C40102**

**GENERAL TESTING LABORATORIES, INC.
1623 LEEDSTOWN ROAD
COLONIAL BEACH, VIRGINIA 22443**

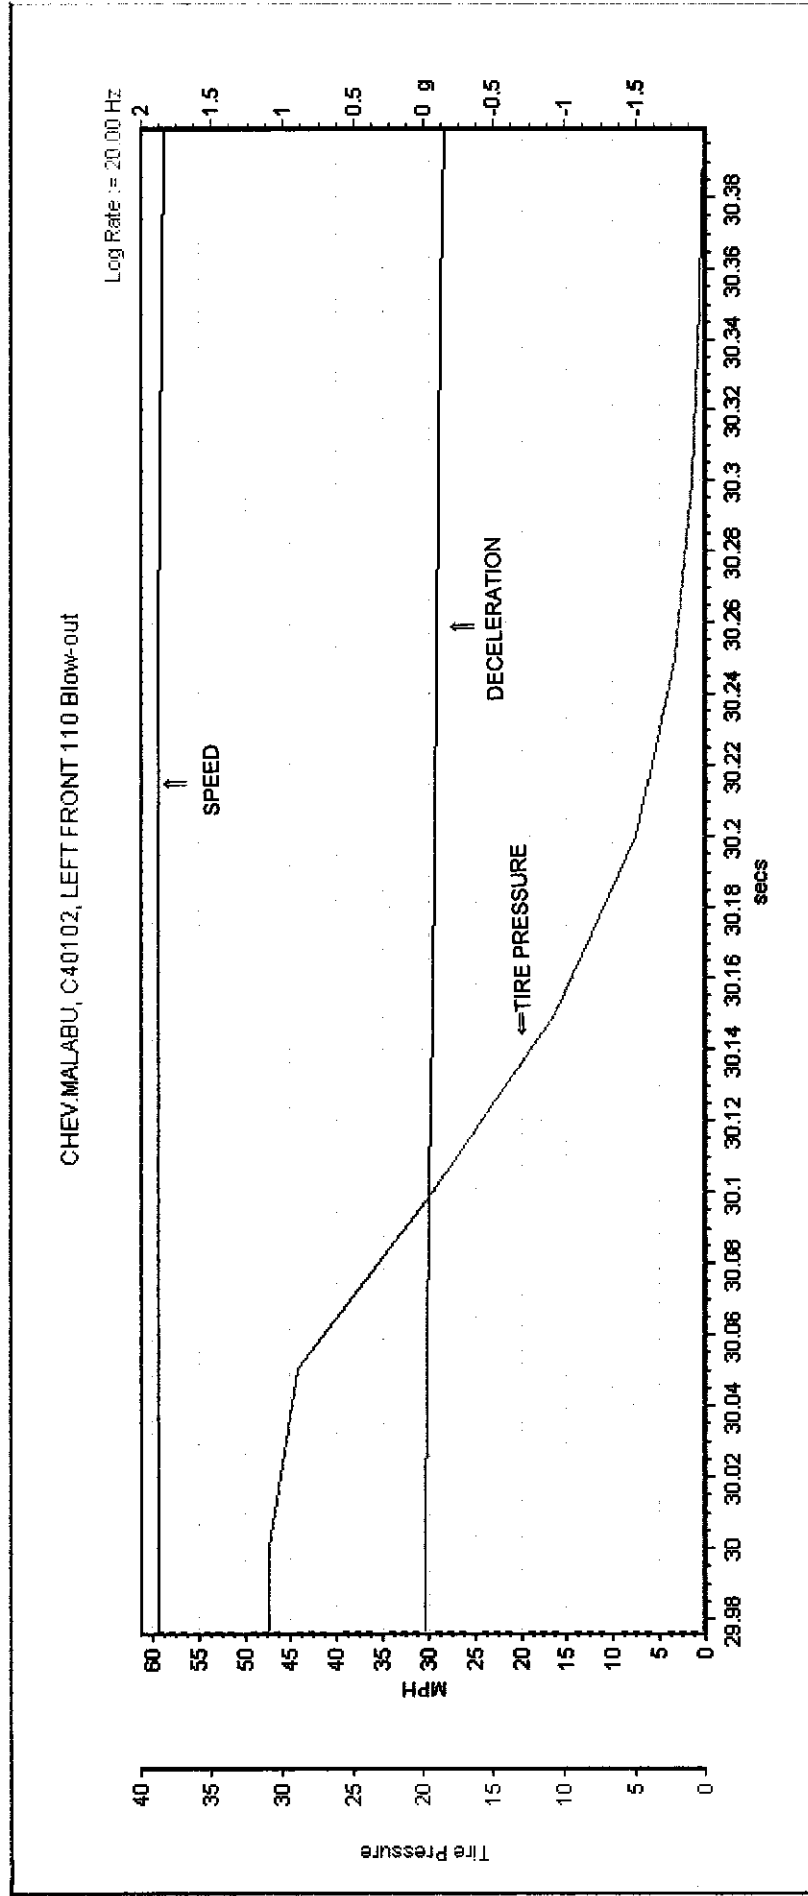
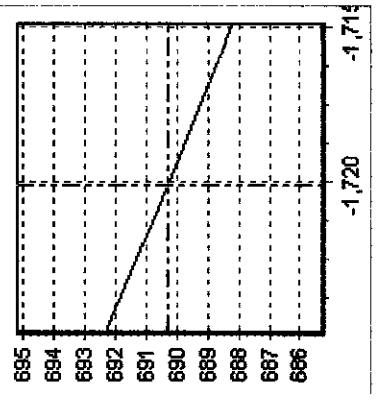
MALABU, VBO :run 1	
Run Time	2 minute 31.20 secs
Cursor (secs)	29.97
Speed (MPH)	59.43
Tire_Press (PSI)	30.924
Longitudinal Acceleration (g)	-0.014
Lateral Acceleration (g)	0.026
Height (Feet)	-114.484
Vertical Velocity (MPH)	0.000
Satellites (Number of)	7

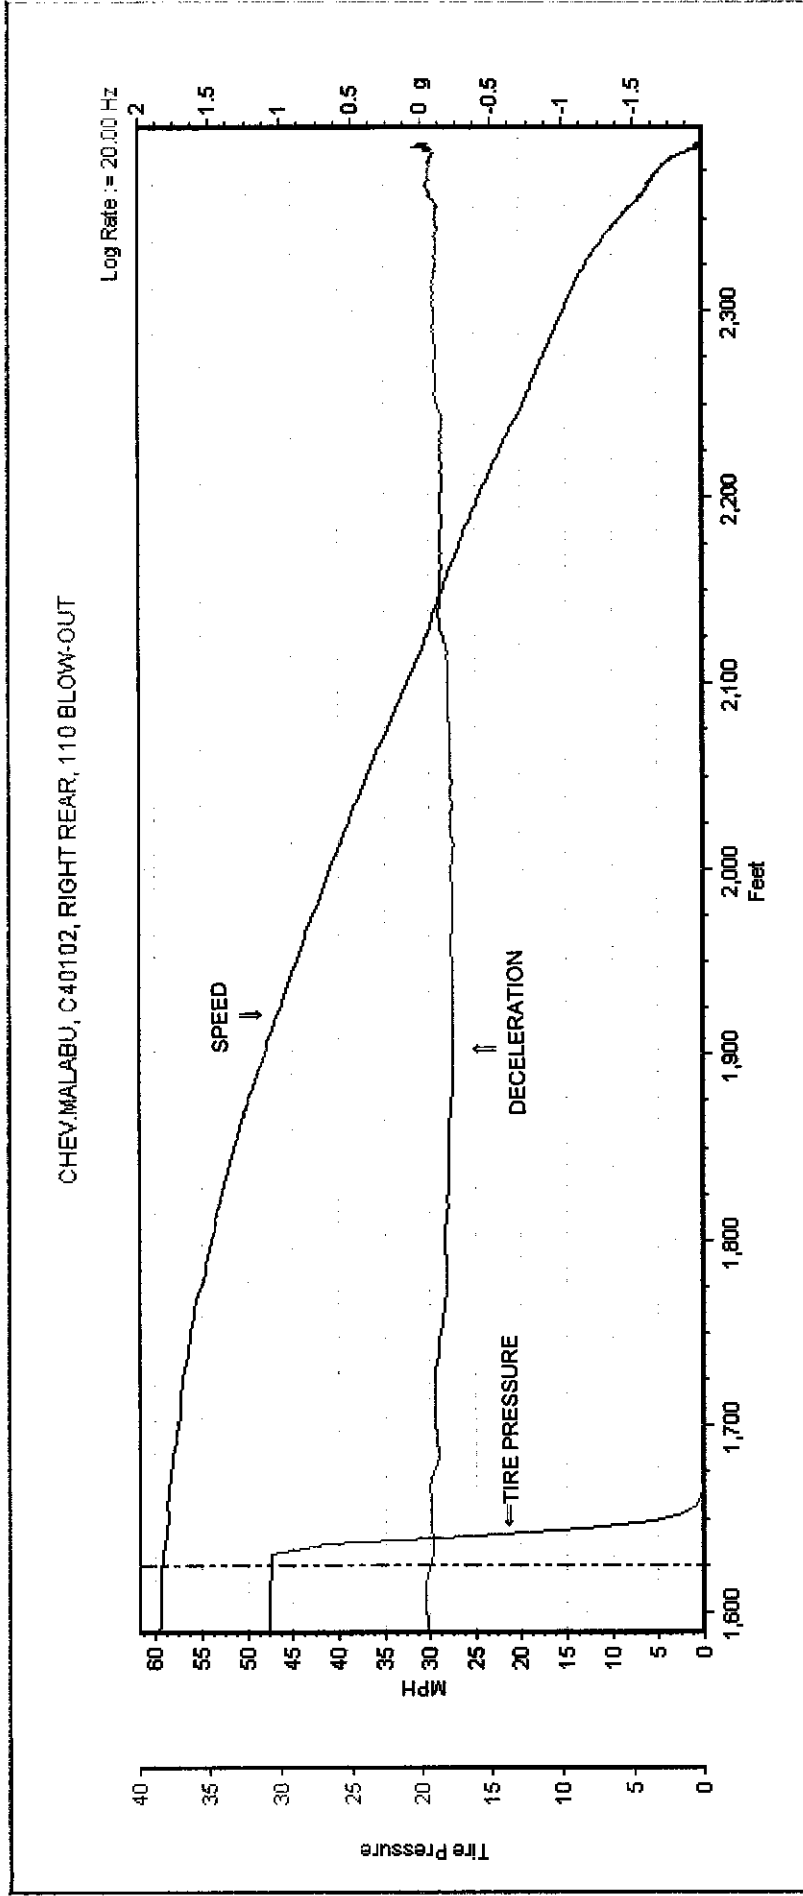
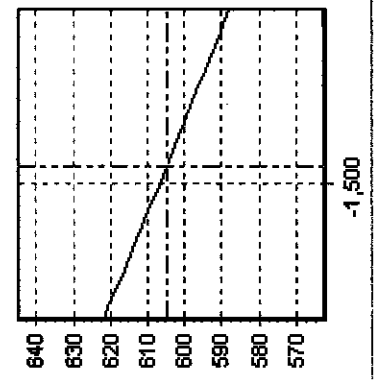
MALABURR.VBO (run 1)	
Run Time	0 minute 58.10 secs
Cursor (Feet)	1624.68
Speed (MPH)	59.35
Tire_Press (PSI)	30.709
Longitudinal Acceleration (g)	-0.060
Lateral Acceleration (g)	-0.010
Height (Feet)	-125.620
Vertical Velocity (MPH)	0.000
Satellites (Number of)	9

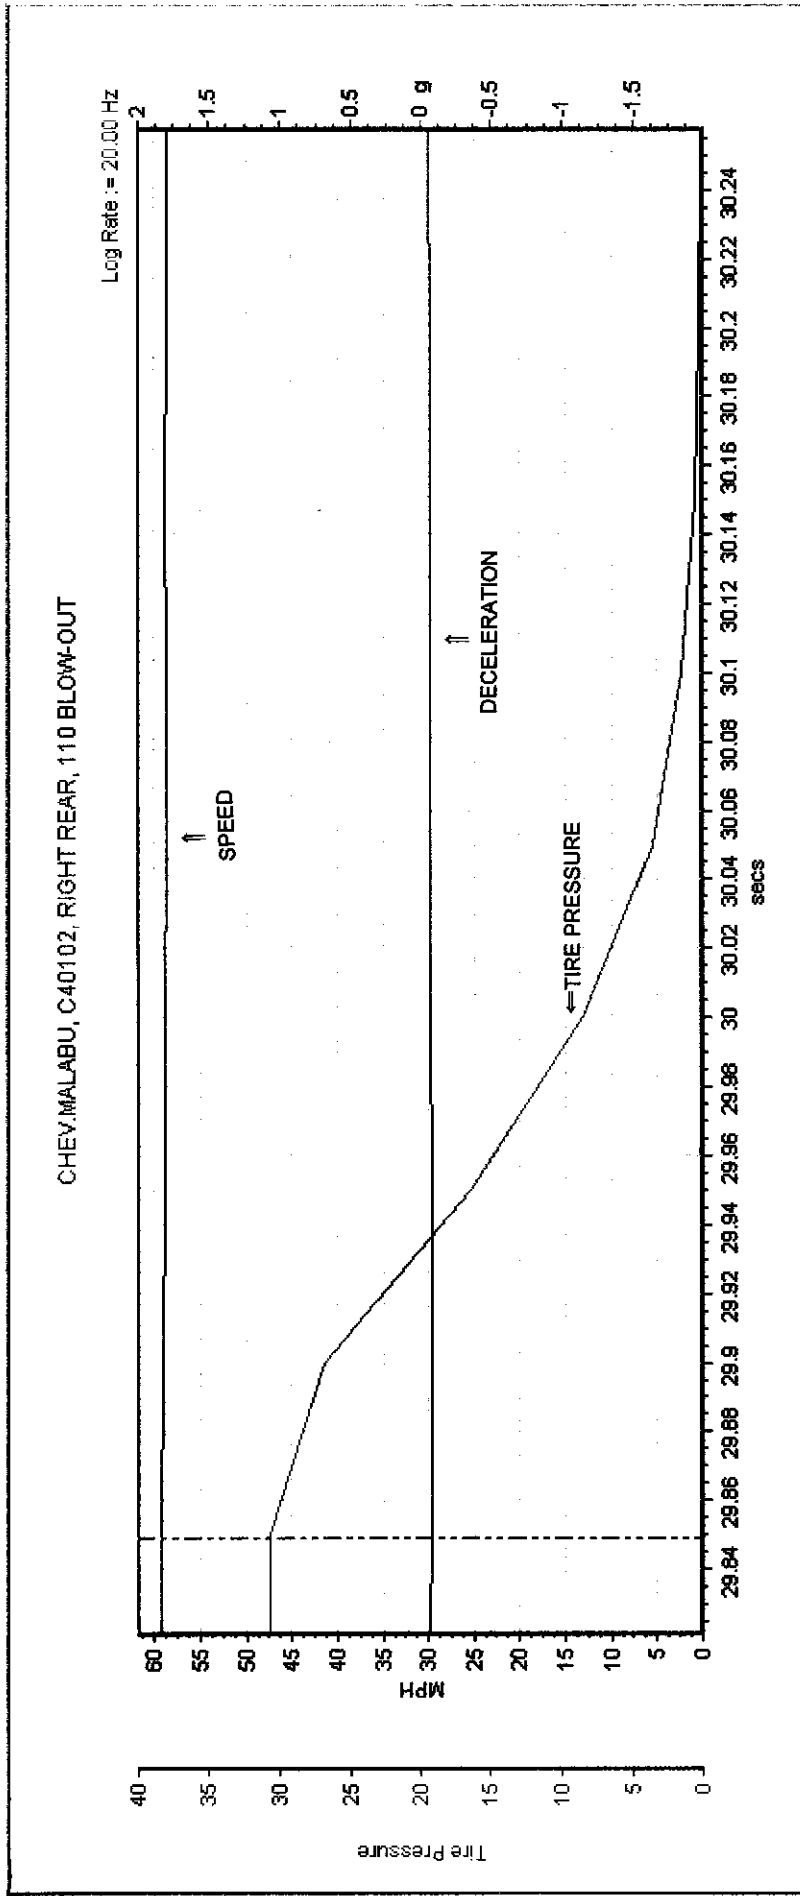
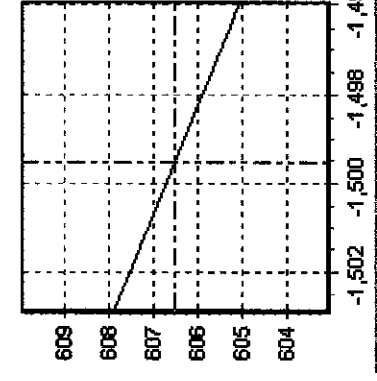
MALABURR.VBO :run 1	
Run Time	0 minute 58.10 secs
Cursor (secs)	29.84
Speed (MPH)	59.18
Tire_Press (PSI)	30.701
Longitudinal Acceleration (g)	-0.076
Lateral Acceleration (g)	-0.026
Height (Feet)	-125.820
Vertical Velocity (MPH)	0.000
Subframes (Number of)	9
