REPORT NUMBER 225-GTL-03-001

**SAFETY COMPLIANCE TESTING FOR  
FMVSS NO. 225  
CHILD RESTRAINT ANCHORAGE SYSTEMS  
LOWER AND TETHER ANCHORAGES**

**BAYERISCHE MOTOREN WERKE AG  
2003 MINI COOPER, PASSENGER CAR  
NHTSA NO. C30506**

FINAL REPORT

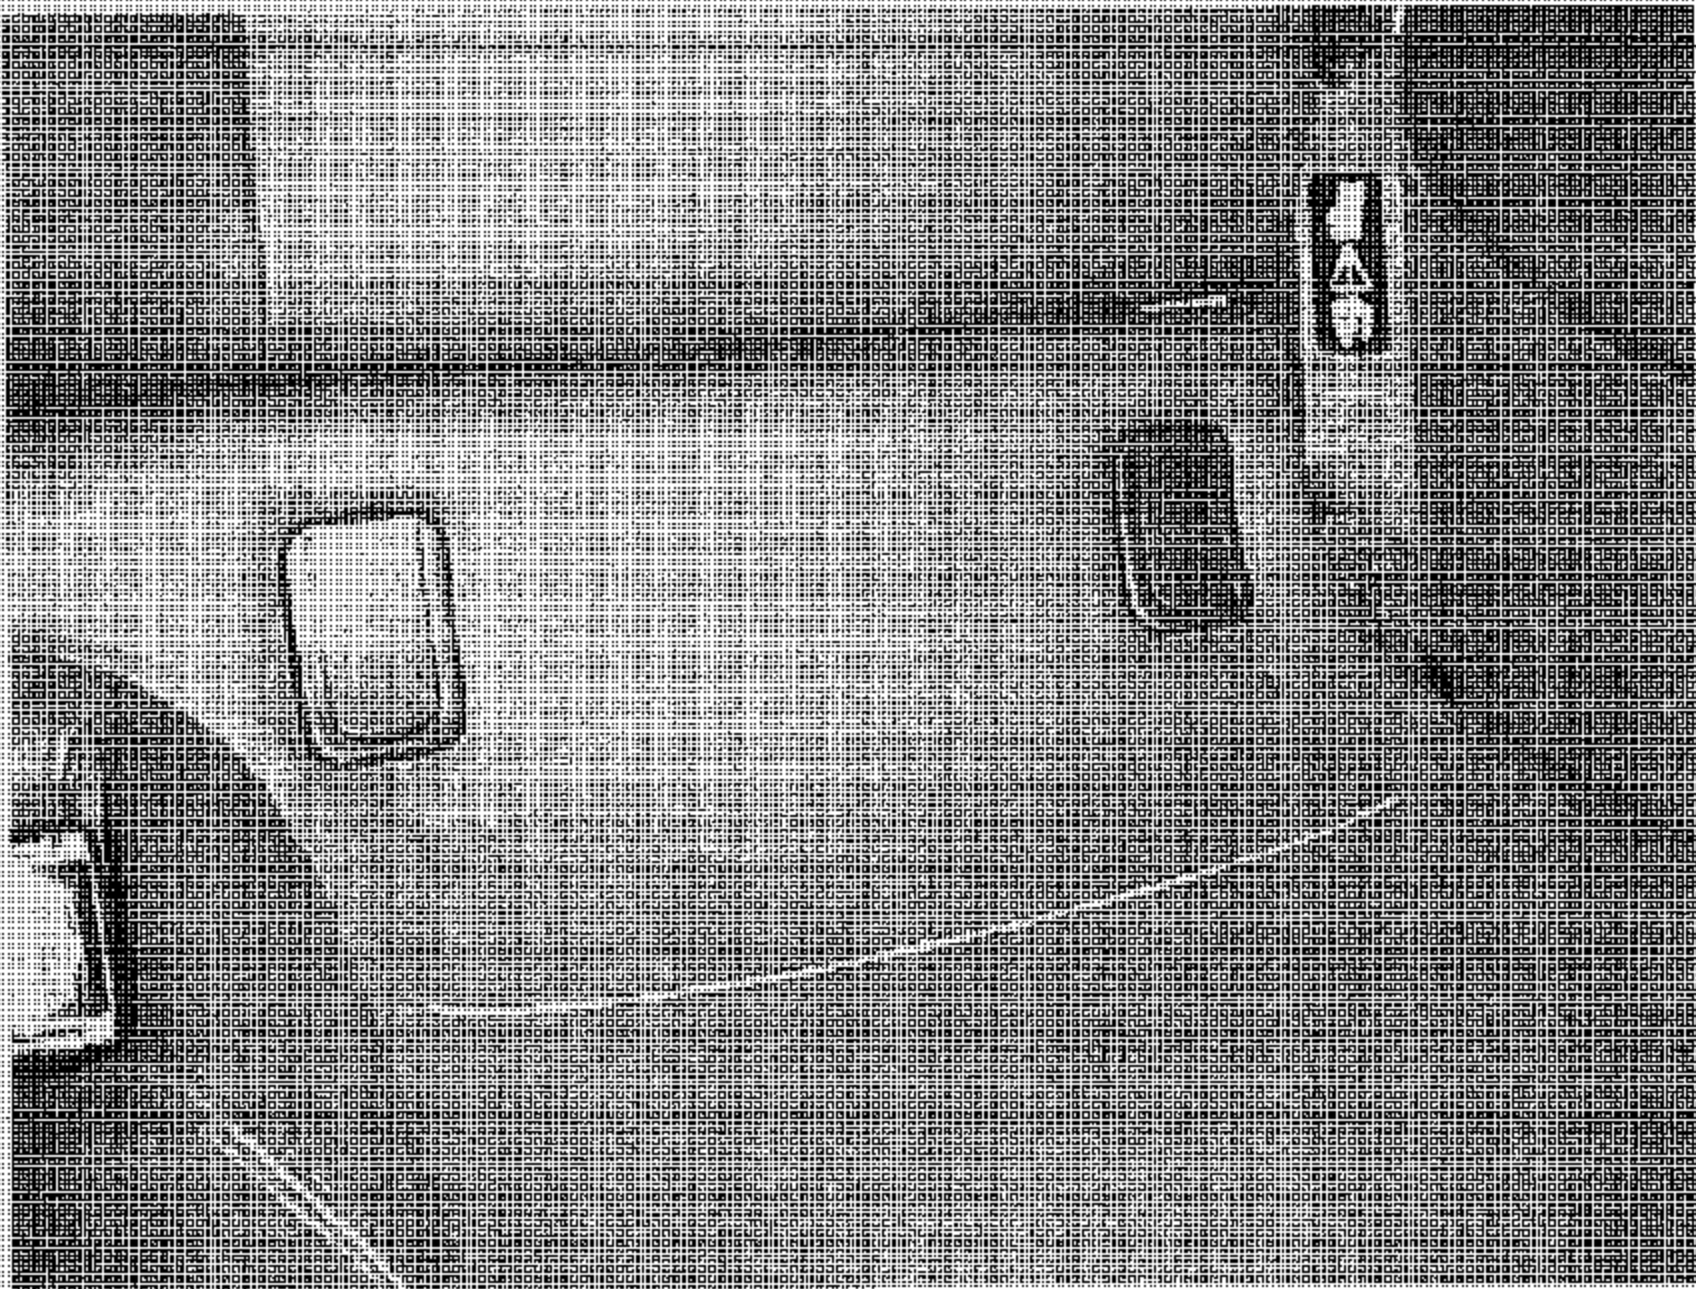
FIGURE 5 16  
2<sup>ND</sup> ROW LEFT LOWER ANCHORS WITH  
COVERS IN PLACE

\* BARS ARE VISIBLE AFTER OPENING THE COVER PLATE WHICH CONCEALS THE BAR WHEN NOT IN USE.

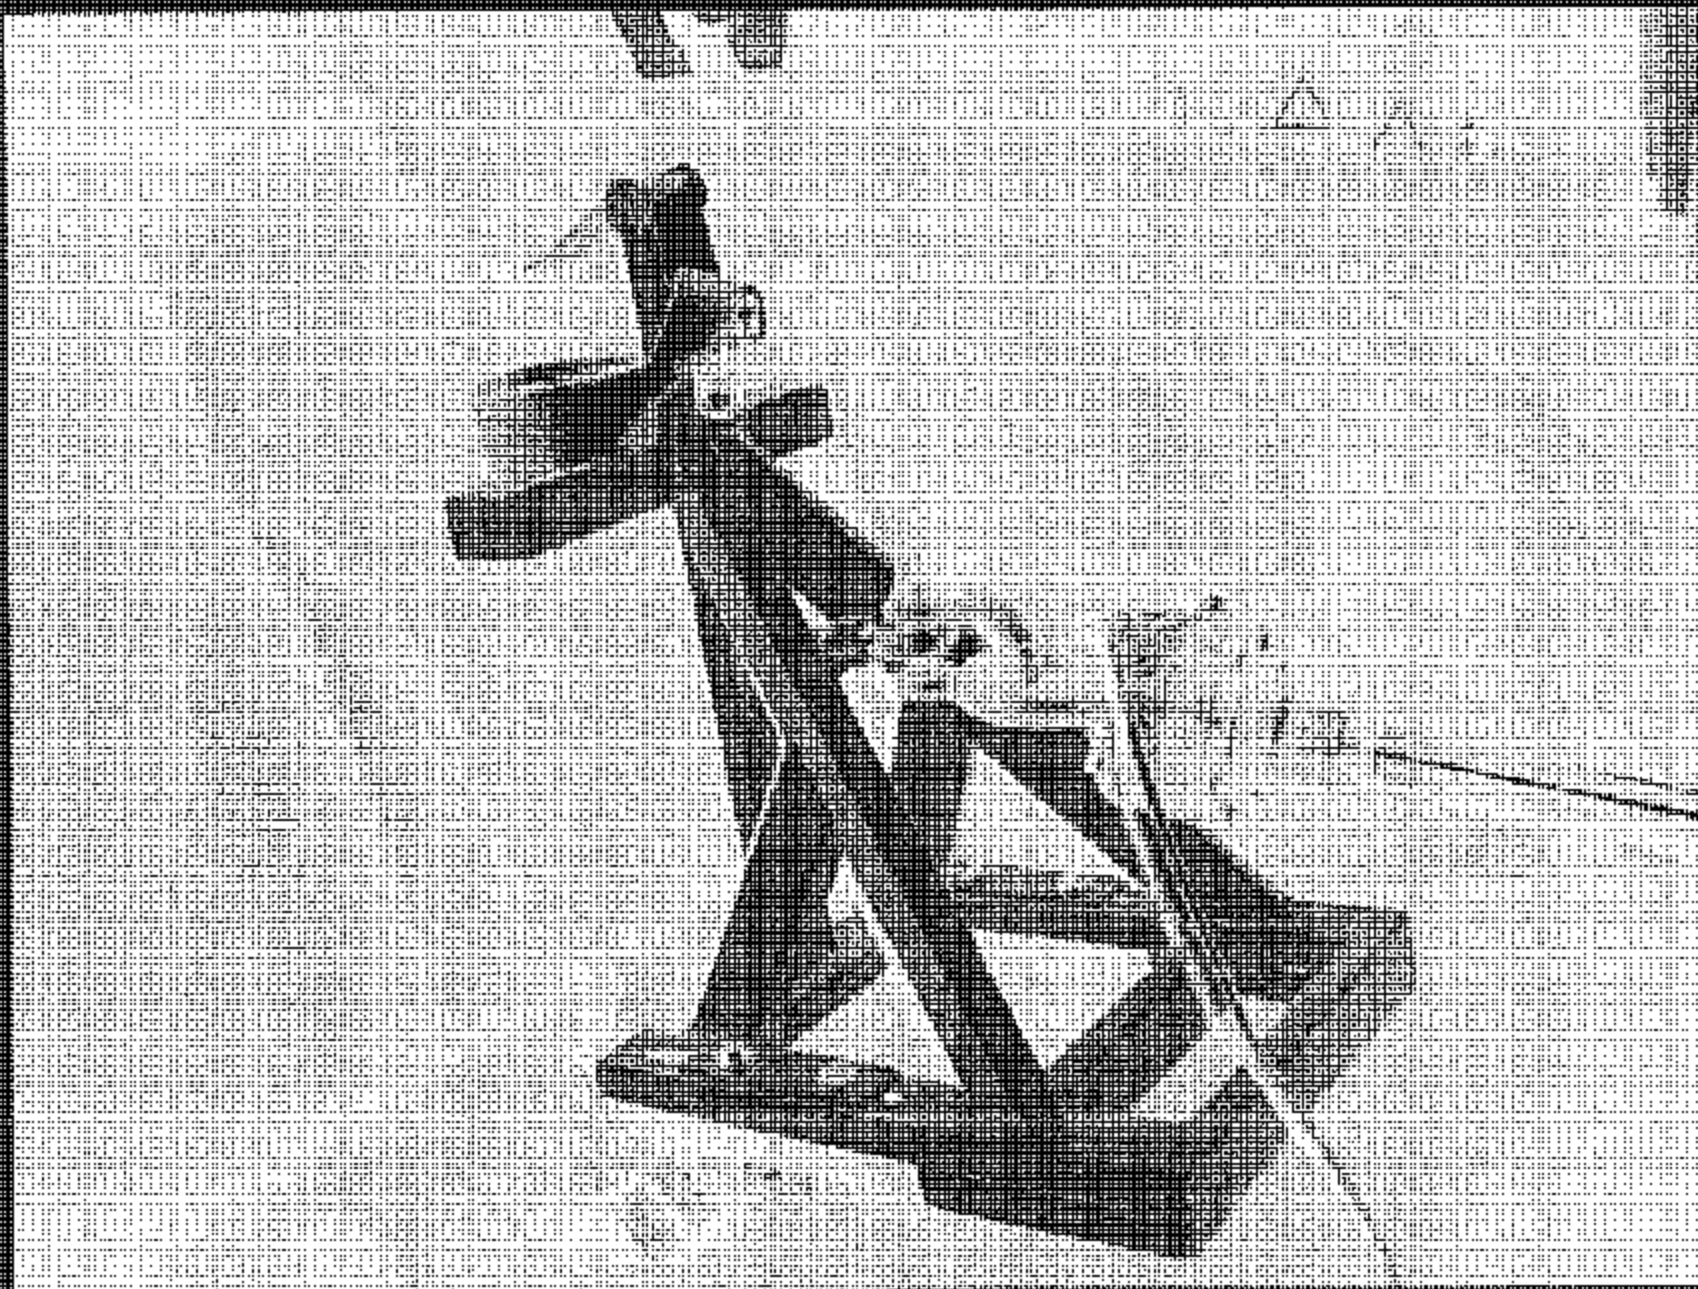
FIGURE 5.24  
PRE-TEST SET-UP 2<sup>ND</sup> ROW LEFT POSITION

REMARKS: 1)TESTED TO S8.3.4, 2) TESTED WITH HEADREST DOWN AND TETHER STRAP BETWEEN SEAT BACK AND HEADREST PER THE OWNER'S MANUAL INSTRUCTIONS. DURING TEST THE HEAD REST EXTENDED UP AS THE TETHER STRAP TIGHTENED.

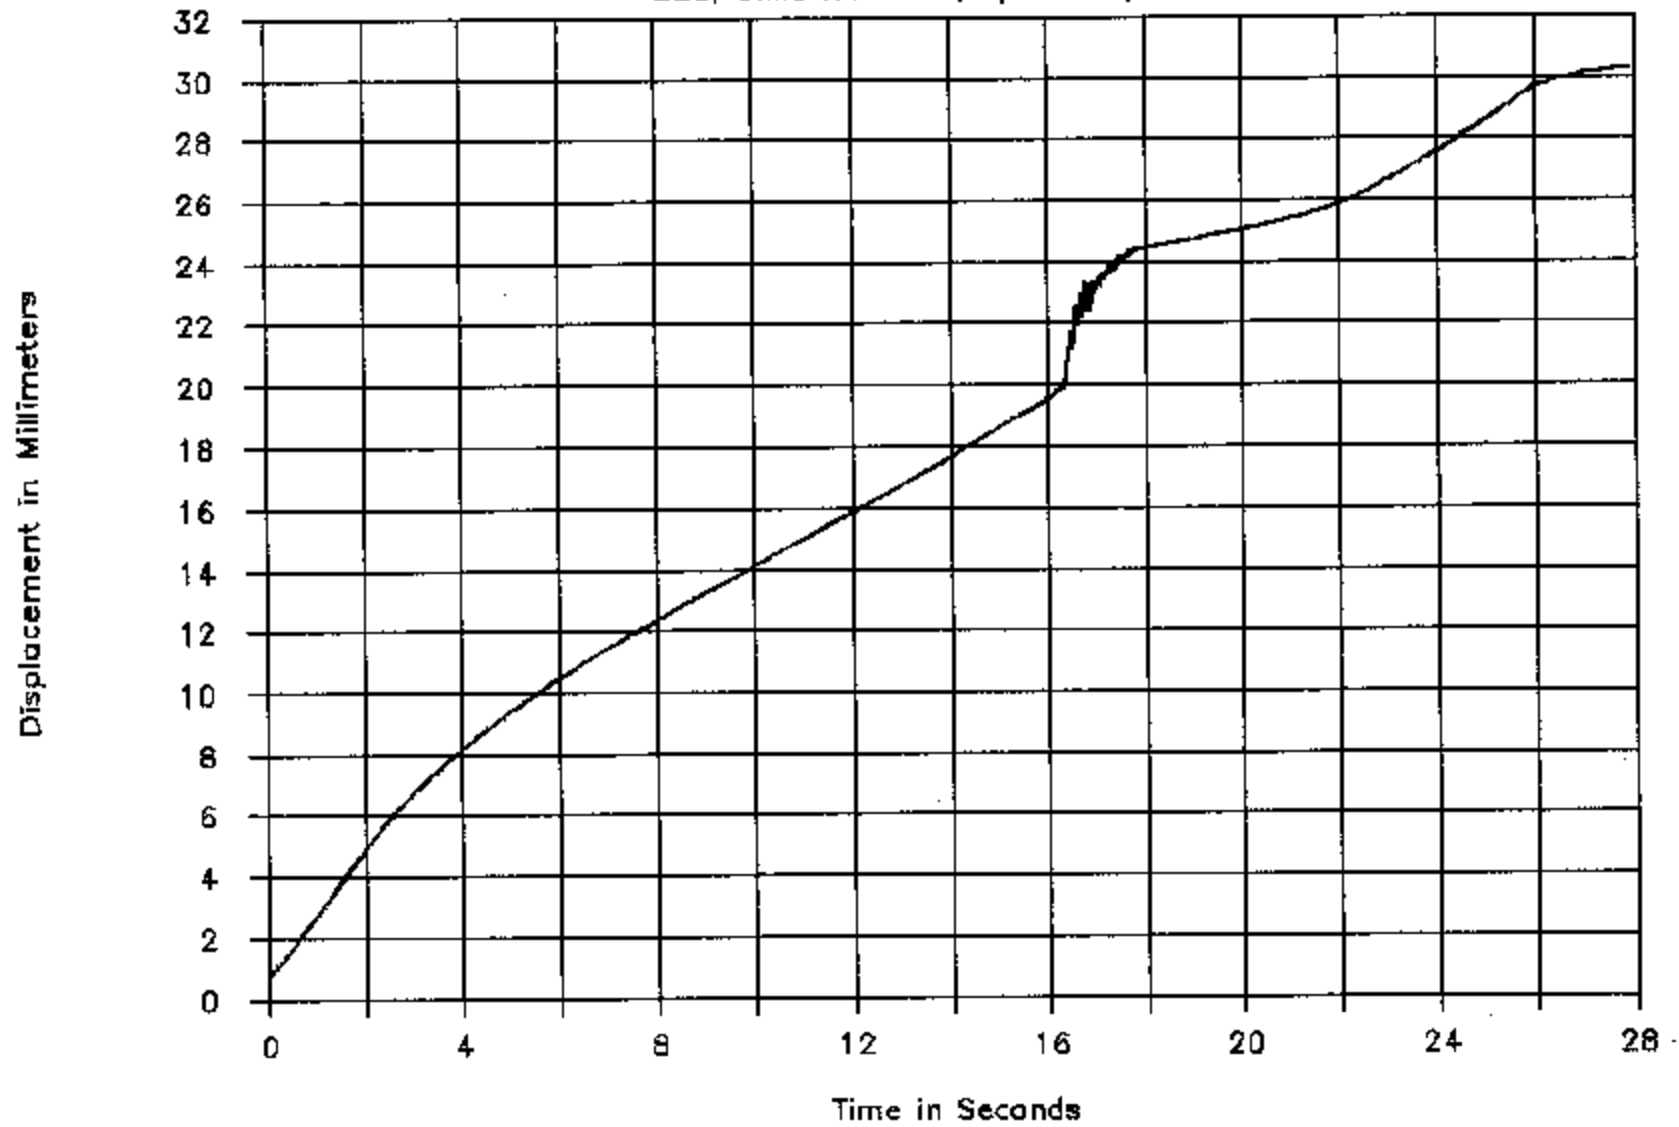
FIGURE 6.2  
2<sup>ND</sup> ROW LEFT TOP TETHER ANCHOR  
GTL 5103, NHTSA C30506.  
225, Child Restraint, Top Tether, S6.3.4

GTL Test #	Fixture Type	Seating Position	Max. Load (N)	Displacement (mm)
5103	SFAD II Tether Strap	2 <sup>nd</sup> Row Left	9927	30.3
5104	Lower Anchorage	2 <sup>nd</sup> Row Right	7926	26.3

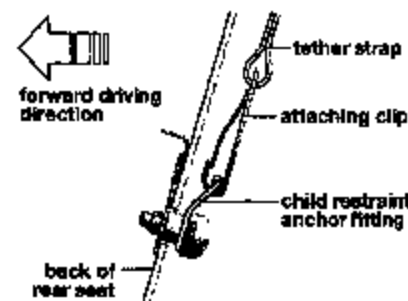
Your vehicle has one of two different types of child-restraint anchor fittings on the back of the rear seats, see arrows 1 or 2.

Anchor fitting 1 is shown above. Anchor fitting 2 is shown in the next column. ◀

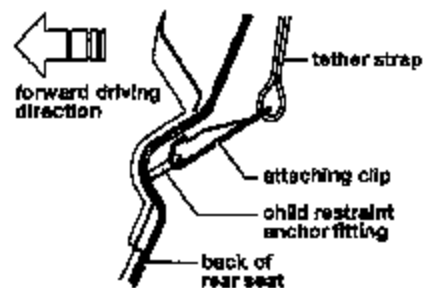
Both seating positions are fitted with a head restraint. Lift the head restraint and pass the tether strap between the head restraint and the seat back. It is recommended to readjust the head restraint into the lowest possible position.
