REPORT NO. 118-KAR-07-001

**SAFETY COMPLIANCE TESTING
FOR FMVSS 118**

2007 PONTIAC G6 GT
2-DOOR COUPE

NHTSA NO. C70120

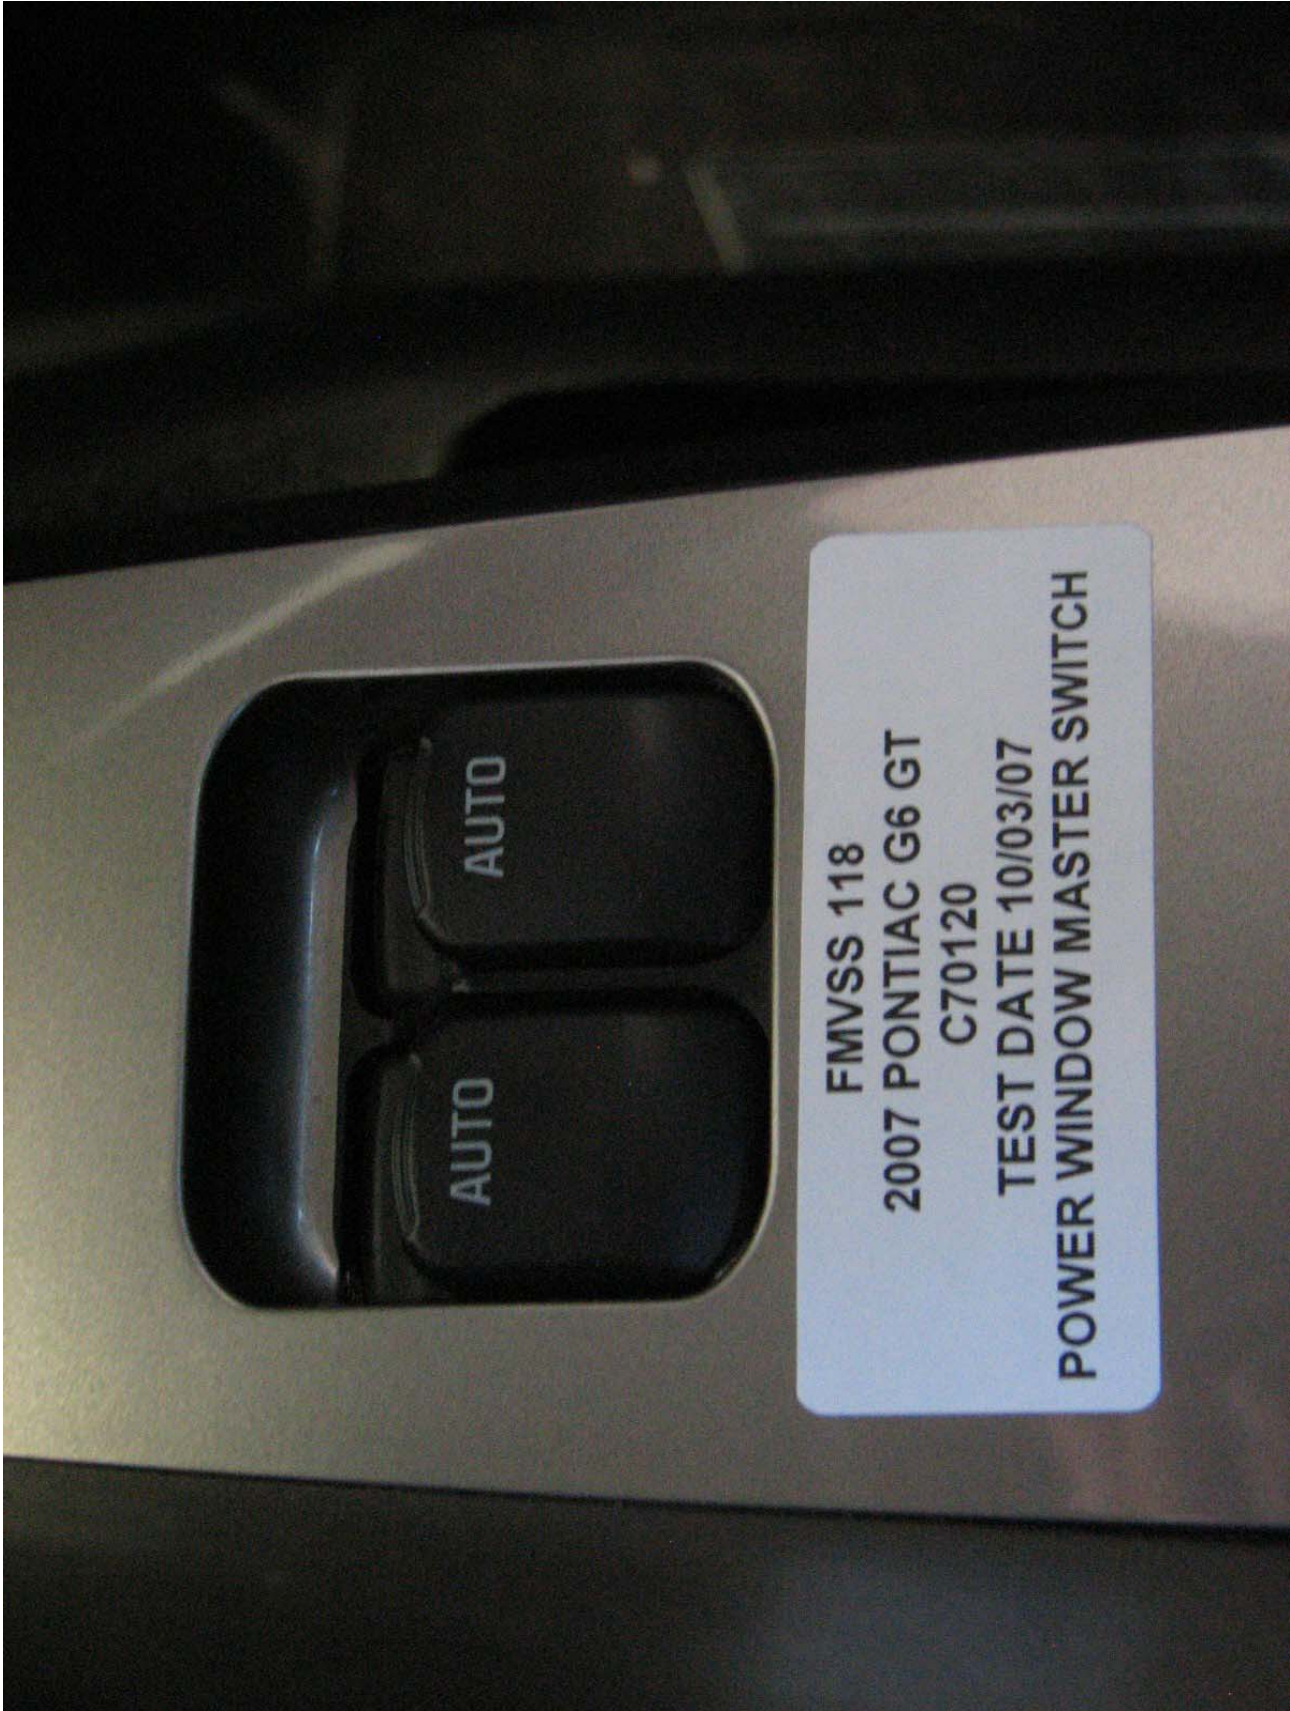
Figure 6: Left Front Master Power Window Switch

REMARKS: The master switch control panel is located on the driver's side door panel and includes the individual left front window switch. Vehicle passed as soon as ignition "off" test was performed.

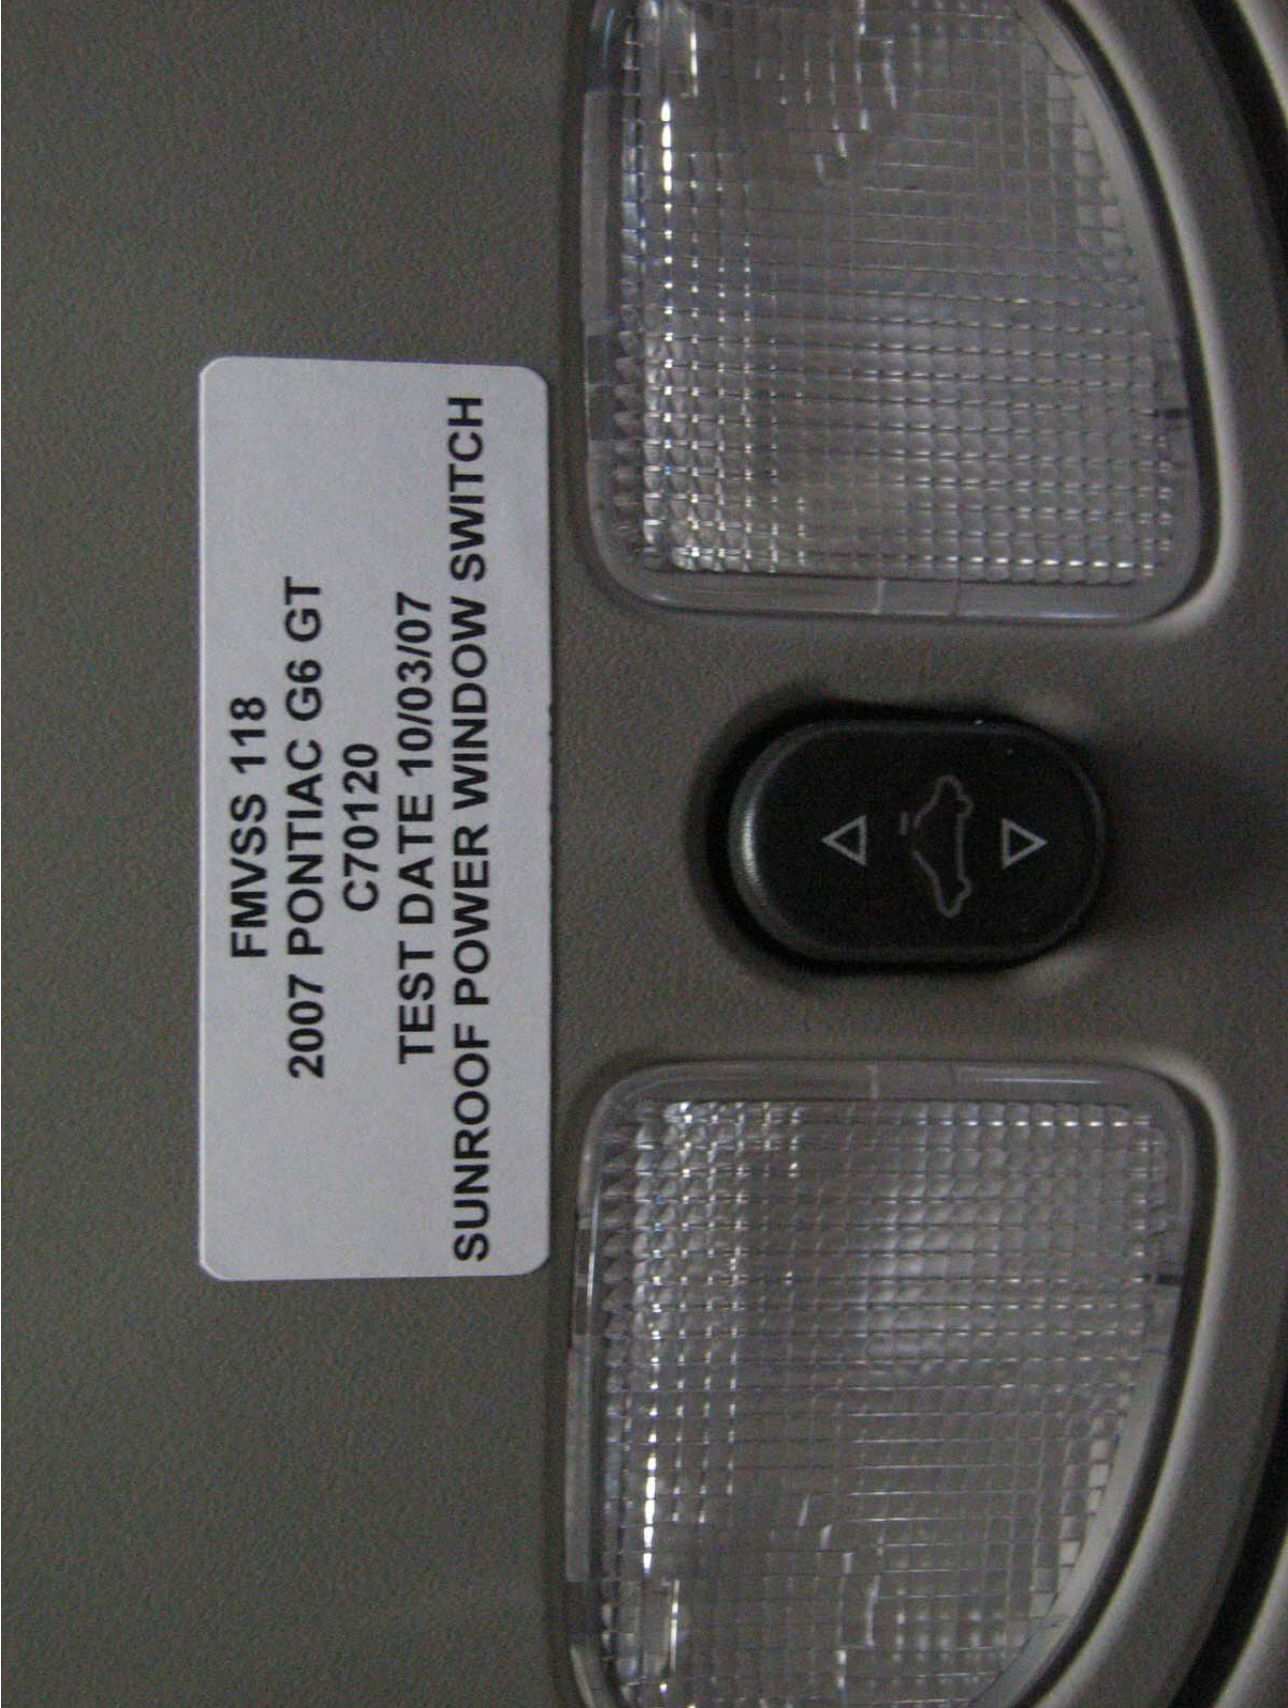
Figure 8: Sunroof Power Window Switch

**FMVSS 118
2007 PONTIAC G6 GT
C70120
TEST DATE 10/03/07
SUNROOF POWER WINDOW SWITCH**

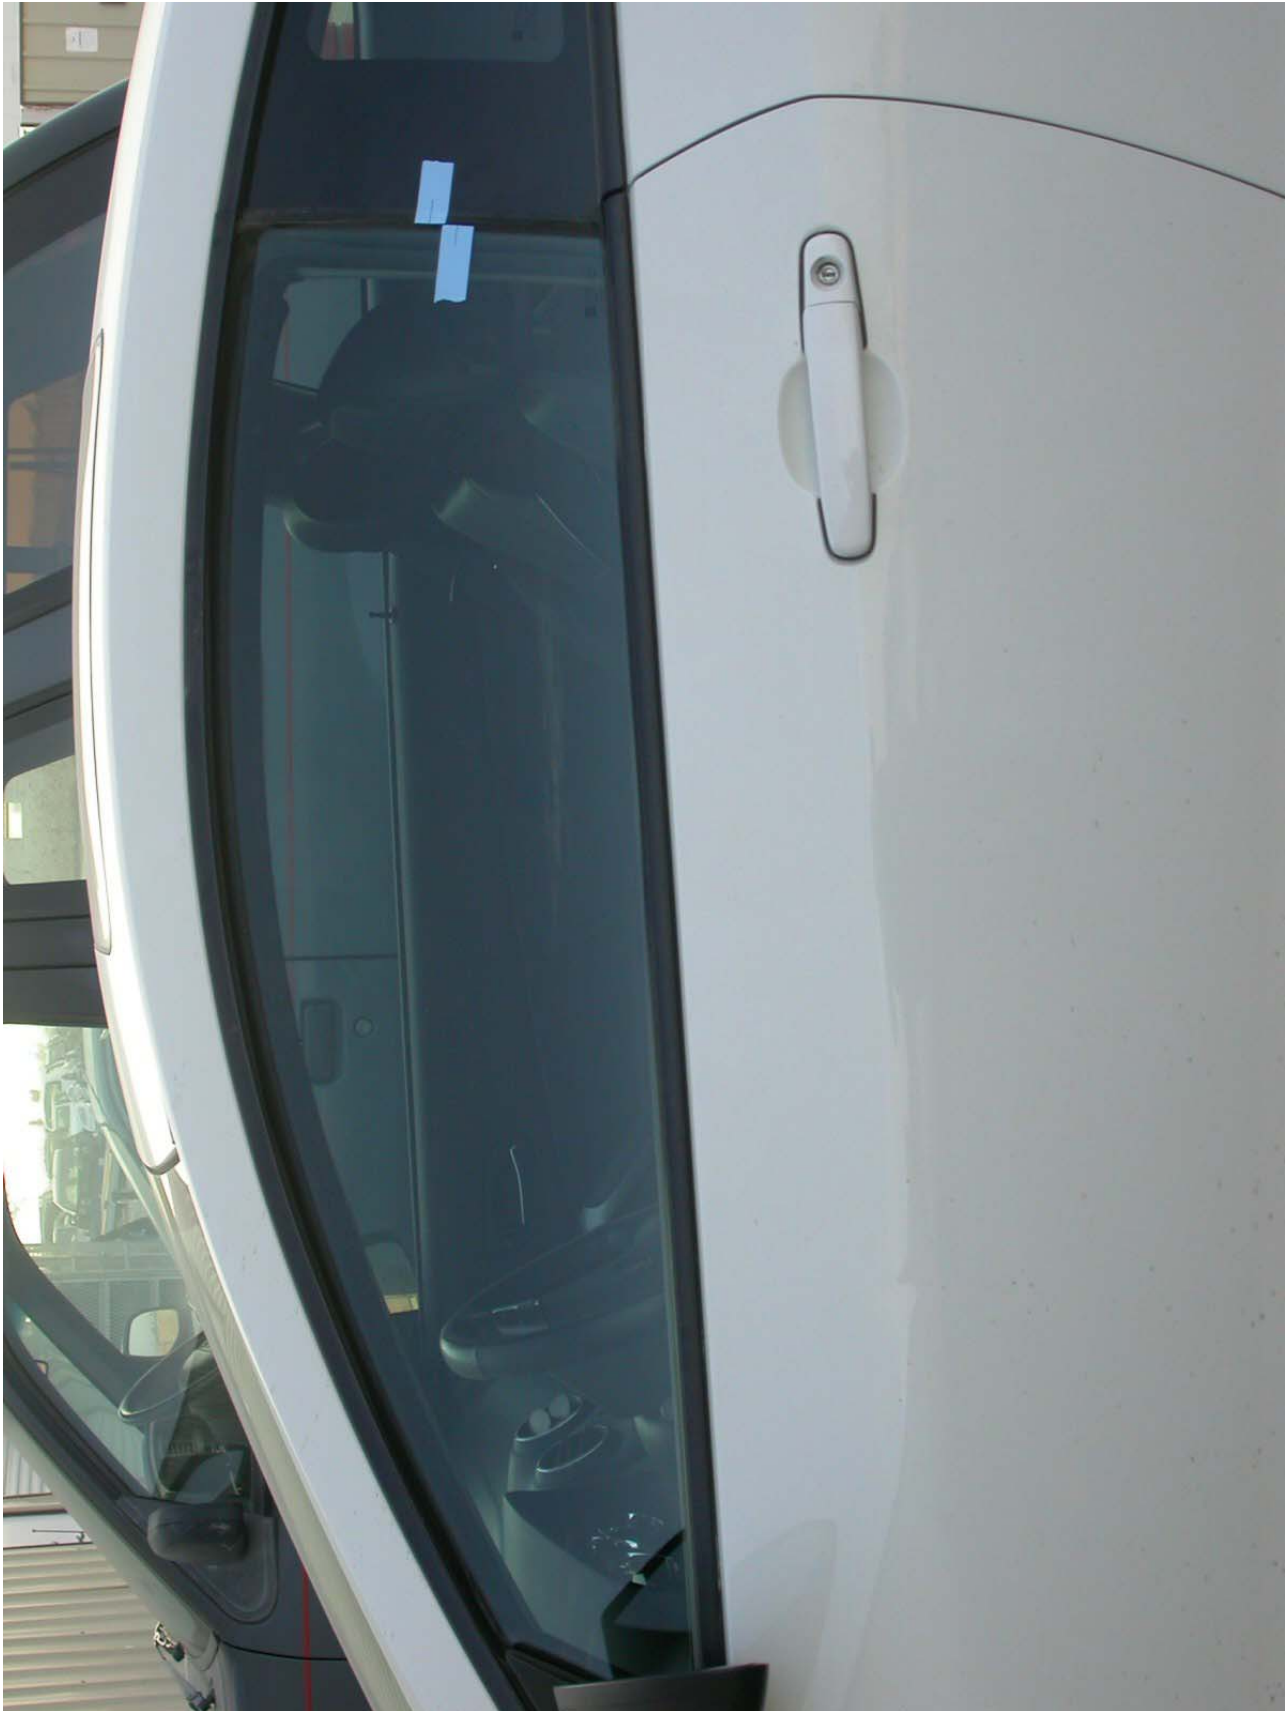
Figure 10: Test Window With Window Indexing Down

This vehicle is equipped with a window indexing feature that allows the windows to be rolled down a small amount (23mm) with door opening, and window rolls up upon door closing. This opening does not allow the top of the window to be separated from the window seal to allow anything to be placed in the gap.
