REPORT NUMBER 138-STF-09-004

SAFETY COMPLIANCE TESTING FOR FMVSS NO. 138 TIRE PRESSURE MONITORING SYSTEMS

FORD MOTOR COMPANY
2009 FORD EDGE SE
FOUR-DOOR MPV
NHTSA NO. C90203

FINAL REPORT

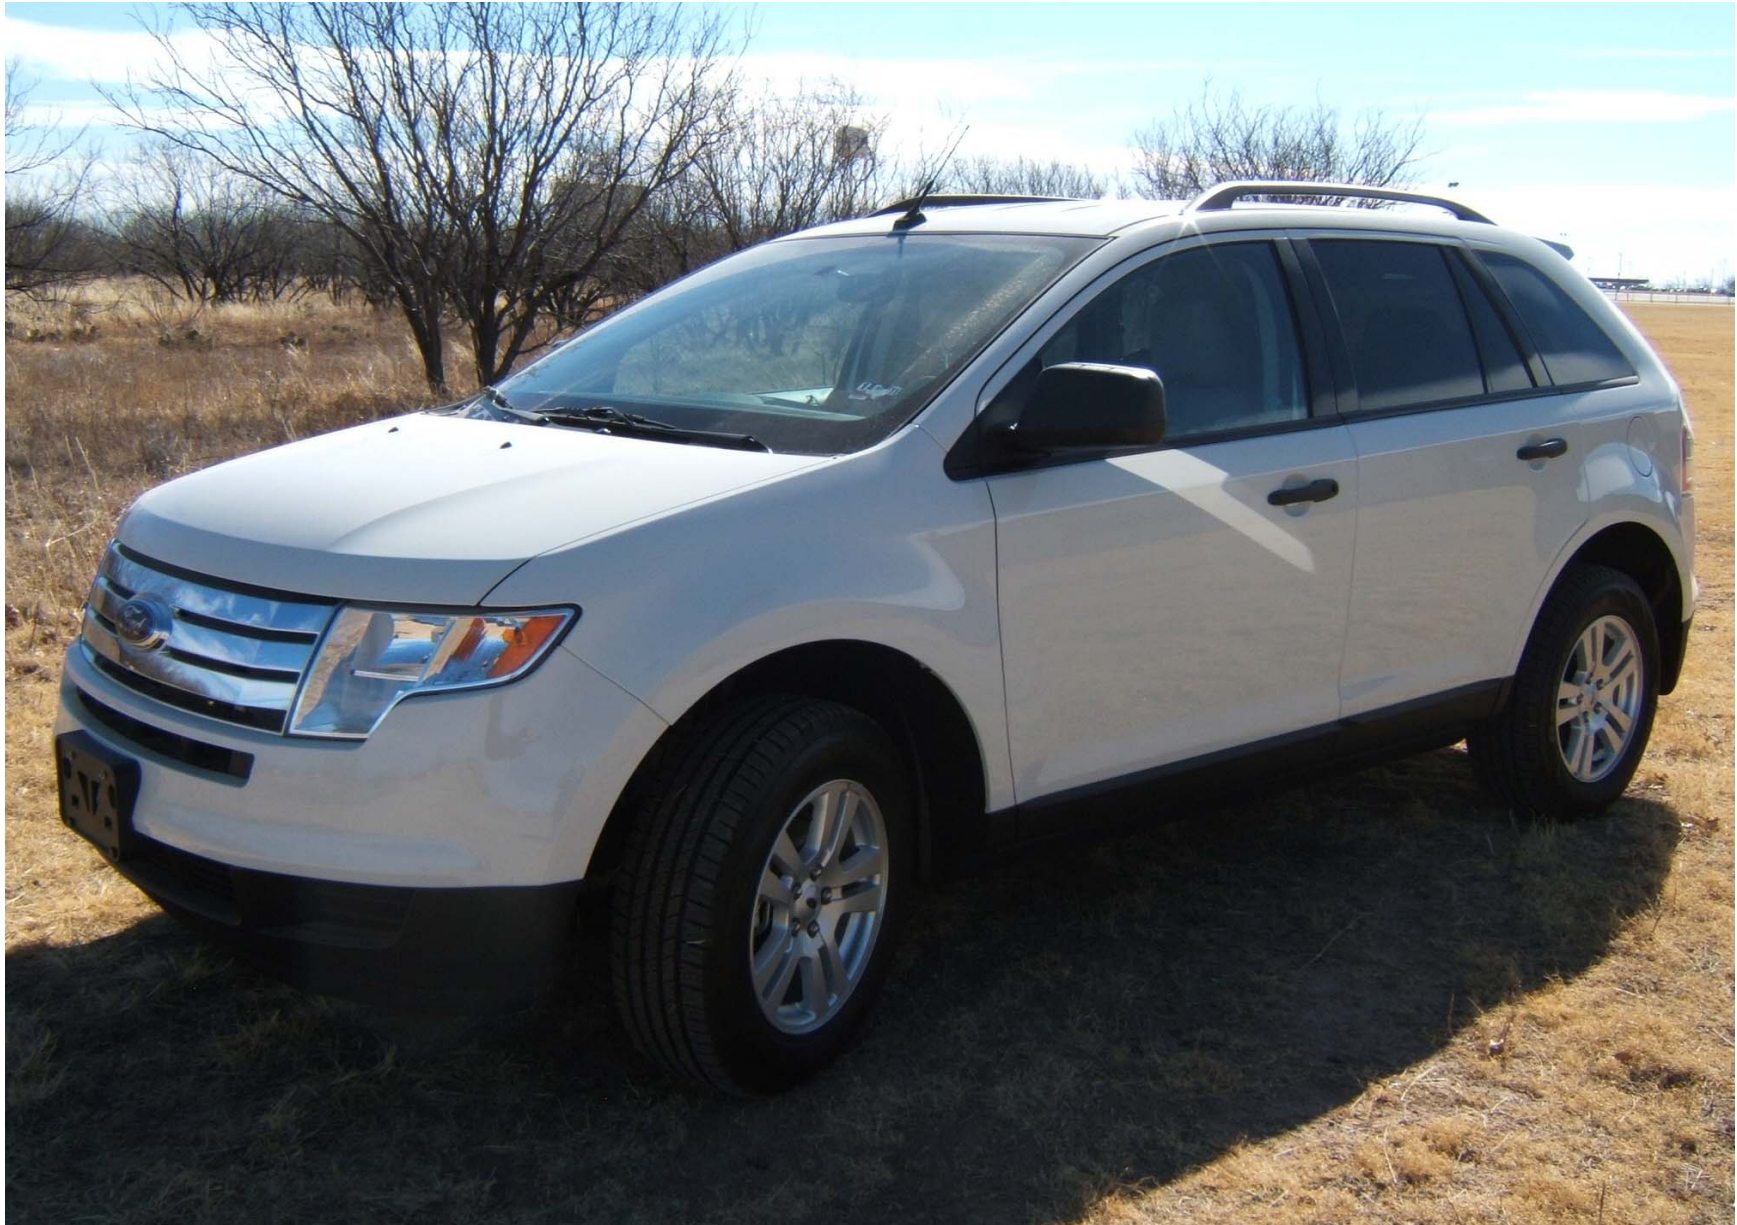
2009 FORD EDGE SE
NHTSA NO. C90203
FMVSS NO.138

FIGURE 5.1
¾ FRONT VIEW FROM LEFT SIDE OF VEHICLE

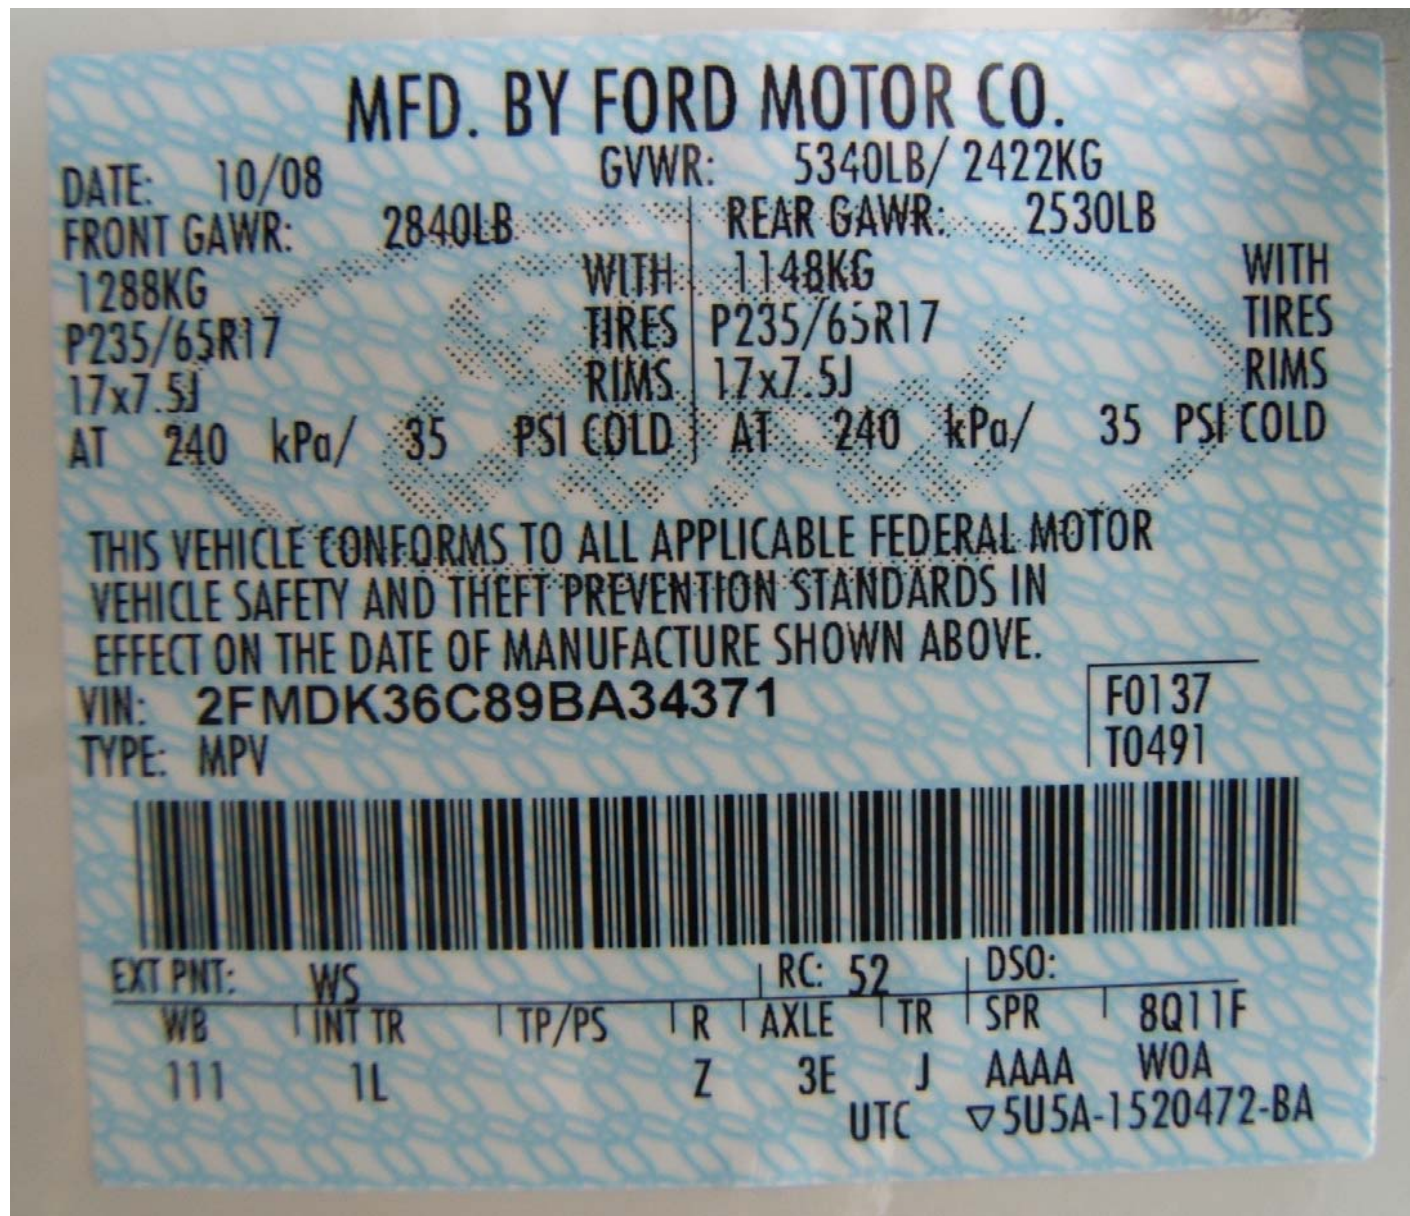
2009 FORD EDGE SE
 NHTSA NO. C90203
 FMVSS NO.138

FIGURE 5.2
 VEHICLE CERTIFICATION LABEL

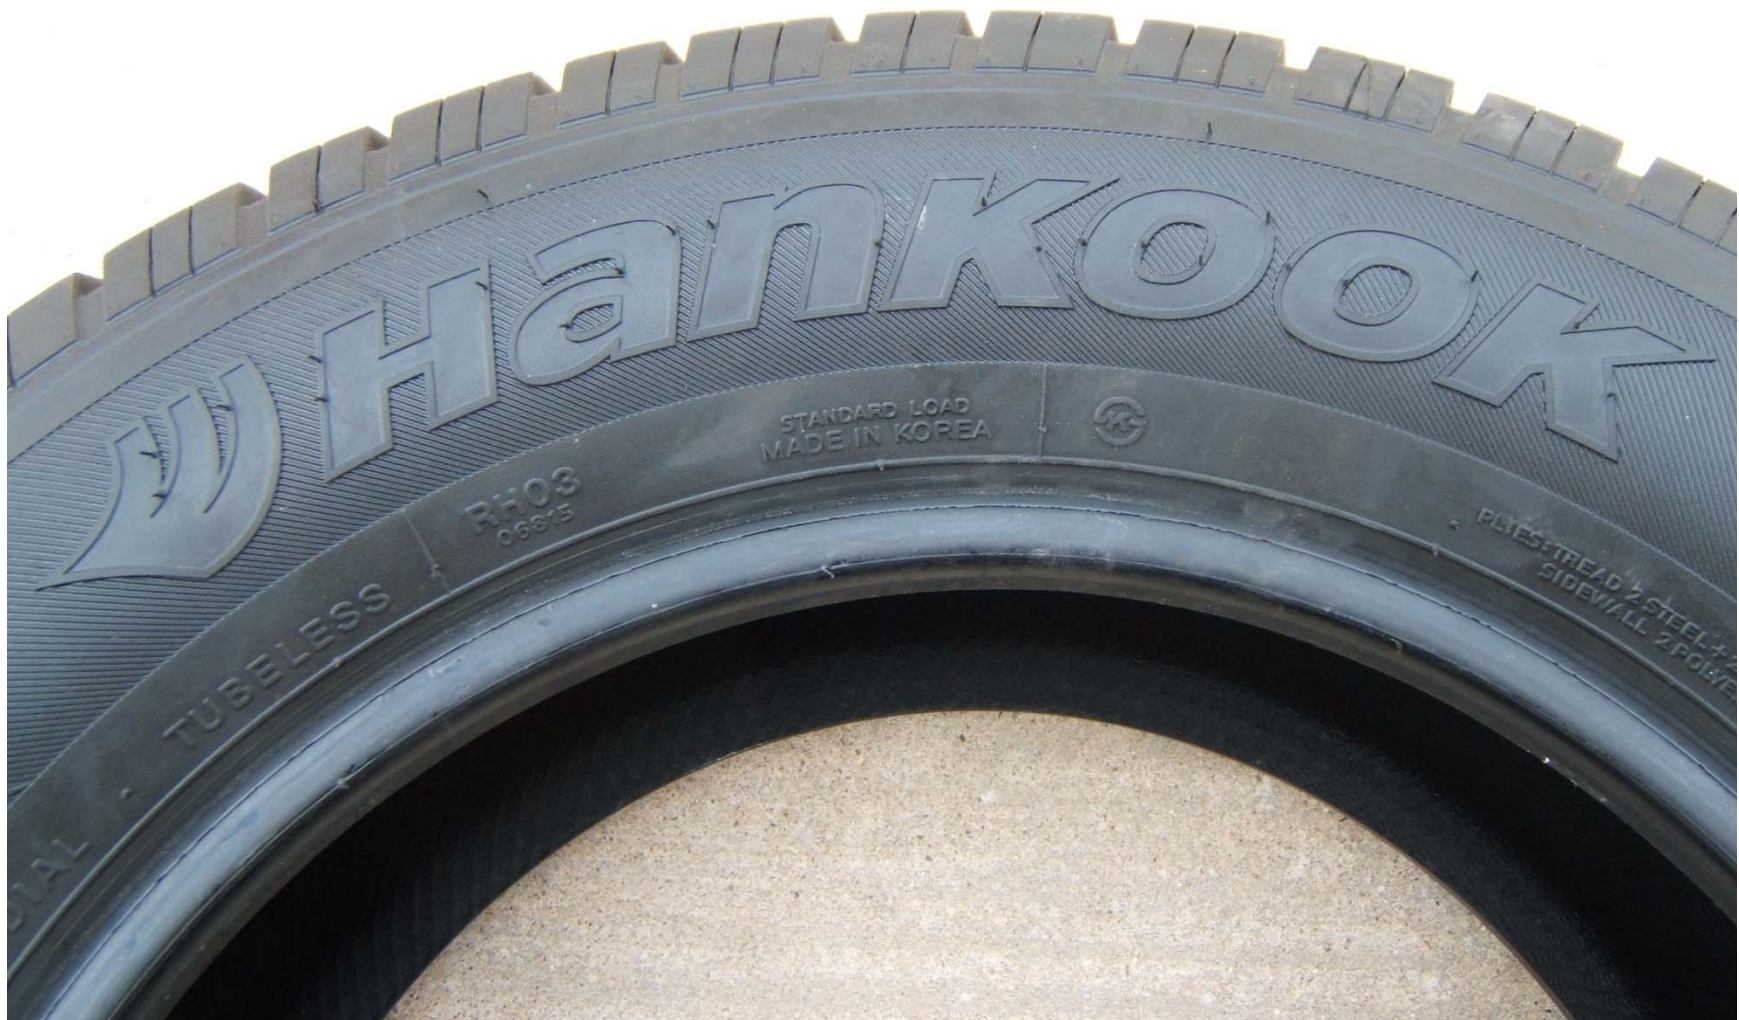
2009 FORD EDGE SE
NHTSA NO. C90203
FMVSS NO. 138

FIGURE 5.4
TIRE SHOWING BRAND

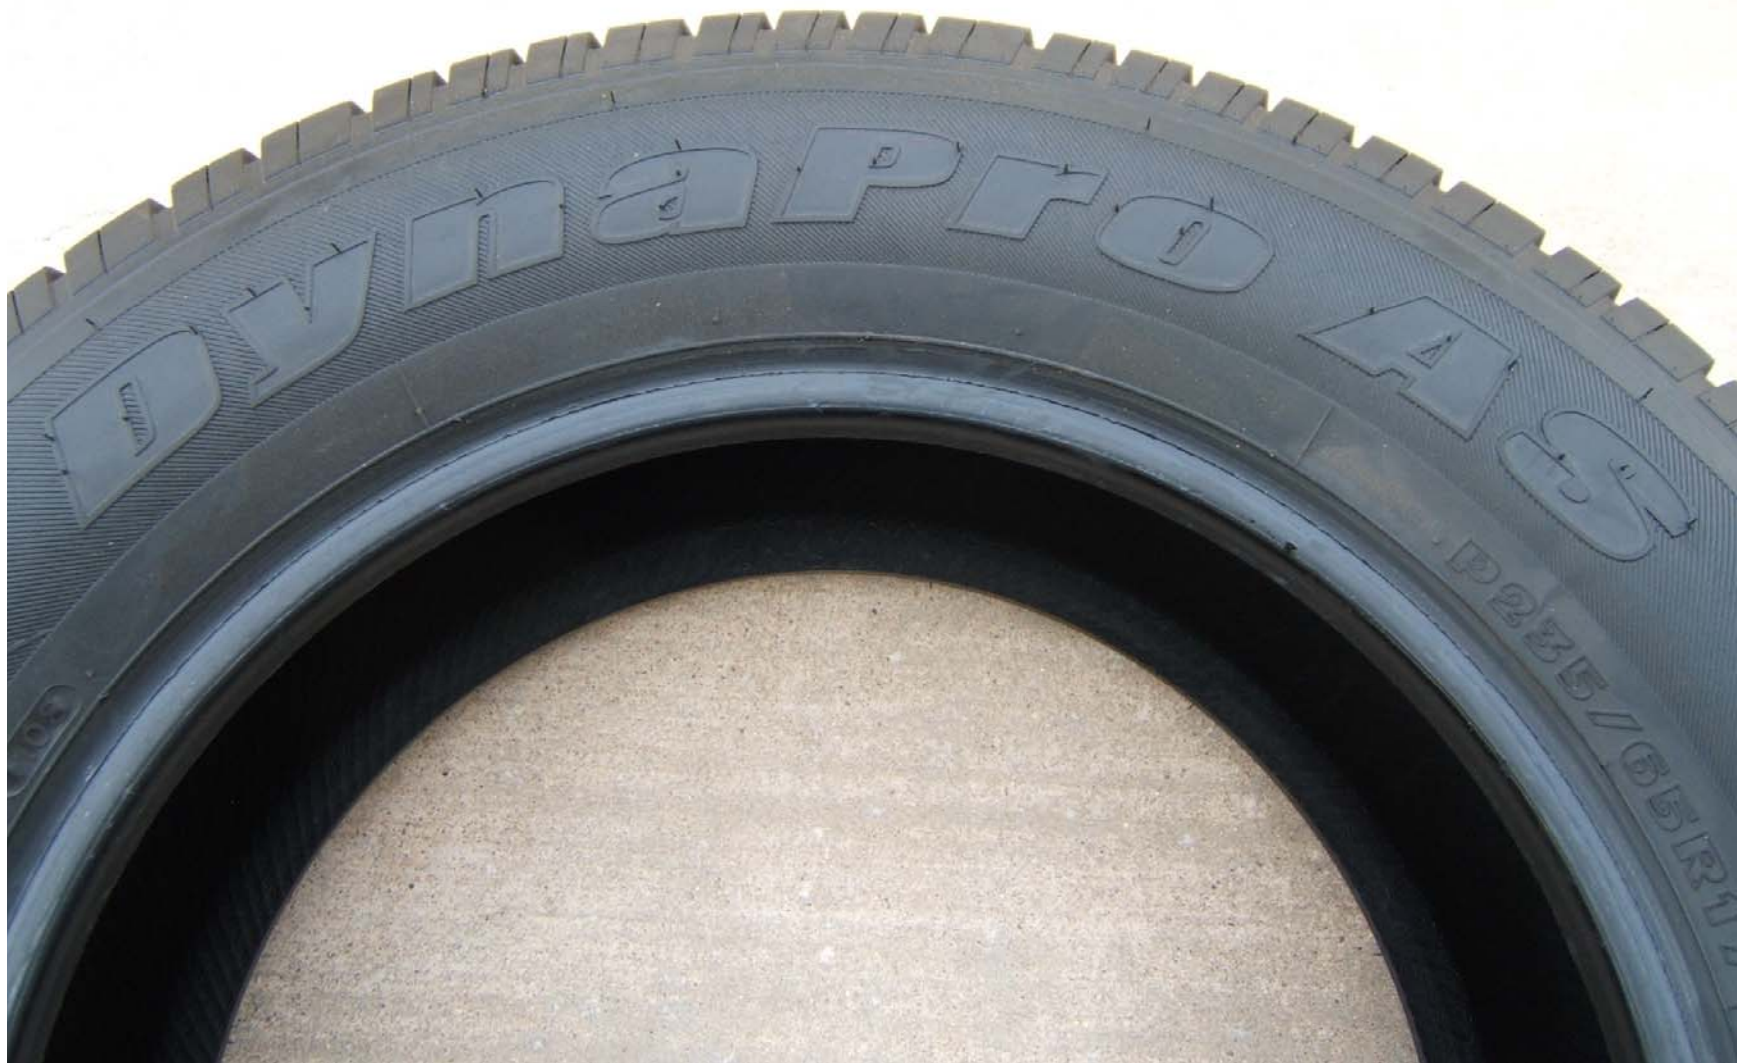
2009 FORD EDGE SE
NHTSA NO. C90203
FMVSS NO. 138

FIGURE 5.5
TIRE SHOWING MODEL

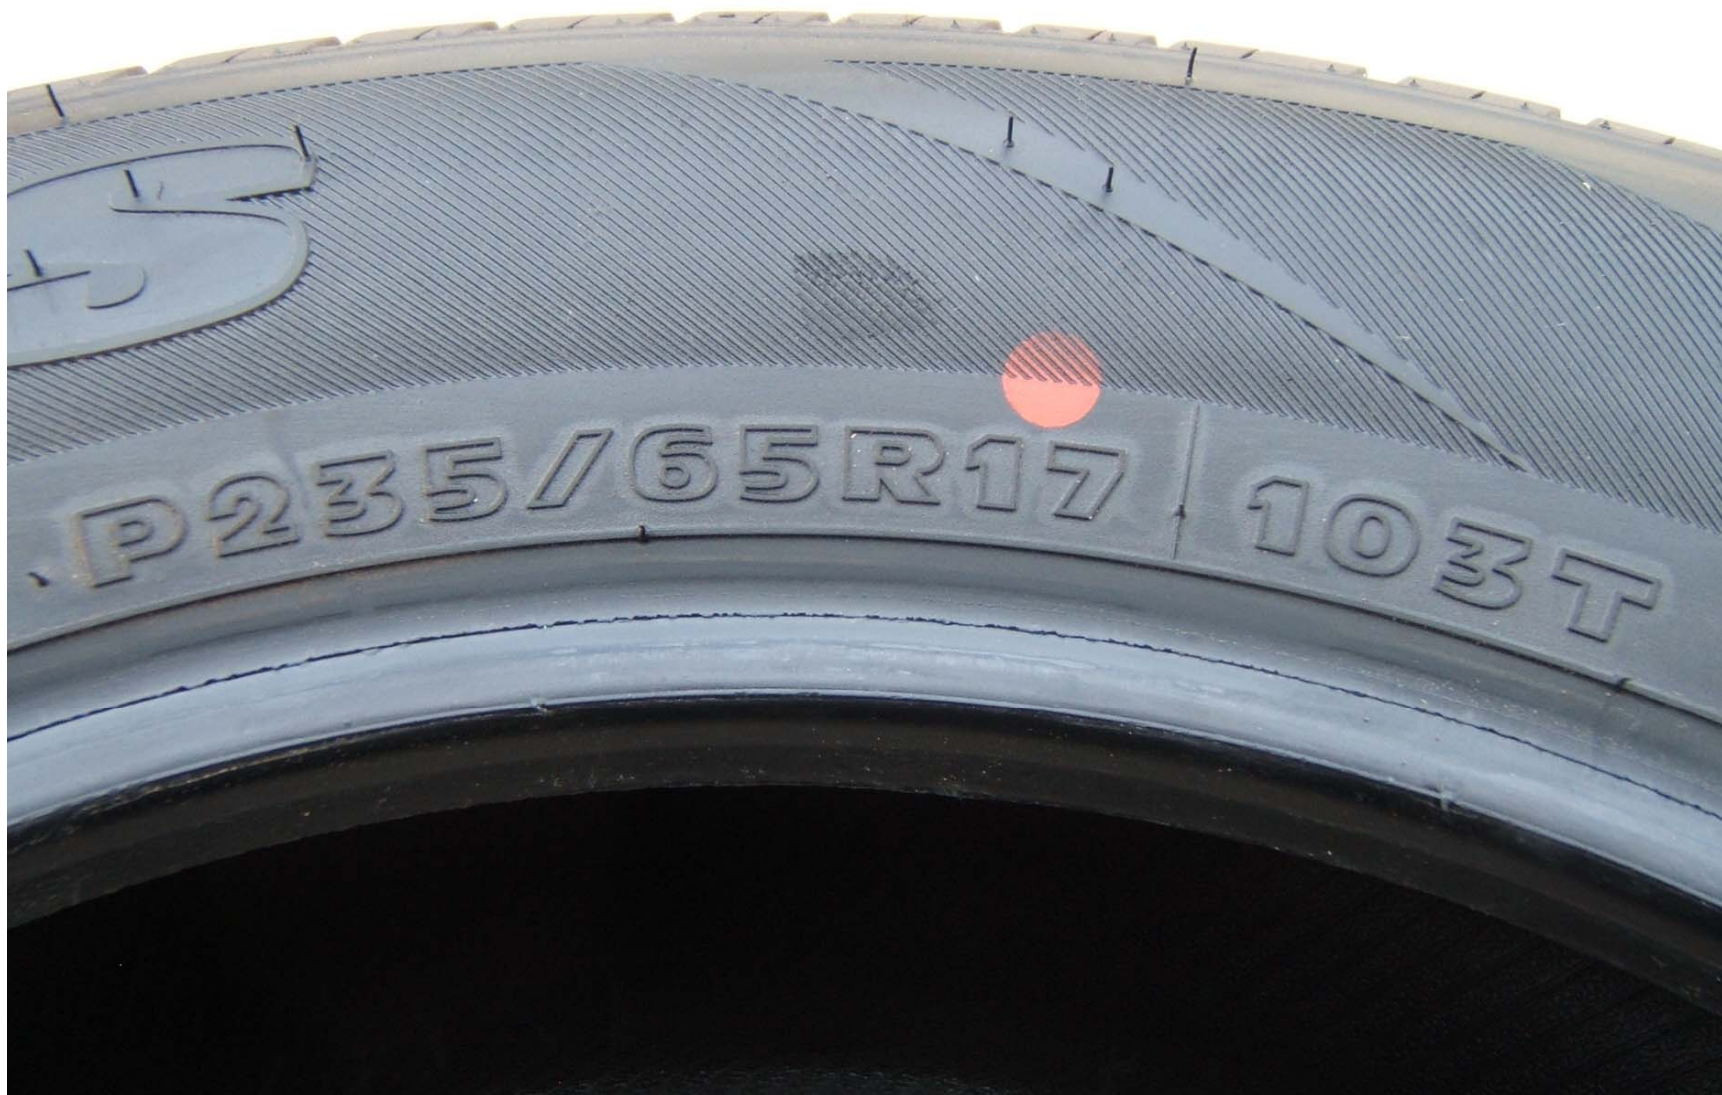
2009 FORD EDGE SE
NHTSA NO. C90203
FMVSS NO. 138

FIGURE 5.6
TIRE SHOWING SIZE AND LOAD INDEX / SPEED RATING

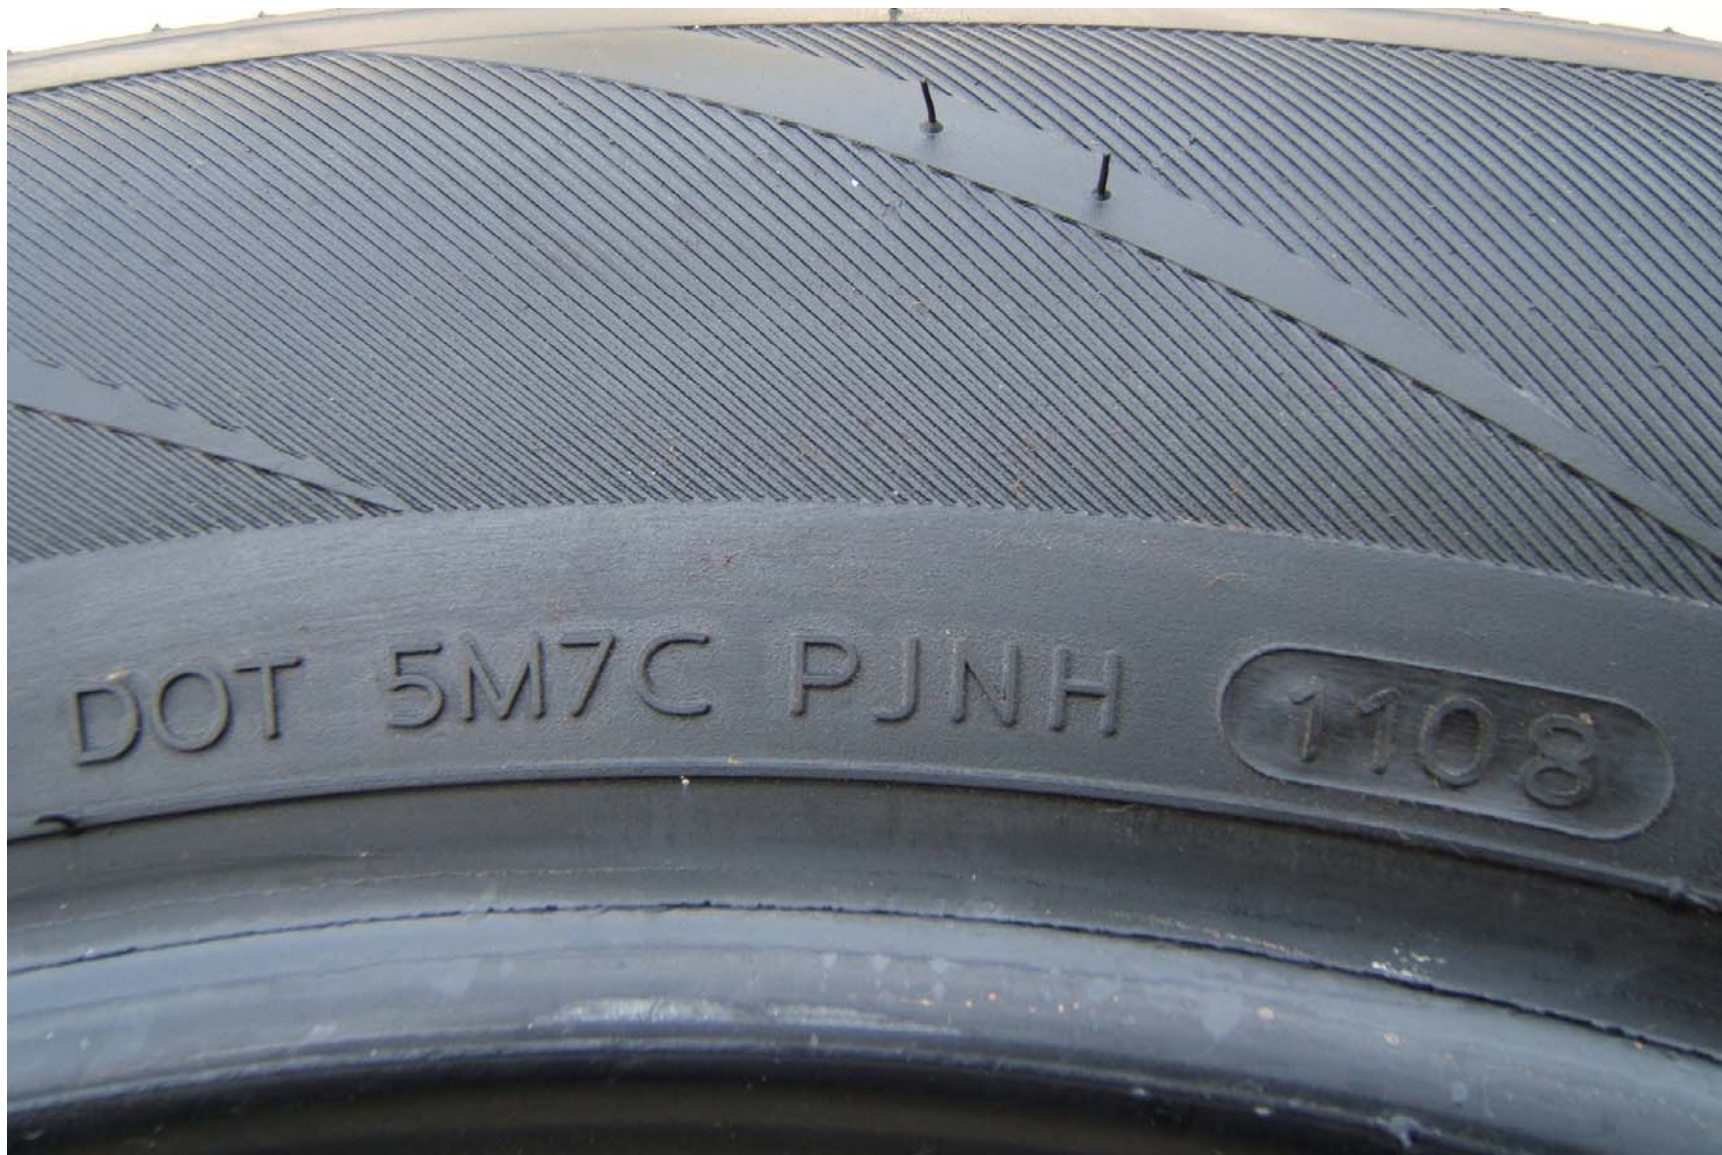
2009 FORD EDGE SE
NHTSA NO. C90203
FMVSS NO. 138

FIGURE 5.7
TIRE SHOWING DOT SERIAL NUMBER

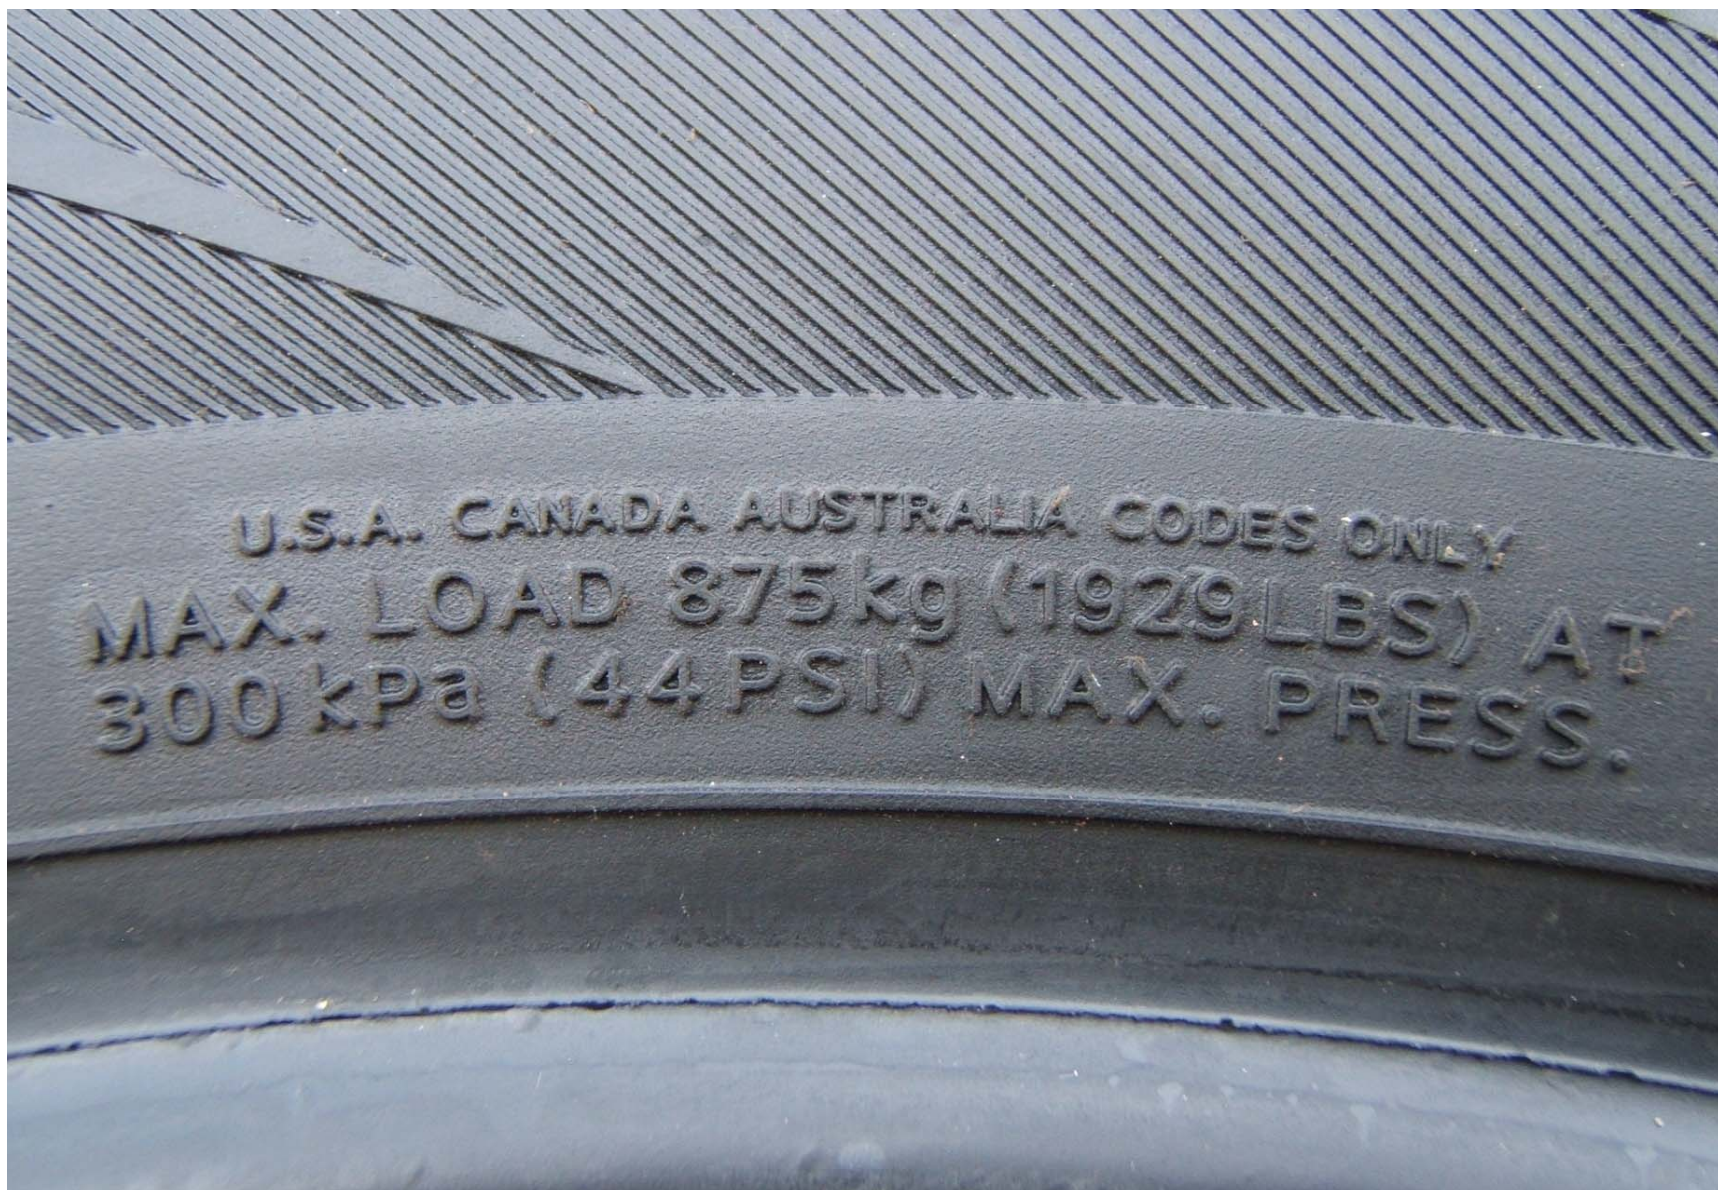
2009 FORD EDGE SE
NHTSA NO. C90203
FMVSS NO. 138

FIGURE 5.8
TIRE SHOWING MAX LOAD RATING
AND MAX COLD INFLATION PRESSURE

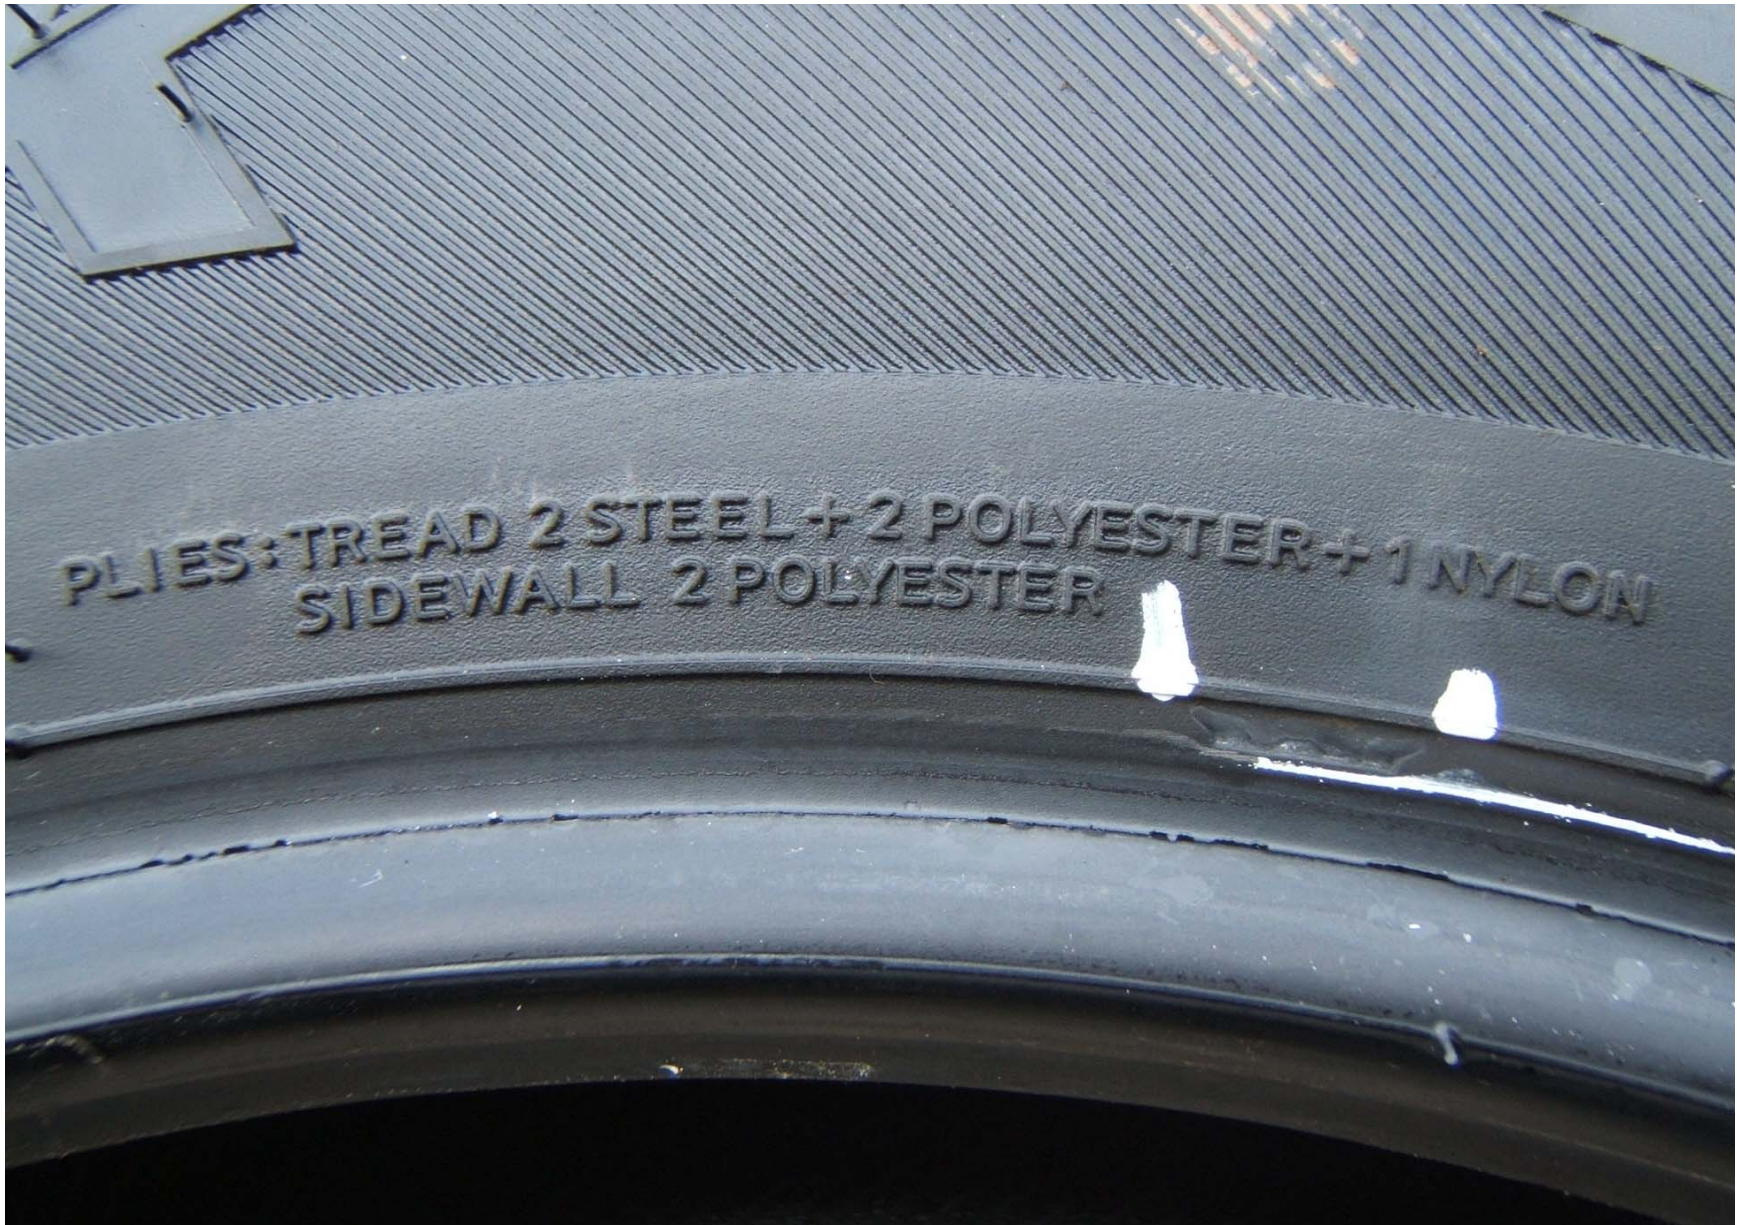
2009 FORD EDGE SE
NHTSA NO. C90203
FMVSS NO. 138

FIGURE 5.9
TIRE SHOWING SIDEWALL / TREAD CONSTRUCTION

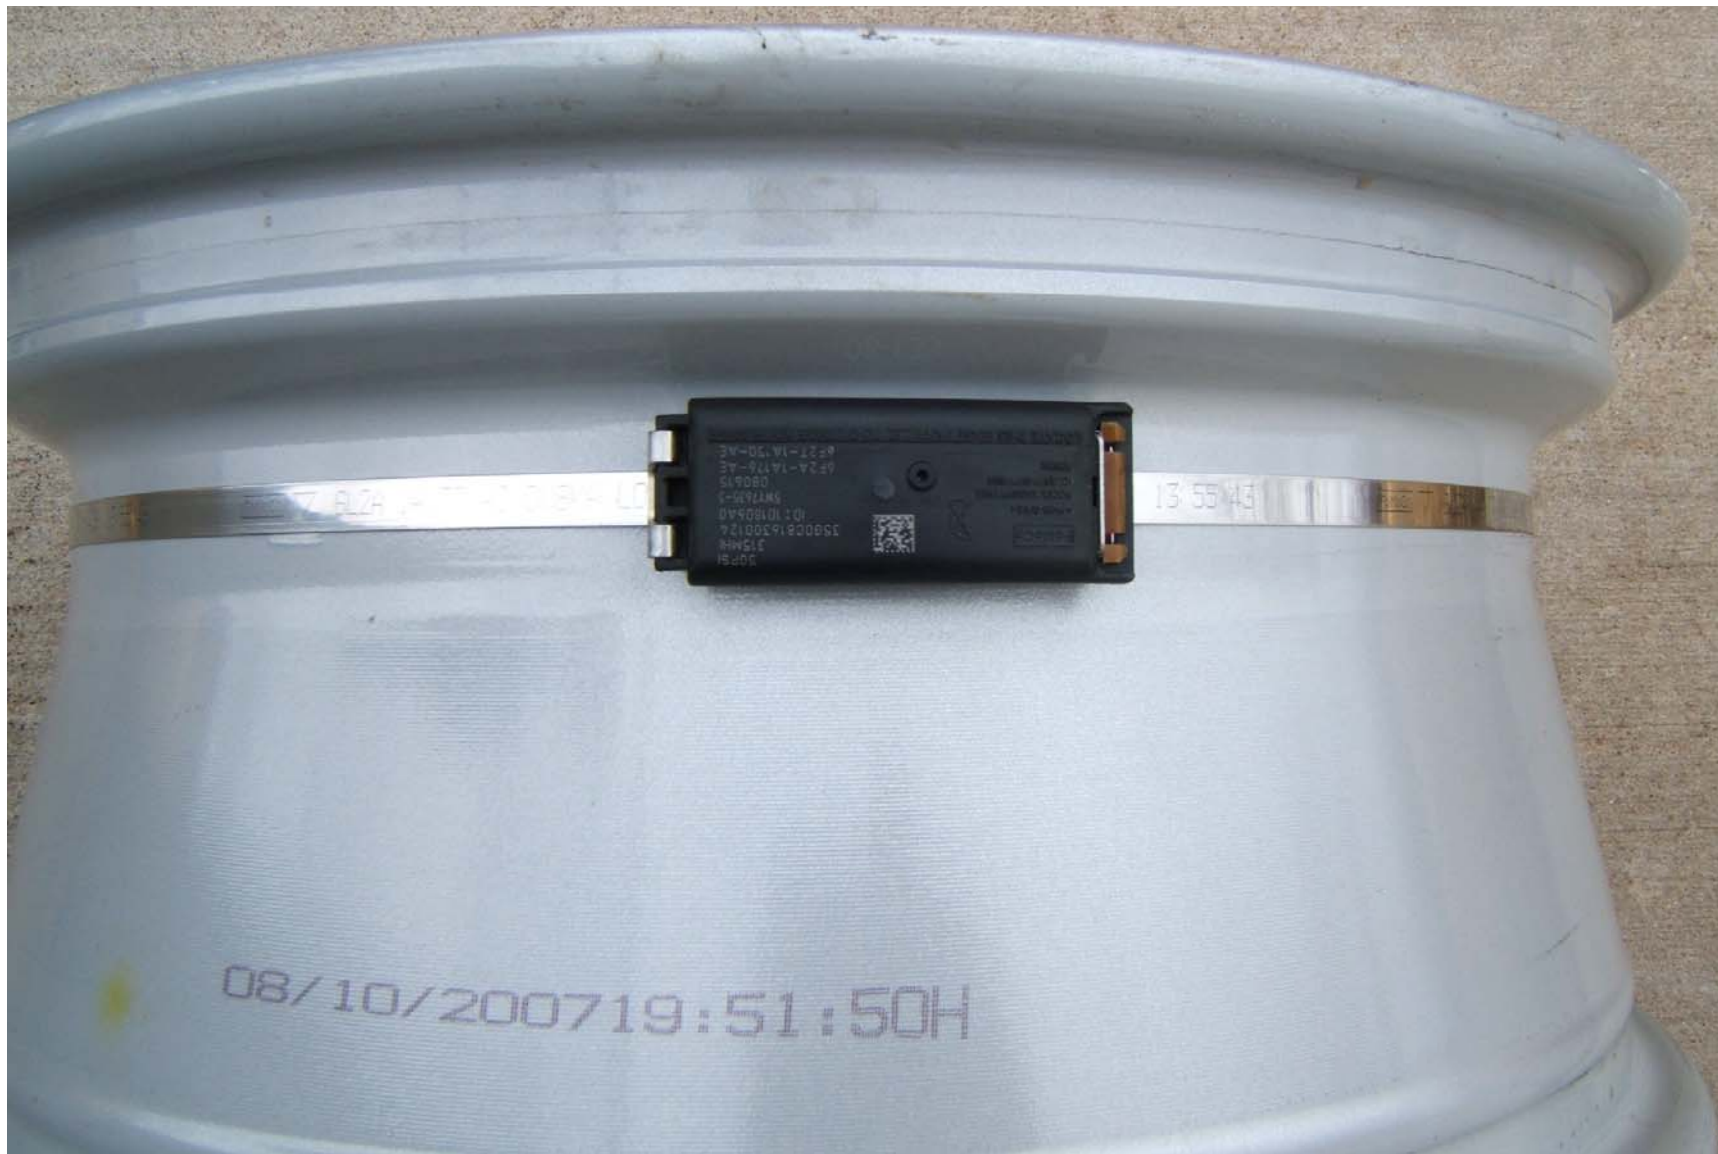
2009 FORD EDGE SE
NHTSA NO. C90203
FMVSS NO. 138

FIGURE 5.10
RIM SHOWING TPMS SENSOR

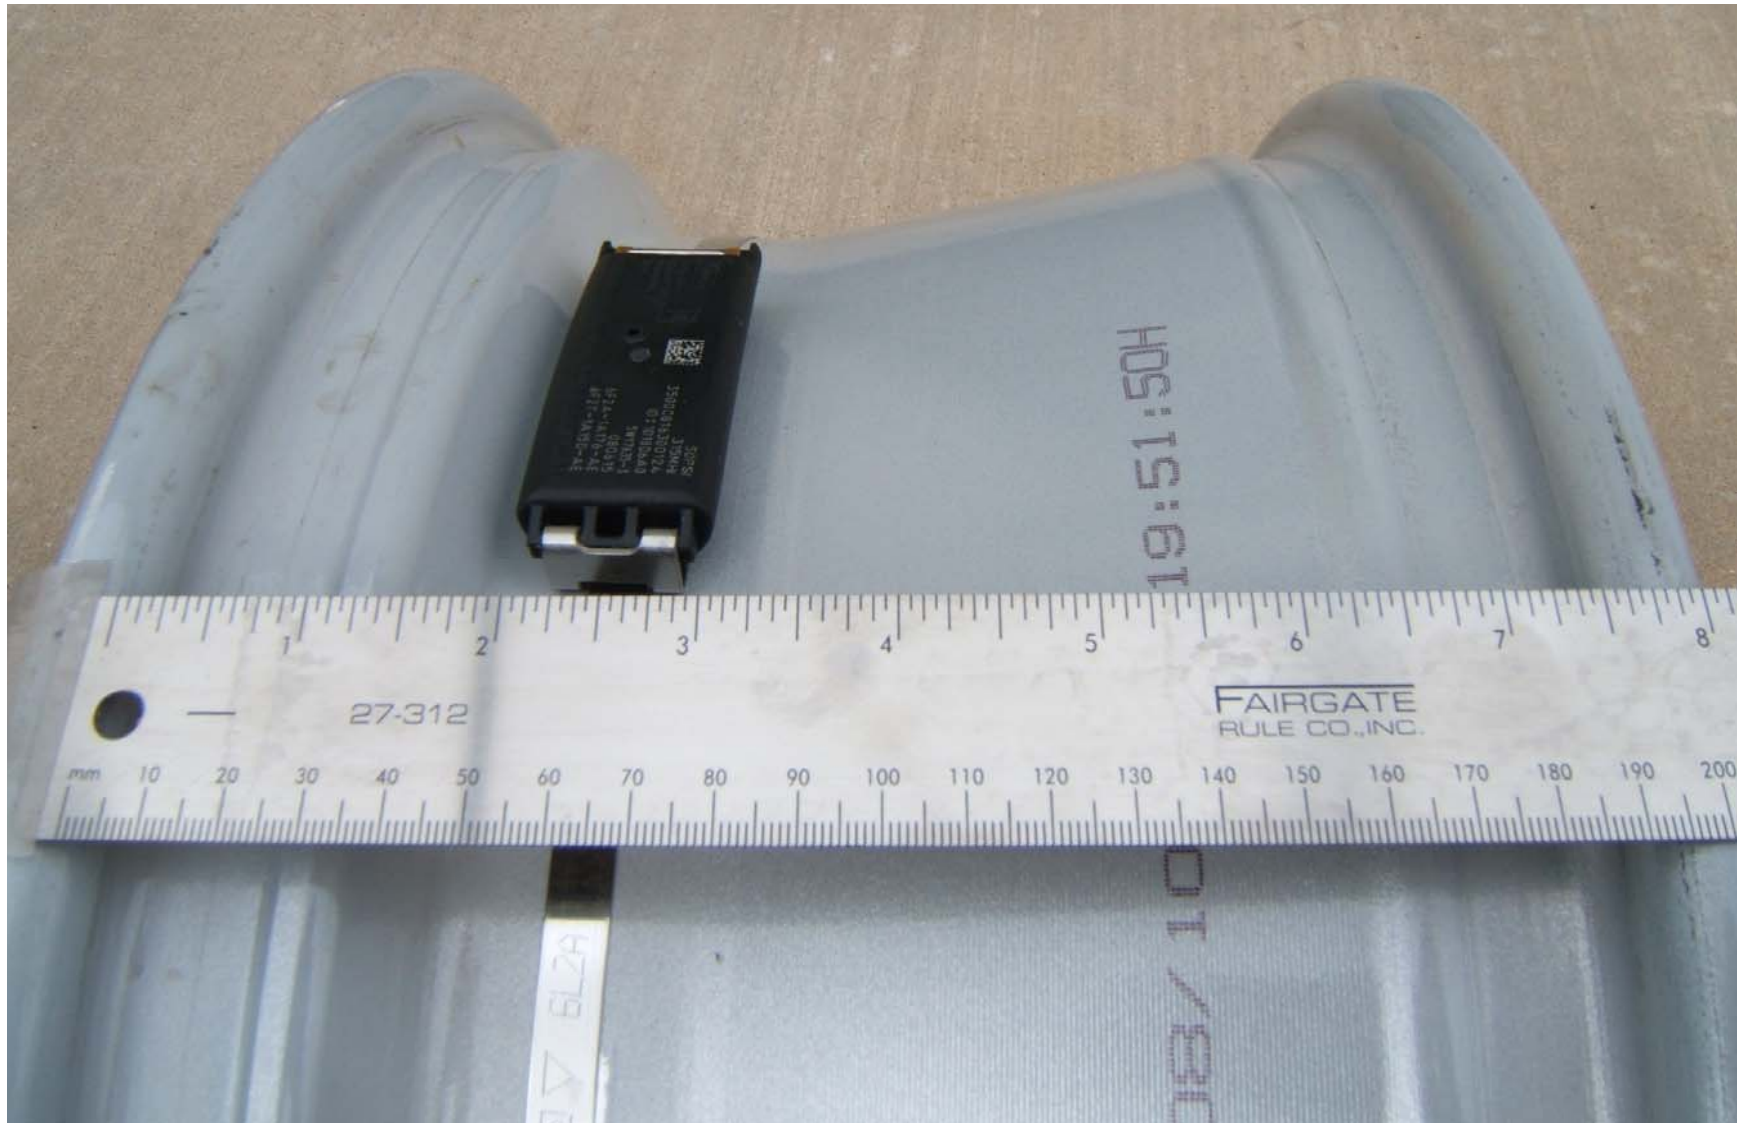
2009 FORD EDGE SE
NHTSA NO. C90203
FMVSS NO. 138

FIGURE 5.11
RIM CONTOUR FOR FULL WIDTH OF CROSS SECTION

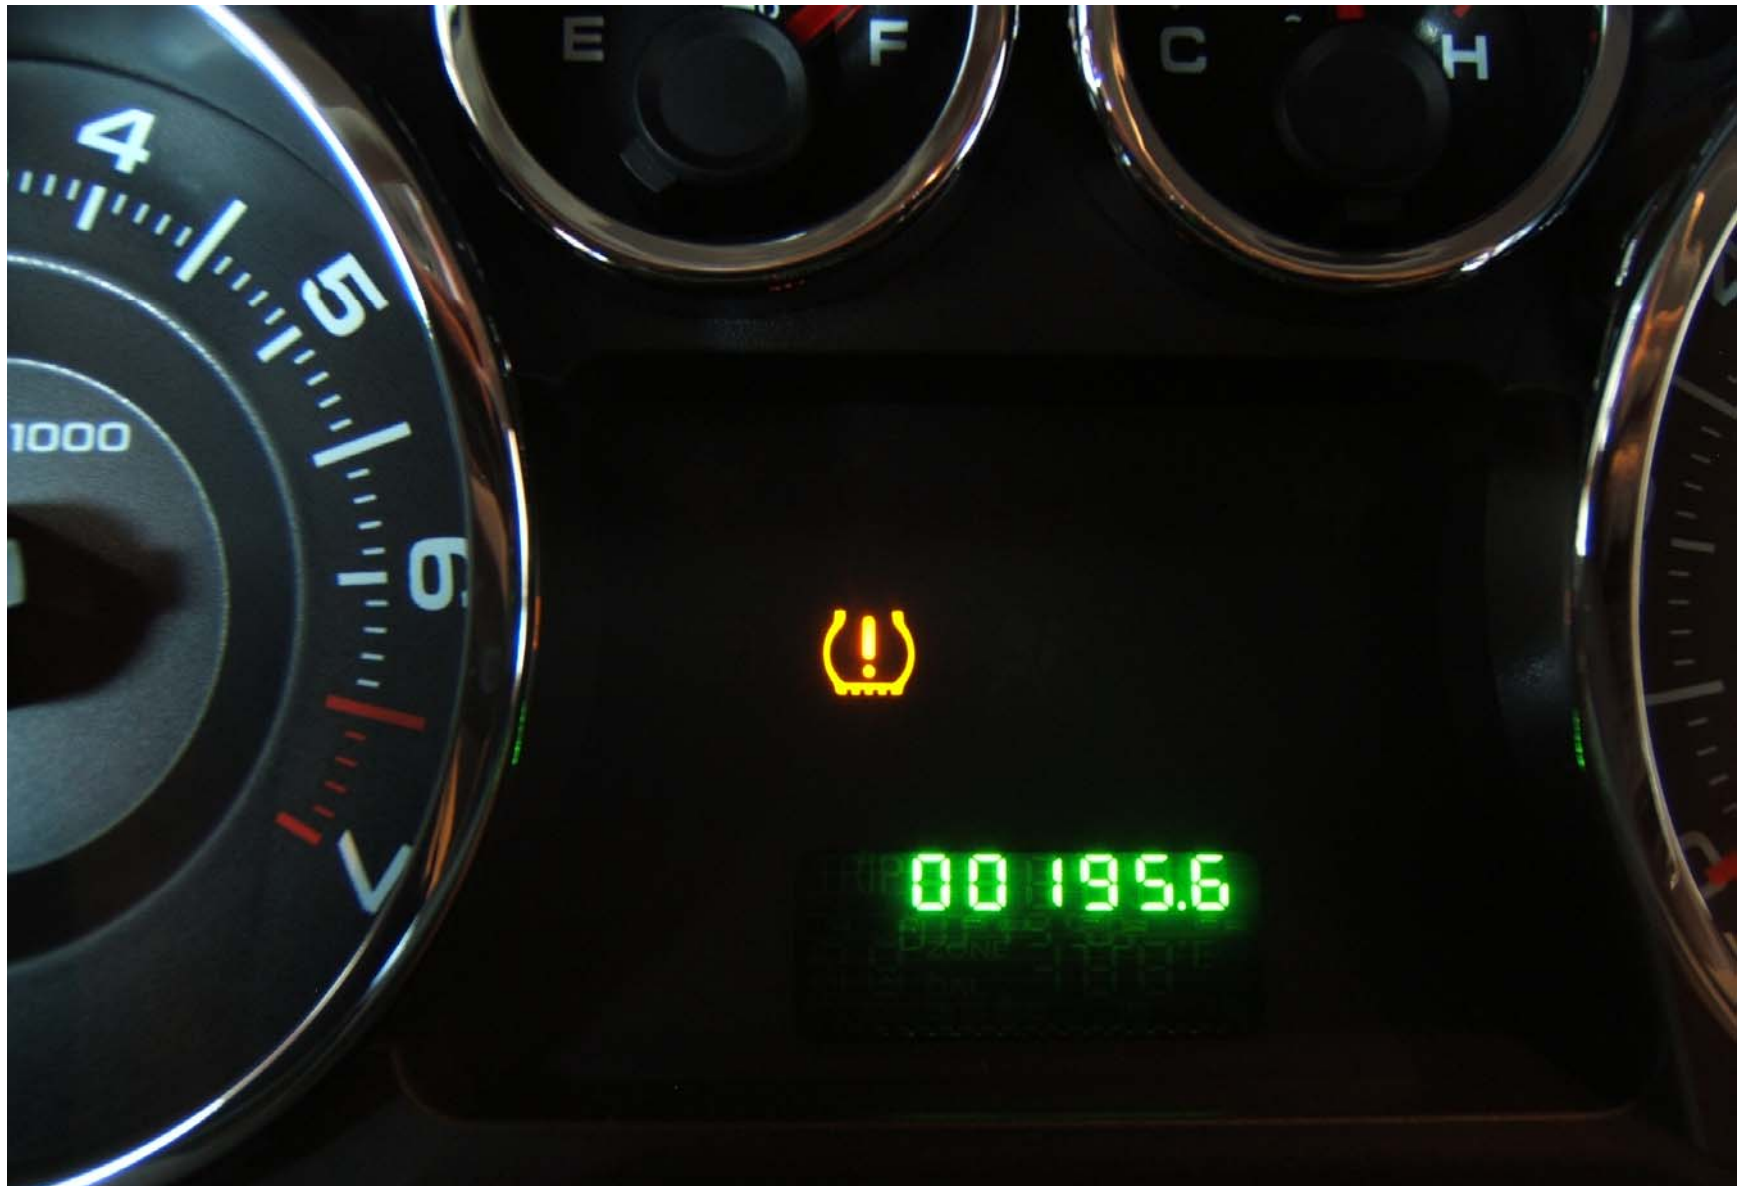
2009 FORD EDGE SE
NHTSA NO. C90203
FMVSS NO. 138

FIGURE 5.12
DISPLAY SHOWING COMBINATION LOW TIRE PRESSURE
WARNING / TPMS MALFUNCTION WARNING TELLTALE
