REPORT NUMBER 138-STF-09-004

SAFETY COMPLIANCE TESTING FOR FMVSS NO. 138 TIRE PRESSURE MONITORING SYSTEMS

FORD MOTOR COMPANY
2009 FORD EDGE SE
FOUR-DOOR MPV
NHTSA NO. C90203

FINAL REPORT

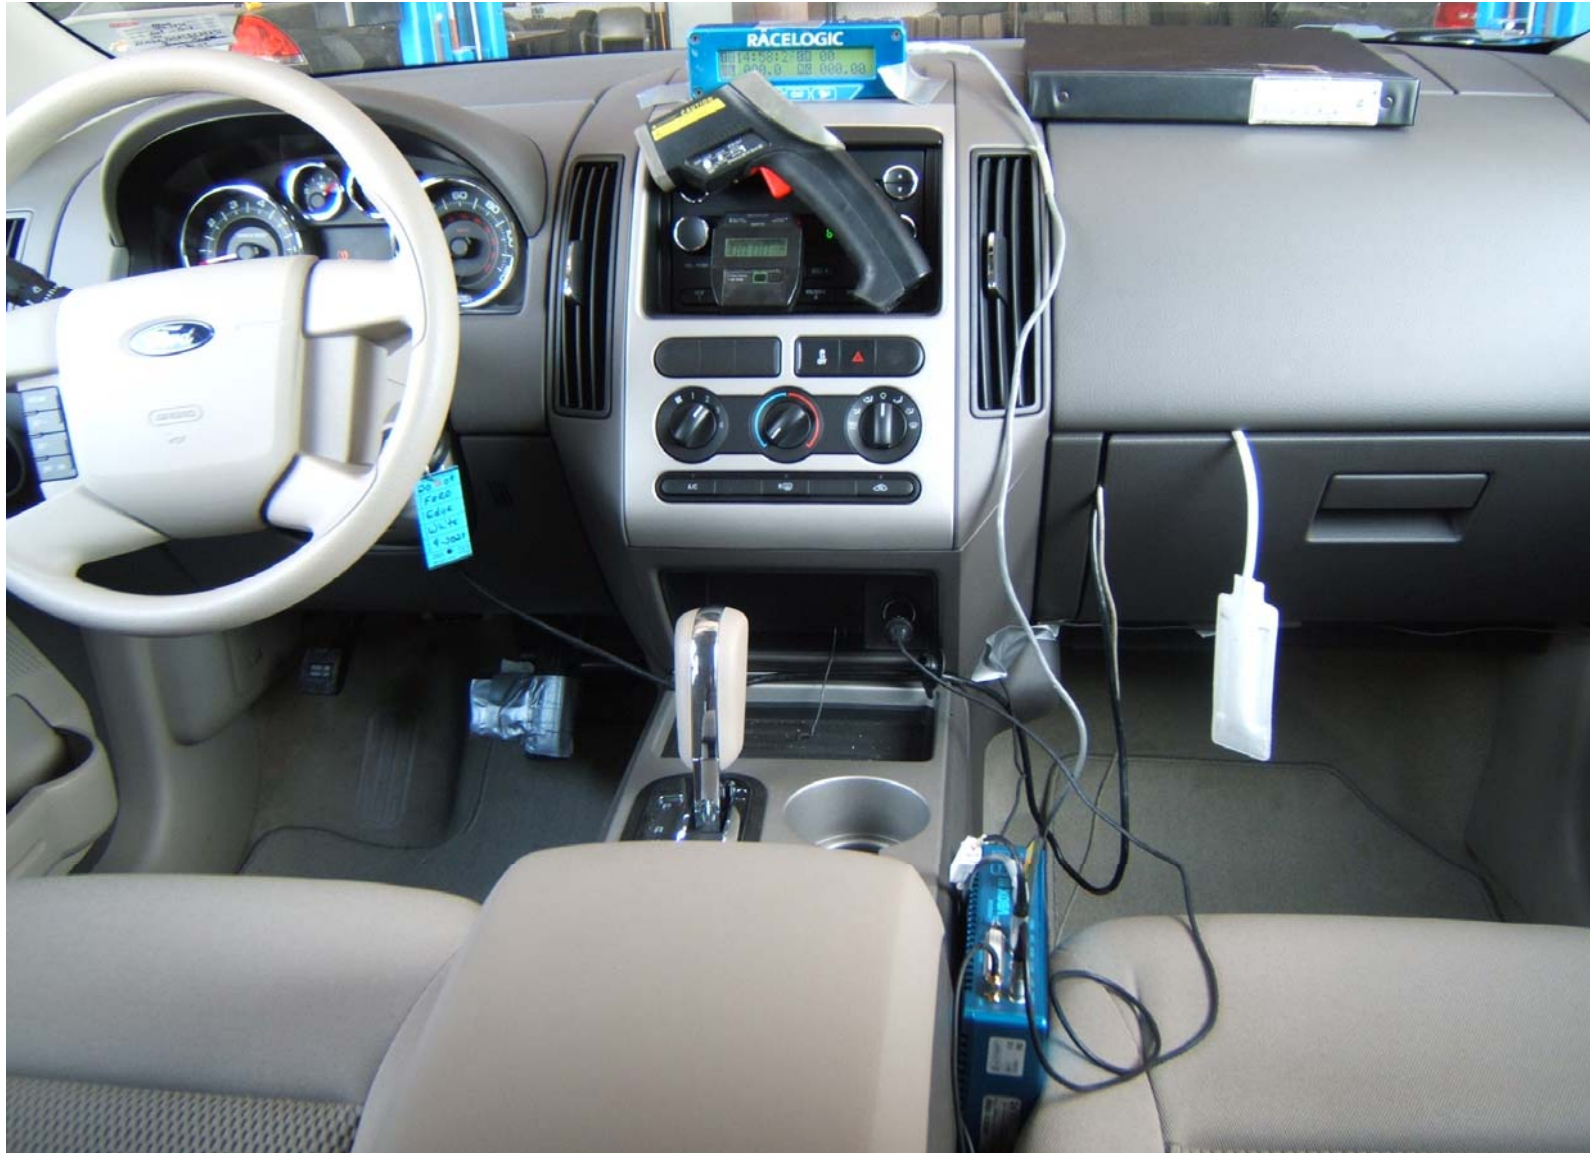
2009 FORD EDGE SE
NHTSA NO. C90203
FMVSS NO 138

The vehicle was instrumented with a Racelogic VBOX III 100 Hz GPS Data Logger and brake pedal trigger. The VBOX uses GPS to measure vehicle speed, time, and distance. Test data were recorded to a compact flash card. During the test, a stopwatch was used to determine the approximate "cumulative driving time" during each test phase. Cumulative driving time does not include time during the brake application or when the vehicle speed was below 50 km/h or above 100 km/h. Upon completion of a tire deflation scenario, graphs were generated by VBOX software showing vehicle speed versus time during the test procedures. The graphs furnish a second-by second analysis of each calibration and low inflation pressure detection phase (as appropriate). The cumulative driving time was calculated by post-processing the VBOX graph data, and is reported in Section 3 (Test Data) as 'Total Driving Time'.

FIGURE 5.13
TEST INSTRUMENTATION INSTALLED IN VEHICLE

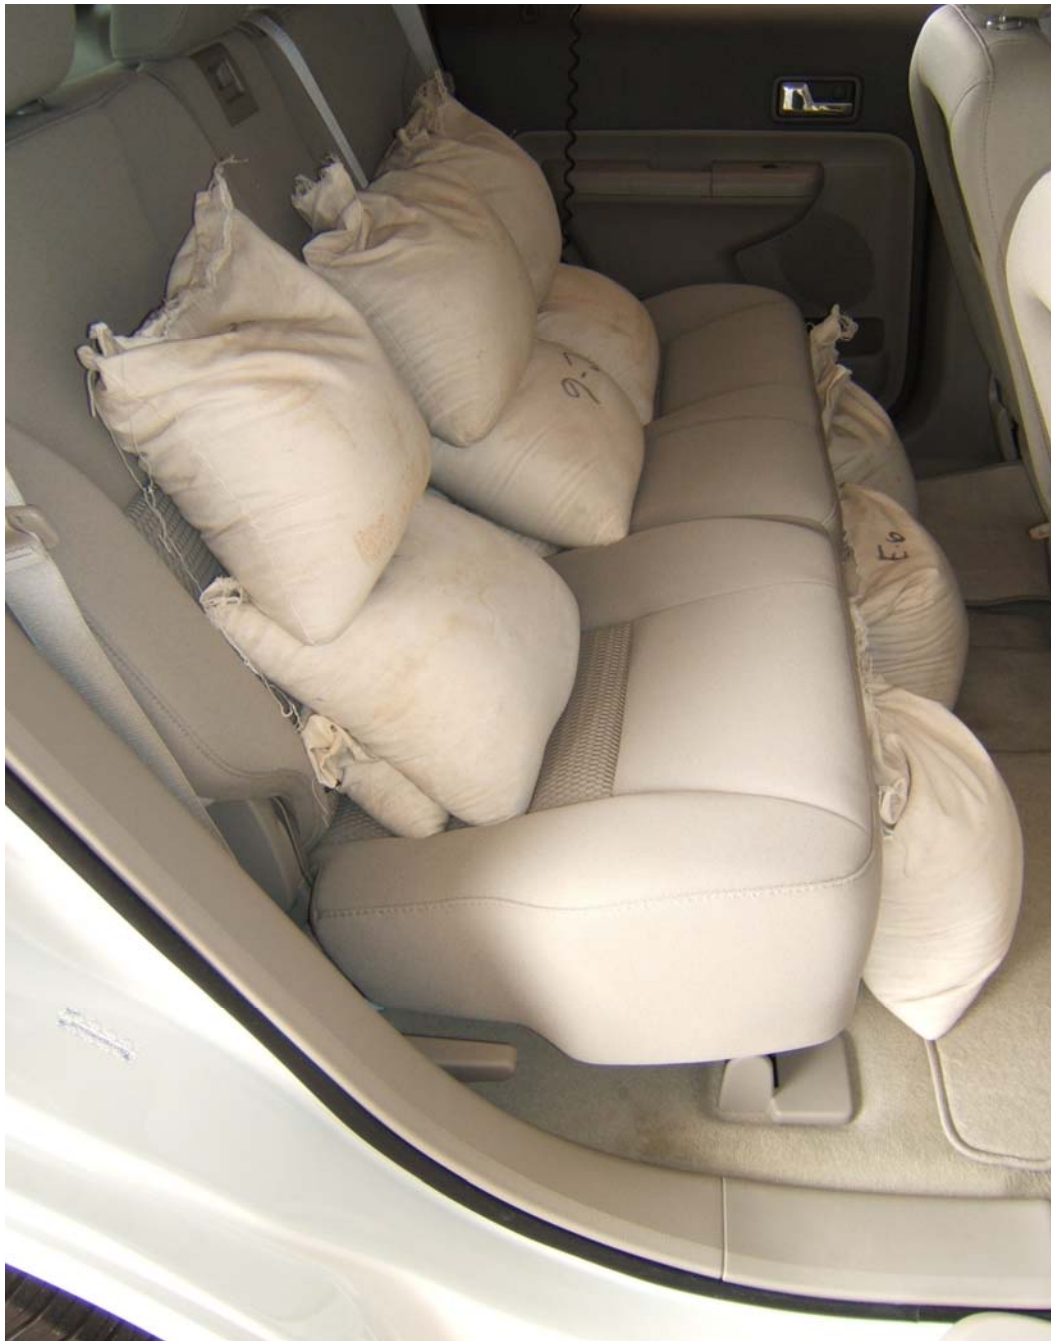
2009 FORD EDGE SE
NHTSA NO. C90203
FMVSS NO. 138

FIGURE 5.14
VEHICLE REAR SEAT BALLAST
FOR UVW + VCW LOAD

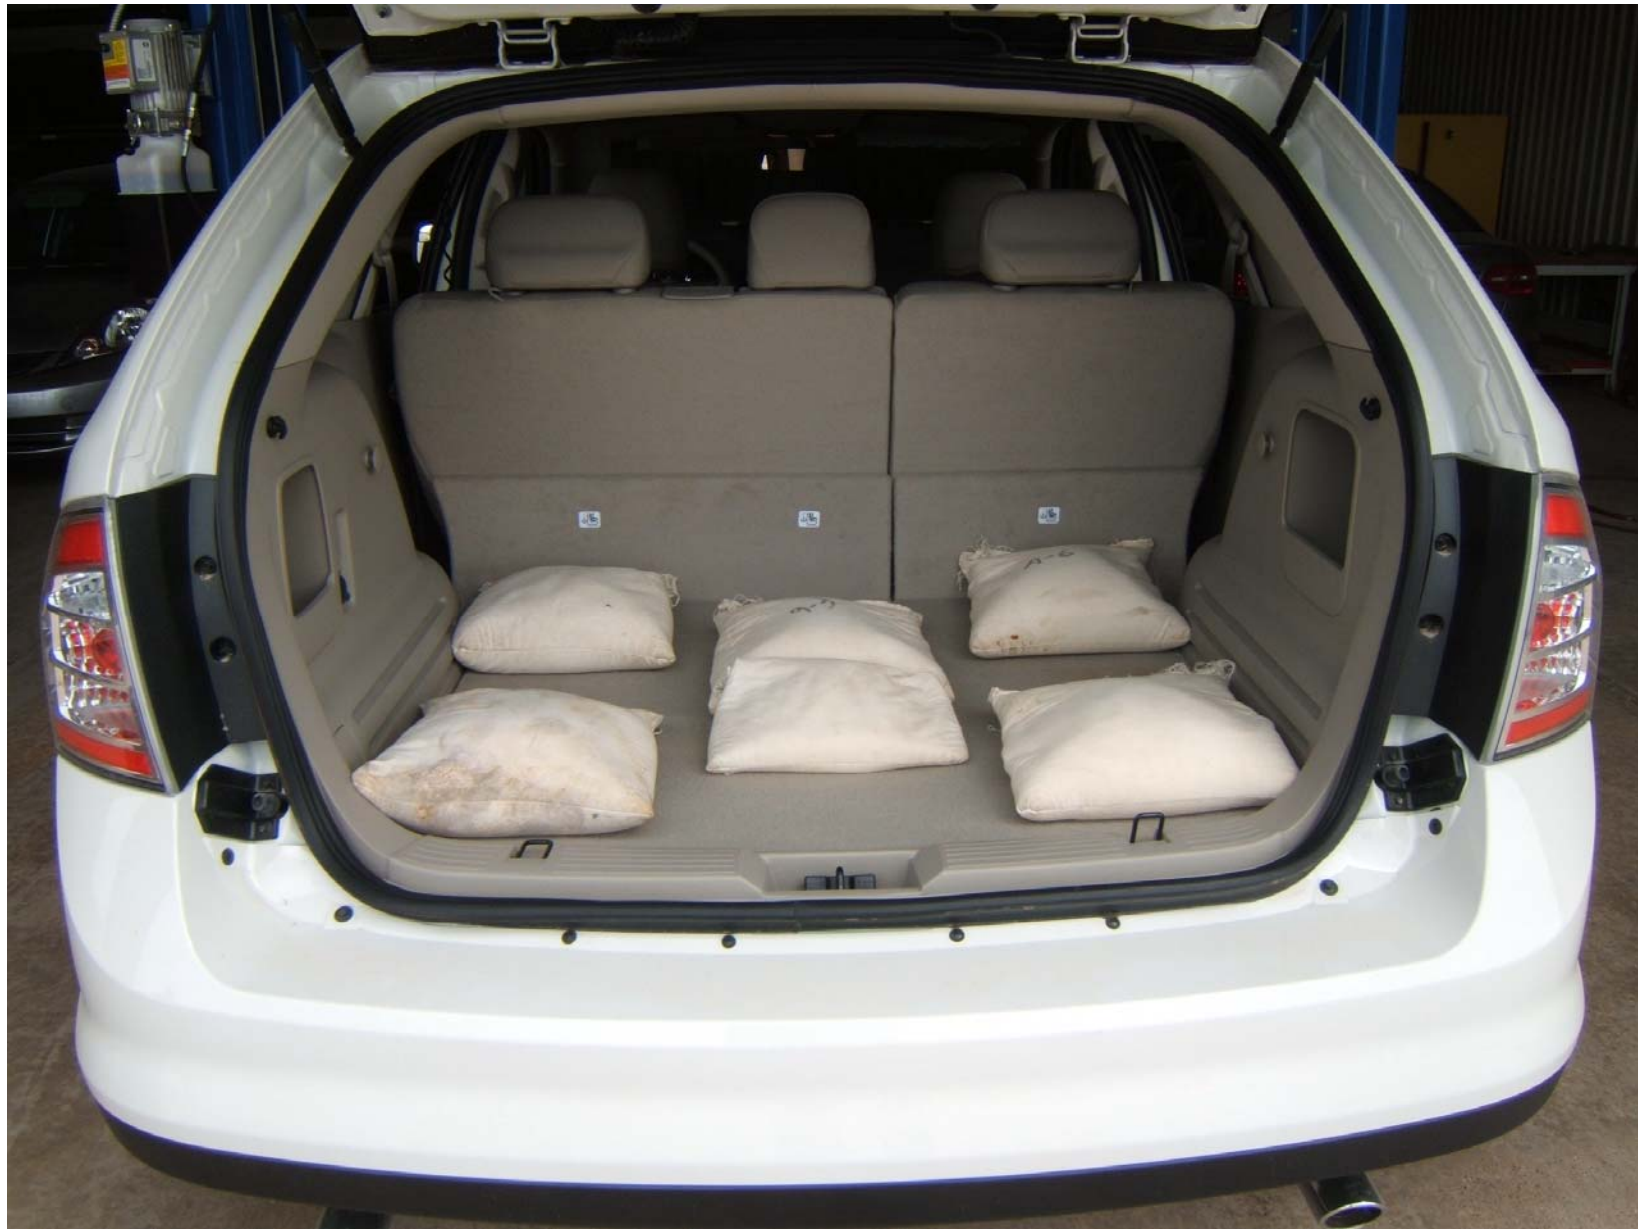
2009 FORD EDGE SE
NHTSA NO. C90203
FMVSS NO. 138

FIGURE 5.15
REAR OF VEHICLE BALLAST FOR UVW + VCW LOAD

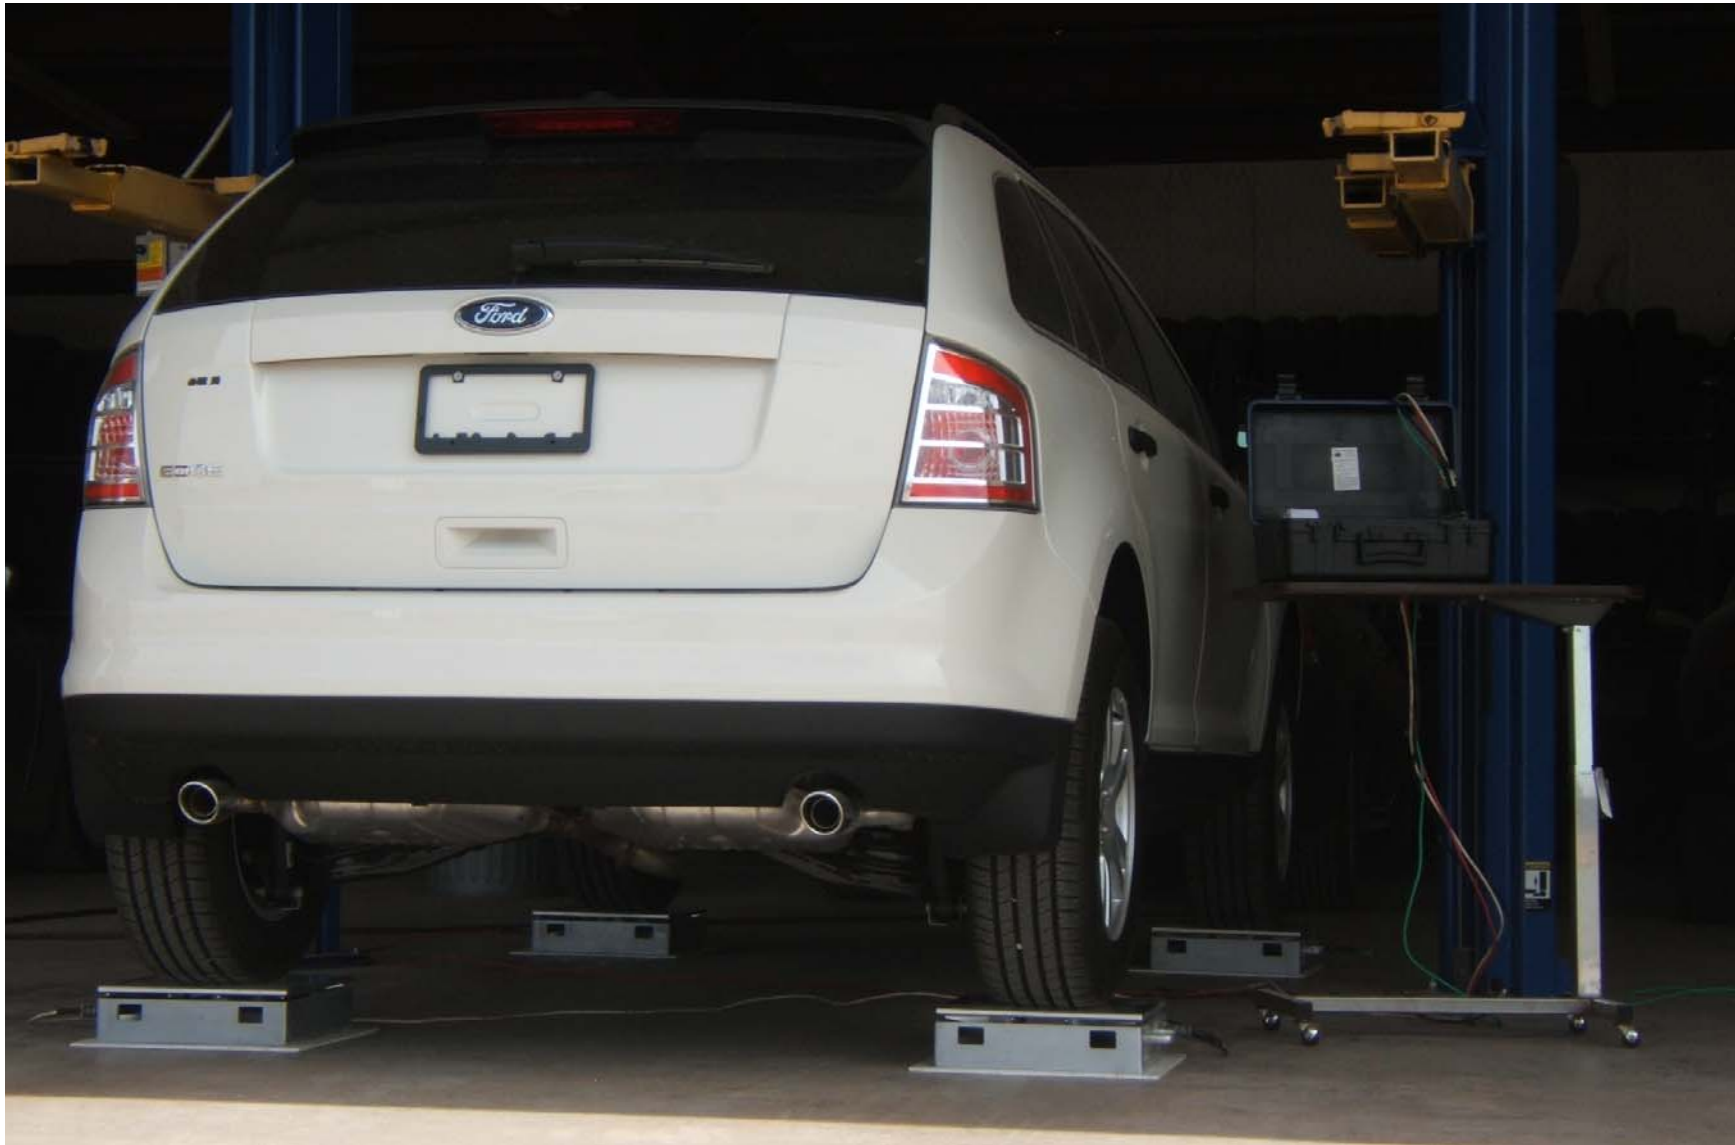
2009 FORD EDGE SE
NHTSA NO. C90203
FMVSS NO. 138

FIGURE 5.16
VEHICLE ON WEIGHT SCALES

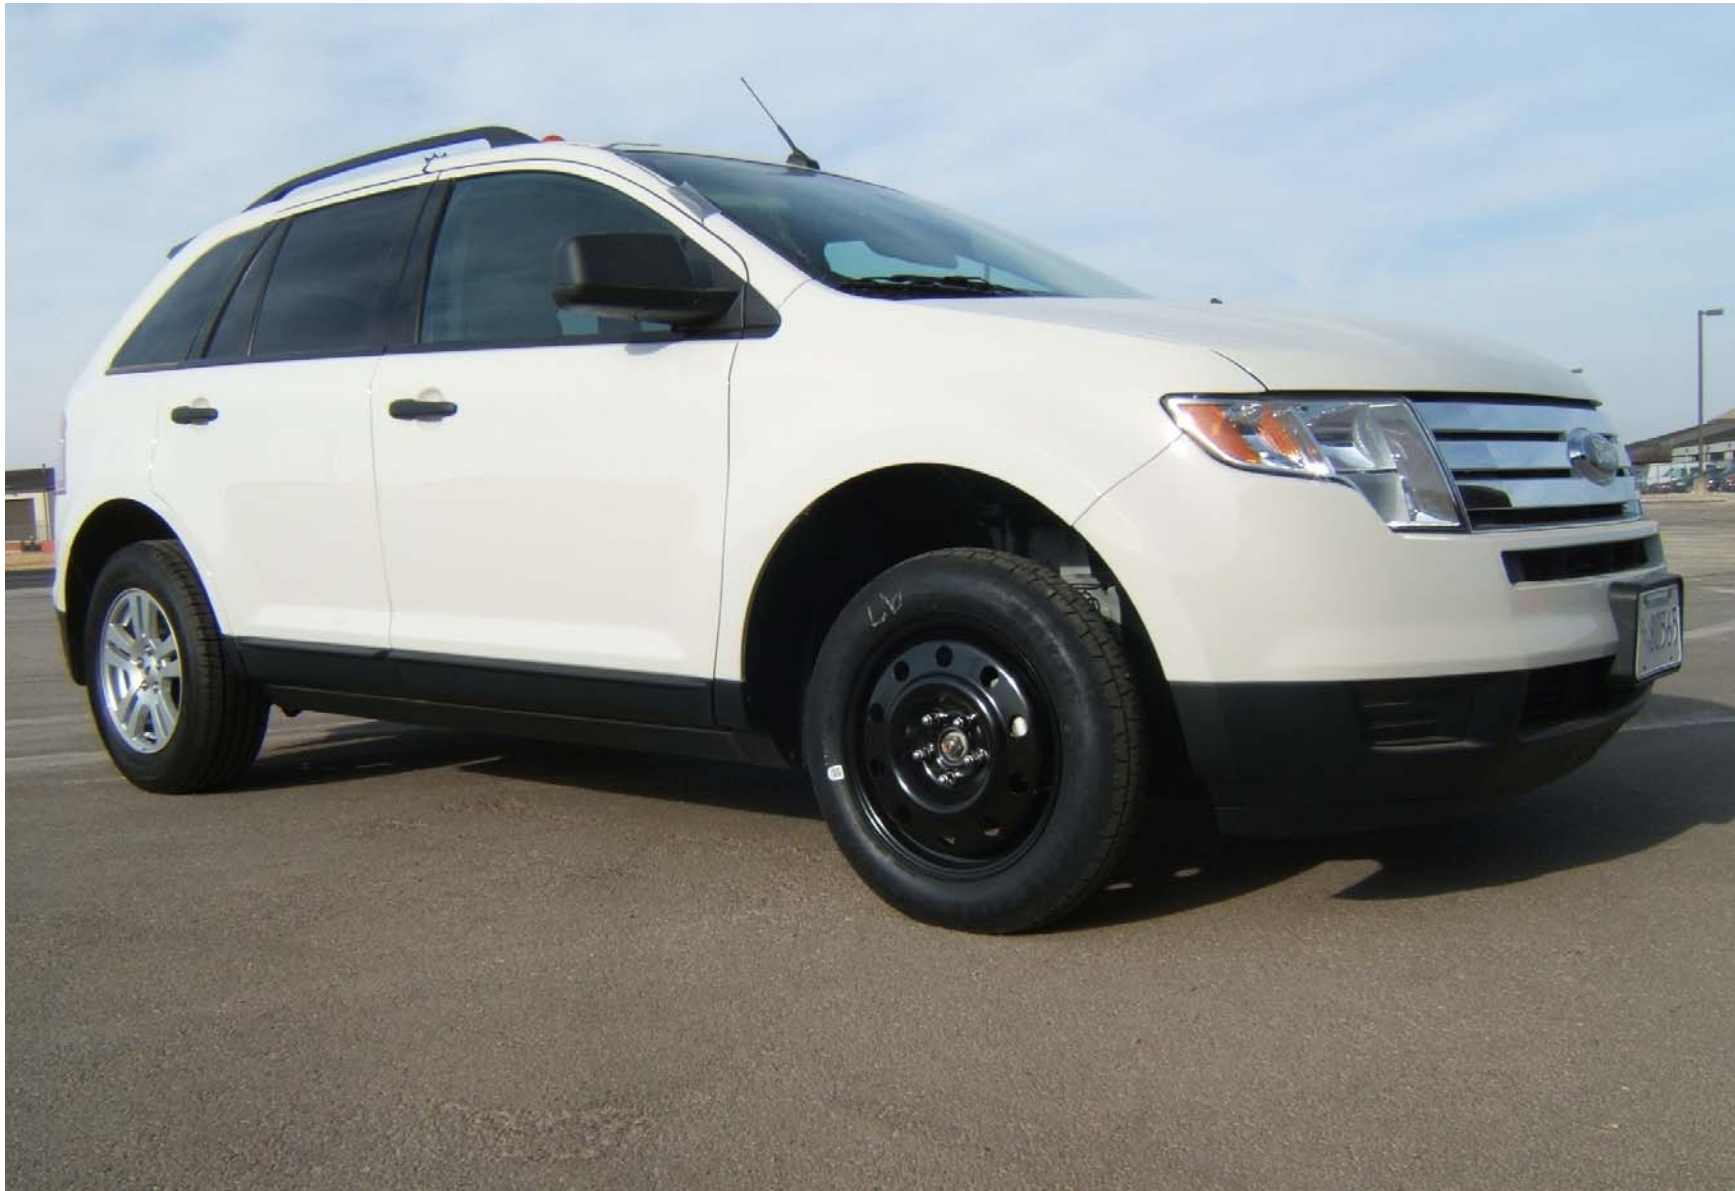
2009 FORD EDGE SE
NHTSA NO. C90203
FMVSS NO. 138

FIGURE 5.17
SPARE INSTALLED ON RIGHT FRONT
FOR MALFUNCTION DETECTION TEST

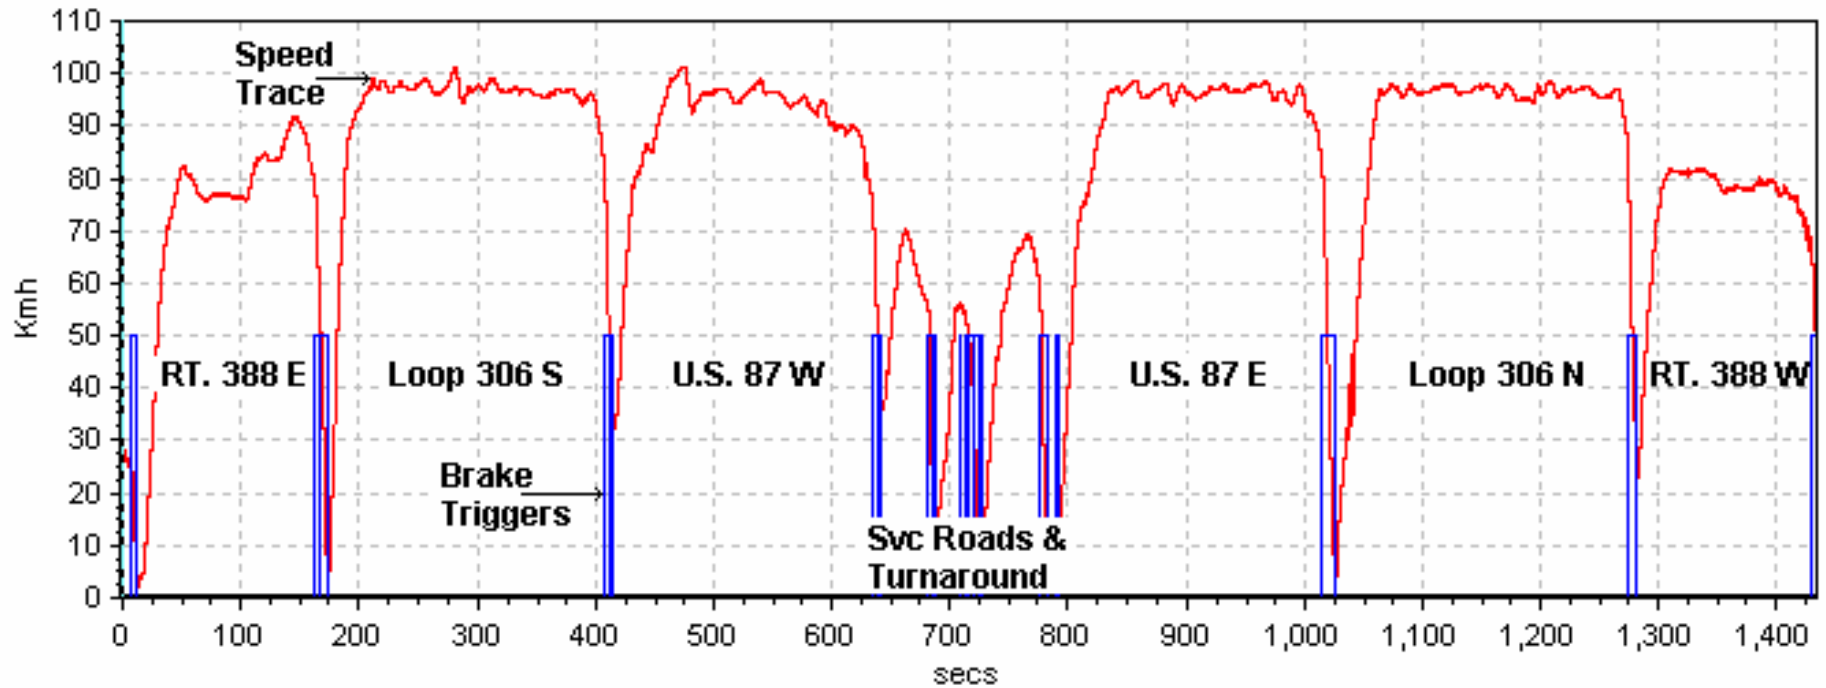
2009 Ford Edge (C90203) RF Calibration LLVW

Log Rate := 100.00 Hz

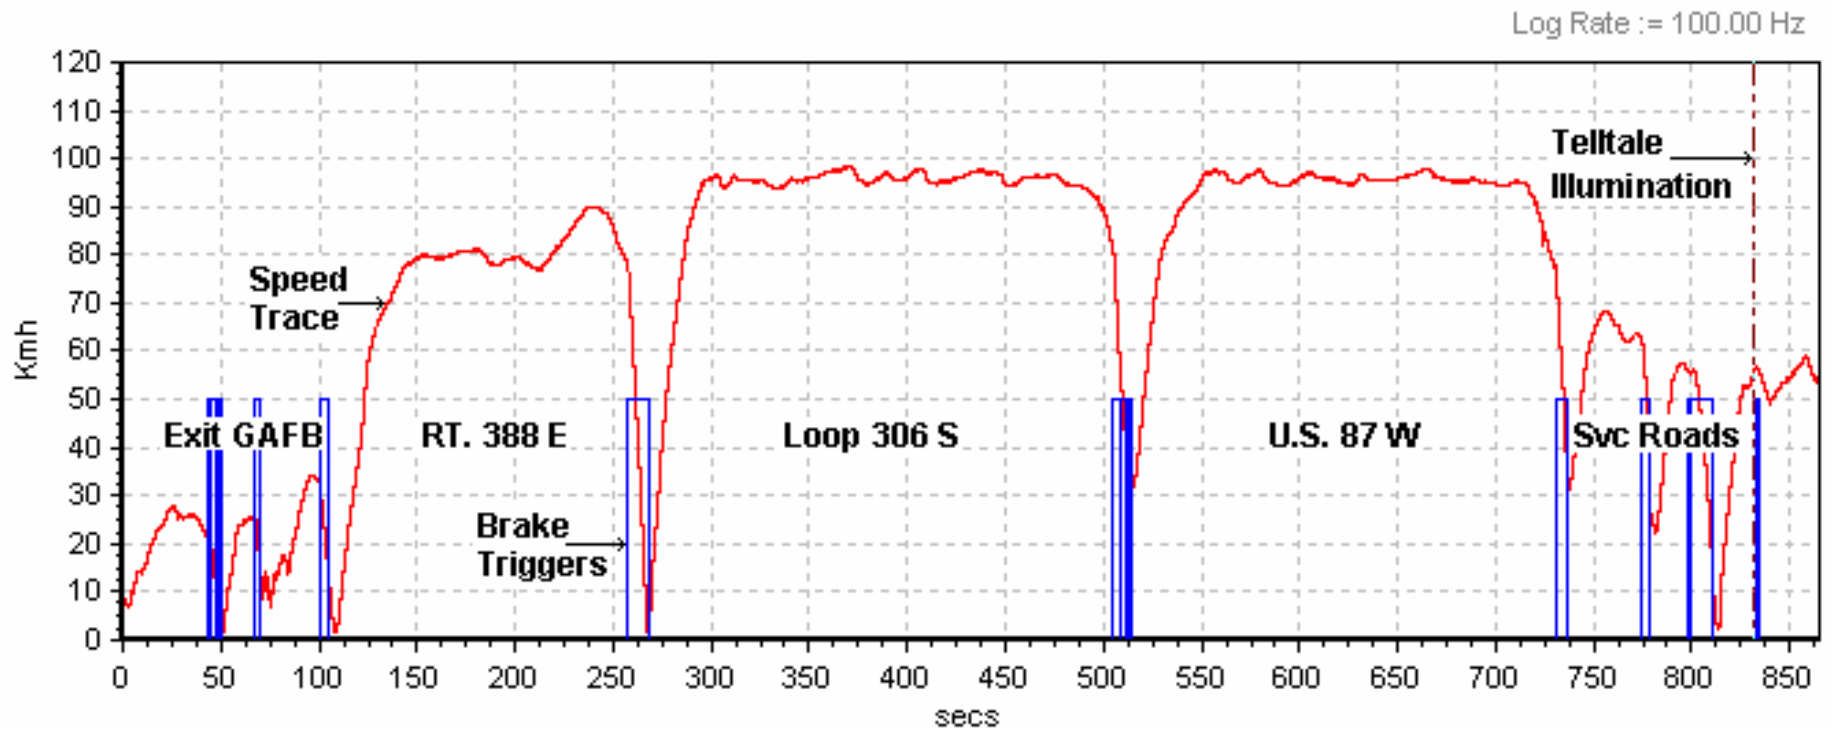
2009 Ford Edge (C90203) RF Illumination LLVW

Scenario A: Right Front Tire at LLVW
Test Date: 3/6/09
Data File Time: 14:25 minutes
Cumulative Driving Time: 10:17 minutes
Start Point: San Angelo Test Facility shop

Detection Phase:

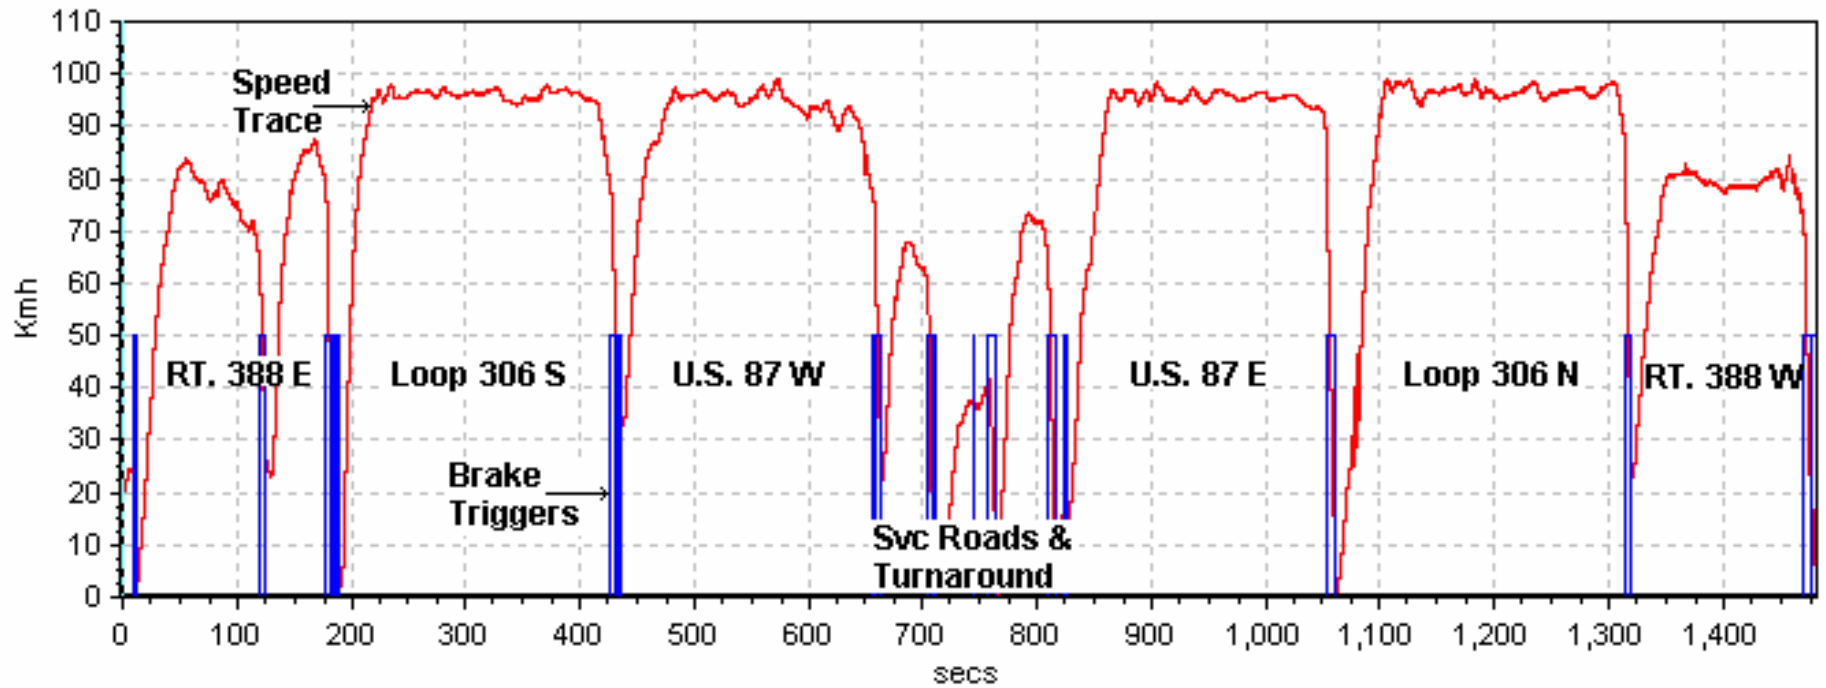
2009 Ford Edge (C90203) LR, RR Calibration LLVW

Scenario B: Left Rear, Right Rear Tires at LLVW
Test Date: 3/9/09
Data File Time: 24:42 minutes
Cumulative Driving Time: 20:20 minutes
Start Point: GAFB North Gate

Calibration Phase:

Log Rate := 100.00 Hz

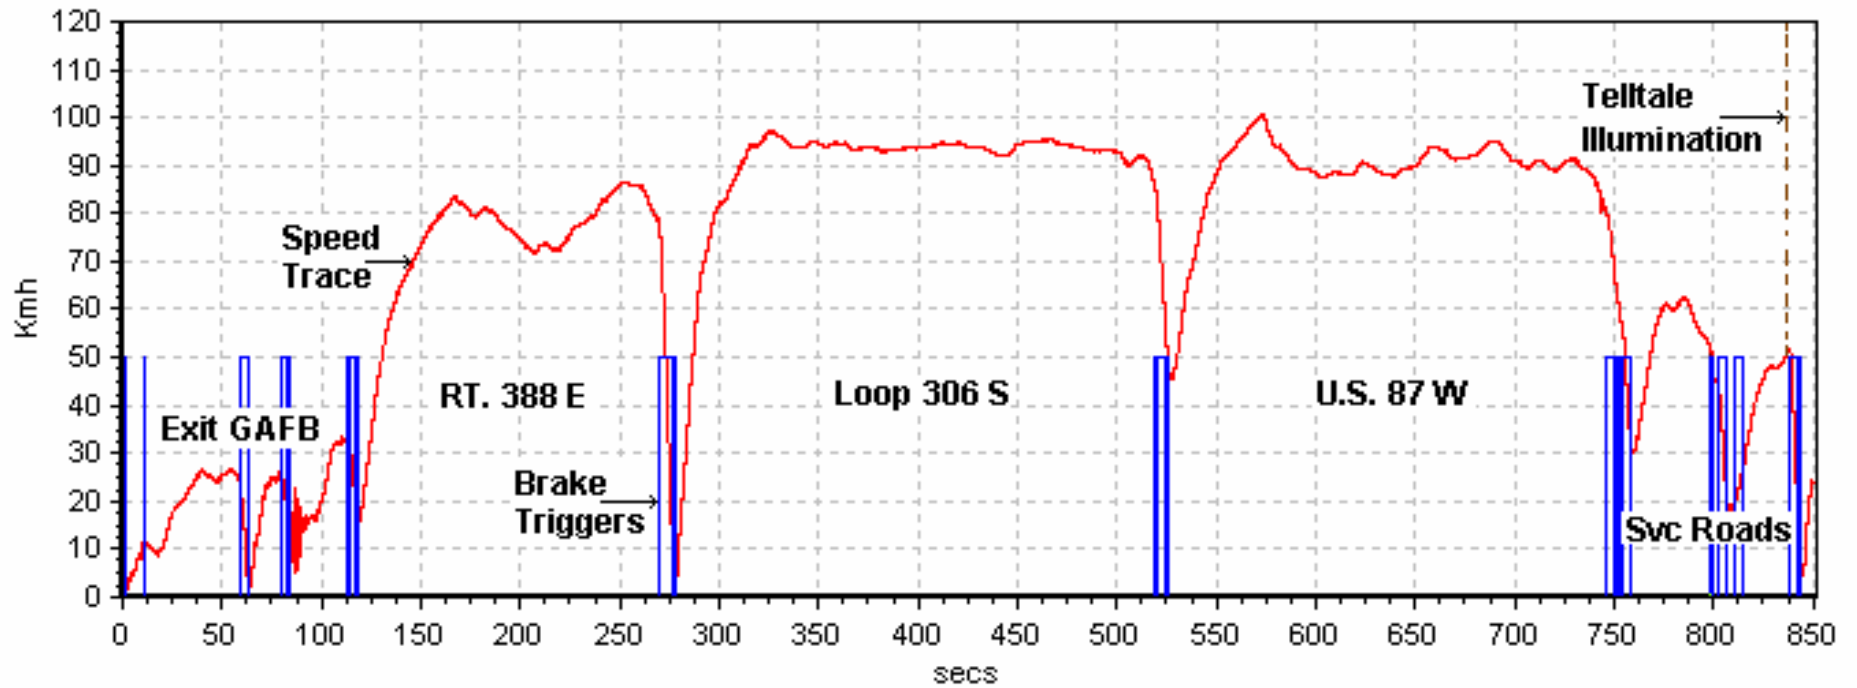
2009 Ford Edge (C90203) LR, RR Illumination LLWW

Scenario B: Left Rear, Right Rear Tires at LLWW
Test Date: 3/9/09
Data File Time: 14:12 minutes
Cumulative Driving Time: 10:18 minutes
Start Point: San Angelo Test Facility shop

Detection Phase:

Log Rate := 100.00 Hz

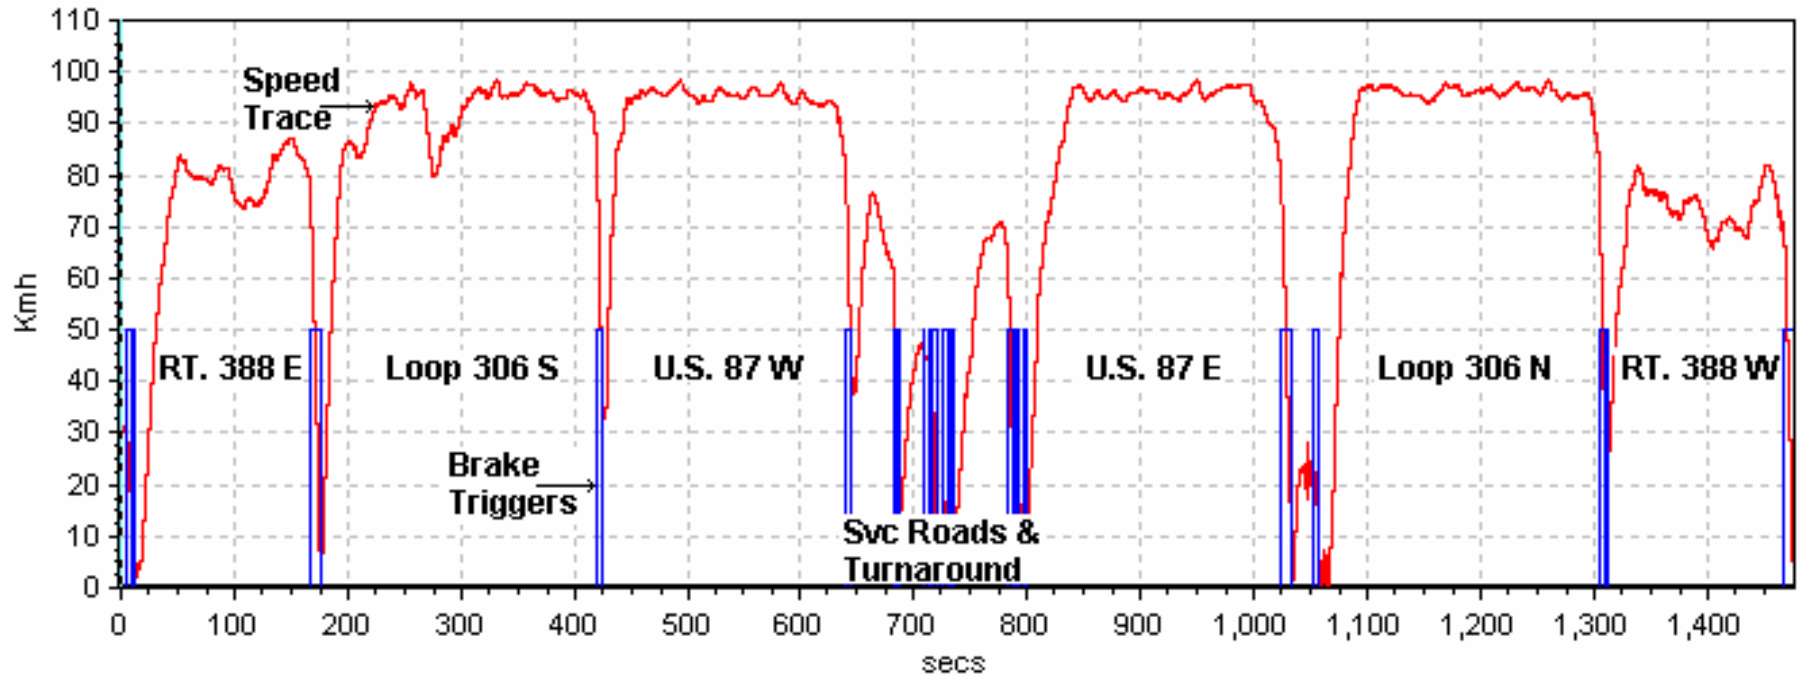
2009 Ford Edge (C90203) LF, LR, RR, RF Calibration LLVW

Scenario C: Left Front, Left Rear, Right Rear, Right Front Tires at LLVW
Test Date: 3/9/09
Data File Time: 24:37 minutes
Cumulative Driving Time: 20:31 minutes
Start Point: GAFB North Gate

Calibration Phase:

Log Rate := 100.00 Hz

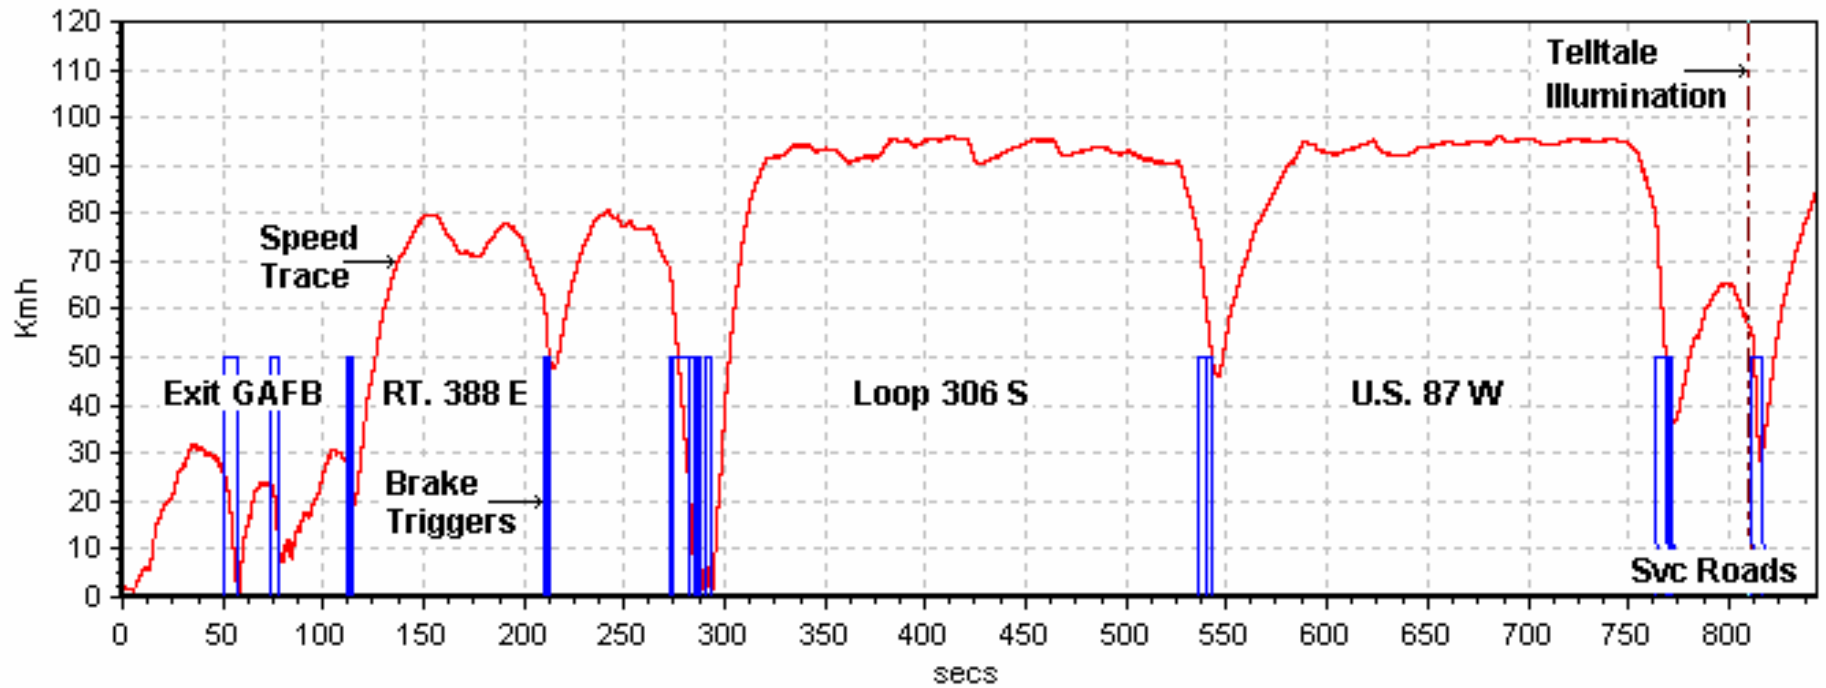
2009 Ford Edge (C90203) LF, LR, RR, RF Illumination LLVW

Scenario C: Left Front, Left Rear, Right Rear, Right Front Tires at LLVW
Test Date: 3/9/09
Data File Time: 14:04 minutes
Cumulative Driving Time: 10:18 minutes
Start Point: San Angelo Test Facility shop

Detection Phase:

Log Rate := 100.00 Hz

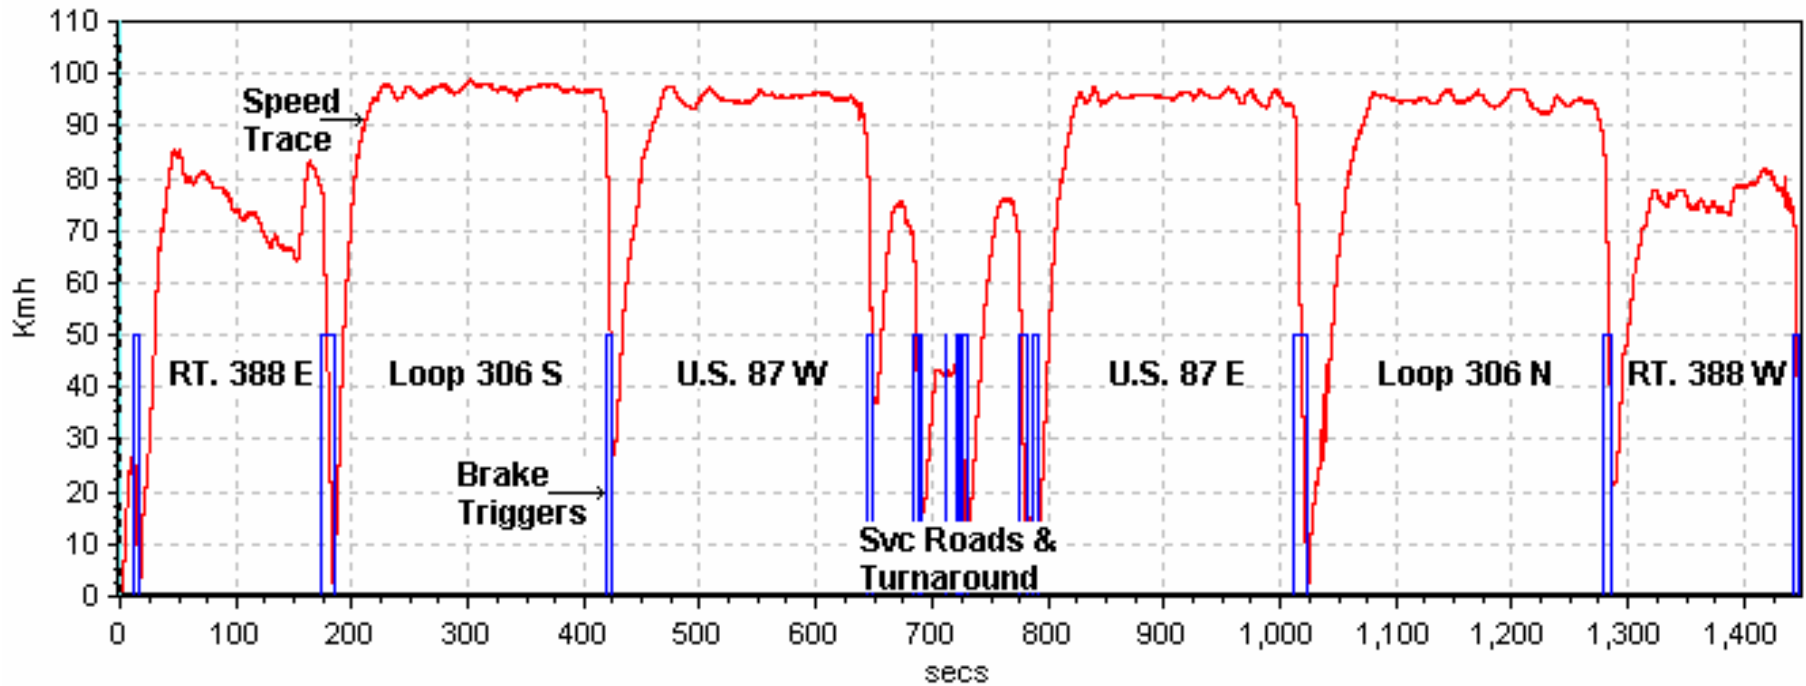
2009 Ford Edge (C90203) LR Calibration UVW+VCW

Scenario D: Left Rear Tire at UVW + VCW
Test Date: 3/16/09
Data File Time: 24:10 minutes
Cumulative Driving Time: 20:30 minutes
Start Point: GAFB North Gate

Calibration Phase:

Log Rate := 100.00 Hz

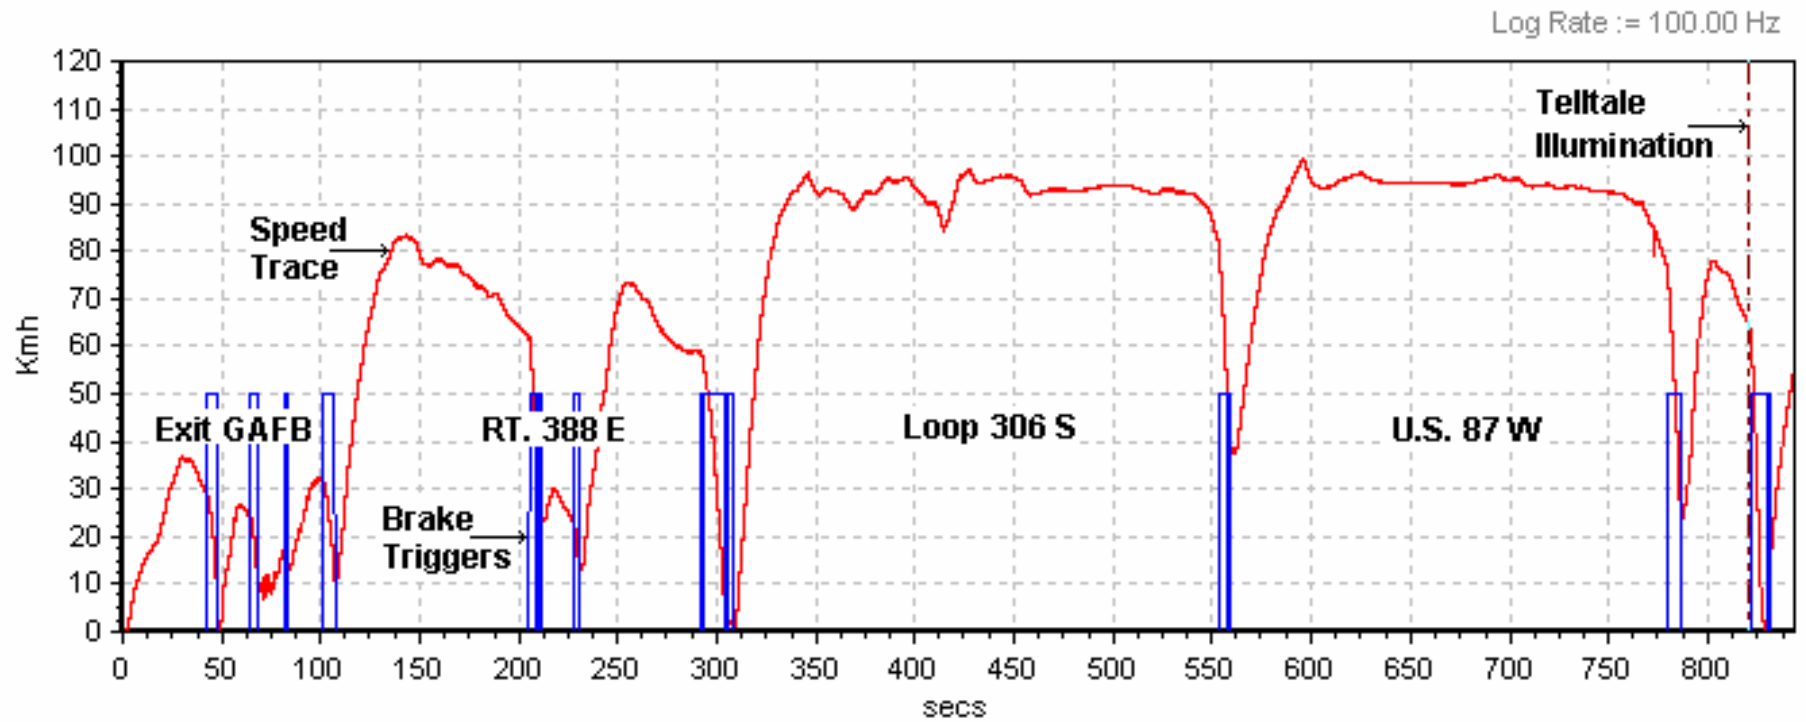
2009 Ford Edge (C90203) LR Illumination UVW+VCW

Scenario D: Left Rear Tire at UVW + VCW
Test Date: 3/16/09
Data File Time: 14:04 minutes
Cumulative Driving Time: 10:11 minutes
Start Point: San Angelo Test Facility shop

Detection Phase:

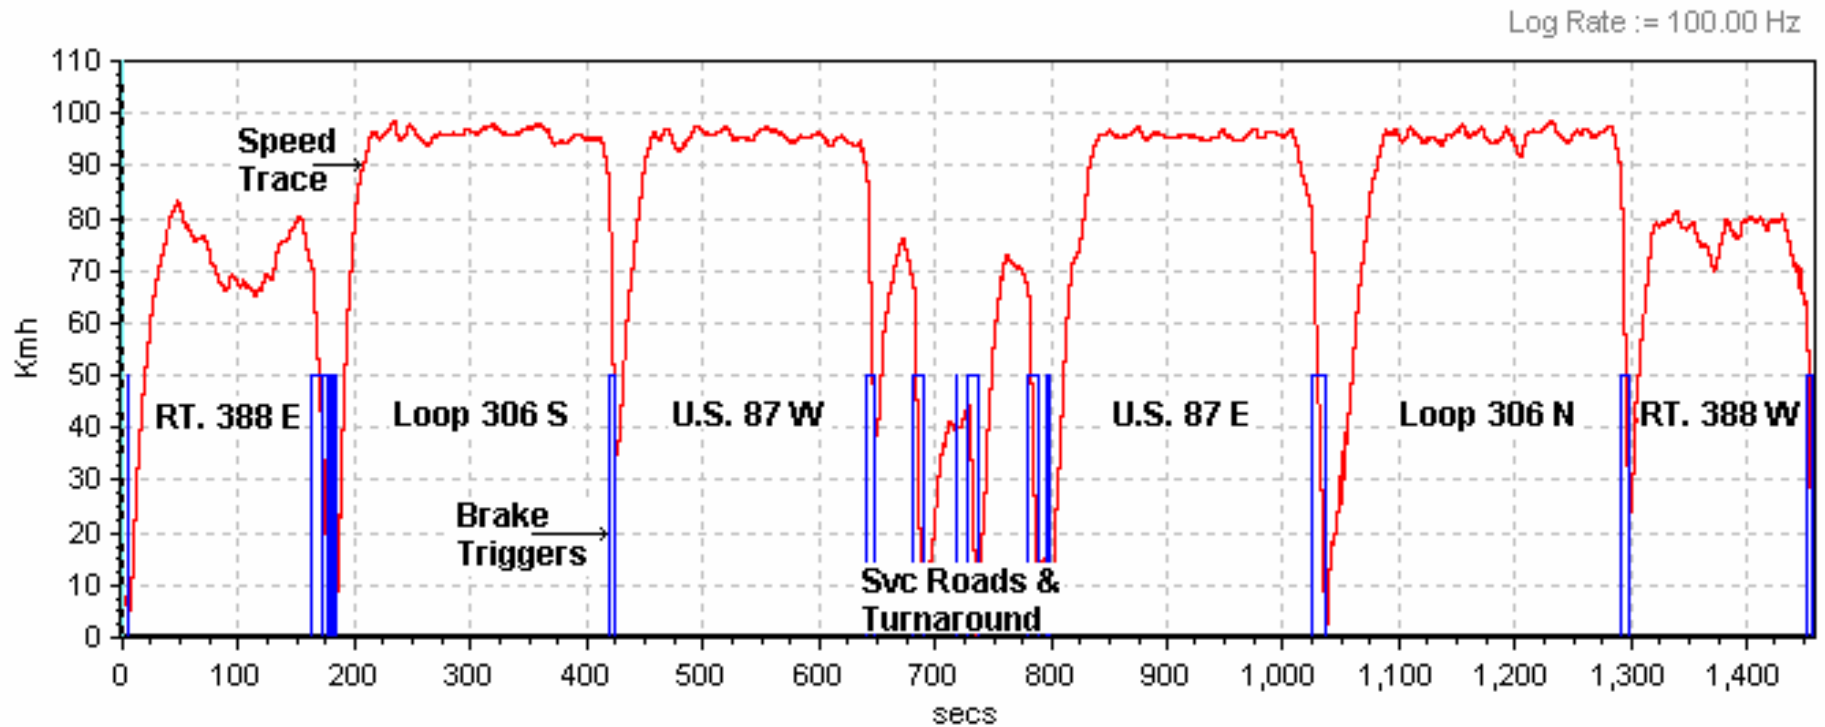
2009 Ford Edge (C90203) LF, RR Calibration UWW+VCW

Scenario E: Left Front, Right Rear Tires at UVW + VCW
Test Date: 3/16/09
Data File Time: 24:18 minutes
Cumulative Driving Time: 20:29 minutes
Start Point: GAFB North Gate

Calibration Phase:

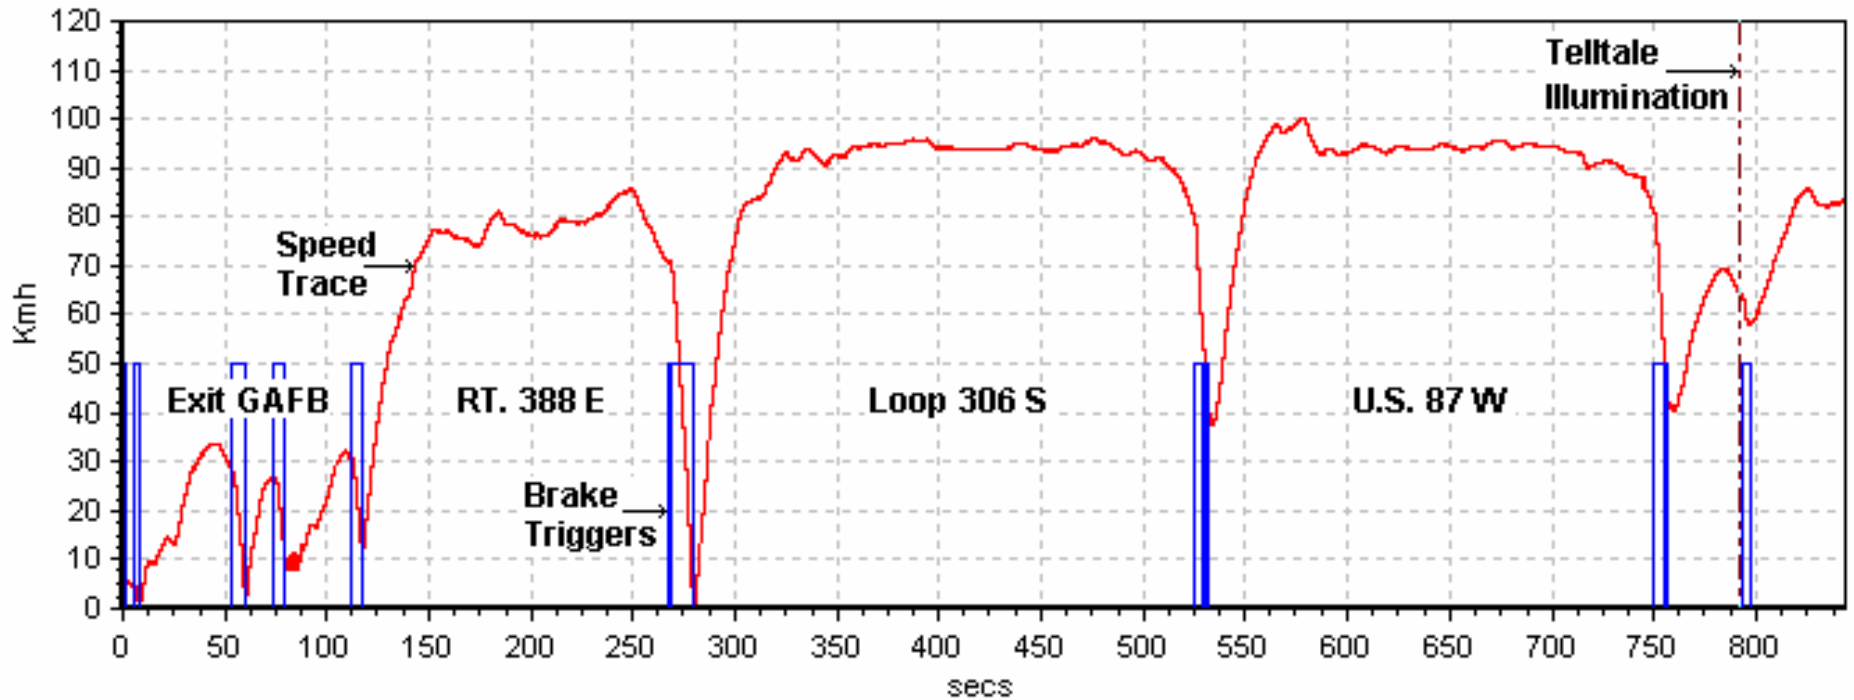
2009 Ford Edge (C90203) LF, RR Illumination UVW+VCW

Scenario E: Left Front, Right Rear Tires at UVW + VCW
Test Date: 3/16/09
Data File Time: 14:04 minutes
Cumulative Driving Time: 10:09 minutes
Start Point: San Angelo Test Facility shop

Detection Phase:

Log Rate := 100.00 Hz
