REPORT NUMBER 138-STF-09-004

SAFETY COMPLIANCE TESTING FOR FMVSS NO. 138 TIRE PRESSURE MONITORING SYSTEMS

FORD MOTOR COMPANY
2009 FORD EDGE SE
FOUR-DOOR MPV
NHTSA NO. C90203

FINAL REPORT

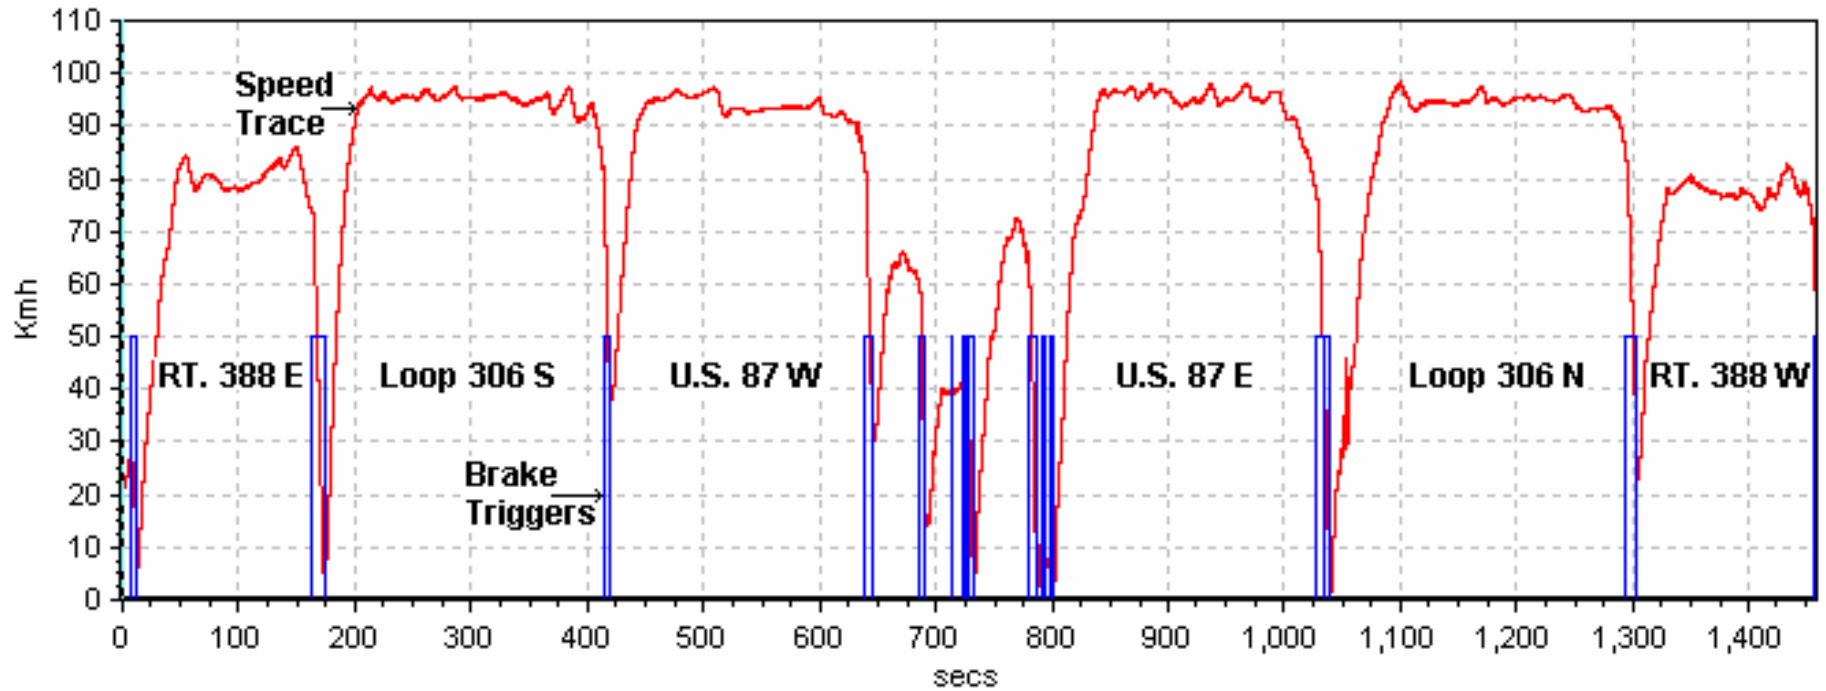
2009 Ford Edge (C90203) LR, RR, RF Calibration UVW+VCW

Scenario F: Left Rear, Right Rear, Right Front Tires at UVW + VCW
Test Date: 3/17/09
Data File Time: 24:18 minutes
Cumulative Driving Time: 20:29 minutes
Start Point: GAFB North Gate

Calibration Phase:

Log Rate := 100.00 Hz

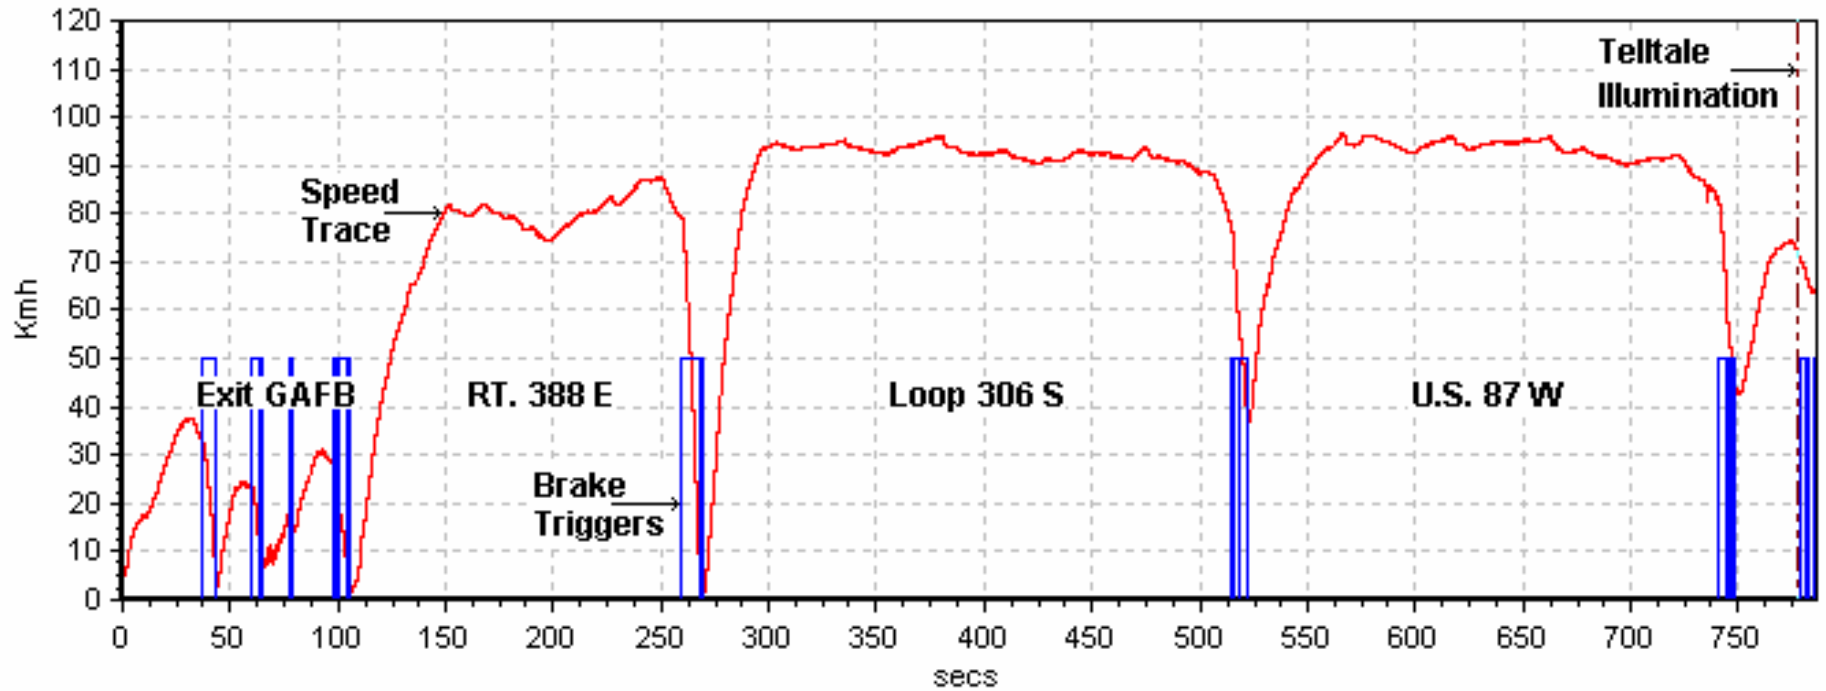
2009 Ford Edge (C90203) LR, RR, RF Illumination UVW+VCW

Scenario F: Left Rear, Right Rear, Right Front Tires at UVW + VCW
Test Date: 3/17/09
Data File Time: 13:06 minutes
Cumulative Driving Time: 10:08 minutes
Start Point: San Angelo Test Facility shop

Detection Phase:

Log Rate := 100.00 Hz

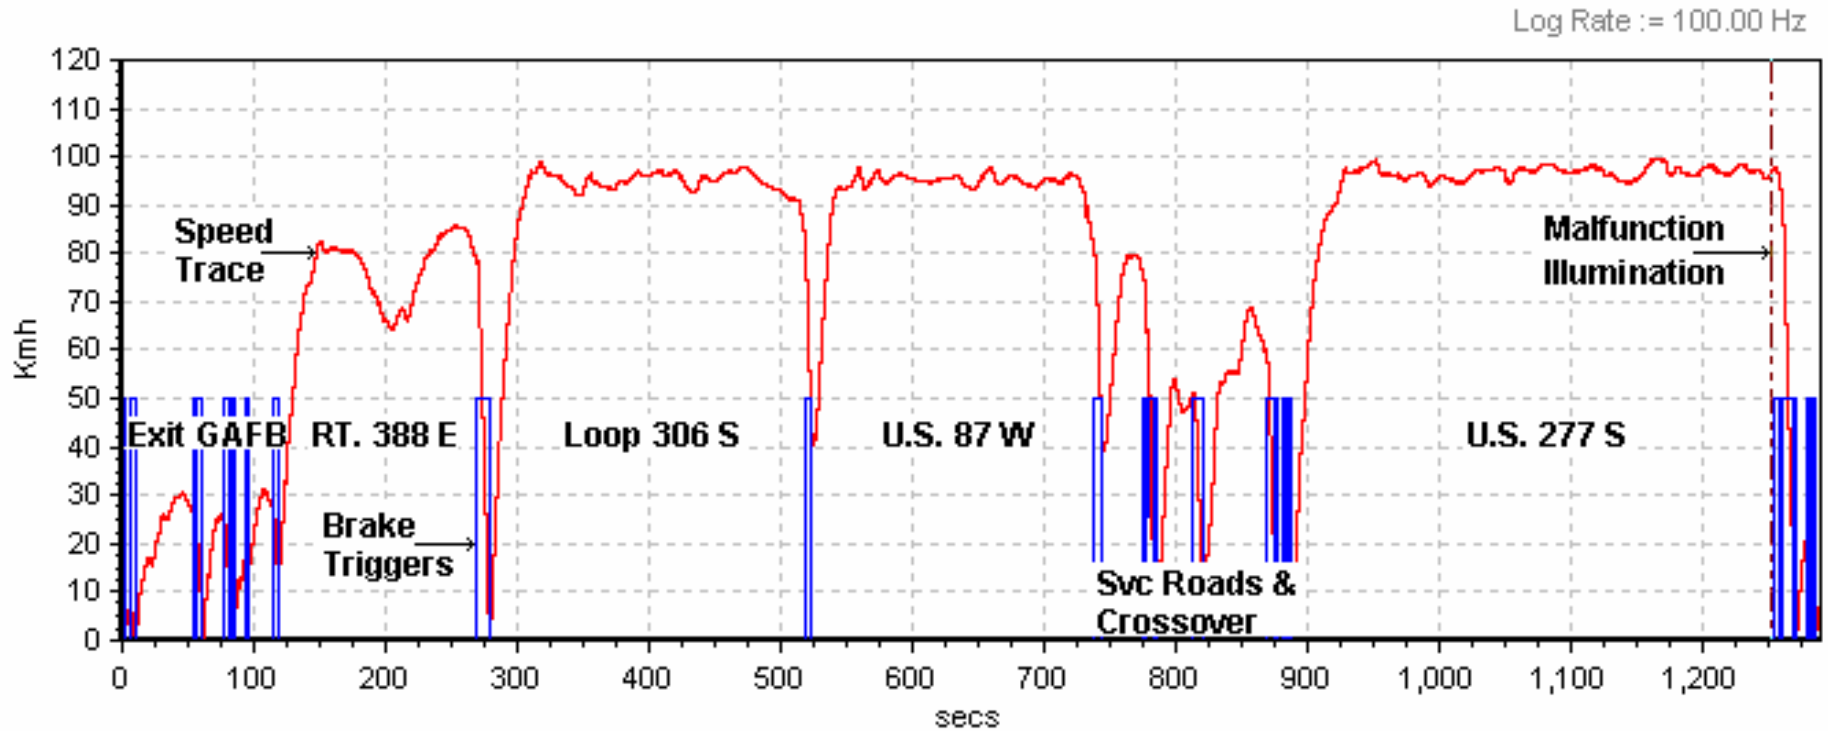
2009 Ford Edge (C90203) RF Spare Tire Malfunction Illumination LLVW

Scenario G Malfunction Illumination: Spare Tire without TPMS Sensor Applied to Right Front at LLVW.
Test Date: 3/5/09
Data File Time: 21:30 minutes
Cumulative Driving Time: 16:52 minutes
Start Point: San Angelo Test Facility shop
