REPORT NUMBER: 201UI-CAL-09-01

**SAFETY COMPLIANCE TESTING FOR FMVSS 201  
OCCUPANT PROTECTION IN INTERIOR IMPACT  
UPPER INTERIOR HEAD IMPACT PROTECTION**

**GENERAL MOTORS CORP.  
2009 CHEVROLET MALIBU**

FINAL REPORT

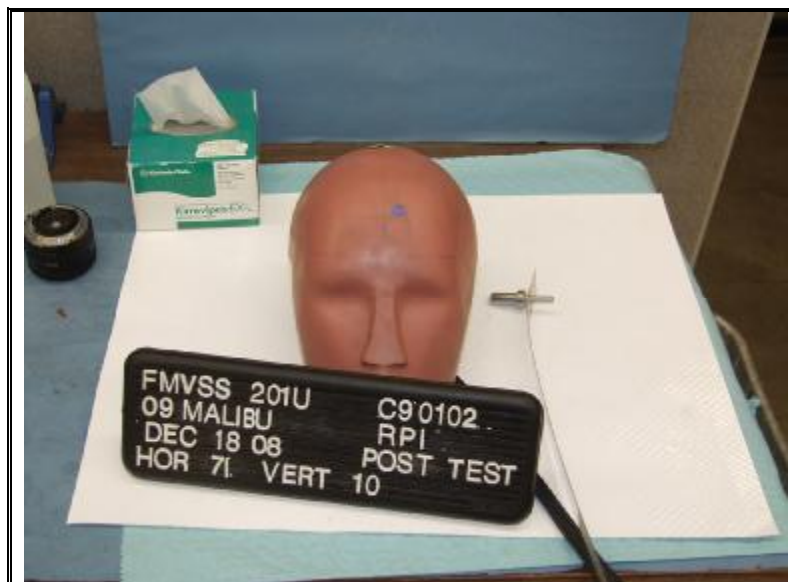
POST-IMPACT RP1 HEADFORM

Free Motion HIC	112.8
HIC(d)	251.5
Impact Velocity (kph)	18.44
HIC T1 (msec)	5.6
HIC T2 (msec)	23.6

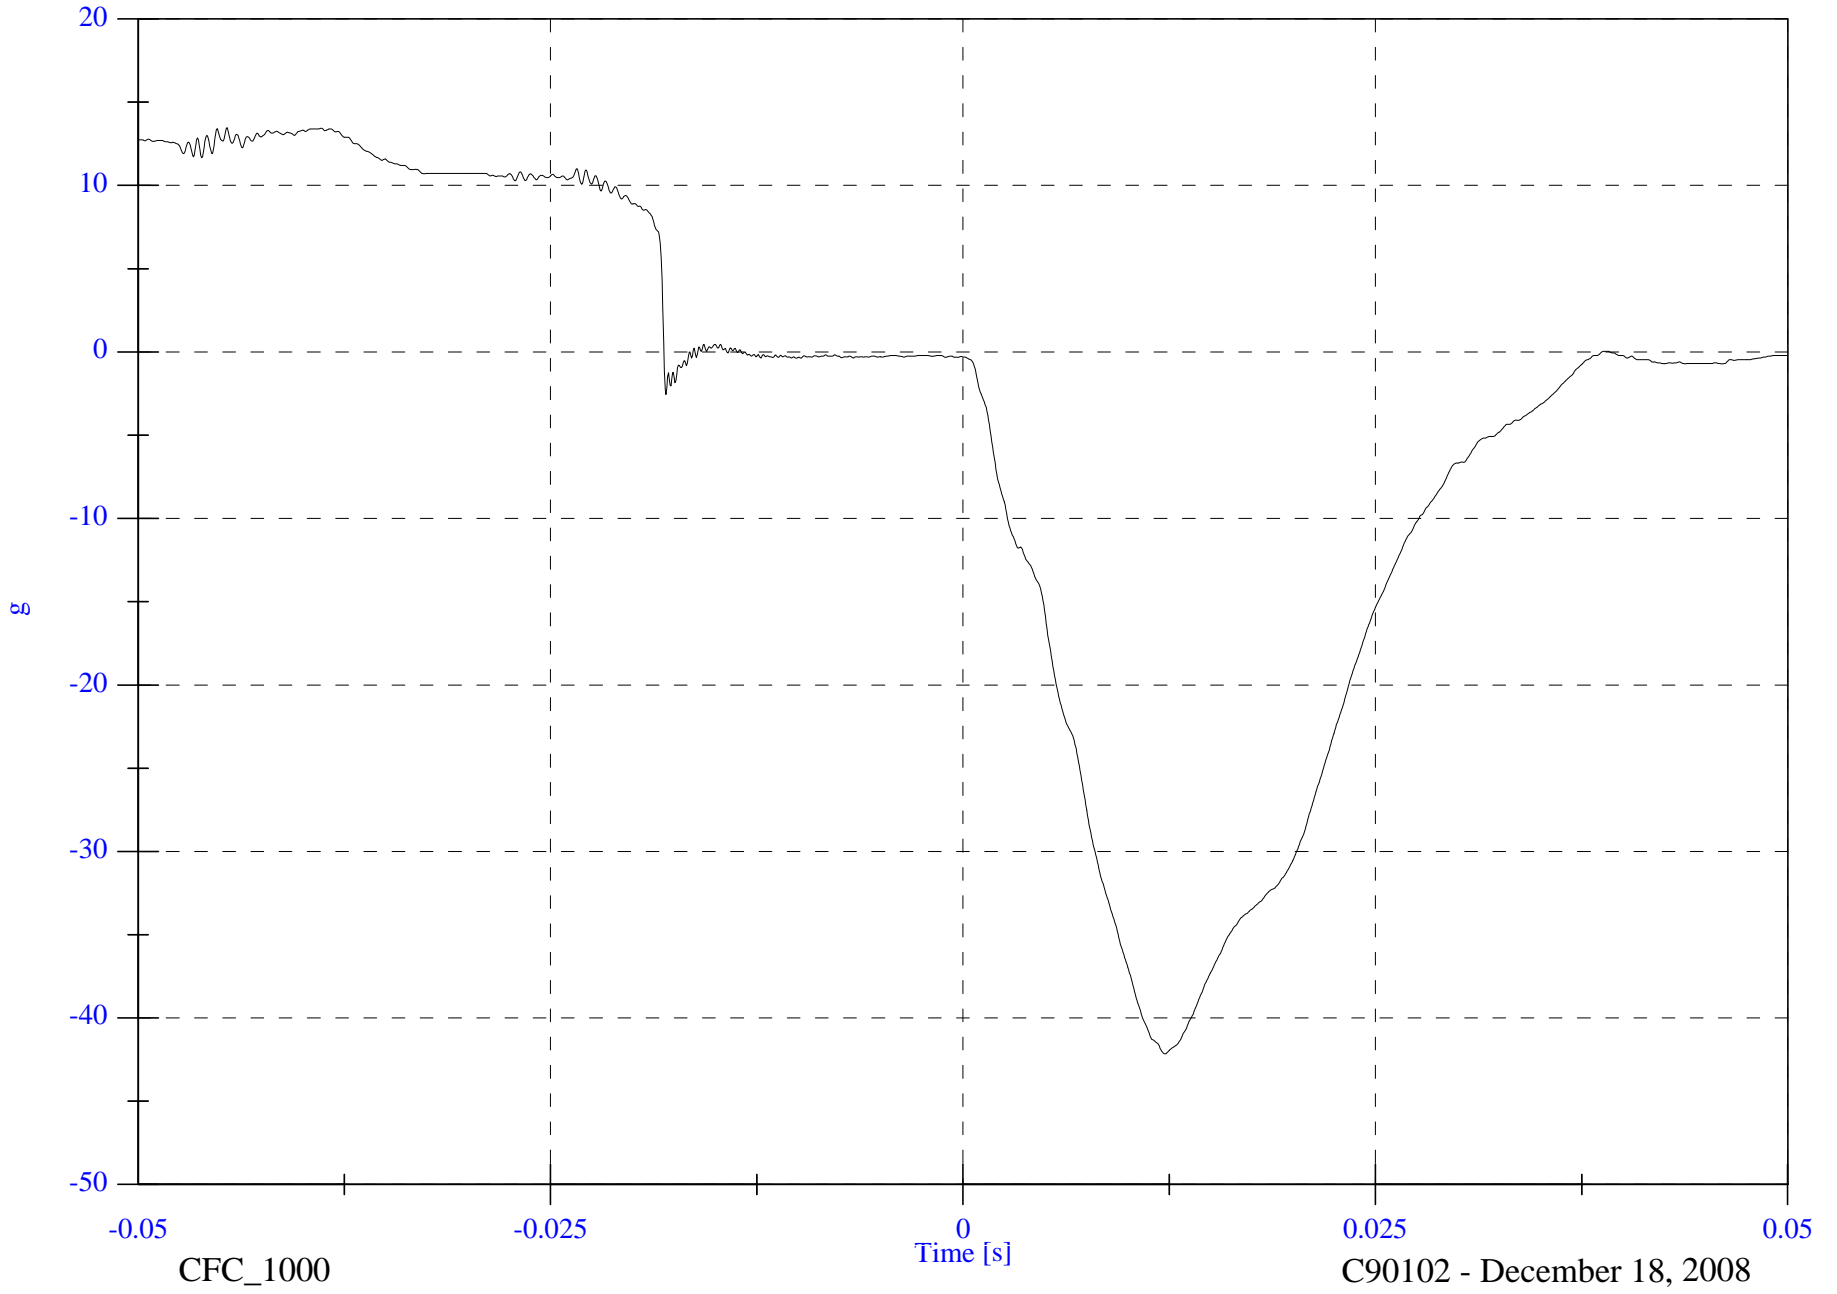
C90102 DRIVER SIDE RP1 IMPACT PLOT #1

FMVSS 201U 09 Chevy Malibu

Headform X Acceleration

Max: 13.5 [g] at -0.045 [s]

Min: -42.2 [g] at 0.012 [s]

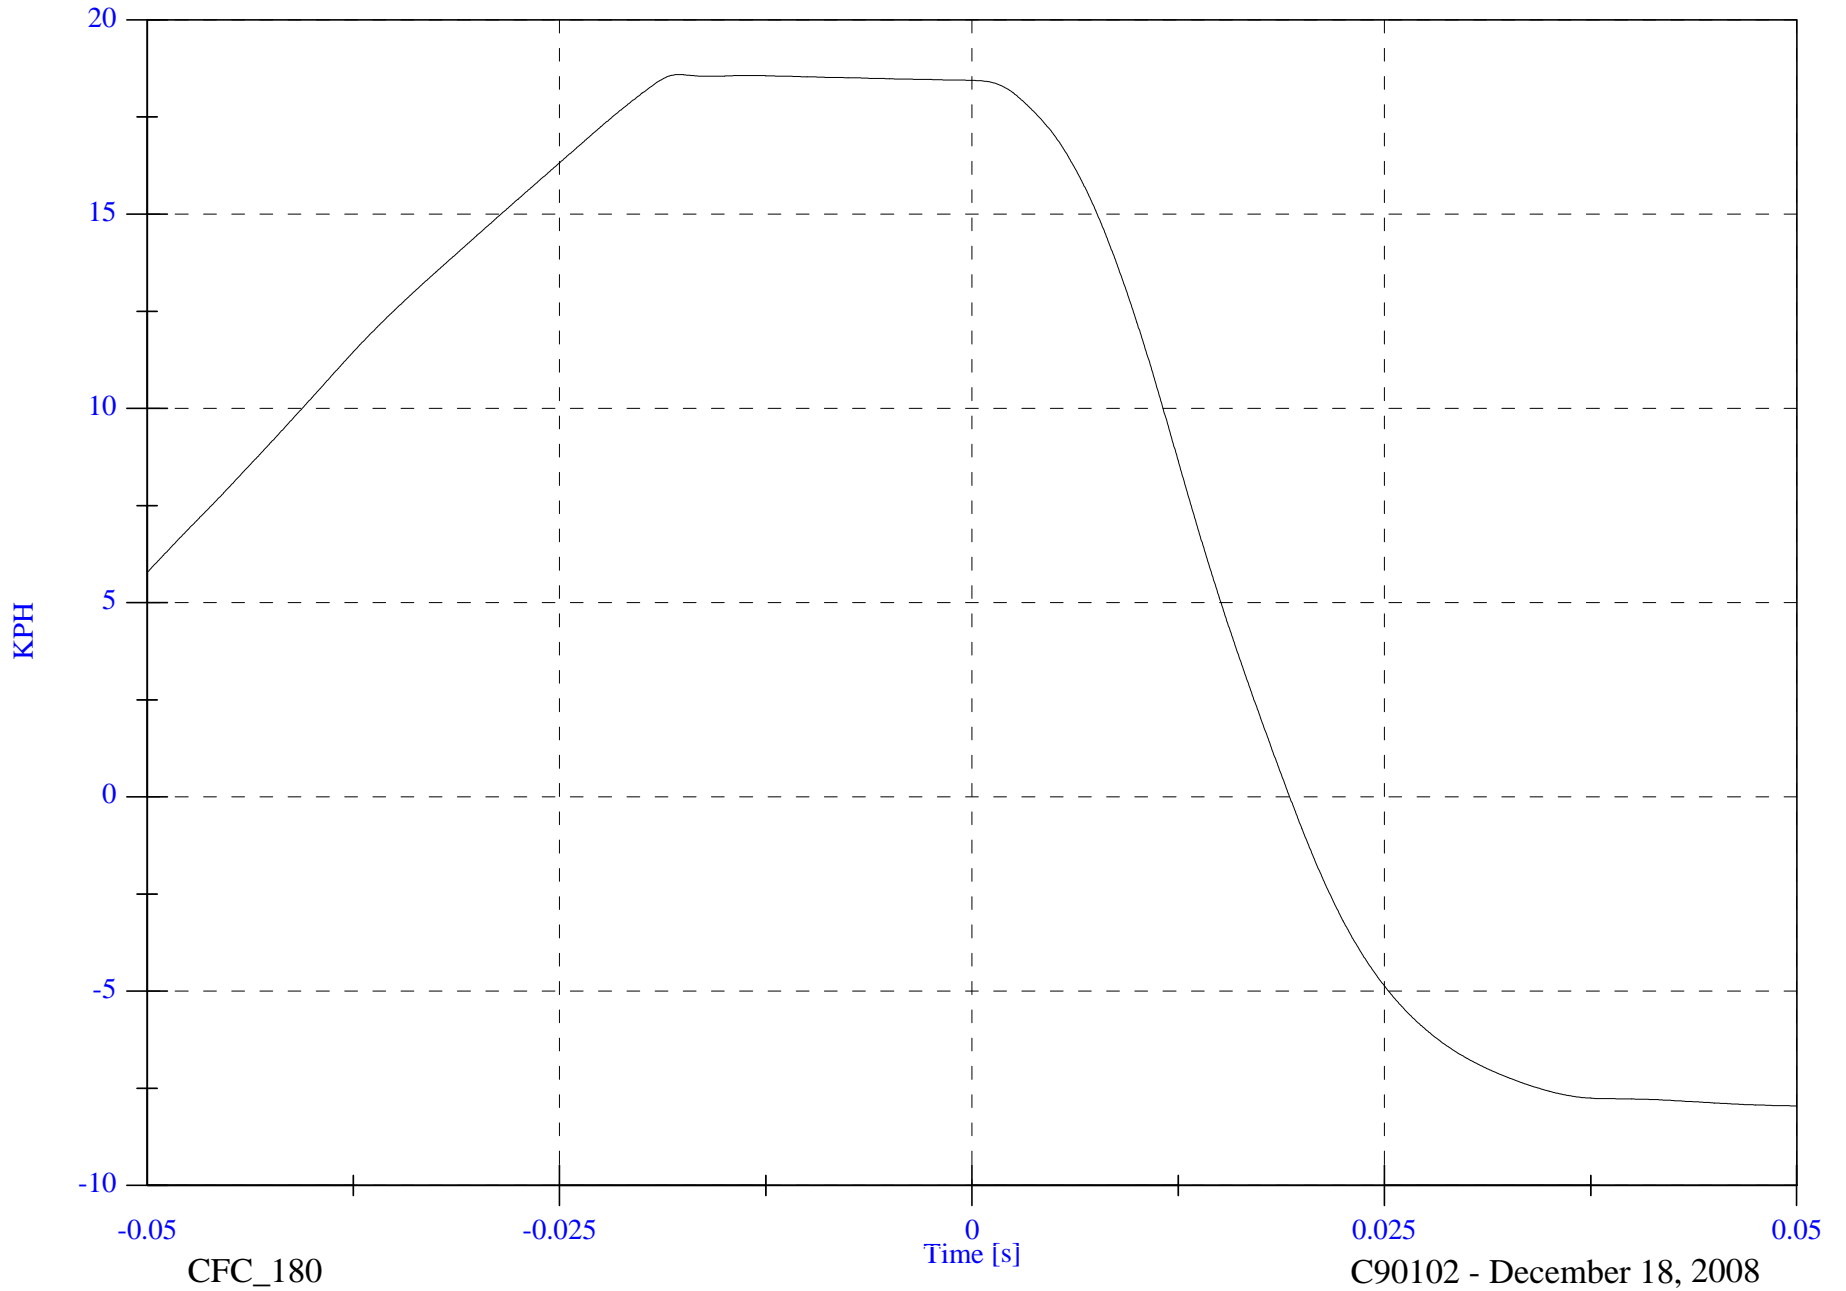
C90102 DRIVER SIDE RP1 IMPACT PLOT #5

### Headform Velocity

Max: 18.6 [KPH] at -0.018 [s]

Min: -8.0 [KPH] at 0.050 [s]

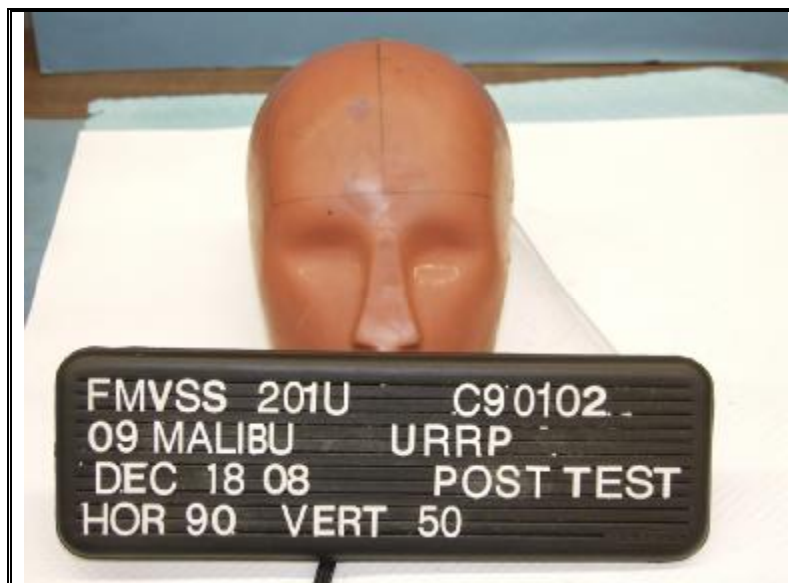
POST-IMPACT URRP HEADFORM

Free Motion HIC	585.8
HIC(d)	608.4
Impact Velocity (kph)	23.58
HIC T1 (msec)	5.8
HIC T2 (msec)	13.6

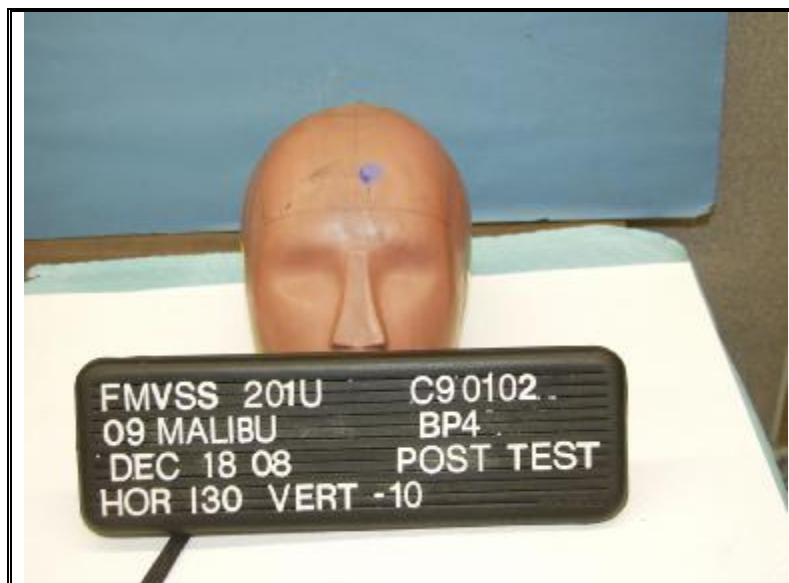
POST-IMPACT BP4 HEADFORM

Free Motion HIC	602.4
HIC(d)	620.9
Impact Velocity (kph)	23.62
HIC T1 (msec)	3.2
HIC T2 (msec)	8.5

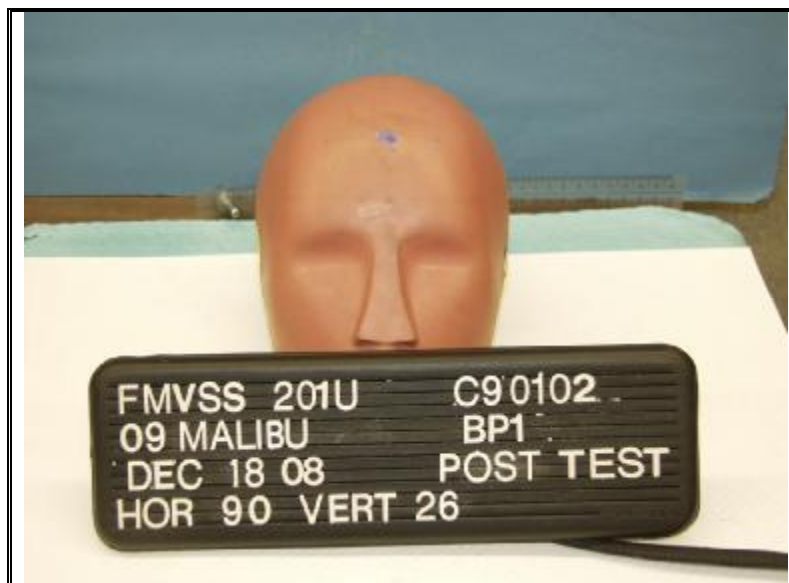
POST-IMPACT BP1 HEADFORM

Free Motion HIC	532.0
HIC(d)	567.8
Impact Velocity (kph)	18.8
HIC T1 (msec)	5.1
HIC T2 (msec)	11.8

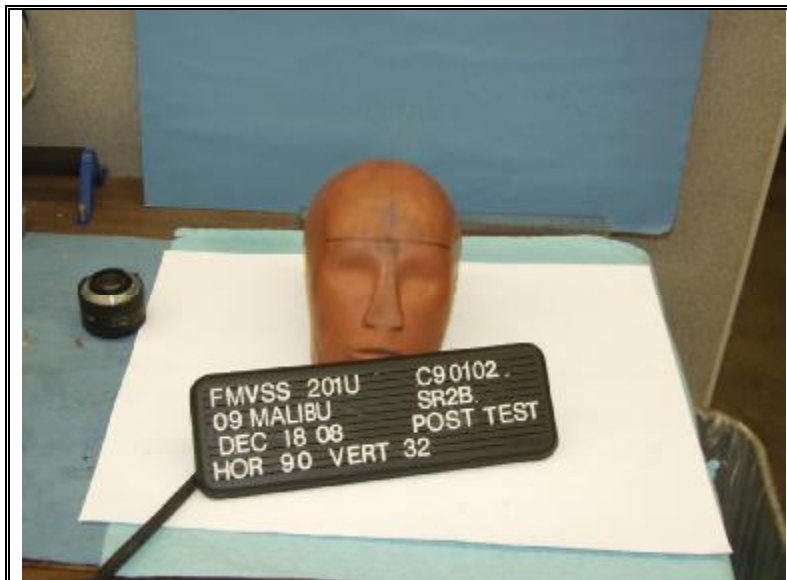
POST-IMPACT SR2B HEADFORM

Free Motion HIC	274.6
HIC(d)	373.6
Impact Velocity (kph)	18.62
HIC T1 (msec)	4.0
HIC T2 (msec)	14.2

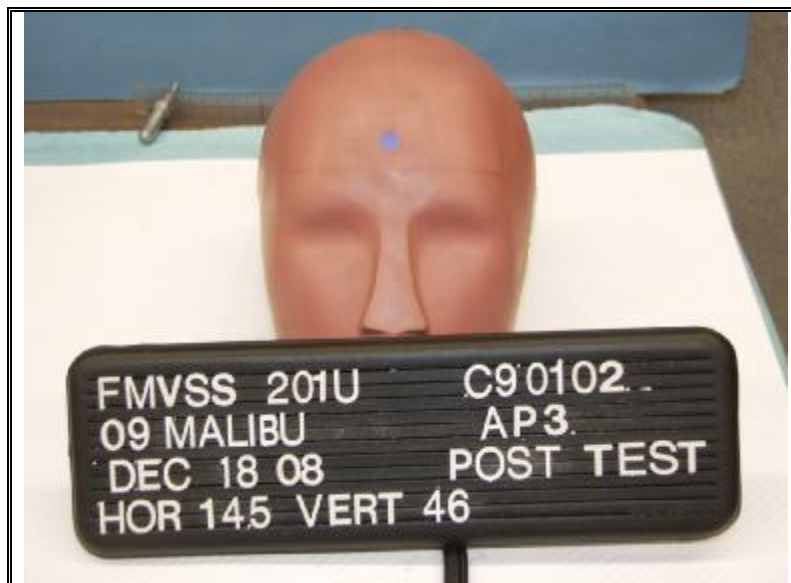
POST-IMPACT AP3 HEADFORM

Free Motion HIC	405.1
HIC(d)	472.0
Impact Velocity (kph)	18.42
HIC T1 (msec)	5.2
HIC T2 (msec)	12.2

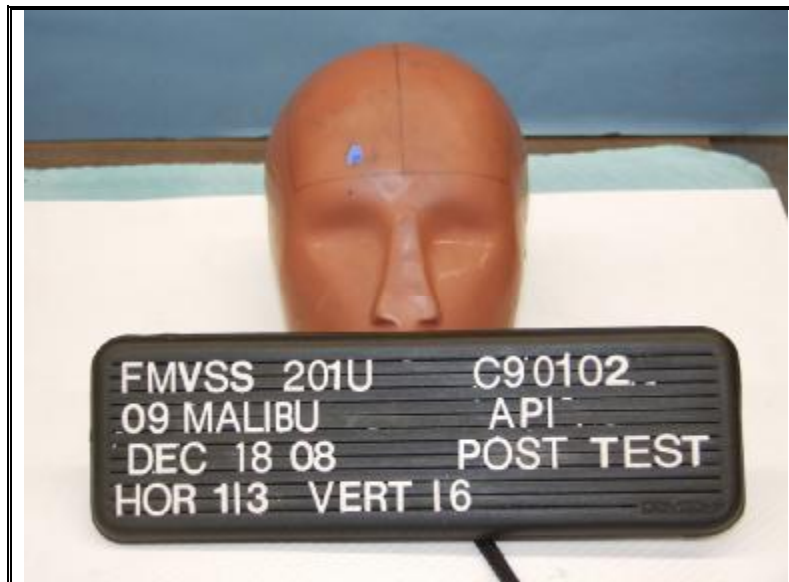
POST-IMPACT AP1 HEADFORM

Free Motion HIC	508.0
HIC(d)	549.7
Impact Velocity (kph)	18.49
HIC T1 (msec)	4.7
HIC T2 (msec)	8.5

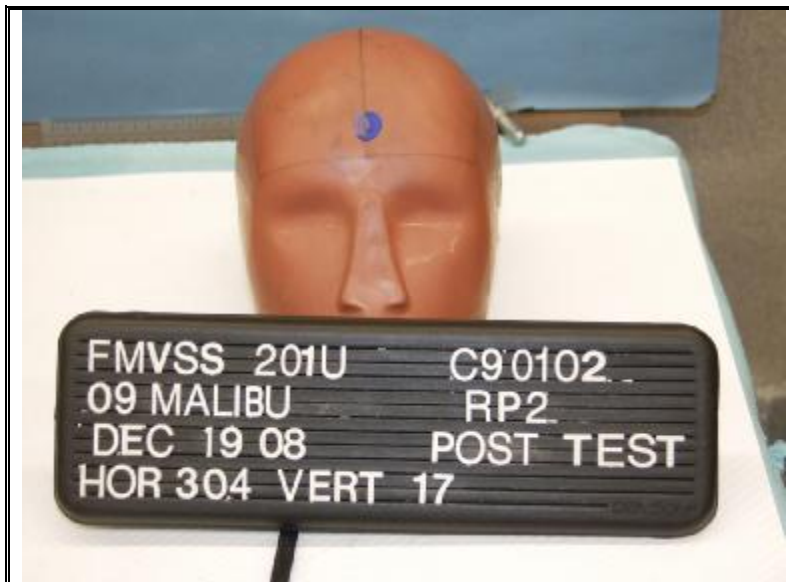
POST-IMPACT RP2 HEADFORM

Free Motion HIC	108.7
HIC(d)	248.4
Impact Velocity (kph)	18.37
HIC T1 (msec)	5.7
HIC T2 (msec)	24.4

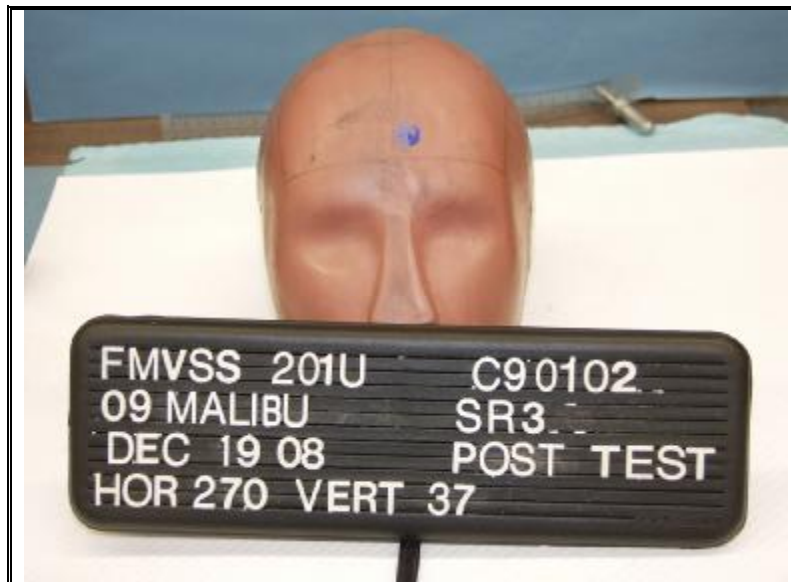
POST-IMPACT SR3 HEADFORM

Free Motion HIC	326.4
HIC(d)	412.6
Impact Velocity (kph)	18.38
HIC T1 (msec)	5.2
HIC T2 (msec)	13.7

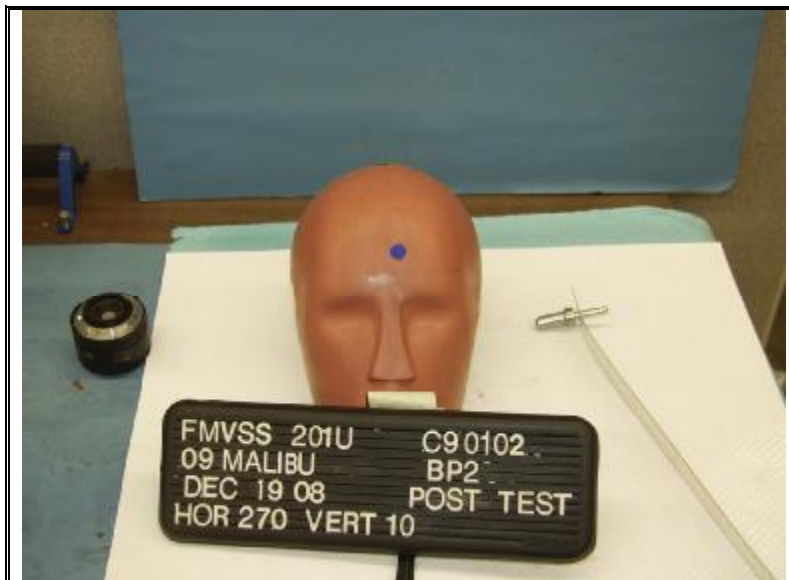
POST-IMPACT BP2 HEADFORM

Free Motion HIC	820.3
HIC(d)	785.3
Impact Velocity (kph)	23.58
HIC T1 (msec)	2.4
HIC T2 (msec)	6.9

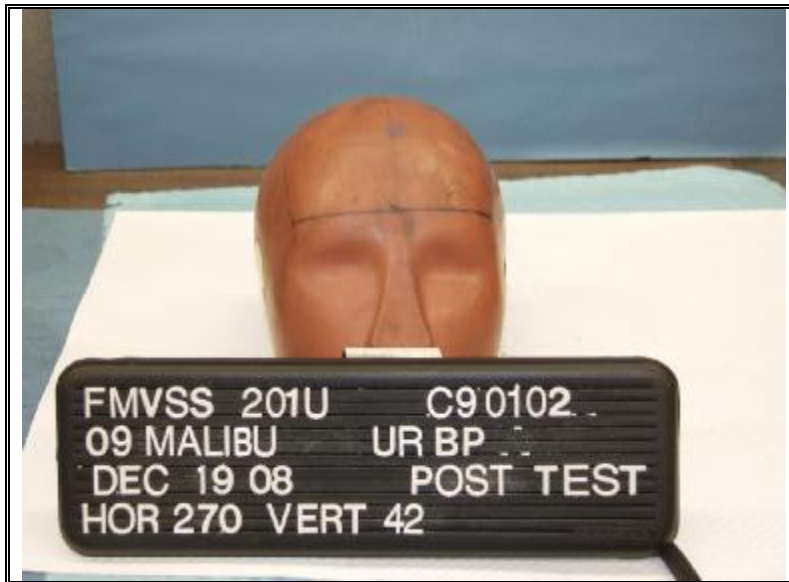
POST-IMPACT URBPHHEADFORM

Free Motion HIC	626.8
HIC(d)	639.3
Impact Velocity (kph)	23.57
HIC T1 (msec)	2.8
HIC T2 (msec)	12.4

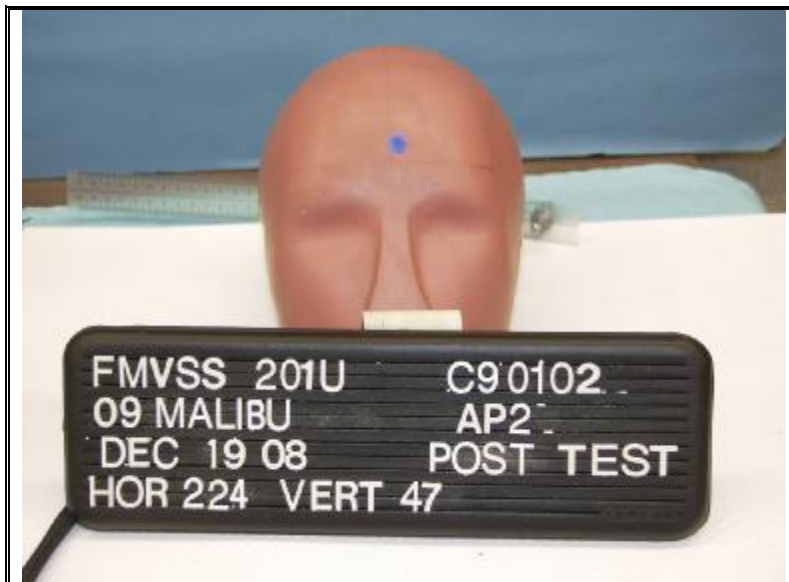
POST-IMPACT AP2 HEADFORM

Free Motion HIC	342.2
HIC(d)	424.6
Impact Velocity (kph)	18.71
HIC T1 (msec)	3.3
HIC T2 (msec)	12.1
