REPORT NUMBER: 217-MGA-2009-002

SAFETY COMPLIANCE TESTING FOR FMVSS NO. 217 SCHOOL BUS EMERGENCY EXITS AND WINDOW RETENTION AND RELEASE

THOMAS BUILT BUSES 2009 THOMAS MINOTOUR SCHOOL BUS NHTSA NO.: C90901

PREPARED BY: MGA RESEARCH CORPORATION 5000 WARREN ROAD BURLINGTON, WI 53105

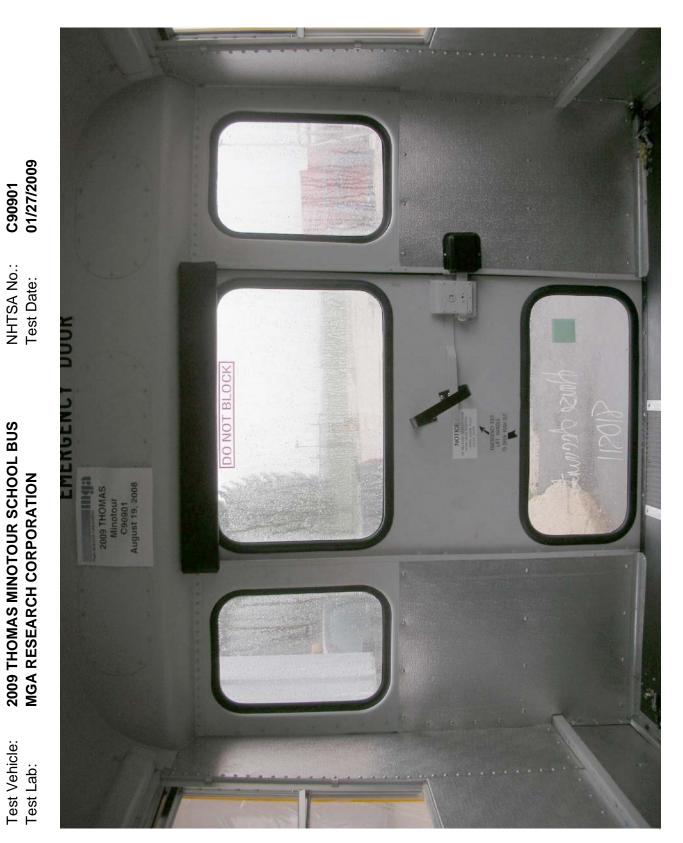
Interior View of Rear Emergency Exit Door Instructions

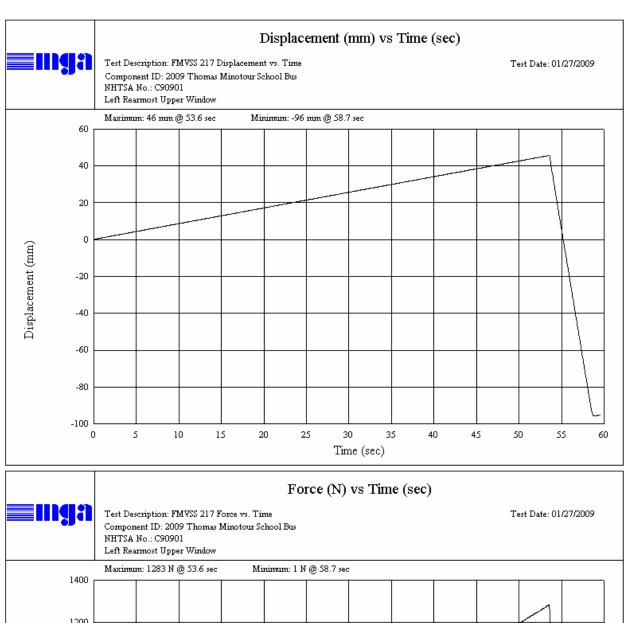
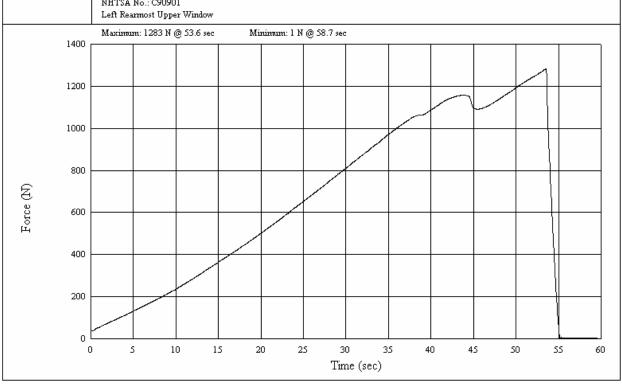
<u>No.</u>		Page No.
1	Rearmost Left Side Window (Upper Half) Displacement vs. Time	49
2	Rearmost Left Side Window (Upper Half) Force vs. Time	49
3	Rearmost Left Side Window (Lower Half) Displacement vs. Time	50
4	Rearmost Left Side Window (Lower Half) Force vs. Time	50
5	Rearmost Right Side Window (Lower Half) Displacement vs. Time	51
6	Rearmost Right Side Window (Lower Half) Force vs. Time	51
7	Rear Exit Door, Upper Window Displacement vs. Time	52
8	Rear Exit Door, Upper Window Force vs. Time	52
