REPORT NUMBER: 217-MGA-03-002

**SAFETY COMPLIANCE TESTING FOR
FMVSS NO. 217
SCHOOL BUS EMERGENCY EXITS AND WINDOW
RETENTION AND RELEASE**

2003 Blue Bird Corporation
All American School Bus
NHTSA No.: C30900

PREPARED BY:
MGA RESEARCH CORPORATION
5000 WARREN ROAD
BURLINGTON, WI 53105

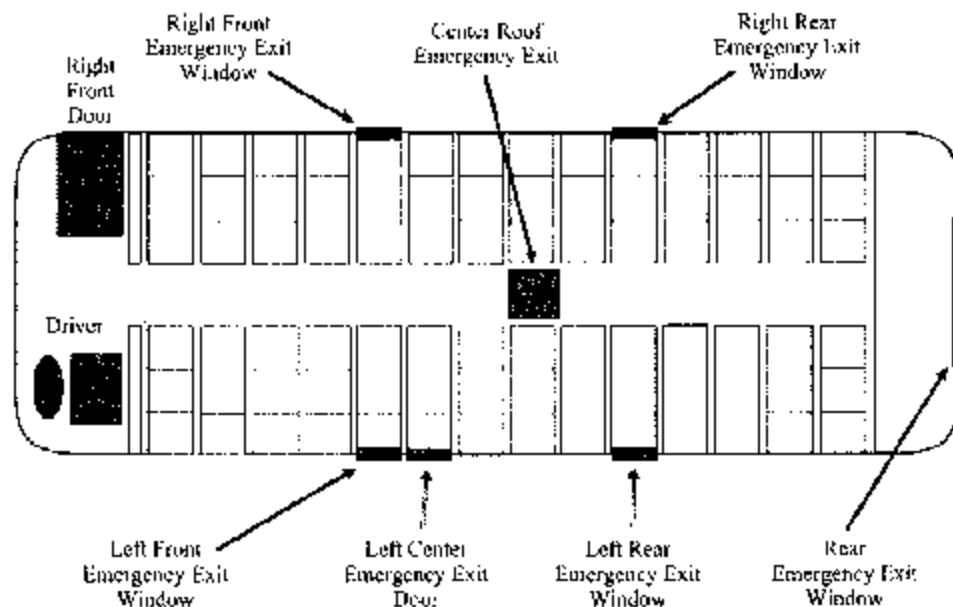
Height (mm)	Width (mm)
1	Left Front Exit Window	505	612
2	Left Rear Exit Window	505	612
3	Right Front Exit Window	505	612
4	Right Rear Exit Window	505	612
5	Rear Exit Window	578	1,359
6	Left Side Exit Door	1,295	610
7	Roof Exit - Rear	580	585

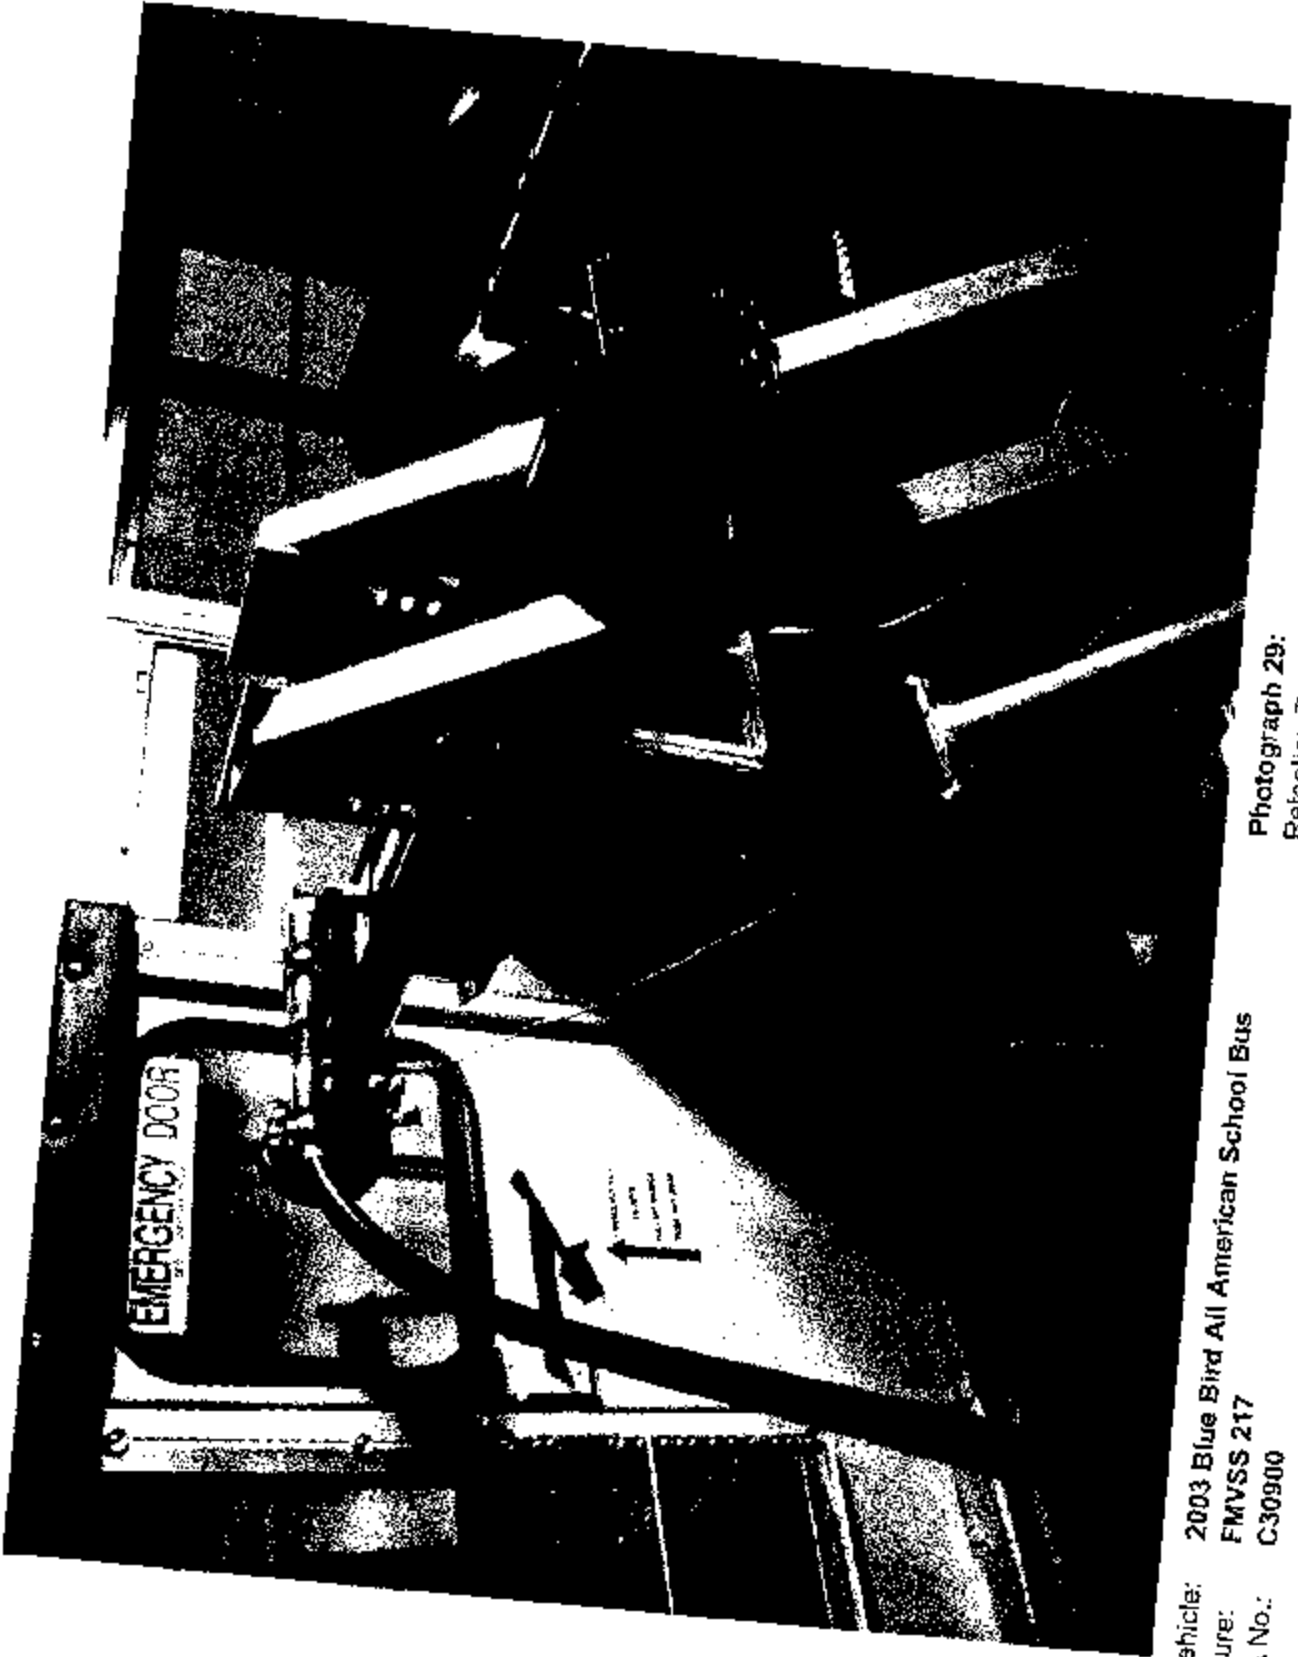
Photograph 29:
Retention Test of Left Exit Door Window (Pre-Test)

1	Test Window Identification:	Left Side Exit Door – Glazing
2	Provide a detailed description of the window such as fixed, push out, single or double glazed, horizontal or vertical sliding, etc.	Double Glazed, Fixed
3	Provide the horizontal and vertical glazing dimensions for each panel.	470 mm x 470 mm
4	Did the window pass the retention requirements? Describe how the window structure and glazing withstood the force per the PASS/FAIL criteria:	Glazing Shattered at 407 kg - PASS
5	Did the window pass the force tests to unlatch and open the exit after the completion of the retention test?	PASS 60.2 N to Unlatch 27.3 N to Open
