REPORT NUMBER 401-STF-09-001

SAFETY COMPLIANCE TESTING FOR FMVSS NO. 401 INTERIOR TRUNK RELEASE

GENERAL MOTORS CORPORATION
2009 CHEVROLET IMPALA
FOUR-DOOR PASSENGER CAR
NHTSA NO. C90100

FINAL REPORT

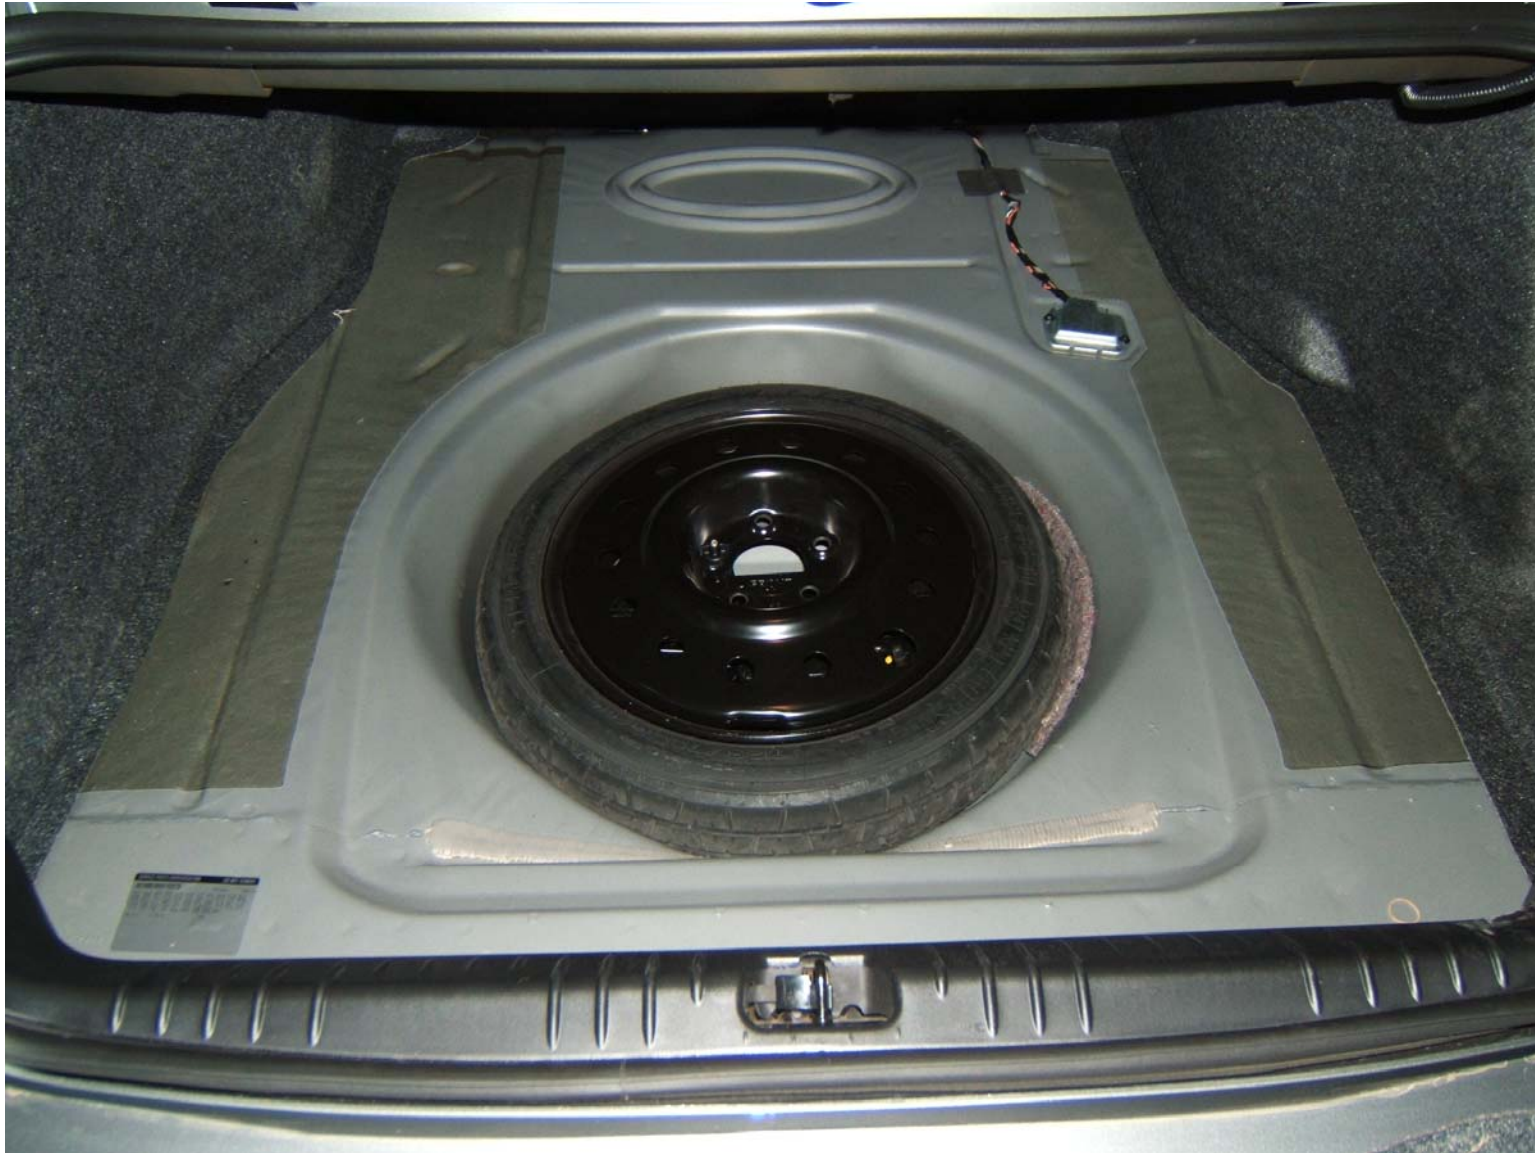
FIGURE 5.7
VEHICLE TRUNK COMPARTMENT INTERIOR
SHOWING ORIGINAL EQUIPMENT INSTALLED

REMARKS: Tire change equipment is stored beneath removable trunk floor.

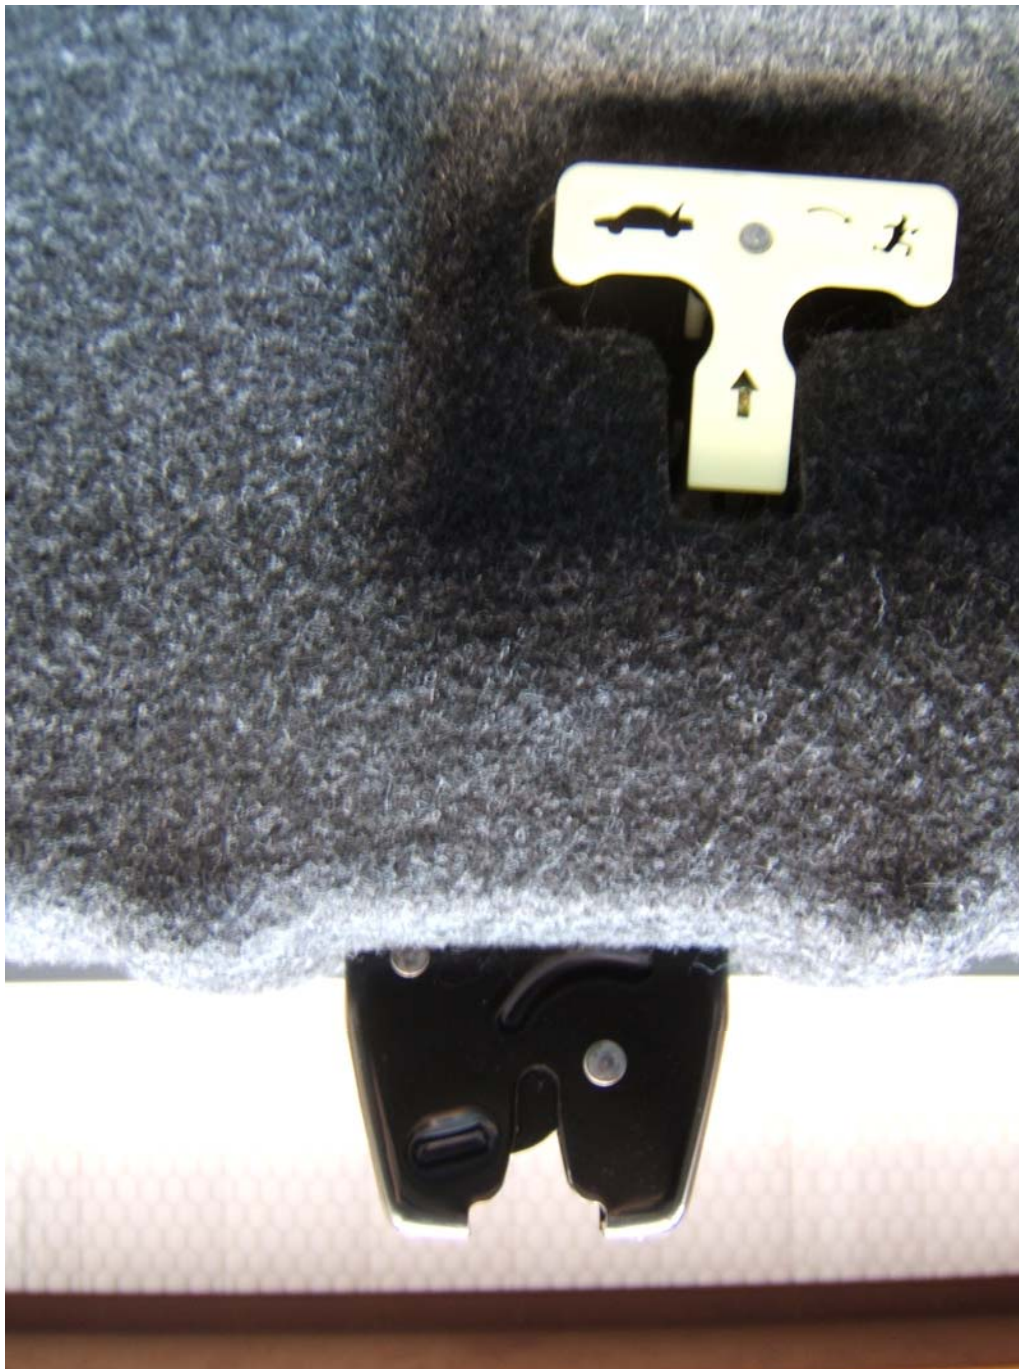
FIGURE 5.8
VEHICLE TRUNK COMPARTMENT MANUAL
RELEASE MECHANISM

Method used to actuate interior trunk release: Grab handle

Method used by vehicle manufacturer to ensure that
release mechanism is visible in the closed trunk compartment: Phosphorescence

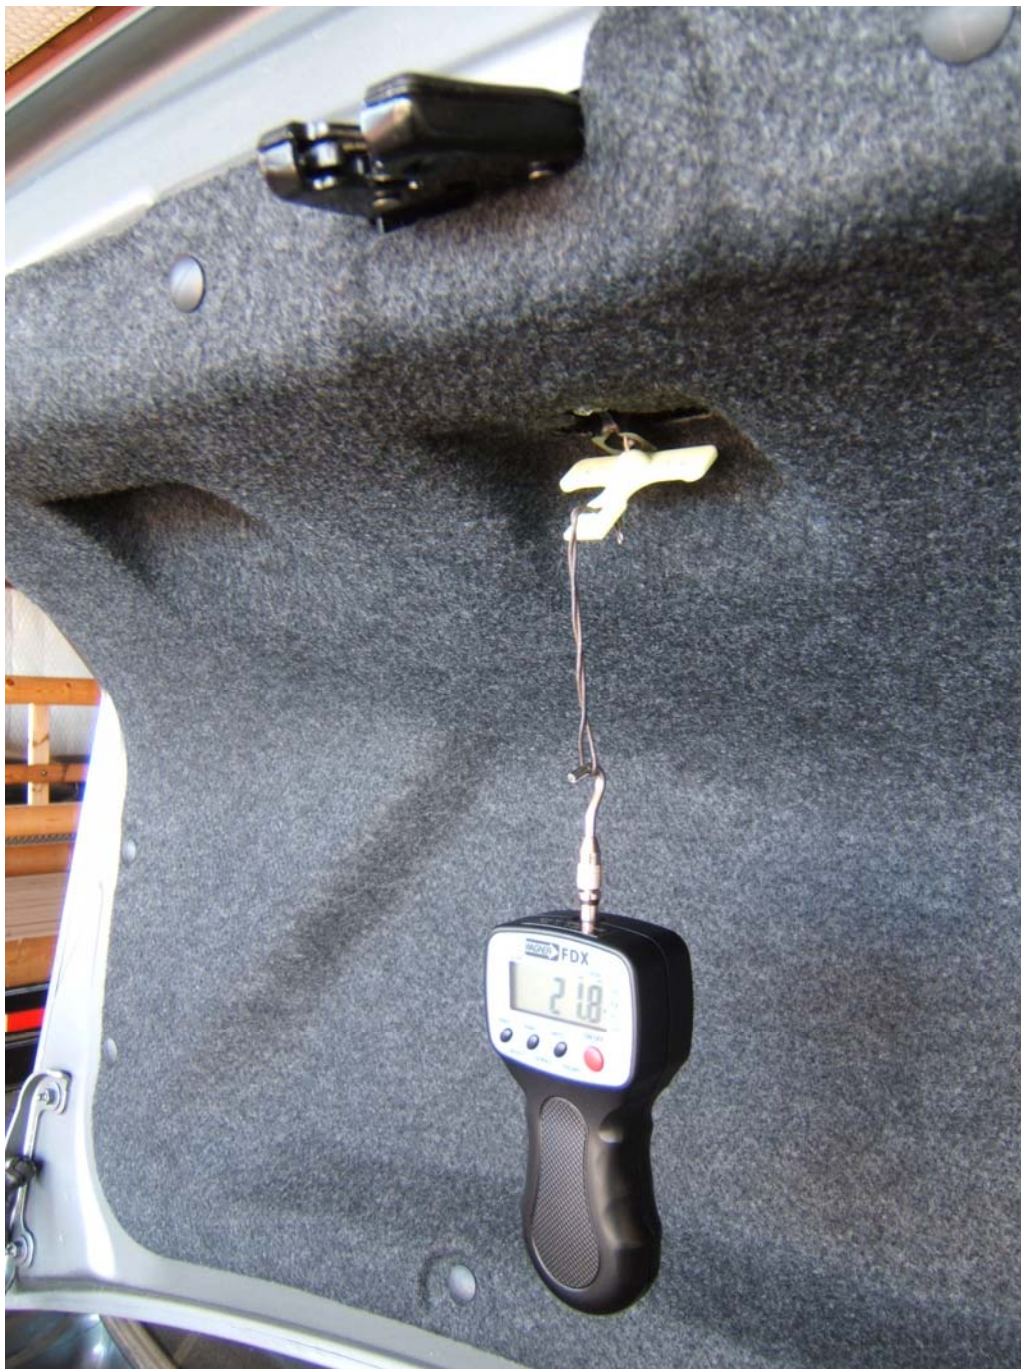
FIGURE 5.9
RELEASE MECHANISM WITH TEST
EQUIPMENT ATTACHED

Vehicle Stationary (0 km/h)	Force in Newtons Required to Release Trunk Lid (no requirement)	Trunk Released from All Latching Positions	Pass/Fail
NO KEY IN IGNITION			
Attempt 1	21.6	Yes	Pass
Attempt 2	22.4	Yes	Pass
Attempt 3	21.8	Yes	Pass
Average	21.9		
ENGINE IDLING			
Attempt 1	22.6	Yes	Pass
Attempt 2	21.6	Yes	Pass
Attempt 3	22.4	Yes	Pass
Average	22.2

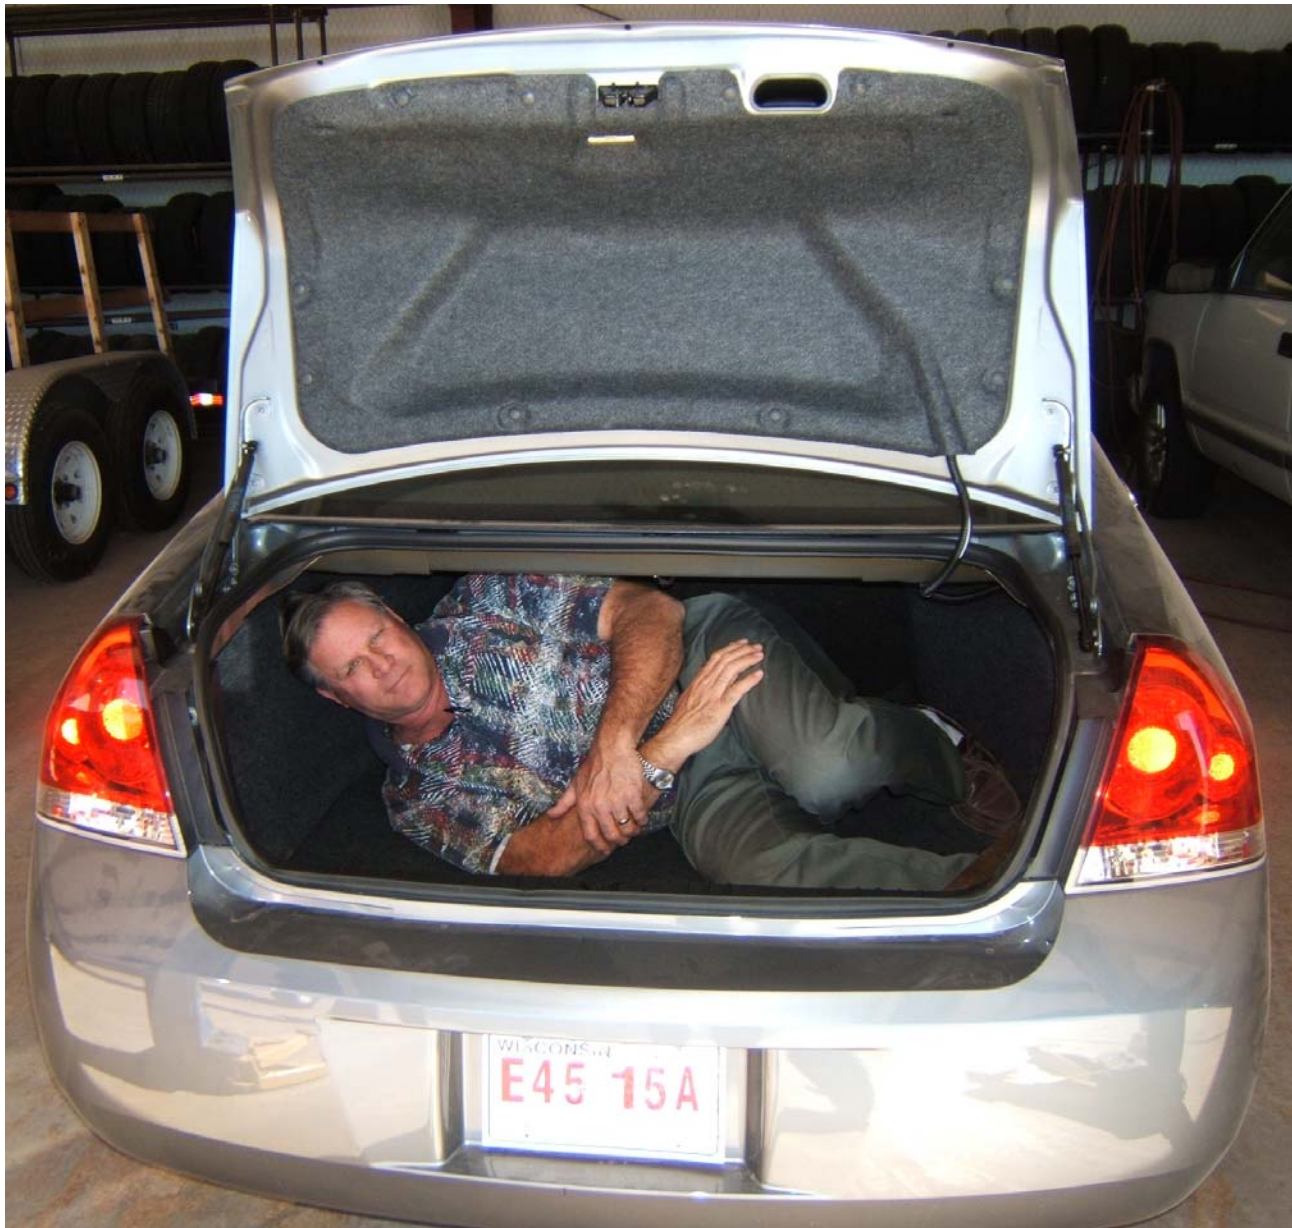
FIGURE 5.10
TEST OBSERVER IN
TRUNK COMPARTMENT

Can test personnel enter trunk and be closed within? Yes

Size of occupant: 5' 10", large frame

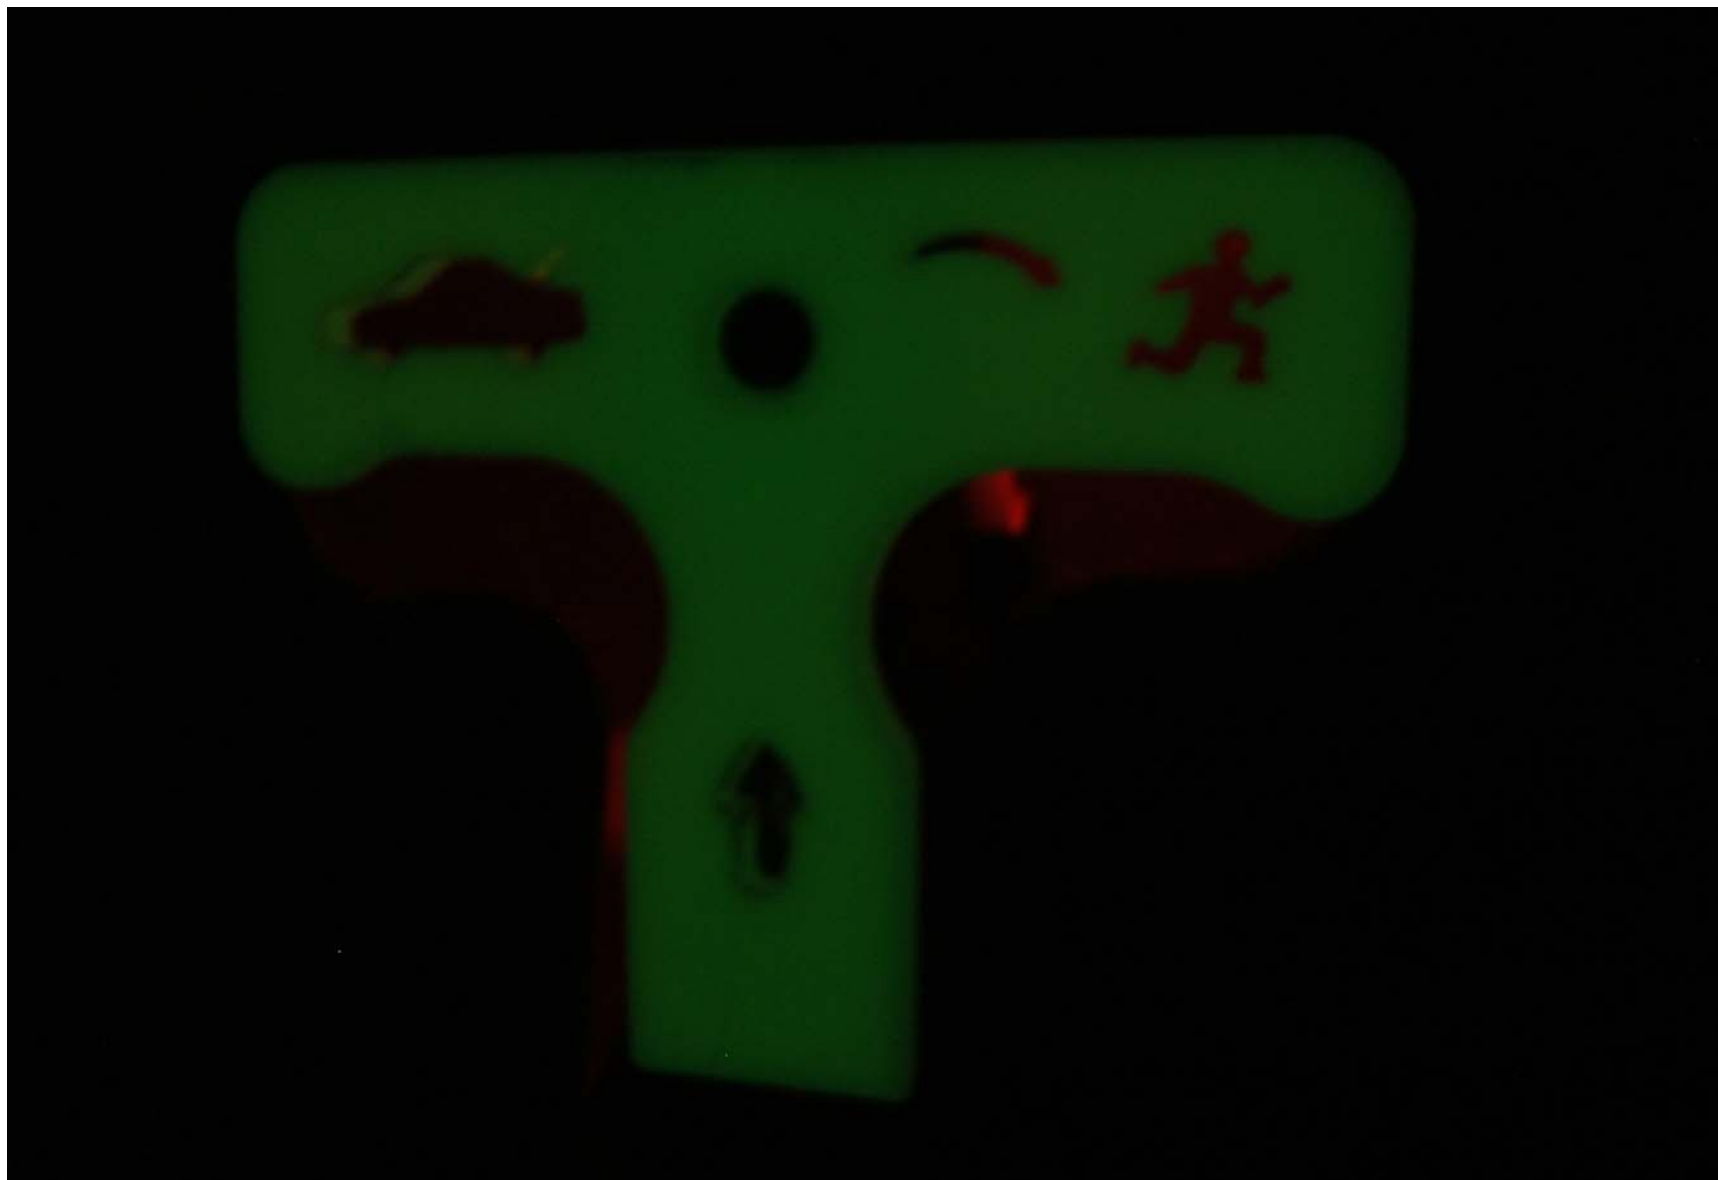
FIGURE 5.12
RELEASE MECHANISM INSIDE CLOSED TRUNK

Can release mechanism be easily seen inside the closed trunk? Yes

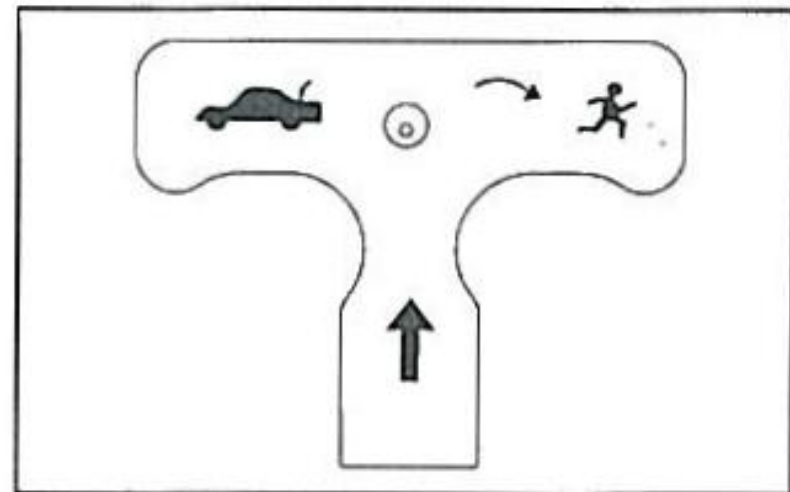
There is a glow-in-the-dark trunk release handle located on the latch inside the trunk. This handle will glow following exposure to light. Pull the release handle to open the trunk from the inside.
