REPORT NUMBER: 201U-CAL-10-04

**SAFETY COMPLIANCE TESTING FOR FMVSS 201
OCCUPANT PROTECTION IN INTERIOR IMPACT
UPPER INTERIOR HEAD IMPACT PROTECTION**

**KIA MOTORS CORPORATION
2010 KIA SOUL**

CALSPAN TEST NUMBER: CC2010-04

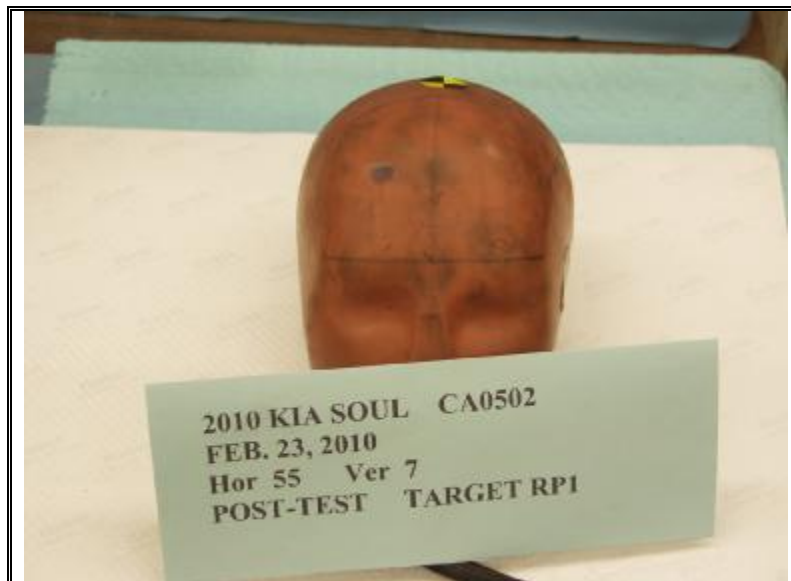
POST-IMPACT RP1 HEADFORM

Test Number:	01
Test Date:	02/23/10
Target Location:	REAR PILLAR
Target Code:	RP1
Horizontal Impact Angle:	55
Vertical Impact Angle:	7
Ambient Temperature:	20°C
Relative Humidity:	27
Time of Impact:	9:30
Headform Number:	0062

Impact Point Description (from lower midpoint on midsagittal line)					
On Centerline	25	<input checked="" type="checkbox"/>	mm right	<input type="checkbox"/>	mm left
On Centerline	42				mm up

Free Motion HIC	415.0
HIC(d)	479.5
Impact Velocity (kph)	23.83
HIC T1 (msec)	2.(
HIC T2 (msec)	12.8

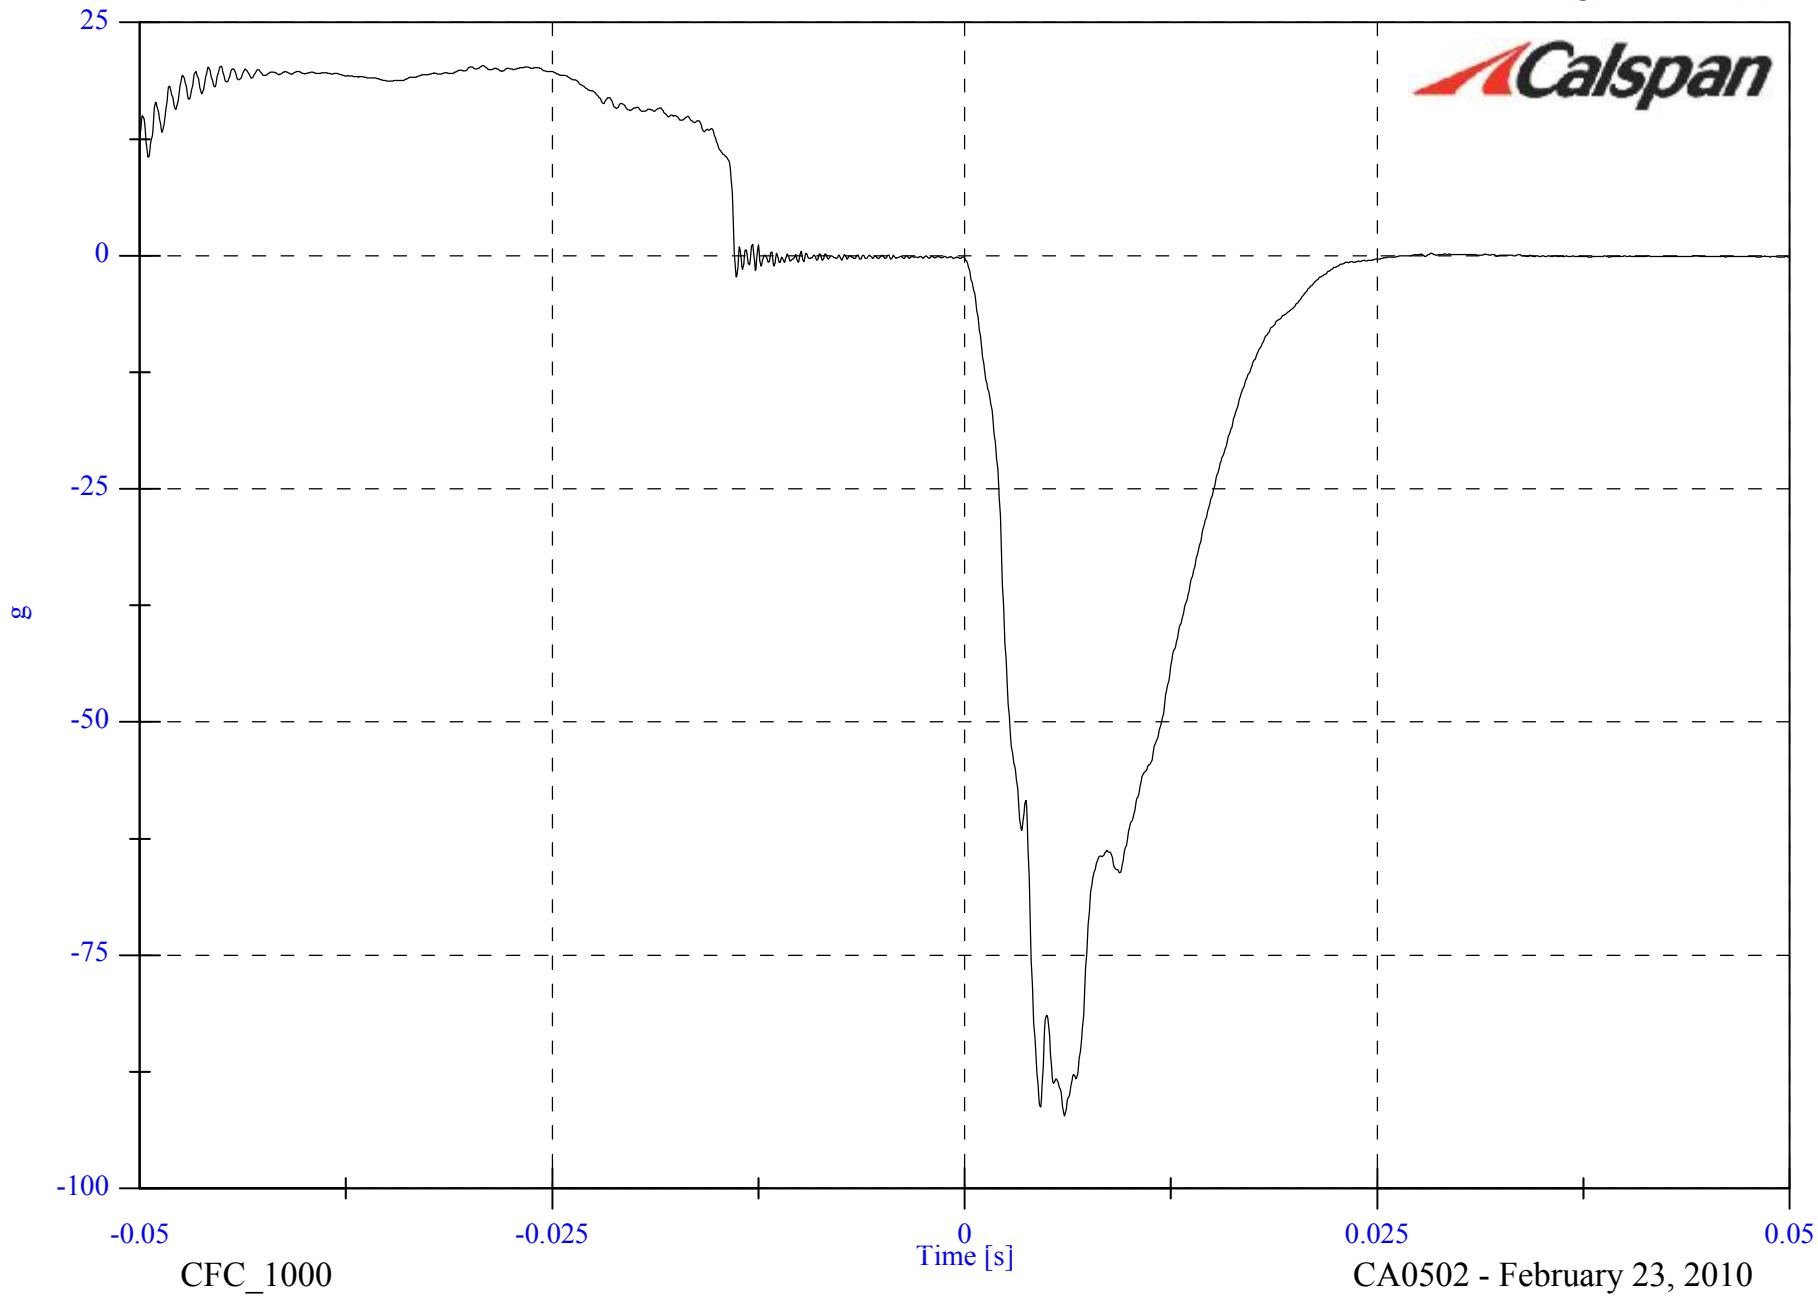
CA0502 PASSENGER SIDE RP1 IMPACT PLOT #1

FMVSS 201U 2010 KIA SOUL

Headform X Acceleration

Max: 20.4 [g] at -0.029 [s]

Min: -92.3 [g] at 0.006 [s]

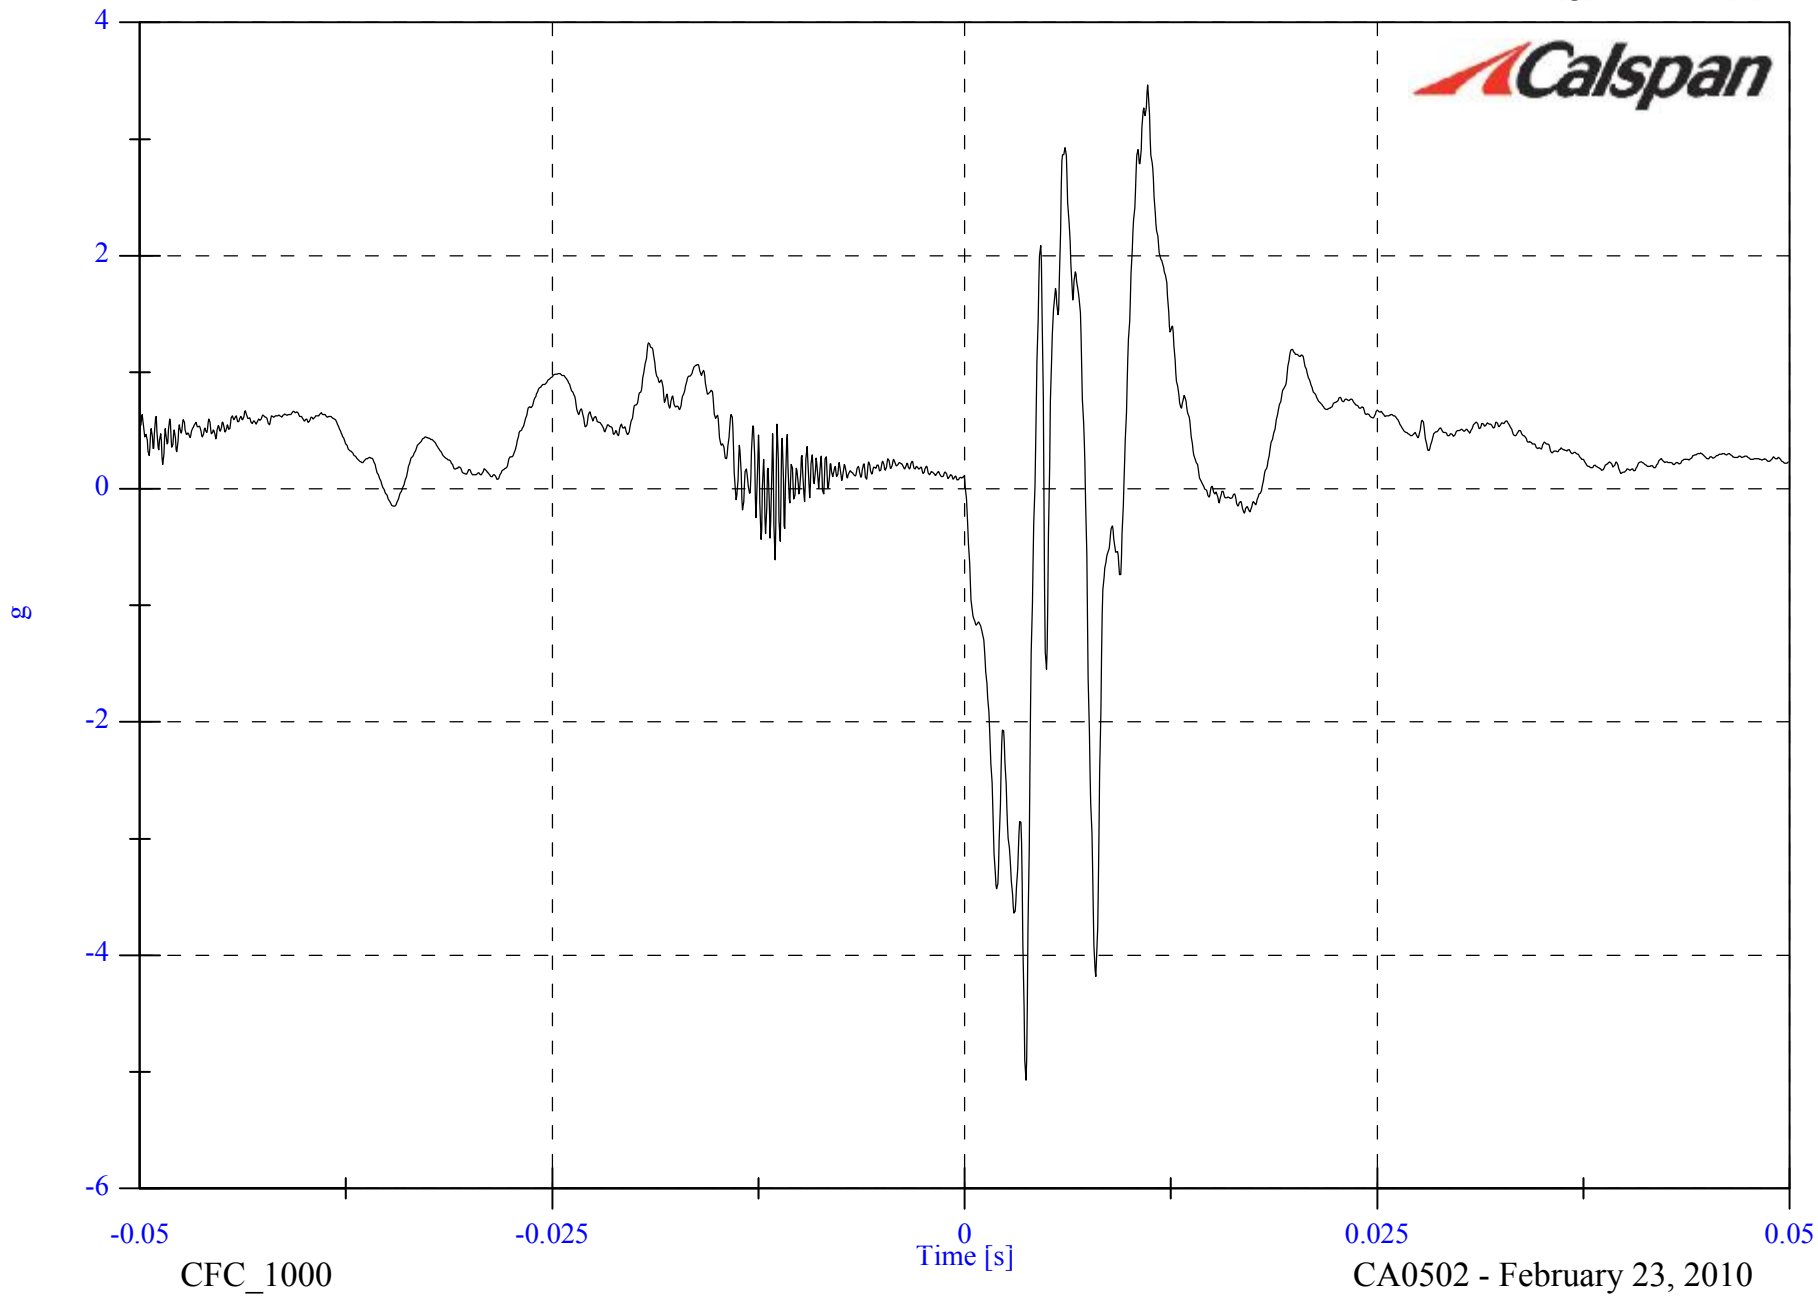
CA0502 PASSENGER SIDE RP1 IMPACT PLOT #2

FMVSS 201U 2010 KIA SOUL

Headform Y Acceleration

Max: 3.5 [g] at 0.011 [s]

Min: -5.1 [g] at 0.004 [s]

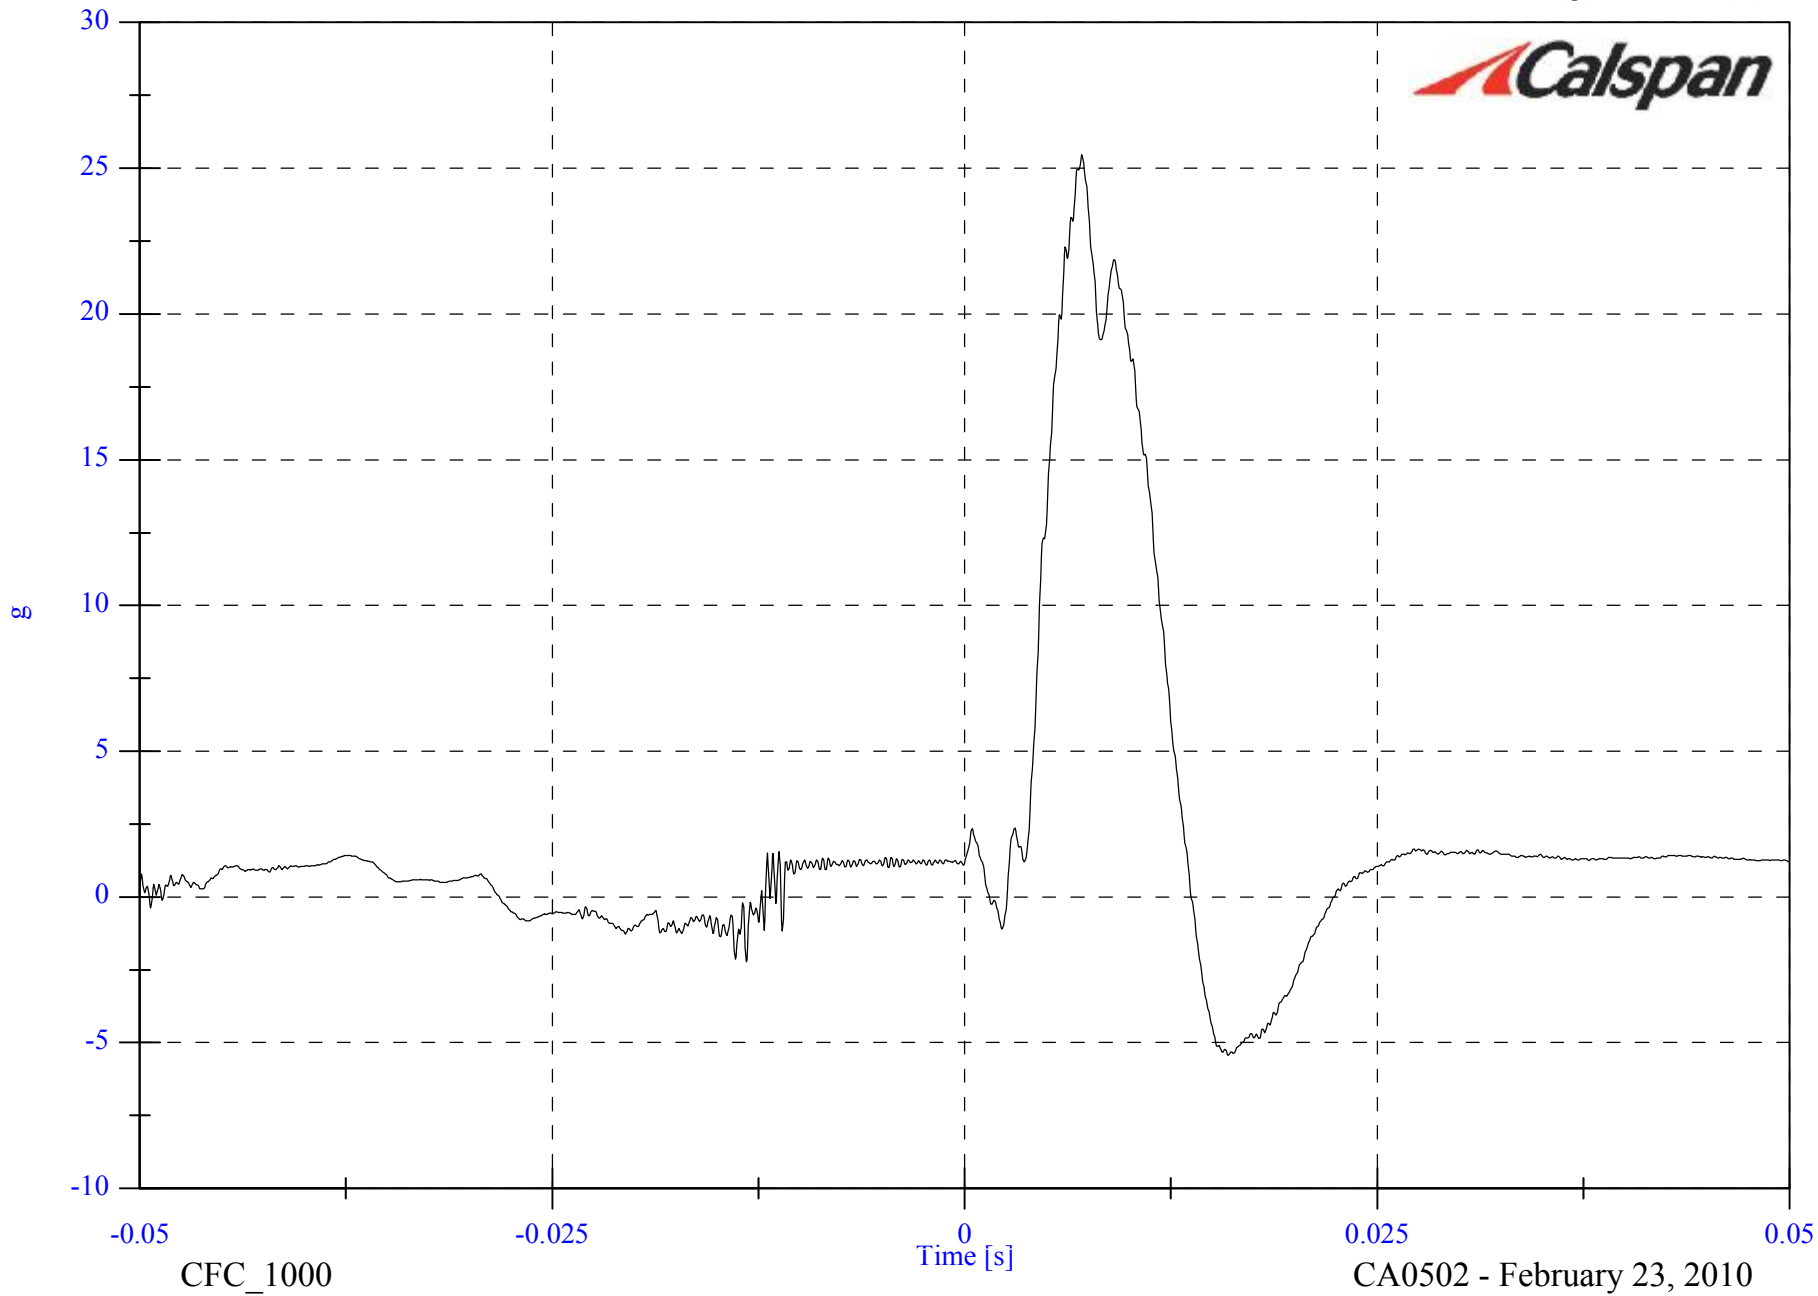
CA0502 PASSENGER SIDE RP1 IMPACT PLOT #3

FMVSS 201U 2010 KIA SOUL

Headform Z Acceleration

Max: 25.5 [g] at 0.007 [s]

Min: -5.4 [g] at 0.016 [s]

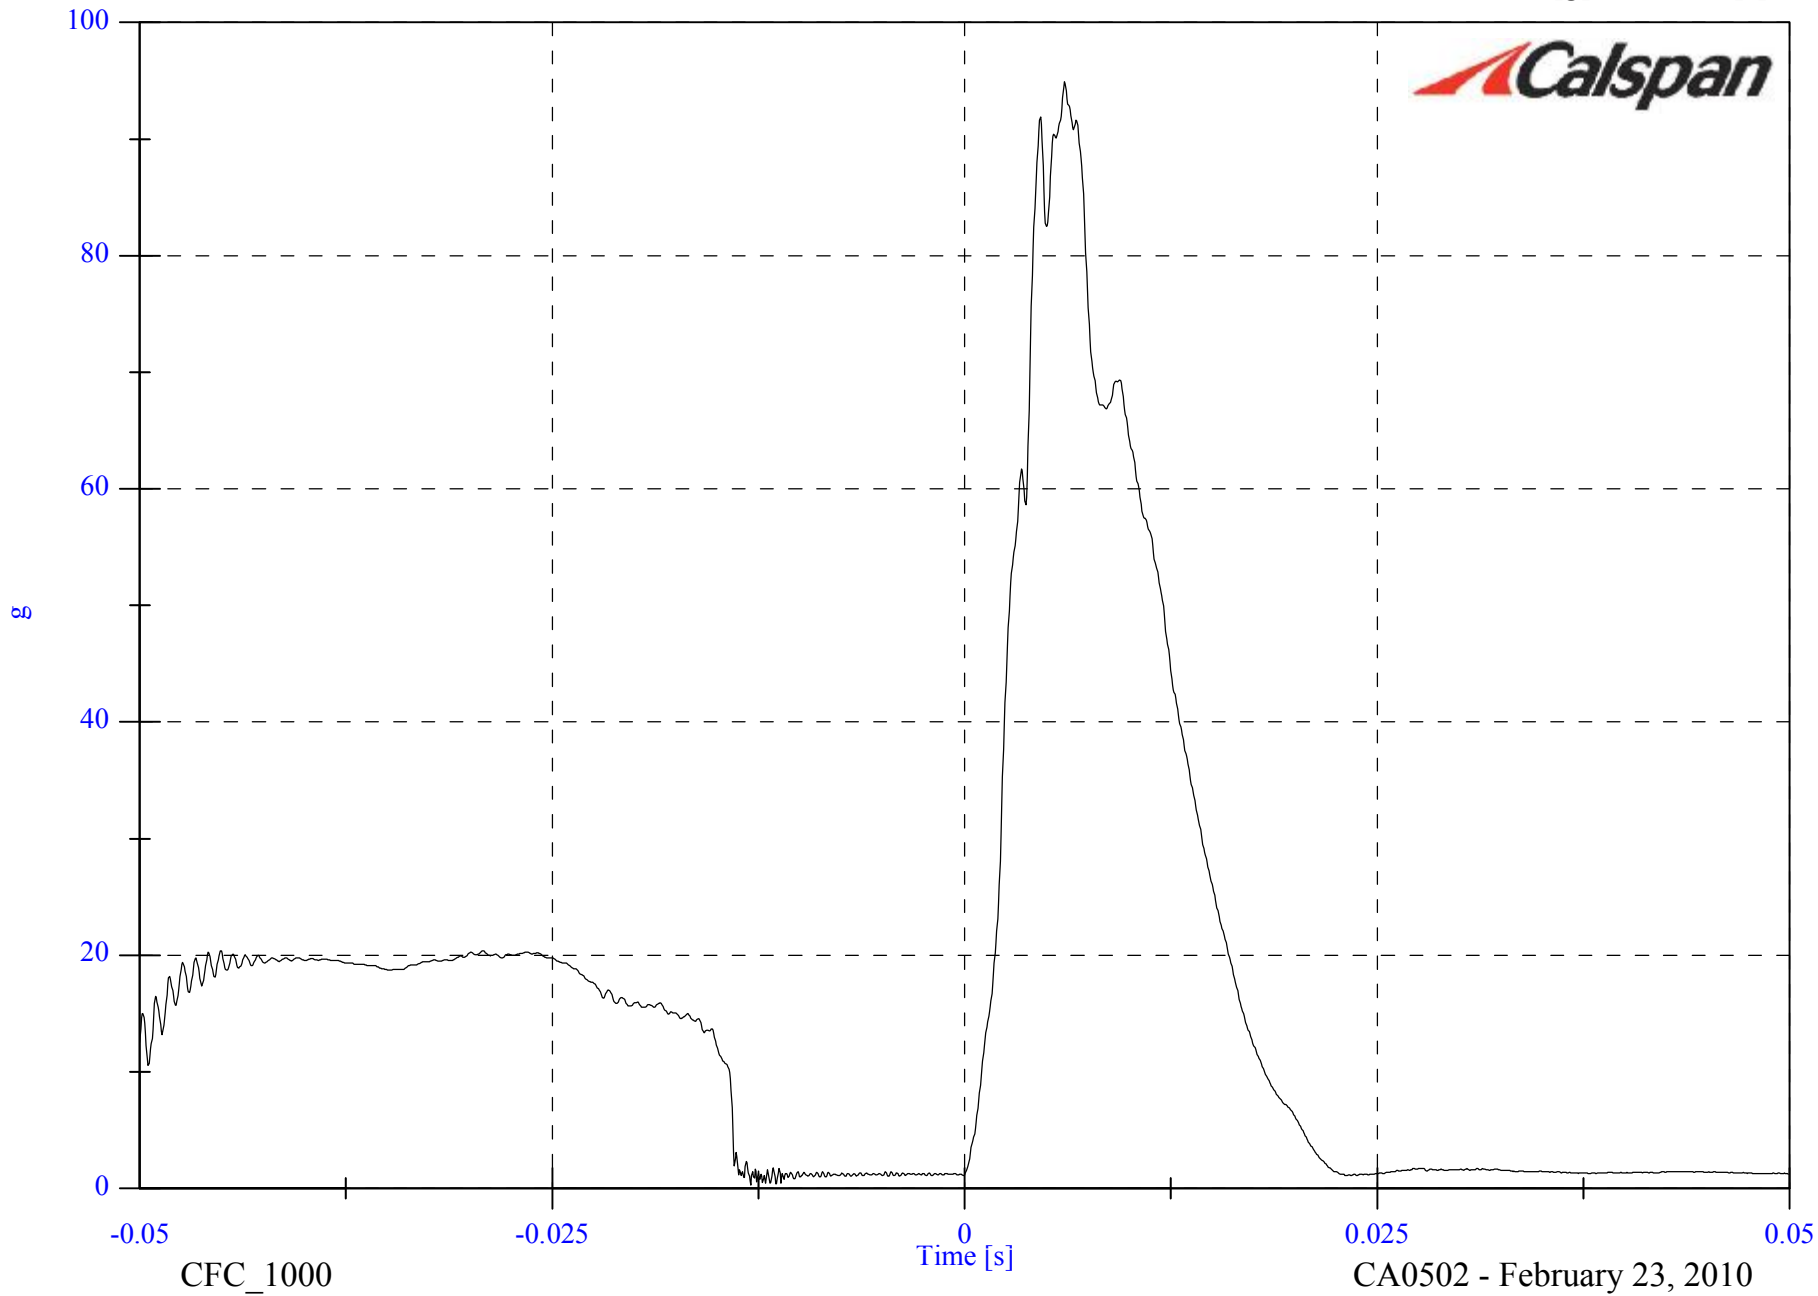
CA0502 PASSENGER SIDE RP1 IMPACT PLOT #4

FMVSS 201U 2010 KIA SOUL

Headform Resultant

Max: 94.9 [g] at 0.006 [s]

Min: 0.3 [g] at -0.013 [s]

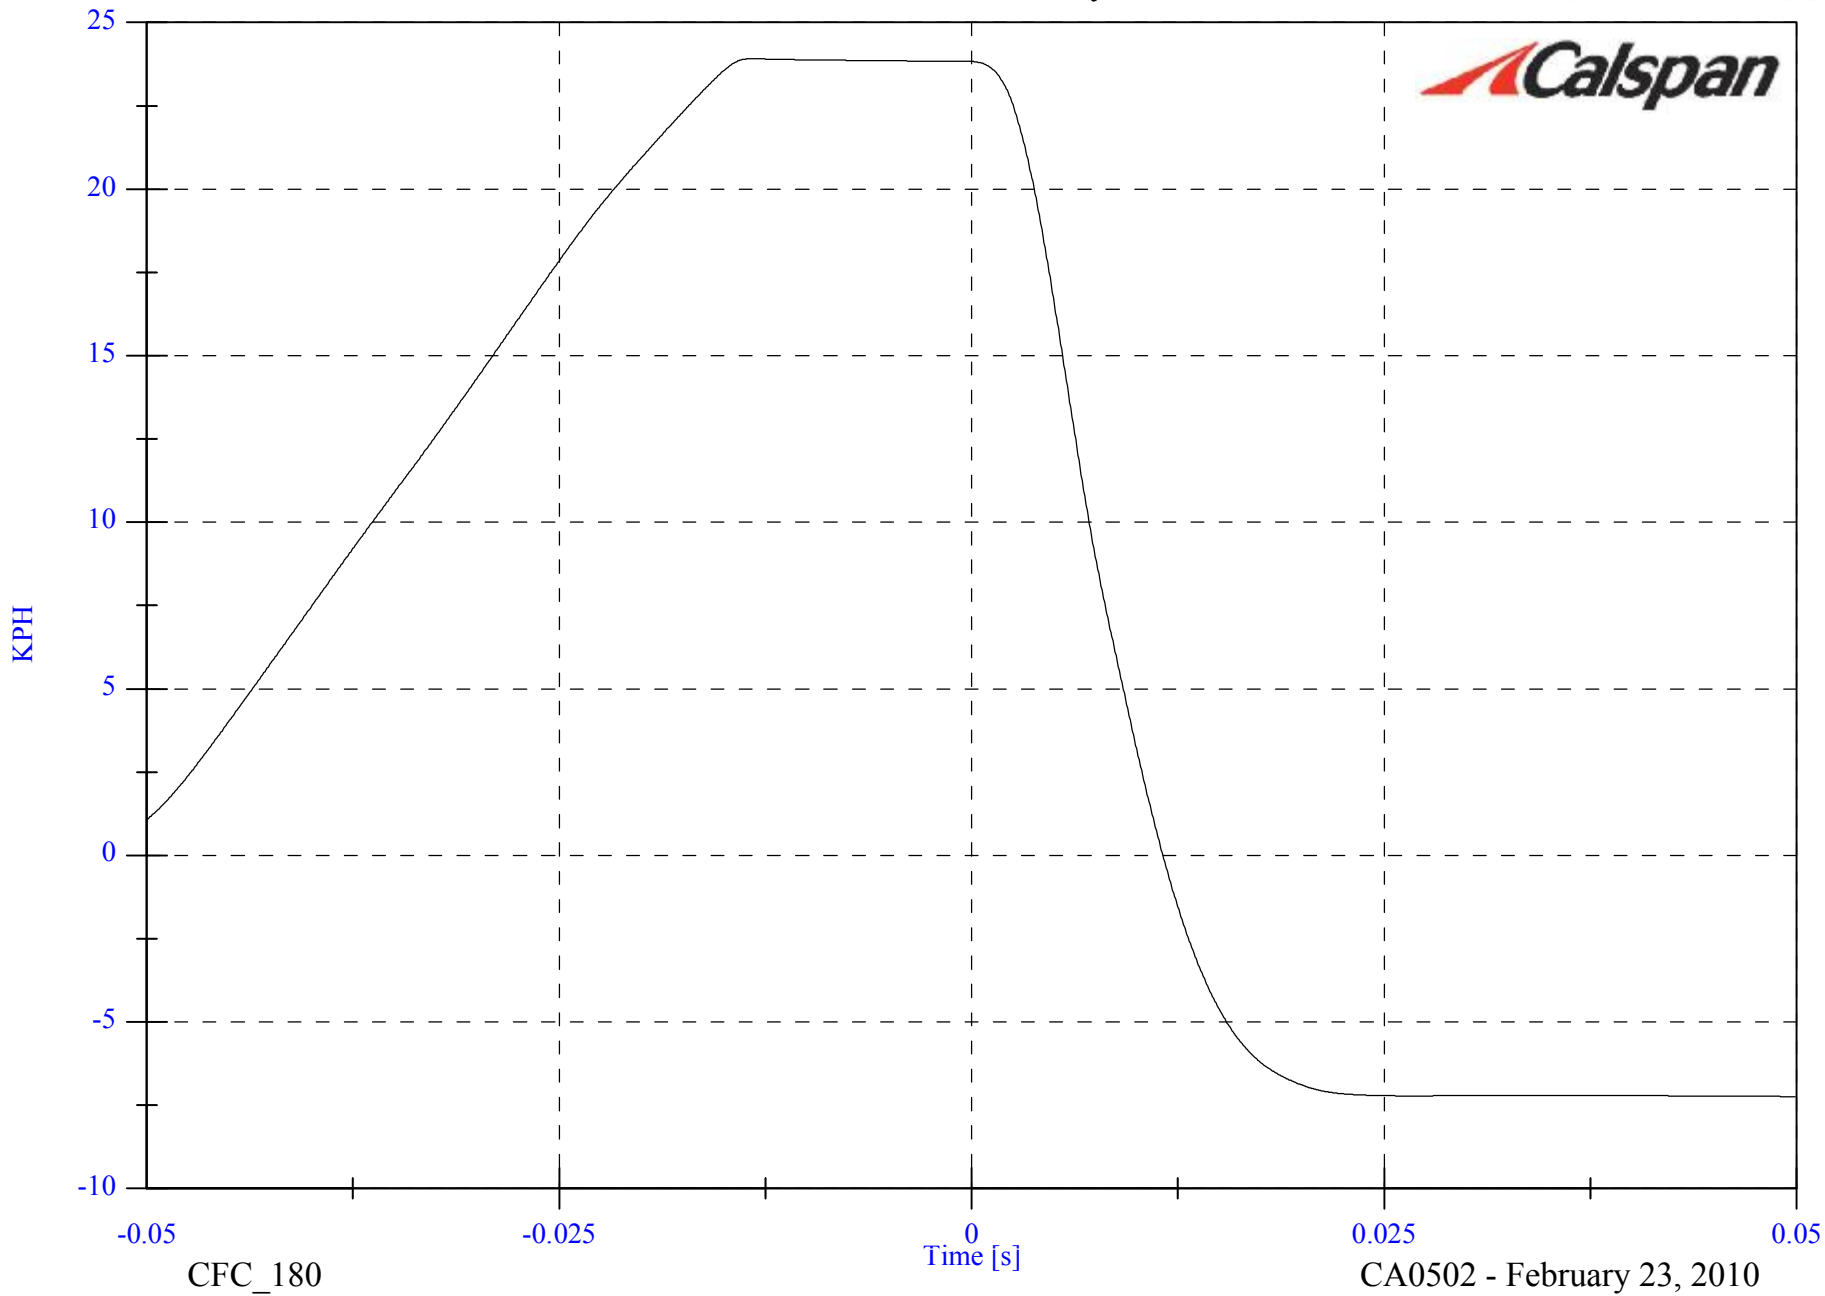
CA0502 PASSENGER SIDE RP1 IMPACT PLOT #5

FMVSS 201U 2010 KIA SOUL

Max: 23.9 [KPH] at -0.013 [s]

Min: -7.2 [KPH] at 0.050 [s]

Headform Velocity

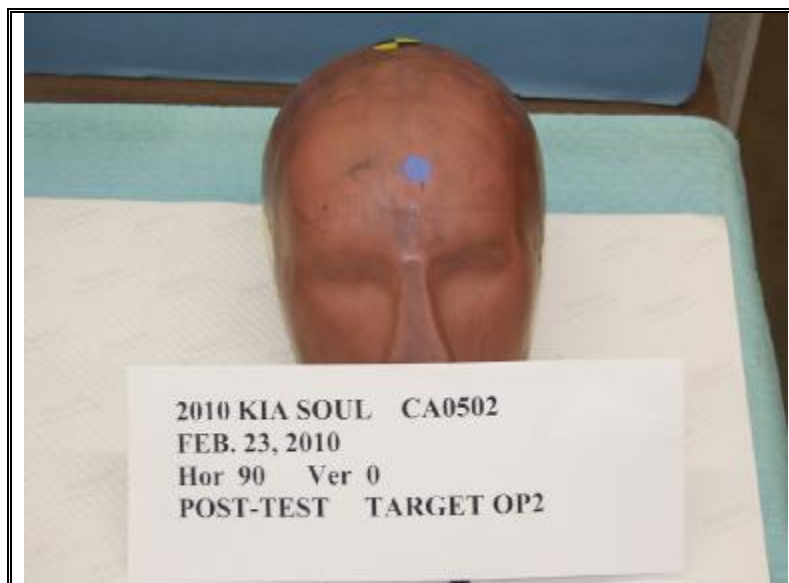
POST-IMPACT OP2 HEADFORM

Test Number:	02
Test Date:	02/23/10
Target Location:	OTHER PILLAR
Target Code:	OP2
Horizontal Impact Angle:	90
Vertical Impact Angle:	0
Ambient Temperature:	20°C
Relative Humidity:	27
Time of Impact:	10:15
Headform Number:	0805

Impact Point Description (from lower midpoint on midsagittal line)					
On Centerline	5	<input type="checkbox"/>	mm right	<input checked="" type="checkbox"/>	mm left
On Centerline	18				mm up

Free Motion HIC	296.6
HIC(d)	390.1
Impact Velocity (kph)	23.77
HIC T1 (msec)	0.5
HIC T2 (msec)	14.0%

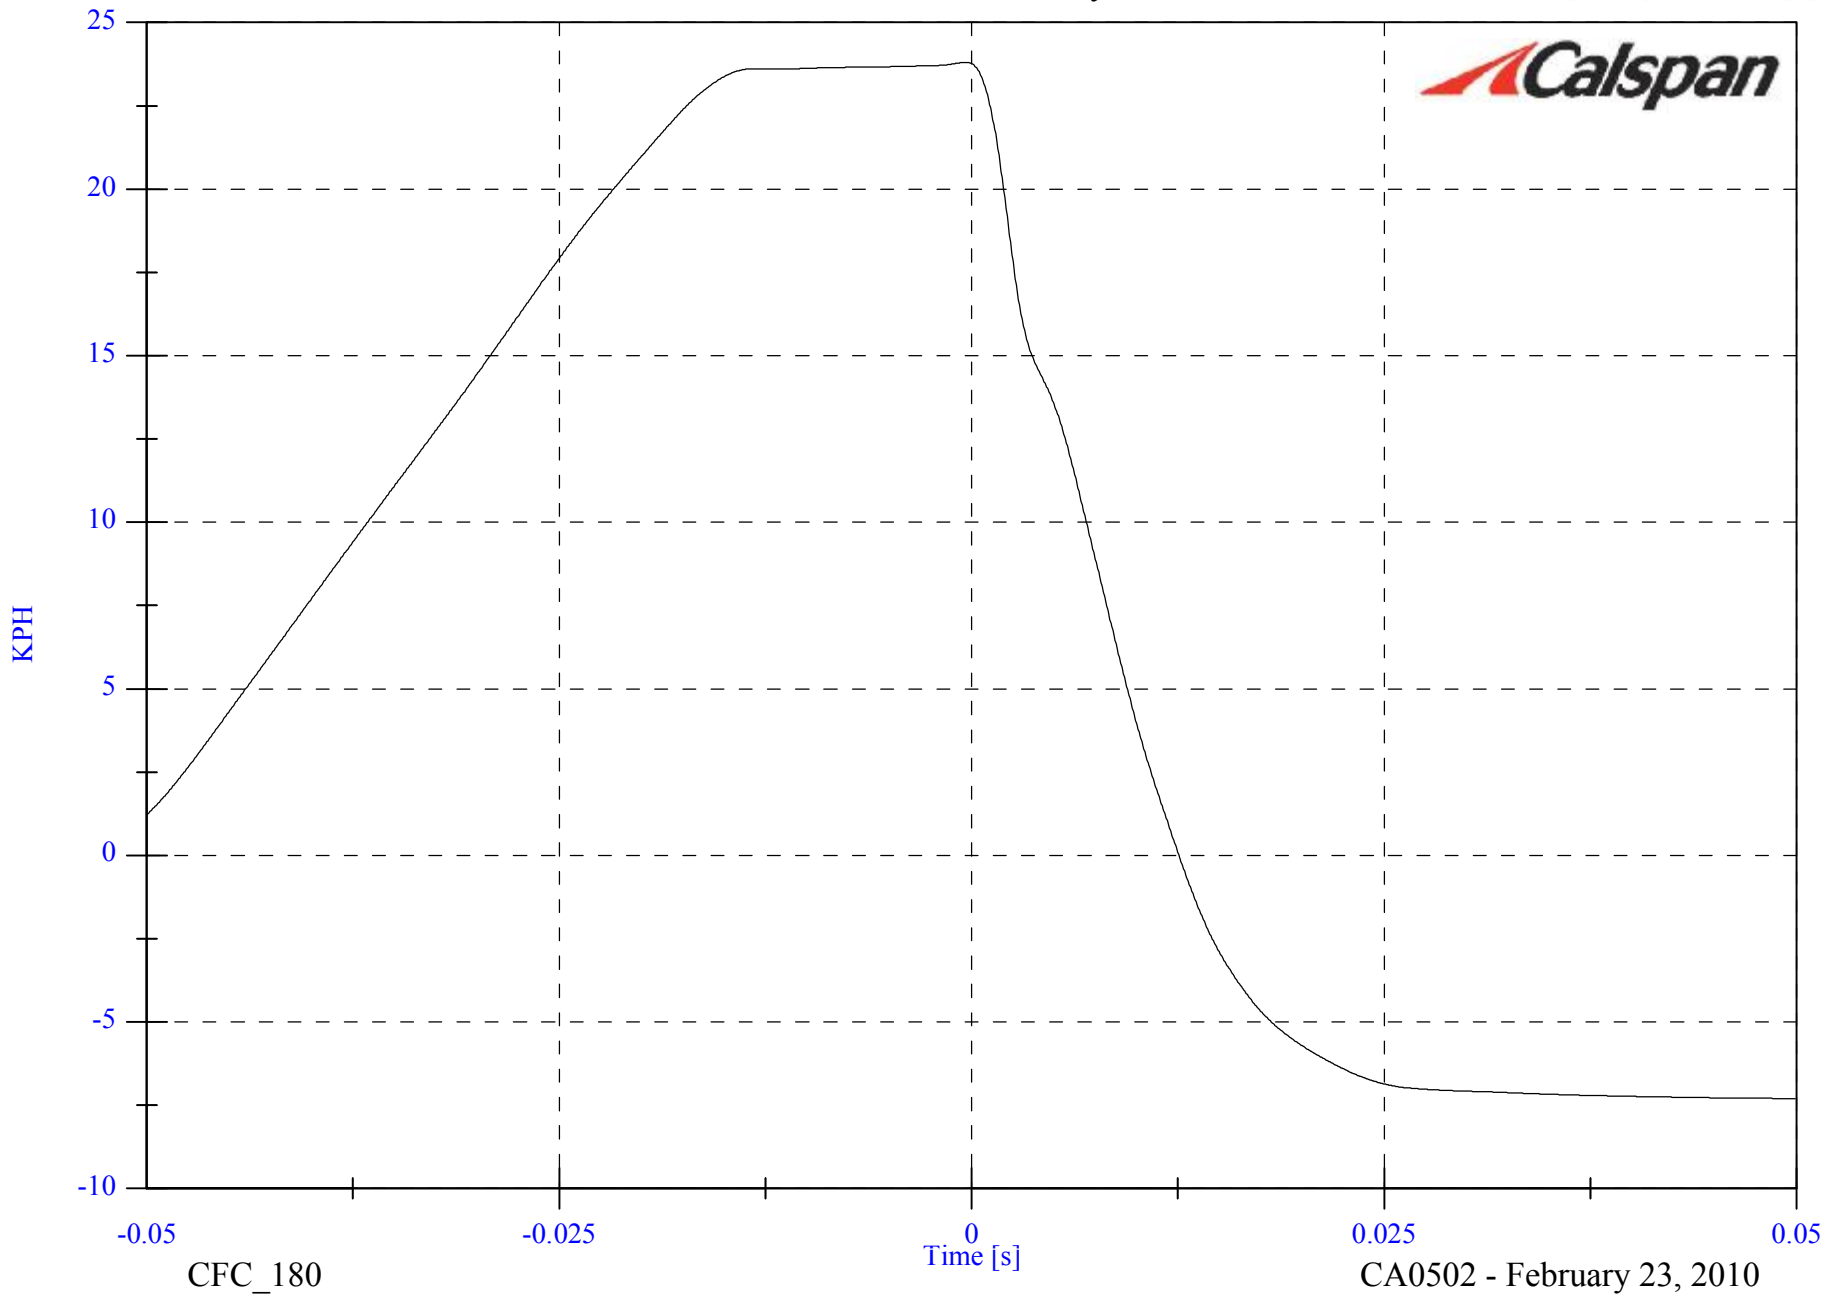
CA0502 PASSENGER SIDE OP2 IMPACT PLOT #5

FMVSS 201U 2010 KIA SOUL

Max: 23.8 [KPH] at -0.000 [s]

Min: -7.3 [KPH] at 0.050 [s]

Headform Velocity

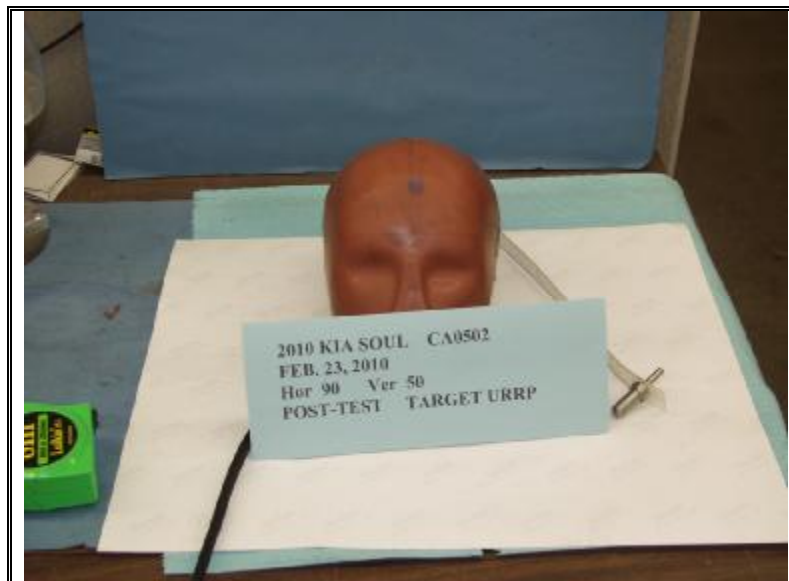
POST-IMPACT URRP HEADFORM

Test Number:	03
Test Date:	02/23/10
Target Location:	UPPER ROOF
Target Code:	URRP
Horizontal Impact Angle:	90
Vertical Impact Angle:	50
Ambient Temperature:	20°C
Relative Humidity:	27
Time of Impact:	10:45
Headform Number:	355

Impact Point Description (from lower midpoint on midsagittal line)			
On Centerline	4	<input type="checkbox"/>	mm right <input checked="" type="checkbox"/> mm left
On Centerline	36		mm up

Free Motion HIC	344.1
HIC(d)	426.0
Impact Velocity (kph)	23.79
HIC T1 (msec)	2.4
HIC T2 (msec)	15.1

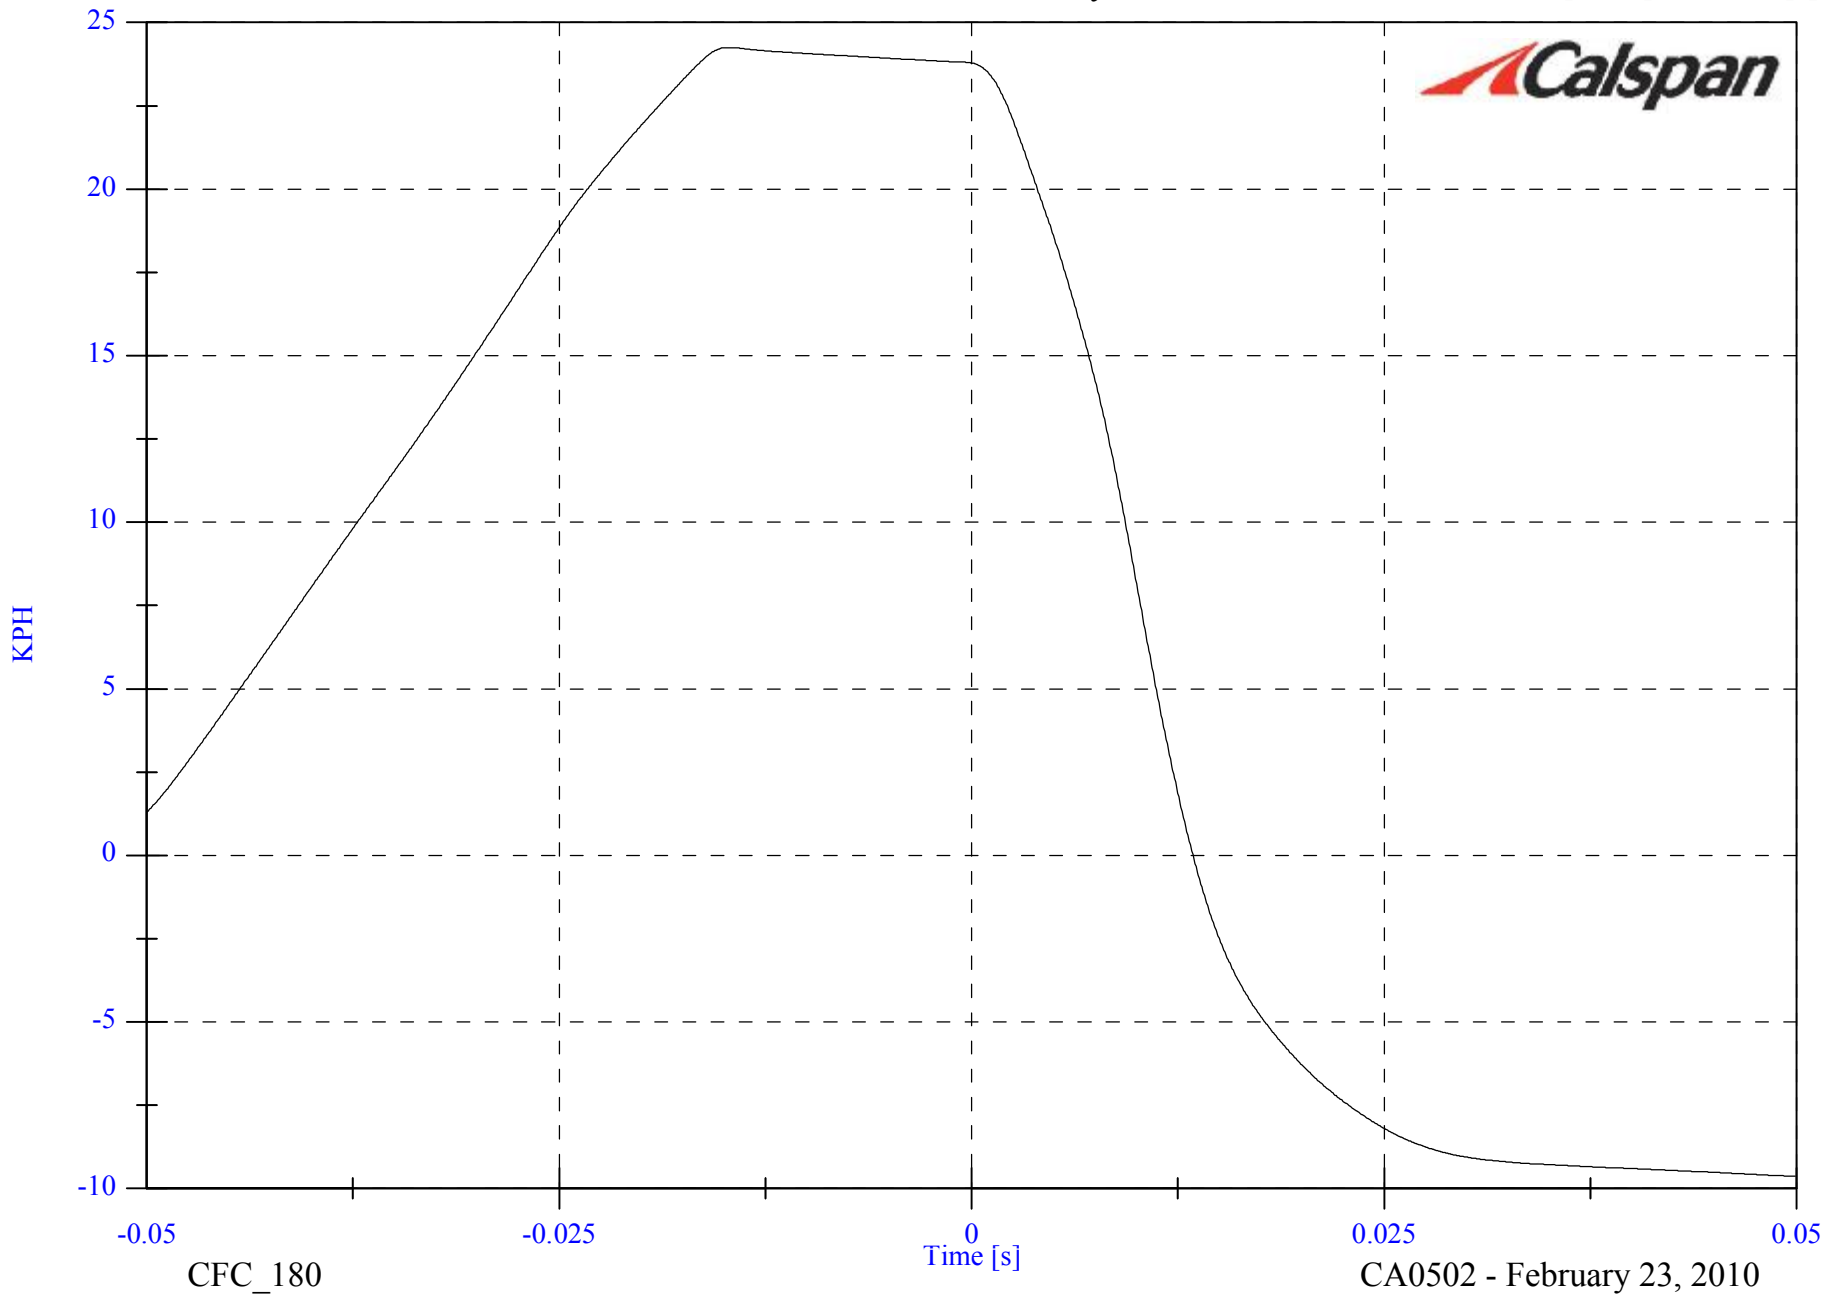
CA0502 PASSENGER SIDE URRP IMPACT PLOT #5

Min: -9.6 [KPH] at 0.050 [s]

Headform Velocity

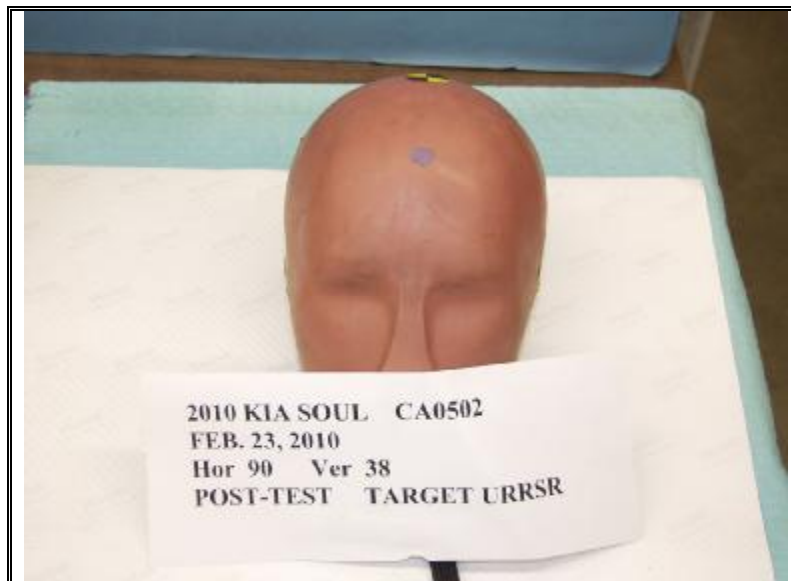
POST-IMPACT URRSR HEADFORM

Test Number:	04
Test Date:	02/23/10
Target Location:	UPPER ROOF
Target Code:	URRSR
Horizontal Impact Angle:	90
Vertical Impact Angle:	38
Ambient Temperature:	20°C
Relative Humidity:	27
Time of Impact:	11:30
Headform Number:	1142

Impact Point Description (from lower midpoint on midsagittal line)					
On Centerline	5	<input type="checkbox"/>	mm right	<input checked="" type="checkbox"/>	mm left
On Centerline	48				mm up

Free Motion HIC	484.0
HIC(d)	531.5
Impact Velocity (kph)	23.71
HIC T1 (msec)	3.8
HIC T2 (msec)	15.2

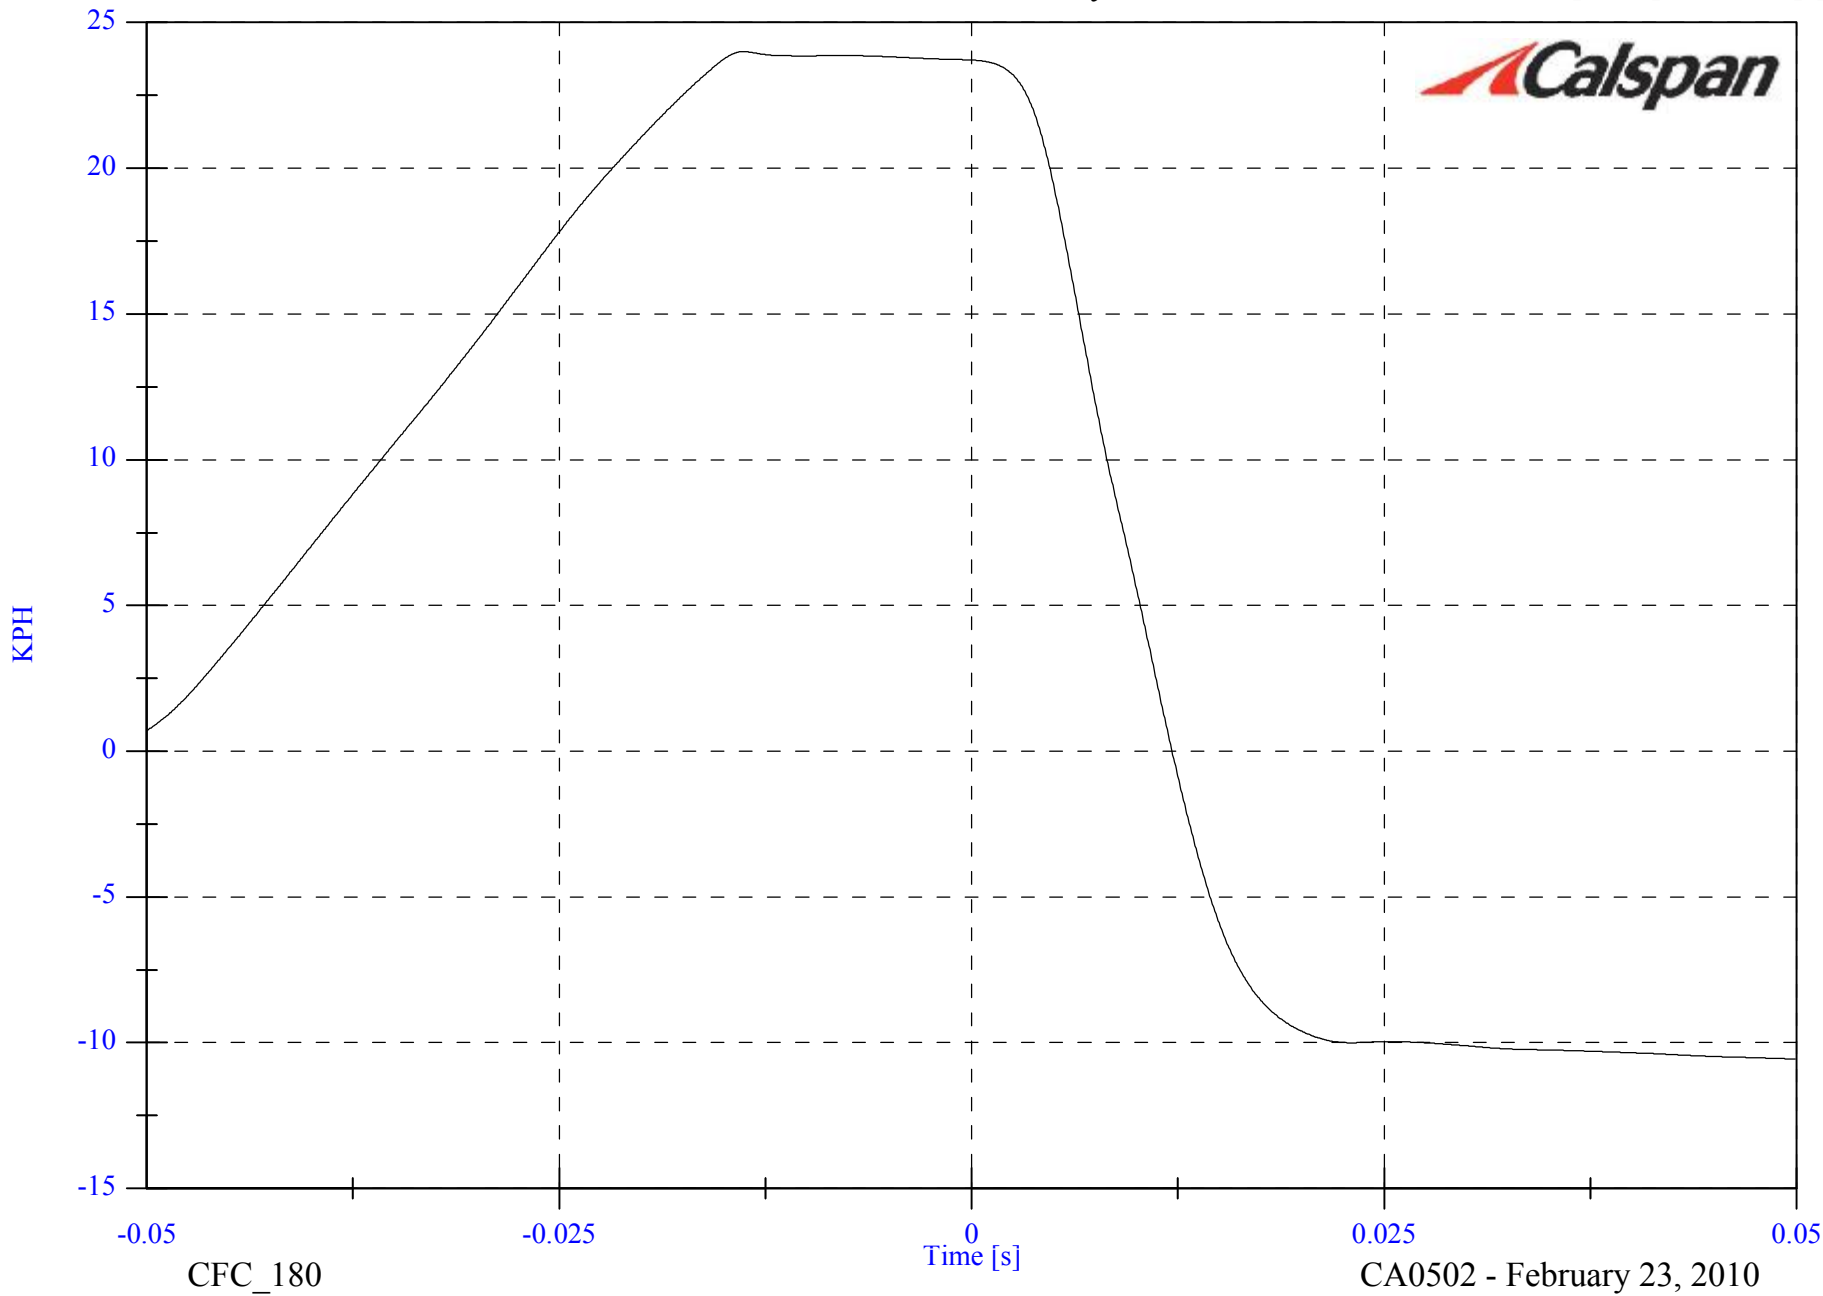
CA0502 PASSENGER SIDE URRSR IMPACT PLOT #5

Min: -10.6 [KPH] at 0.050 [s]

Headform Velocity

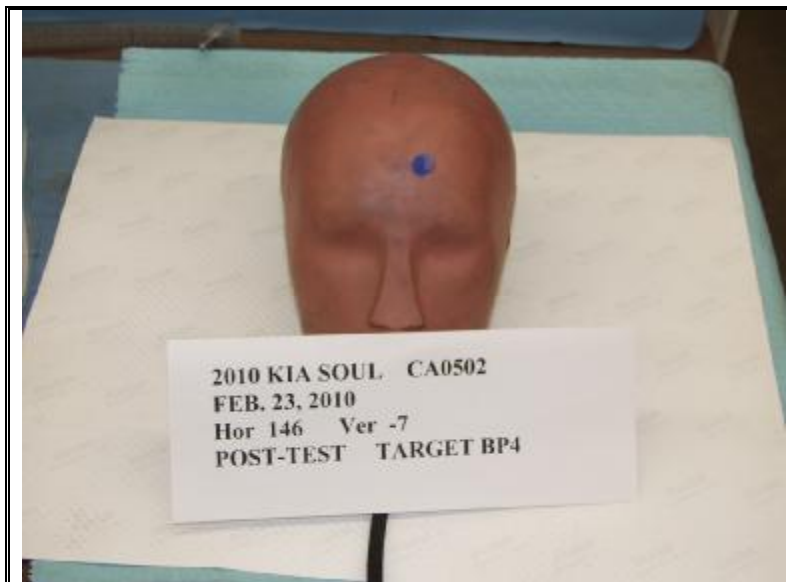
POST-IMPACT BP4 HEADFORM

Test Number:	05
Test Date:	02/23/10
Target Location:	B-PILLAR
Target Code:	BP4
Horizontal Impact Angle:	146
Vertical Impact Angle:	-7
Ambient Temperature:	20°C
Relative Humidity:	27
Time of Impact:	12:55
Headform Number:	1140

Impact Point Description (from lower midpoint on midsagittal line)					
On Centerline	14	<input type="checkbox"/>	mm right	<input checked="" type="checkbox"/>	mm left
On Centerline	19				mm up

Free Motion HIC	735.9
HIC(d)	721.6
Impact Velocity (kph)	23.48
HIC T1 (msec)	&S
HIC T2 (msec)	10.1
