REPORT NUMBER: 201U-CAL-10-04

**SAFETY COMPLIANCE TESTING FOR FMVSS 201
OCCUPANT PROTECTION IN INTERIOR IMPACT
UPPER INTERIOR HEAD IMPACT PROTECTION**

**KIA MOTORS CORPORATION
2010 KIA SOUL**

CALSPAN TEST NUMBER: CC2010-04

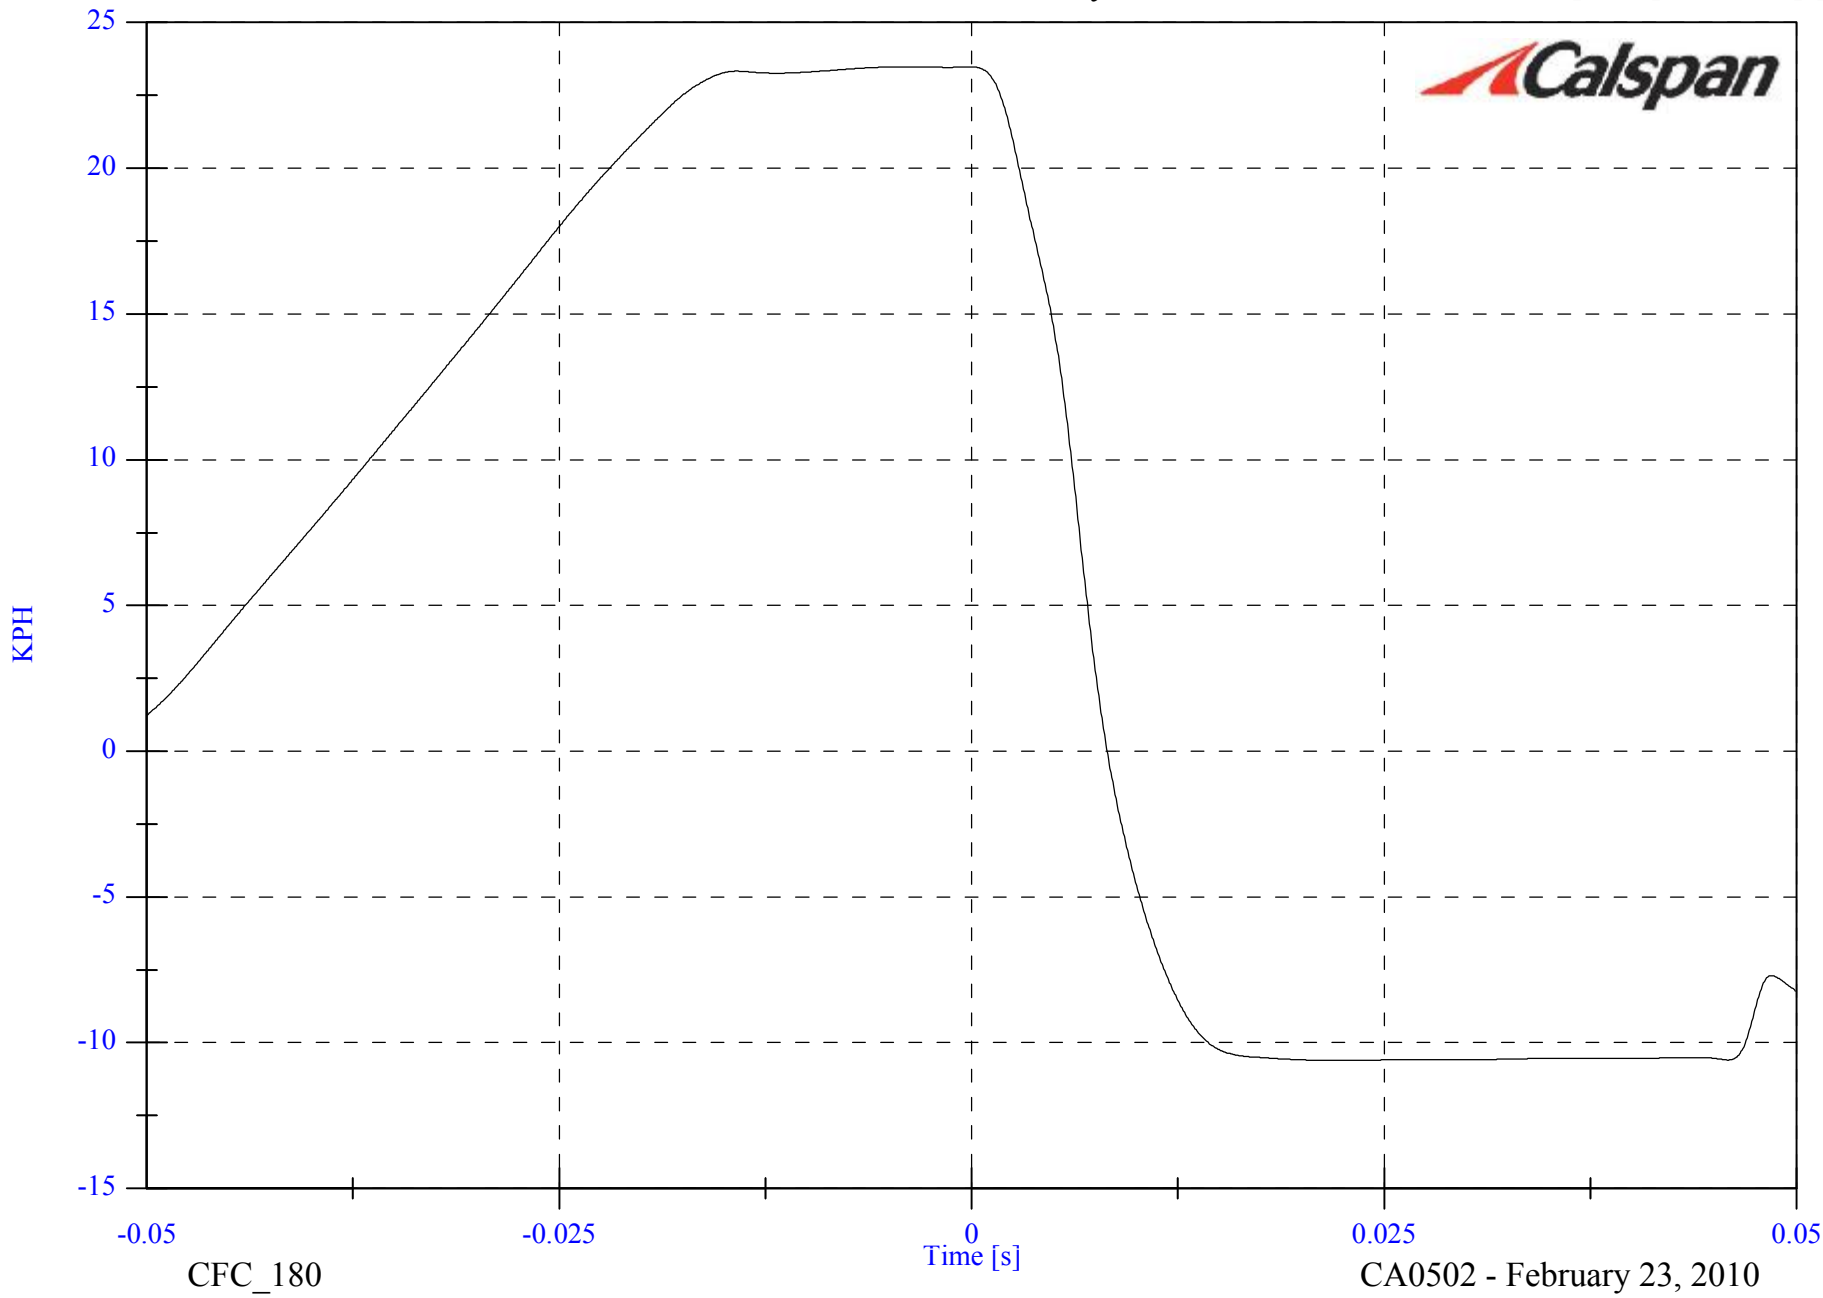
CA0502 PASSENGER SIDE BP4 IMPACT PLOT #5

Min: -10.6 [KPH] at 0.022 [s]

Headform Velocity

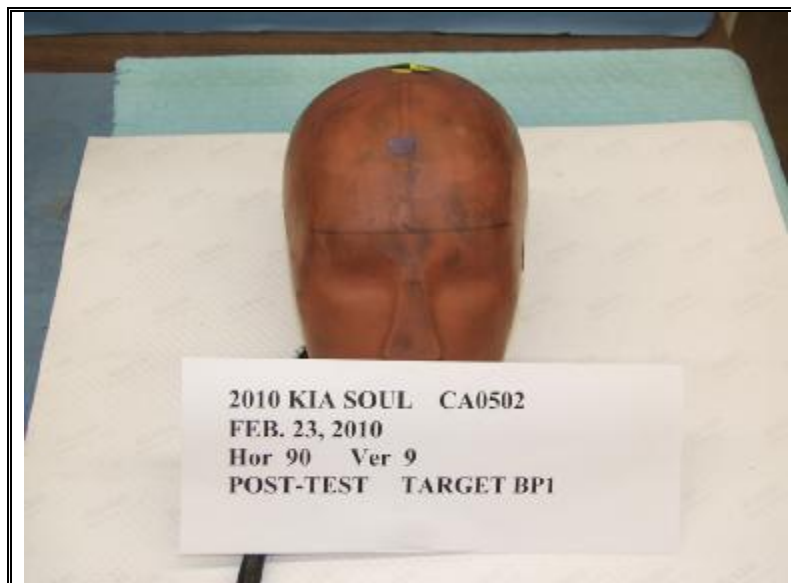
POST-IMPACT BP1 HEADFORM

Test Number:	06
Test Date:	02/23/10
Target Location:	B-PILLAR
Target Code:	BP1
Horizontal Impact Angle:	90
Vertical Impact Angle:	9
Ambient Temperature:	20°C
Relative Humidity:	27
Time of Impact:	13:50
Headform Number:	0062

Impact Point Description (from lower midpoint on midsagittal line)					
On Centerline	7	<input checked="" type="checkbox"/>	mm right	<input type="checkbox"/>	mm left
On Centerline	48				mm up

Free Motion HIC	28'.9
HIC(d)	380.6
Impact Velocity (kph)	18.76
HIC T1 (msec)	5.7
HIC T2 (msec)	14.2

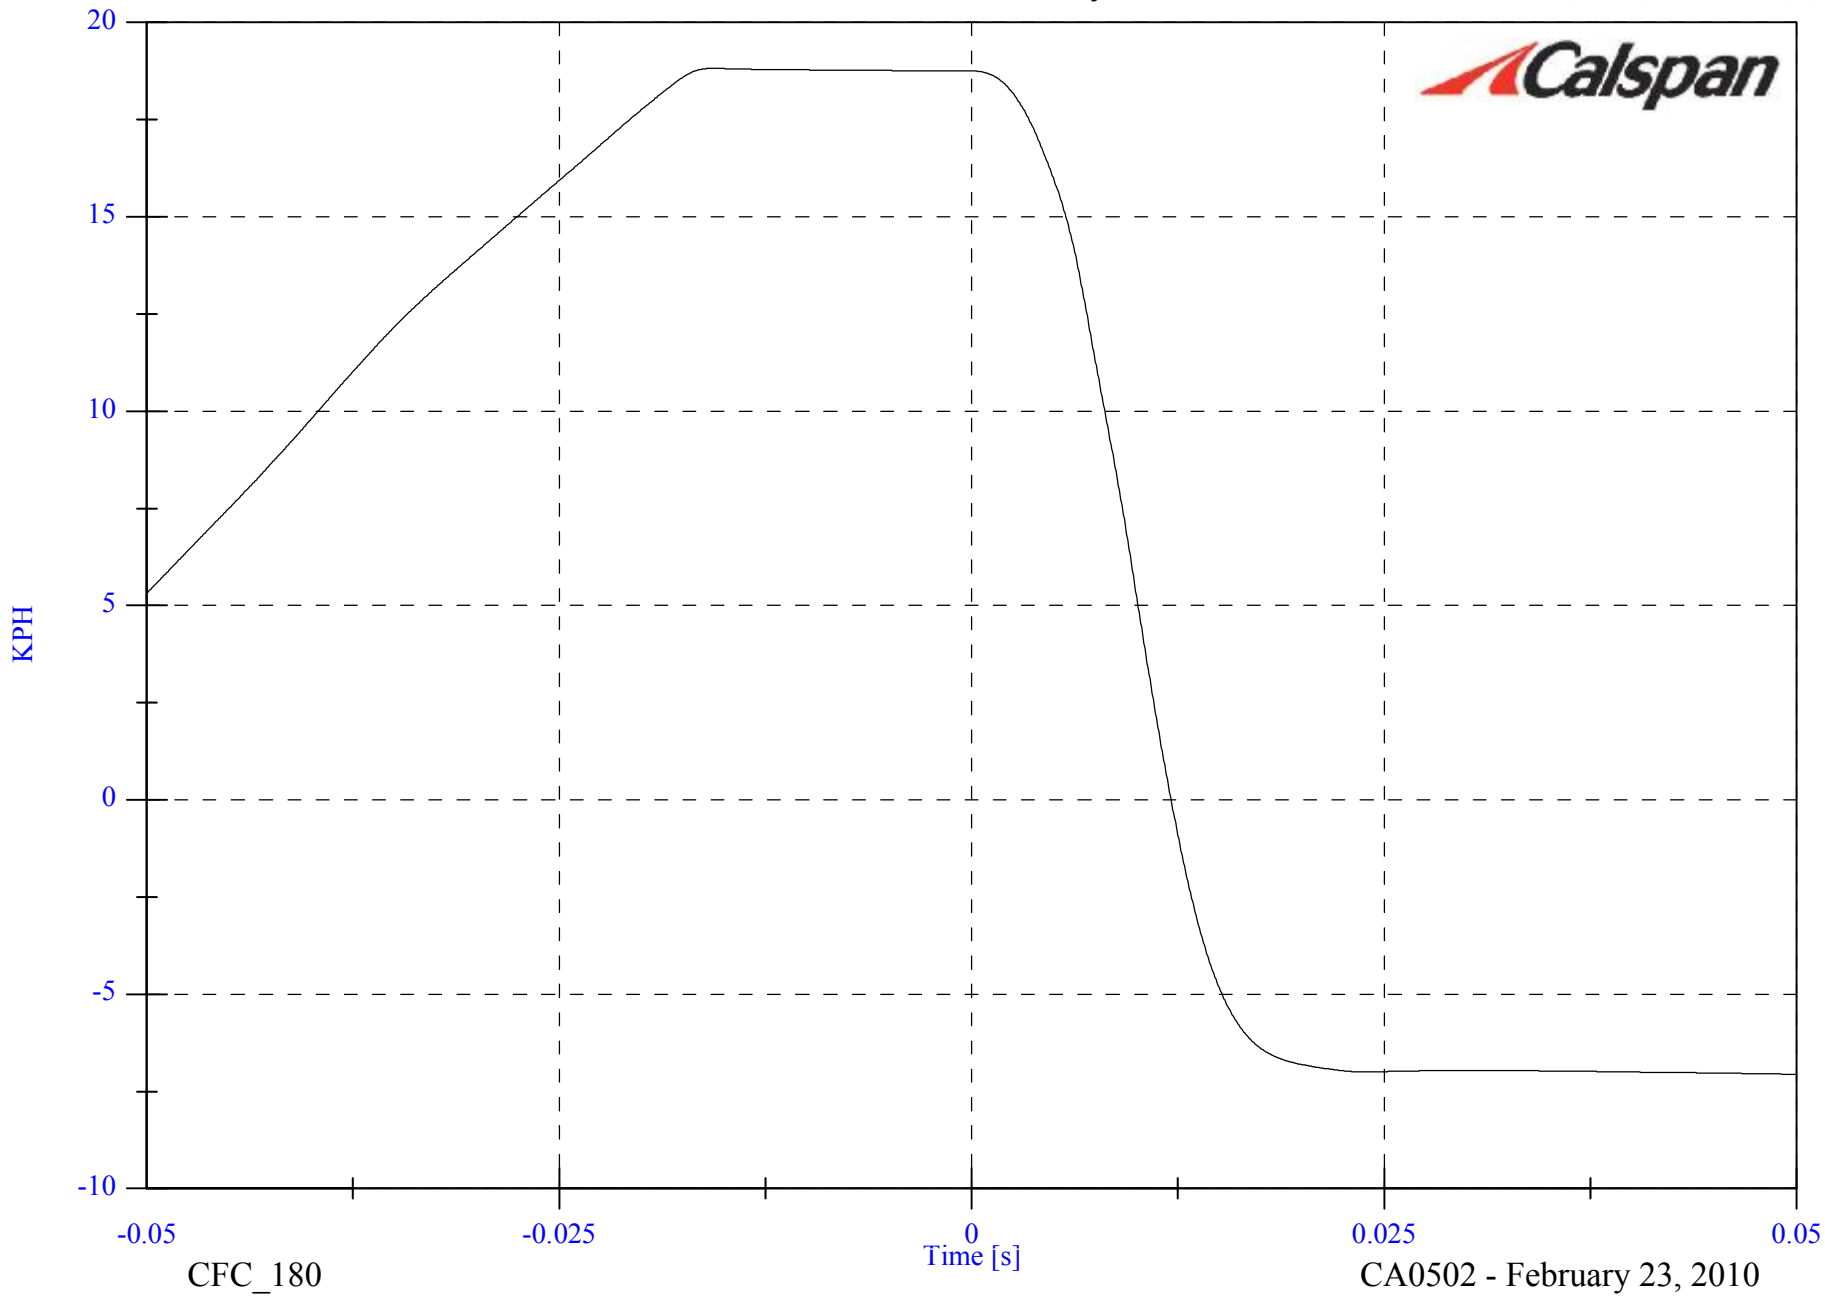
CA0502 PASSENGER SIDE BP1 IMPACT PLOT #5

Min: -7.1 [KPH] at 0.050 [s]

Headform Velocity

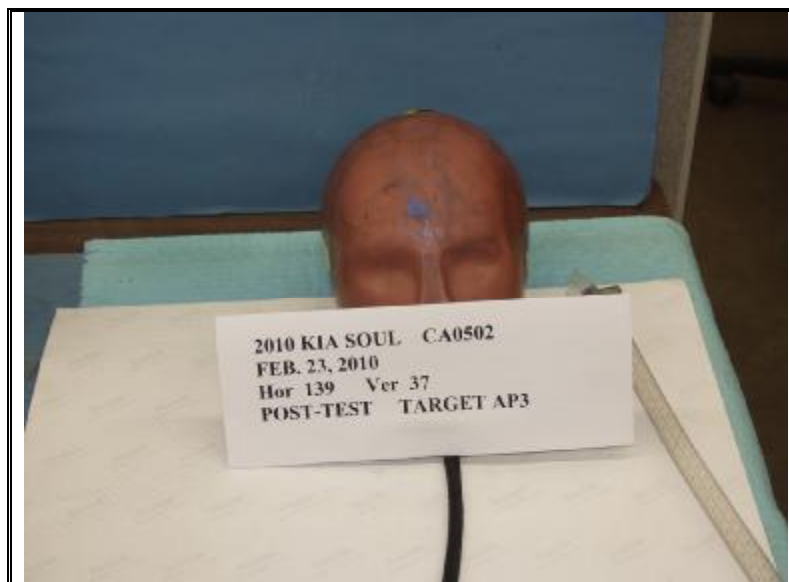
POST-IMPACT AP3 HEADFORM

Test Number:	07
Test Date:	02/23/10
Target Location:	A-PILLAR
Target Code:	AP3
Horizontal Impact Angle:	139
Vertical Impact Angle:	37
Ambient Temperature:	20°C
Relative Humidity:	27
Time of Impact:	14:30
Headform Number:	805

Impact Point Description (from lower midpoint on midsagittal line)					
On Centerline	6	<input checked="" type="checkbox"/>	mm right	<input type="checkbox"/>	mm left
On Centerline	6				mm up

Free Motion HIC	273.5
HIC(d)	372.8
Impact Velocity (kph)	18.83
HIC T1 (msec)	1.,
HIC T2 (msec)	14.0

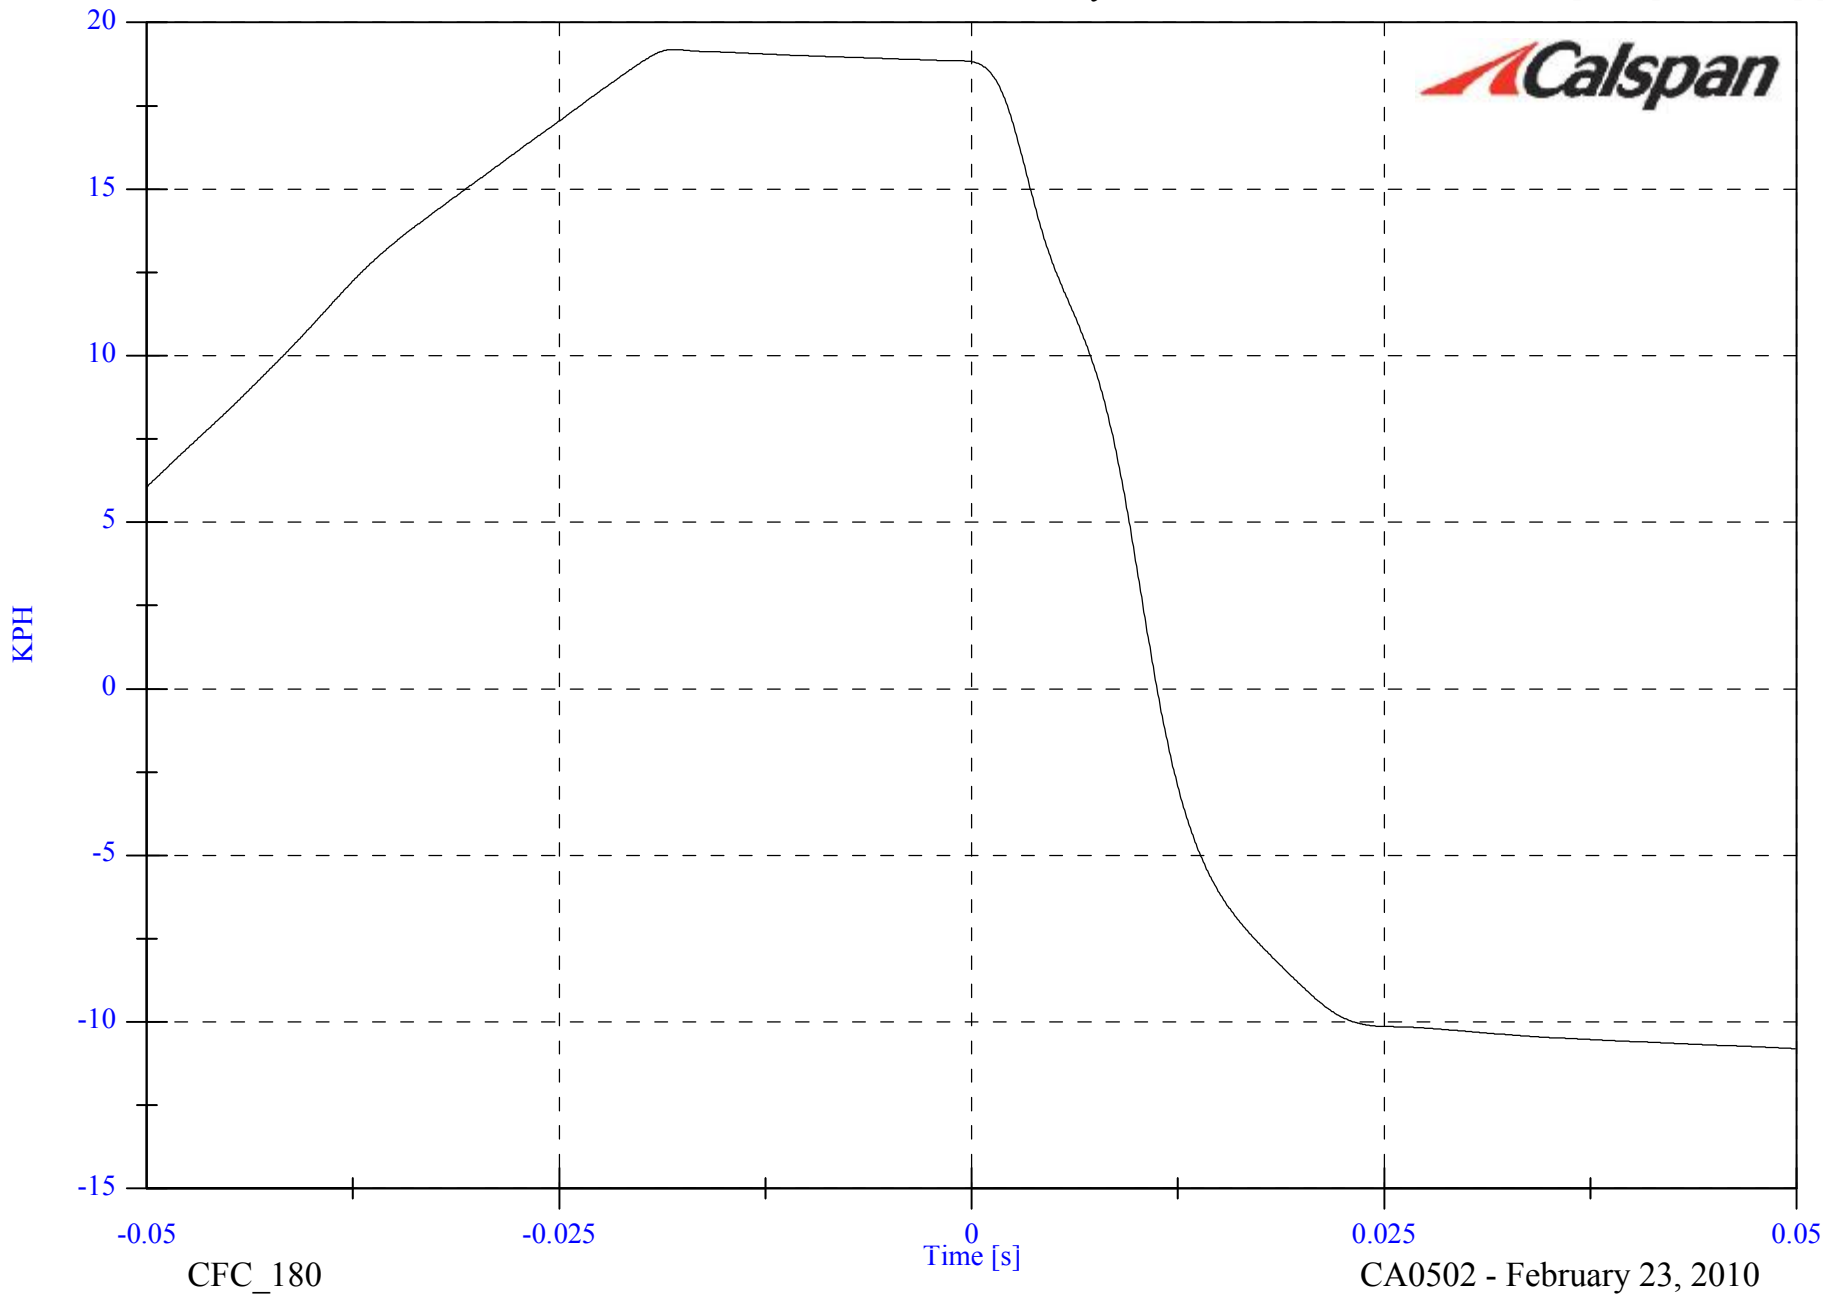
CA0502 PASSENGER SIDE AP3 IMPACT PLOT #5

Min: -10.8 [KPH] at 0.050 [s]

Headform Velocity

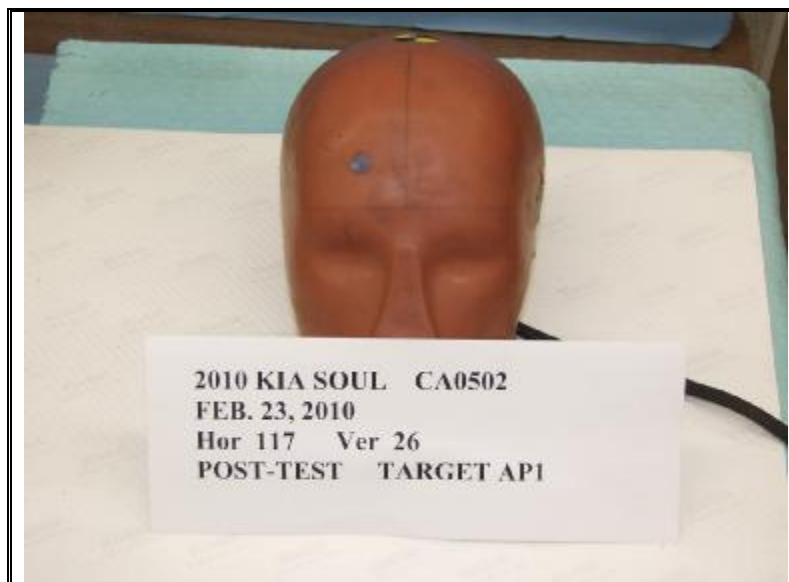
POST-IMPACT AP1 HEADFORM

Test Number:	08
Test Date:	02/23/10
Target Location:	A-PILLAR
Target Code:	AP1
Horizontal Impact Angle:	117
Vertical Impact Angle:	26
Ambient Temperature:	20°C
Relative Humidity:	27
Time of Impact:	15:00
Headform Number:	0355

Impact Point Description (from lower midpoint on midsagittal line)					
On Centerline	24	X	mm right		mm left
On Centerline	22				mm up

Free Motion HIC	244.5
HIC(d)	350.9
Impact Velocity (kph)	18.31
HIC T1 (msec)	1
HIC T2 (msec)	13.3

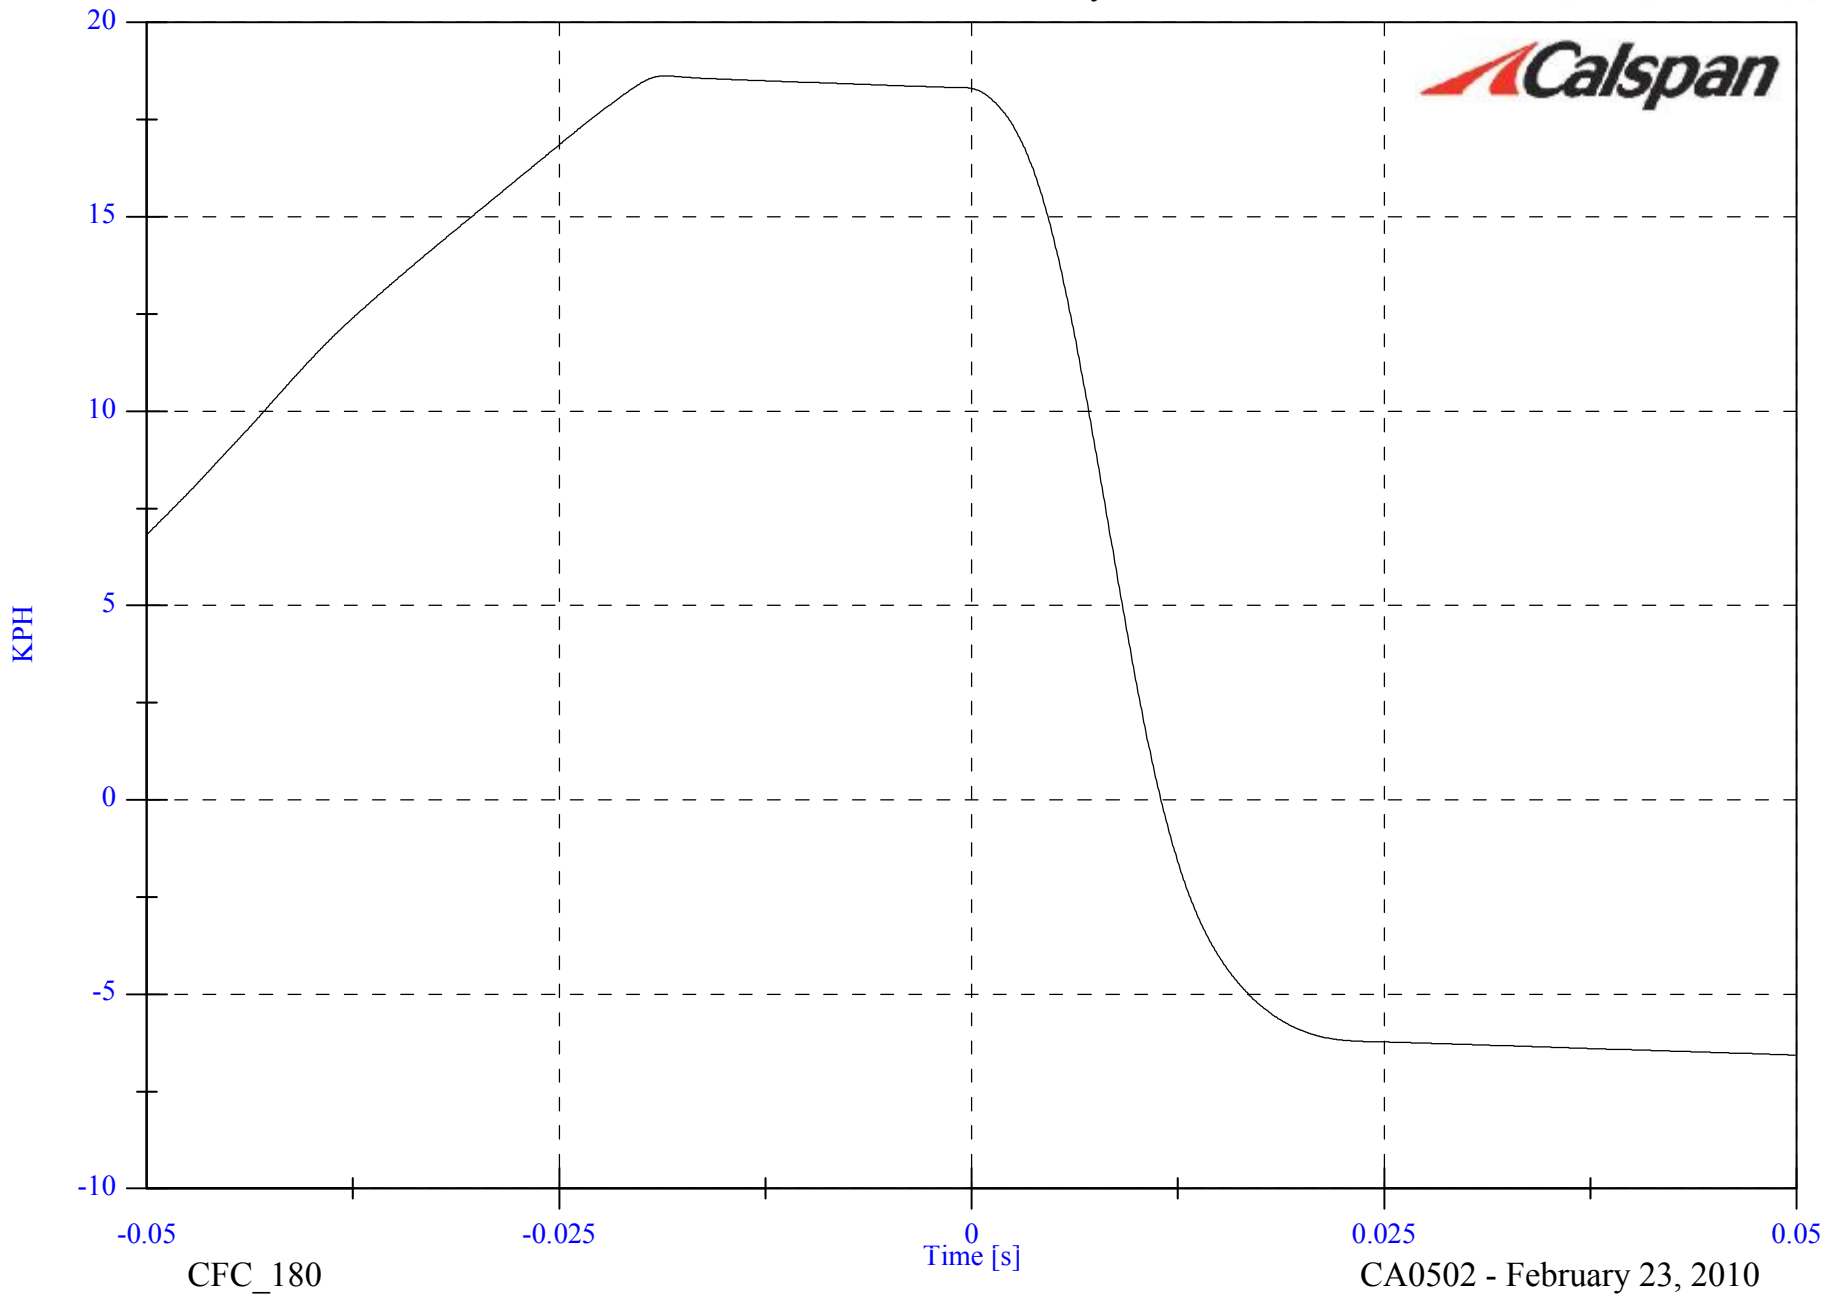
CA0502 PASSENGER SIDE AP1 IMPACT PLOT #5

Min: -6.6 [KPH] at 0.050 [s]

Headform Velocity

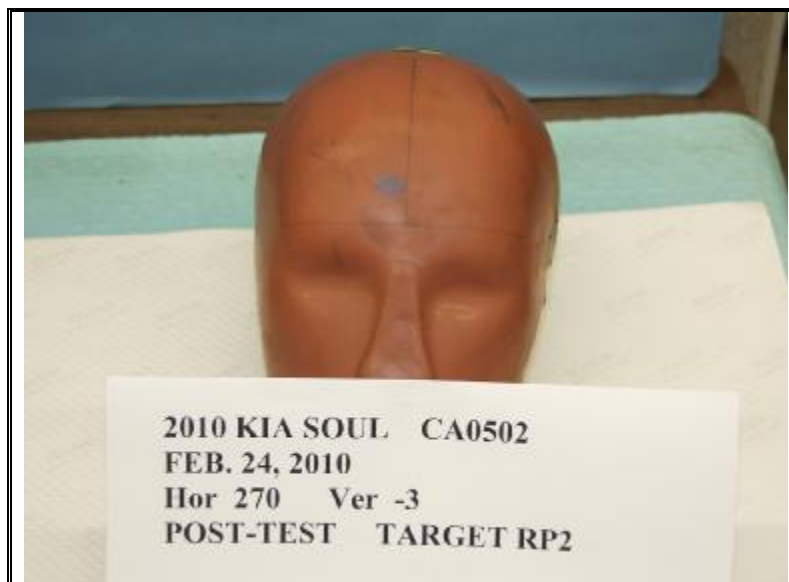
POST-IMPACT RP2 HEADFORM

Test Number:	09
Test Date:	02/24/10
Target Location:	REAR PILLAR
Target Code:	RP2
Horizontal Impact Angle:	270
Vertical Impact Angle:	-3
Ambient Temperature:	20°C
Relative Humidity:	24
Time of Impact:	9:15
Headform Number:	355

Impact Point Description (from lower midpoint on midsagittal line)					
On Centerline	8	<input checked="" type="checkbox"/>	mm right	<input type="checkbox"/>	mm left
On Centerline	15				mm up

Free Motion HIC	388.2
HIC(d)	459.2
Impact Velocity (kph)	23.62
HIC T1 (msec)	0.8
HIC T2 (msec)	13.3

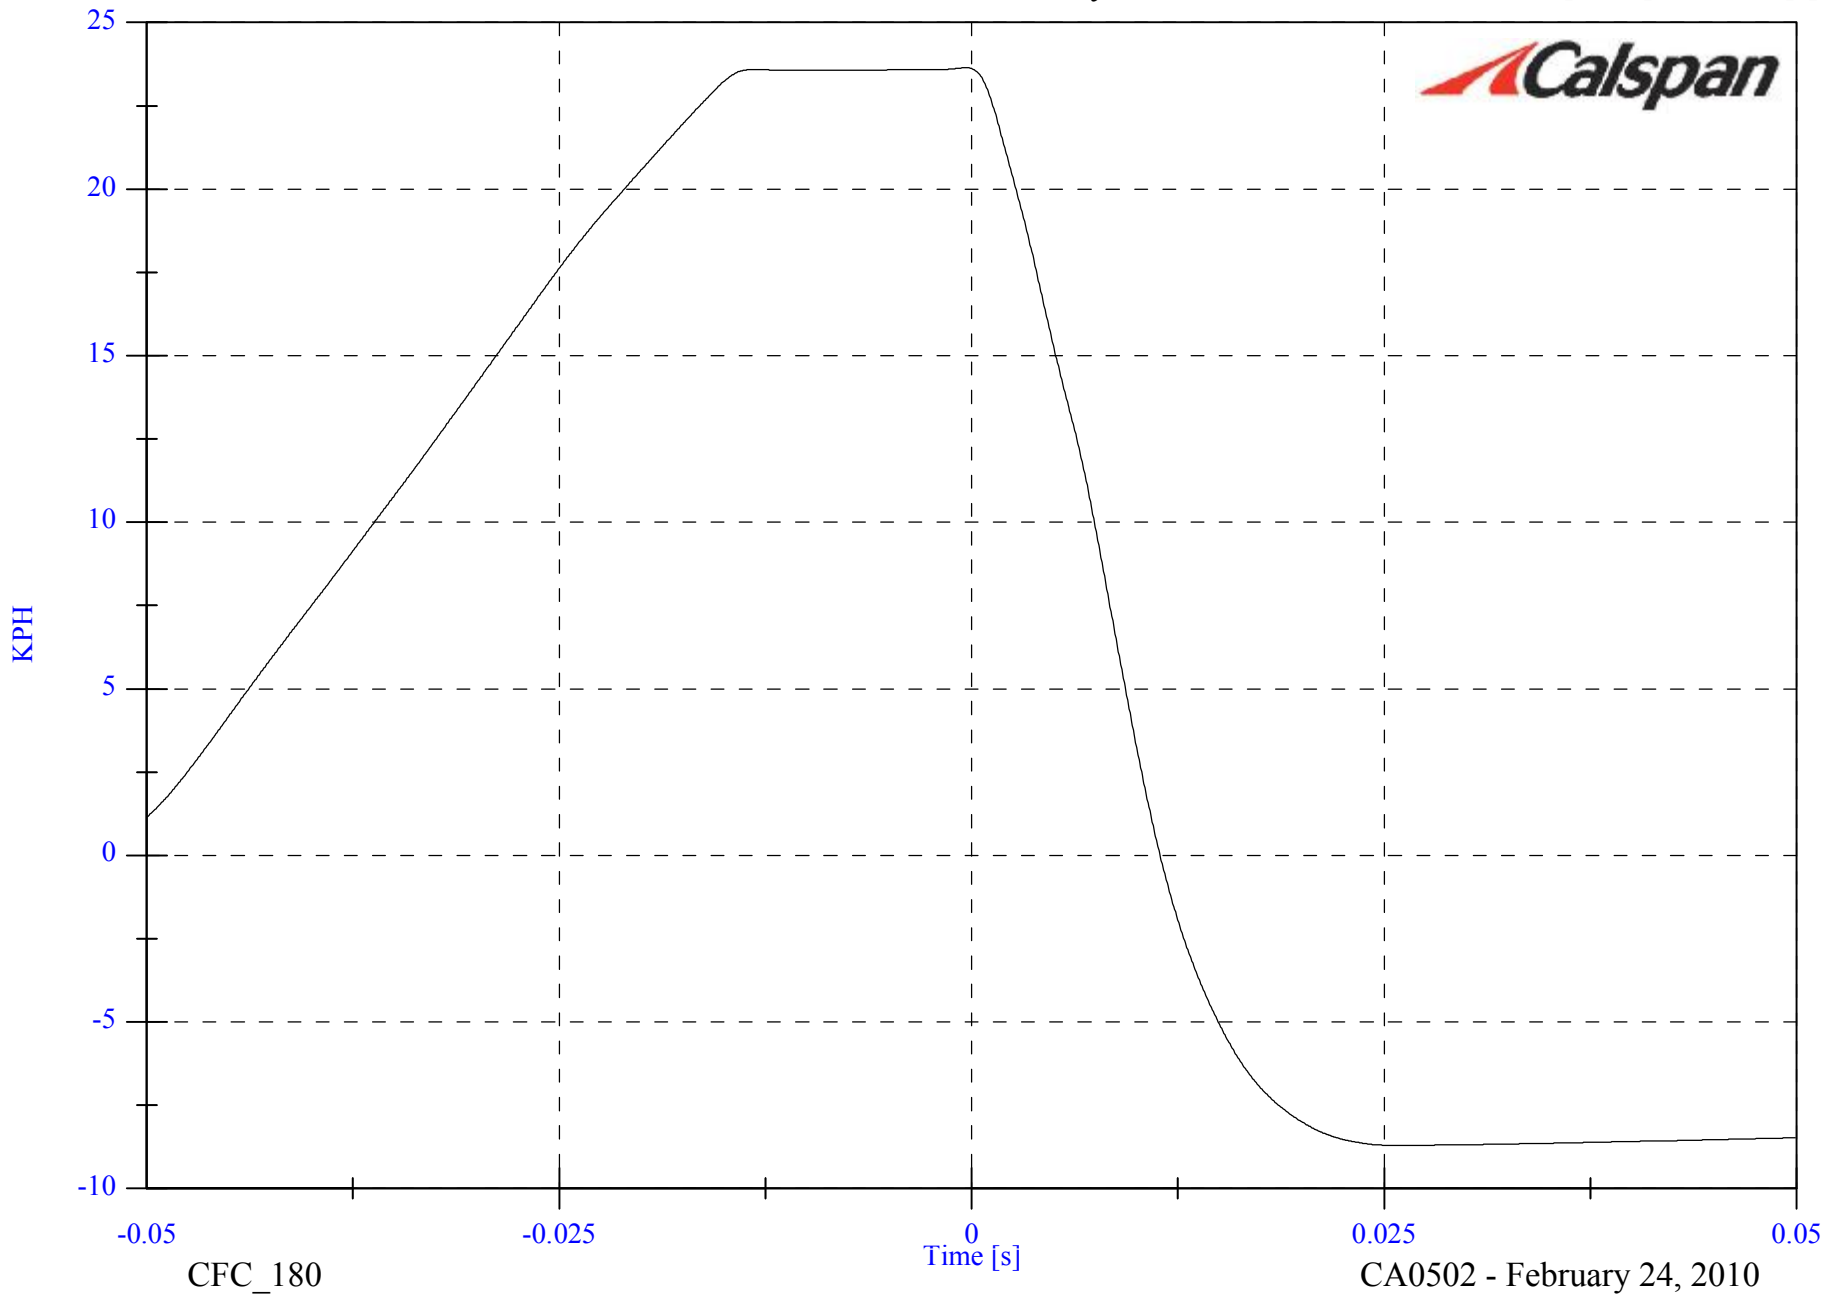
CA0502 DRIVER SIDE RP2 IMPACT PLOT #5

Min: -8.7 [KPH] at 0.026 [s]

Headform Velocity

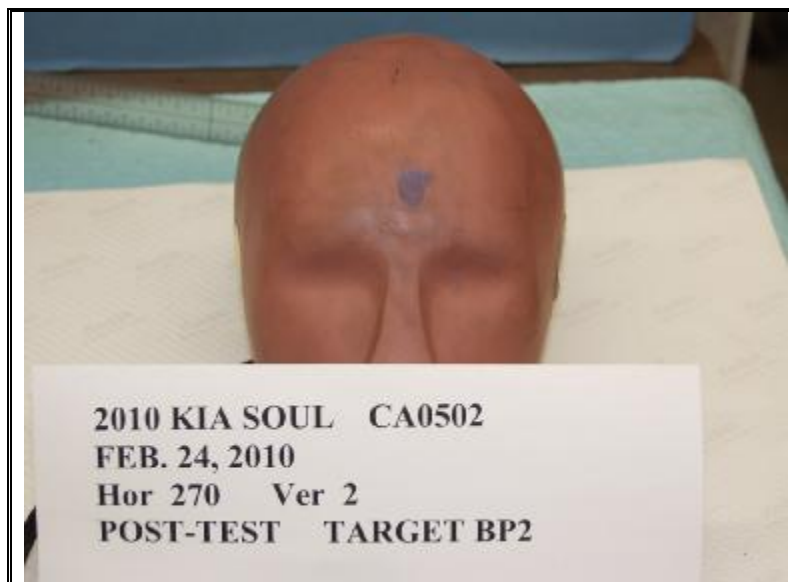
POST-IMPACT BP2 HEADFORM

Test Number:	10
Test Date:	02/24/10
Target Location:	B-PILLAR
Target Code:	BP2
Horizontal Impact Angle:	270
Vertical Impact Angle:	2
Ambient Temperature:	20°C
Relative Humidity:	24
Time of Impact:	10:00
Headform Number:	1140

Impact Point Description (from lower midpoint on midsagittal line)					
On Centerline	5	<input type="checkbox"/>	mm right	<input checked="" type="checkbox"/>	mm left
On Centerline	8				mm up

Free Motion HIC	381.7
HIC(d)	454.4
Impact Velocity (kph)	23.55
HIC T1 (msec)	1.4
HIC T2 (msec)	13.%

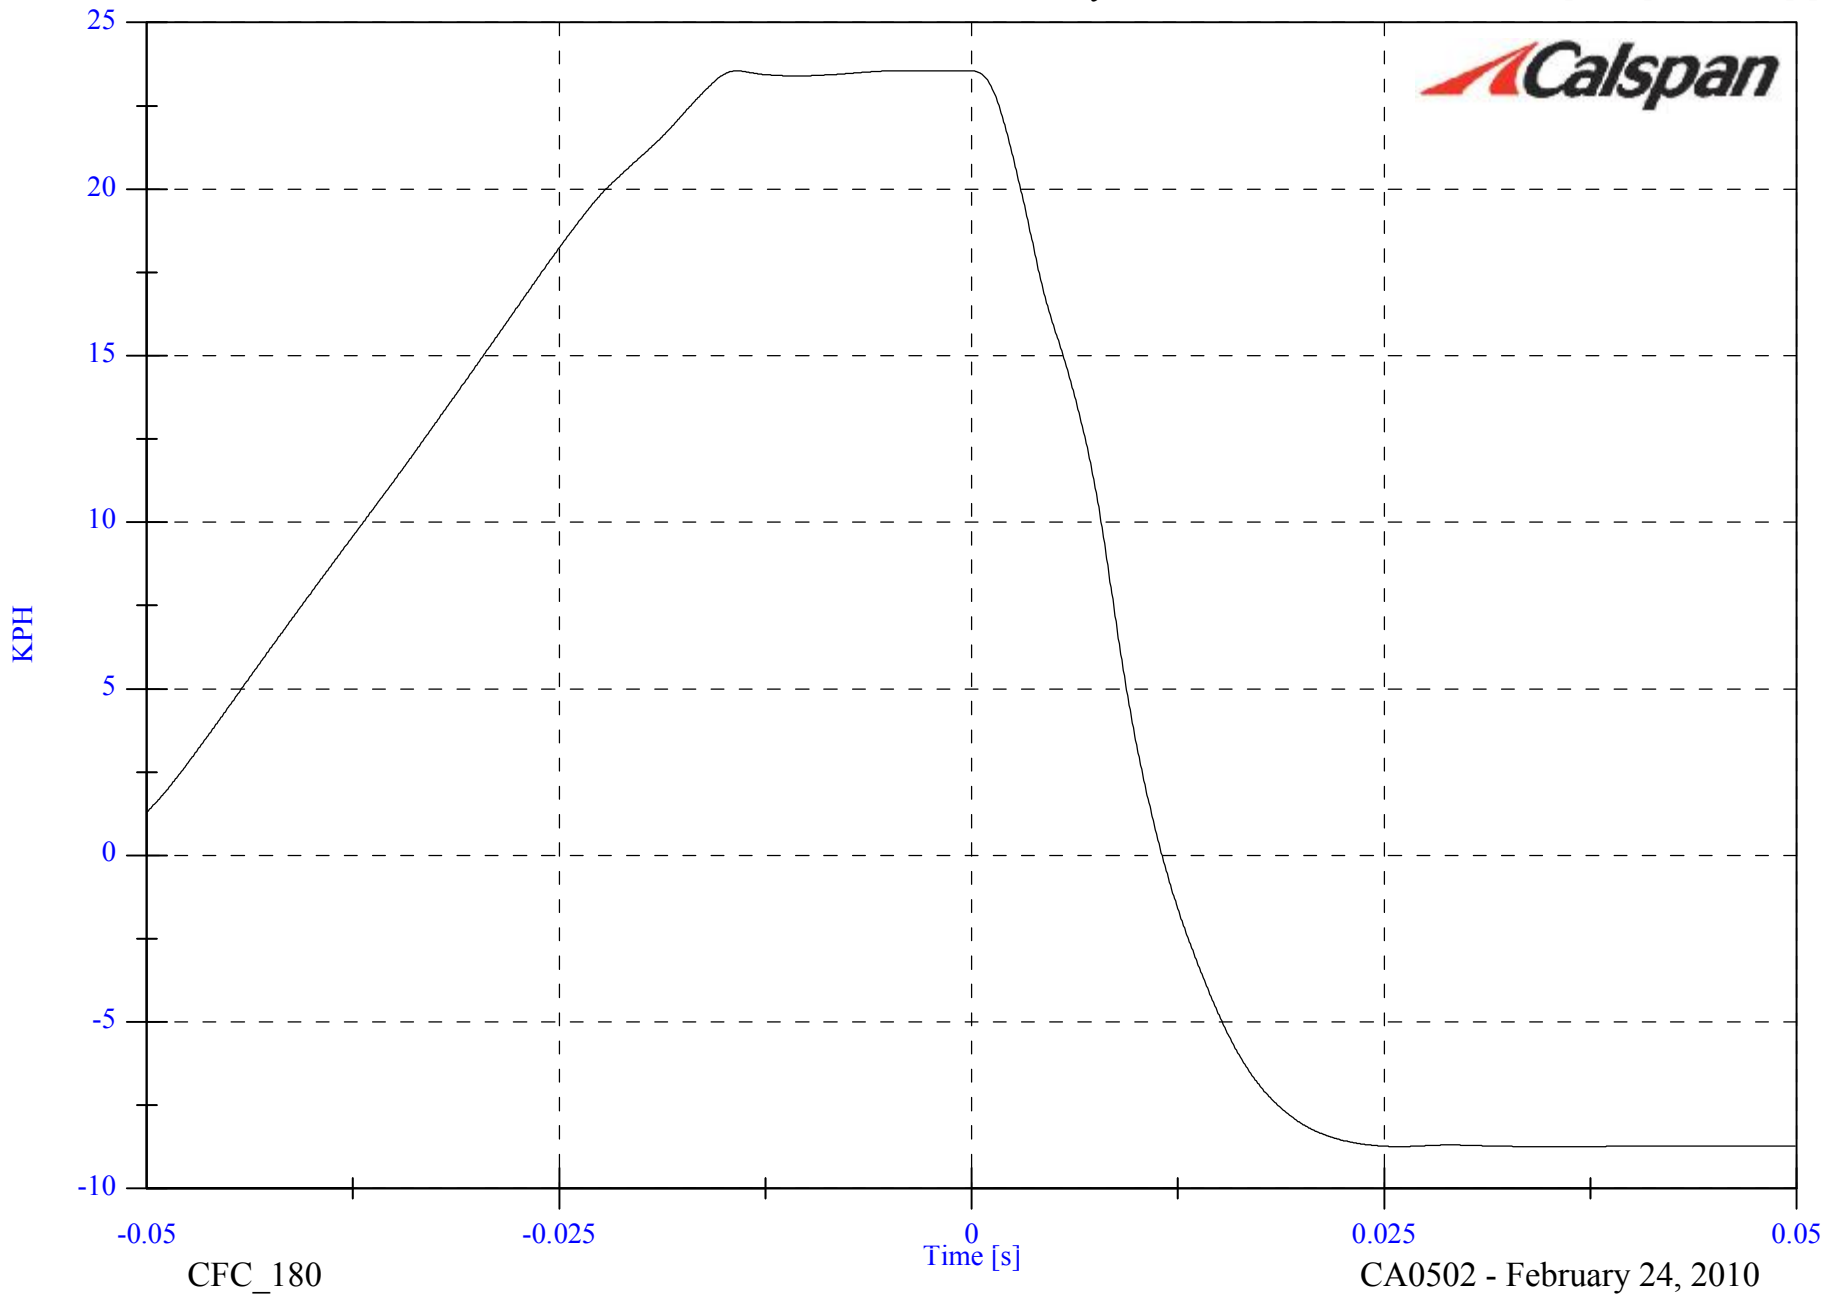
CA0502 DRIVER SIDE BP2 IMPACT PLOT #5

FMVSS 201U 2010 KIA SOUL

Max: 23.6 [KPH] at -0.004 [s]

Headform Velocity

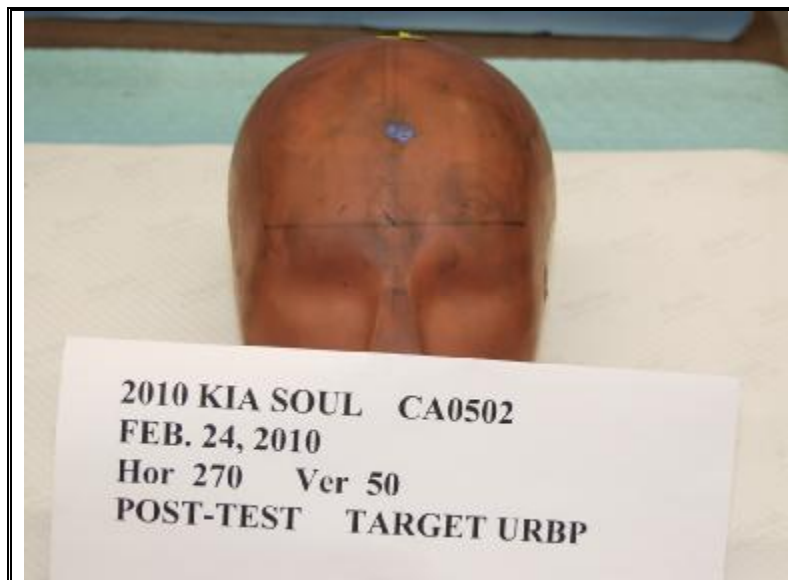
POST-IMPACT URBPHEADFORM

Test Number:	11
Test Date:	02/24/10
Target Location:	UPPER ROOF
Target Code:	URBP
Horizontal Impact Angle:	270
Vertical Impact Angle:	50
Ambient Temperature:	20°C
Relative Humidity:	24
Time of Impact:	10:50
Headform Number:	62

Impact Point Description (from lower midpoint on midsagittal line)					
On Centerline	0	<input type="checkbox"/>	mm right	<input type="checkbox"/>	mm left
On Centerline	39				mm up

Free Motion HIC	445.8
HIC(d)	502.7
Impact Velocity (kph)	23.83
HIC T1 (msec)	4.%
HIC T2 (msec)	13.7

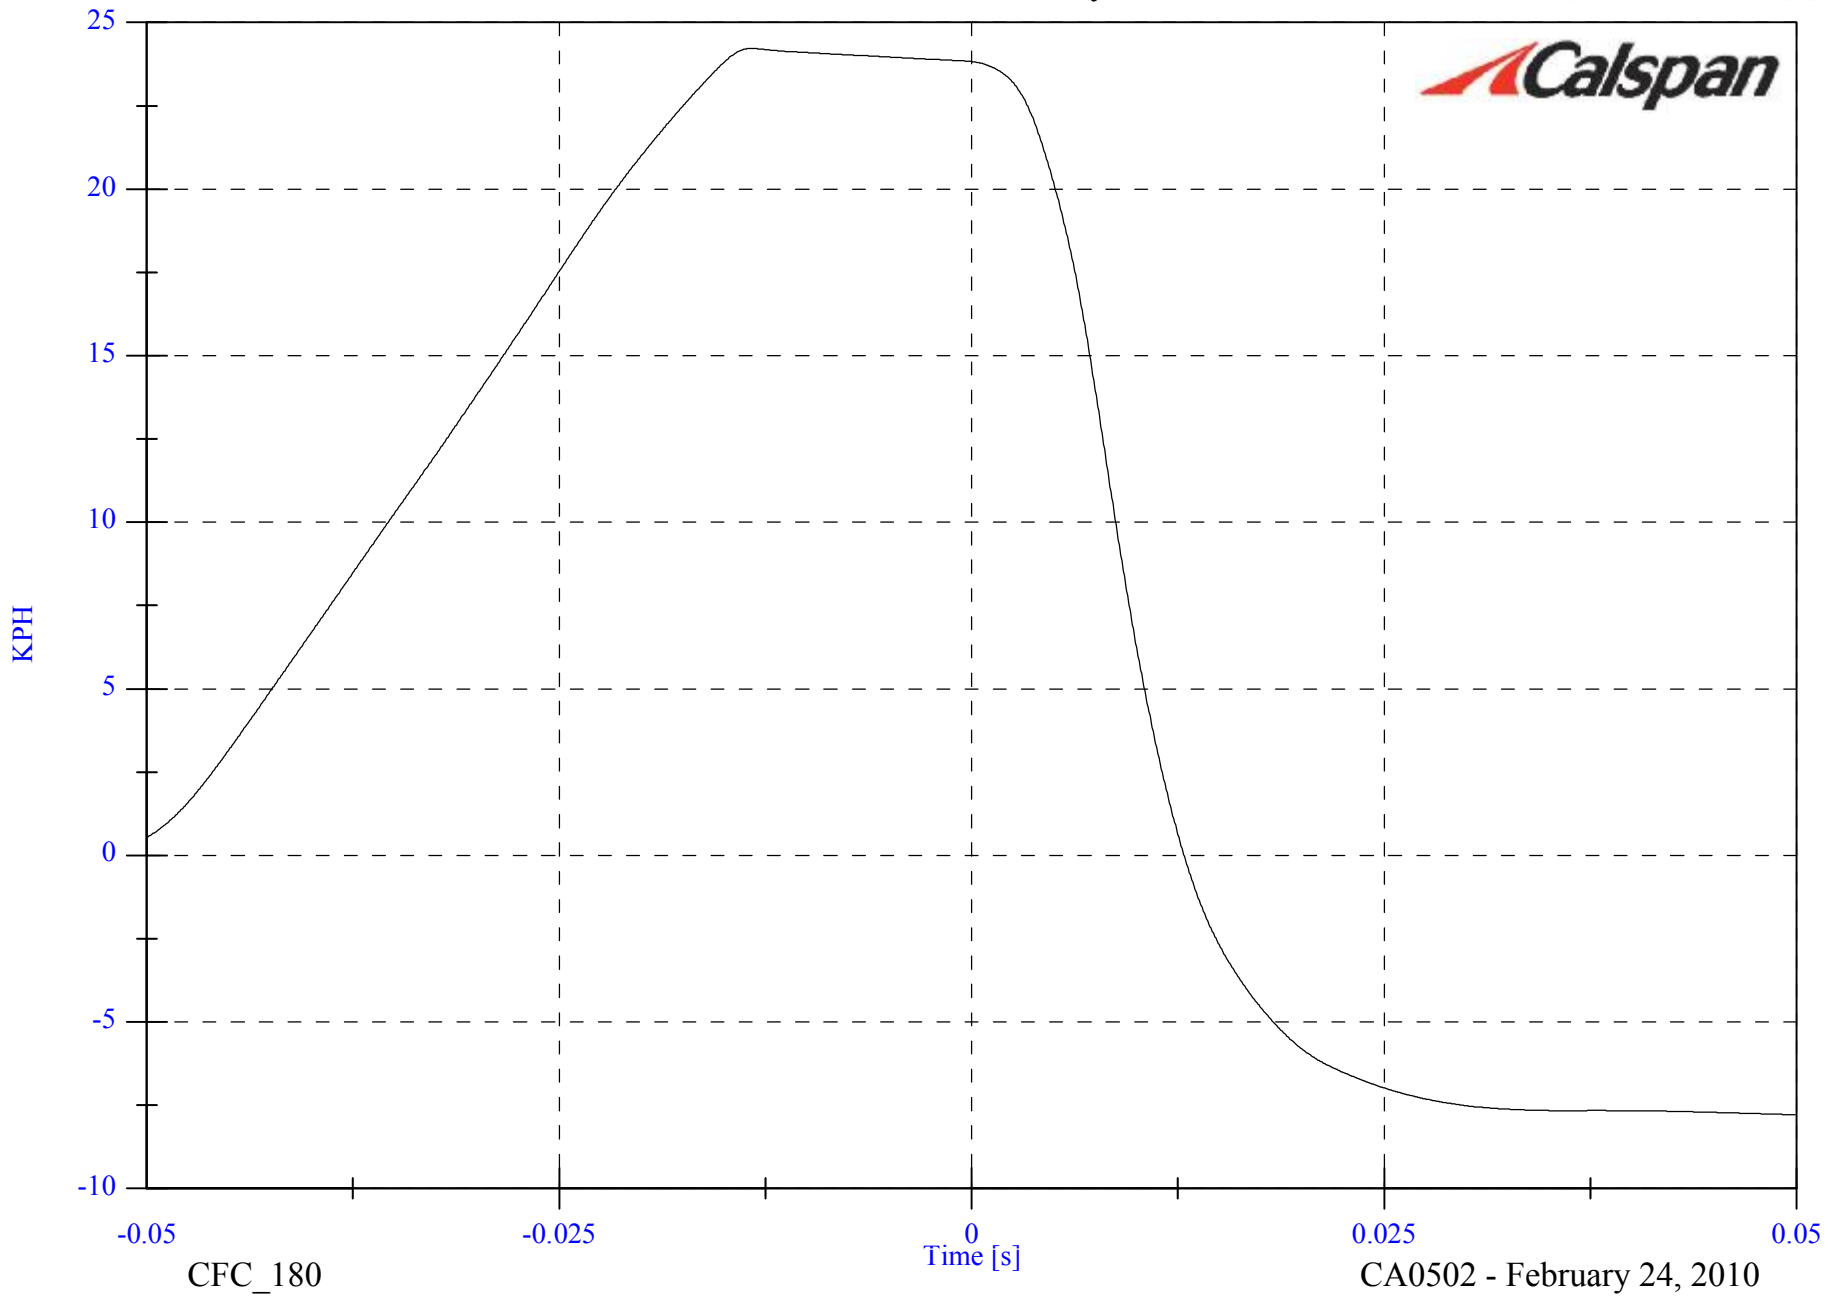
CA0502 DRIVER SIDE URBP IMPACT PLOT #5

FMVSS 201U 2010 KIA SOUL

Max: 24.2 [KPH] at -0.013 [s]

Headform Velocity

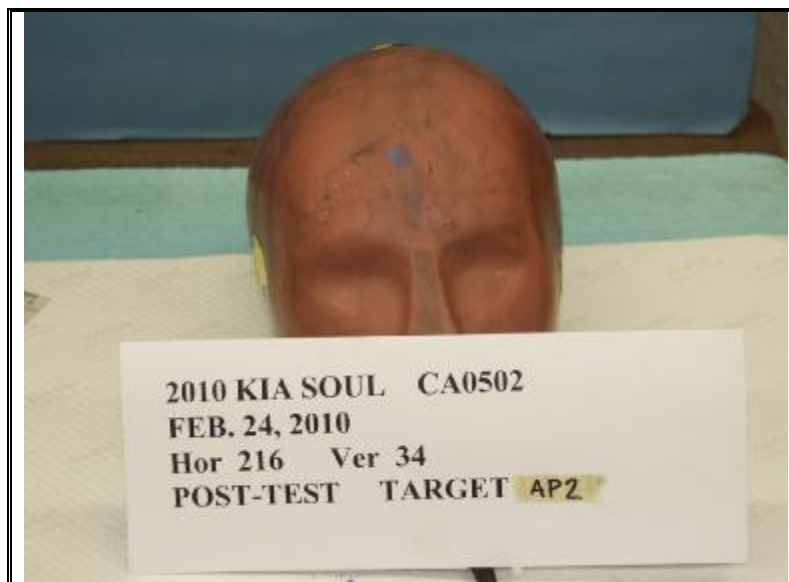
POST-IMPACT AP2 HEADFORM

Test Number:	12
Test Date:	02/24/10
Target Location:	A-PILLAR
Target Code:	AP2
Horizontal Impact Angle:	216
Vertical Impact Angle:	34
Ambient Temperature:	20°C
Relative Humidity:	24
Time of Impact:	11:15
Headform Number:	0805

Impact Point Description (from lower midpoint on midsagittal line)					
On Centerline	6	<input checked="" type="checkbox"/>	mm right	<input type="checkbox"/>	mm left
On Centerline	18				mm up

Free Motion HIC	194.1
HIC(d)	312.9
Impact Velocity (kph)	18.75
HIC T1 (msec)	1.)
HIC T2 (msec)	15.8
