REPORT NUMBER: 201U-CAL-10-04

**SAFETY COMPLIANCE TESTING FOR FMVSS 201
OCCUPANT PROTECTION IN INTERIOR IMPACT
UPPER INTERIOR HEAD IMPACT PROTECTION**

**KIA MOTORS CORPORATION
2010 KIA SOUL**

CALSPAN TEST NUMBER: CC2010-04

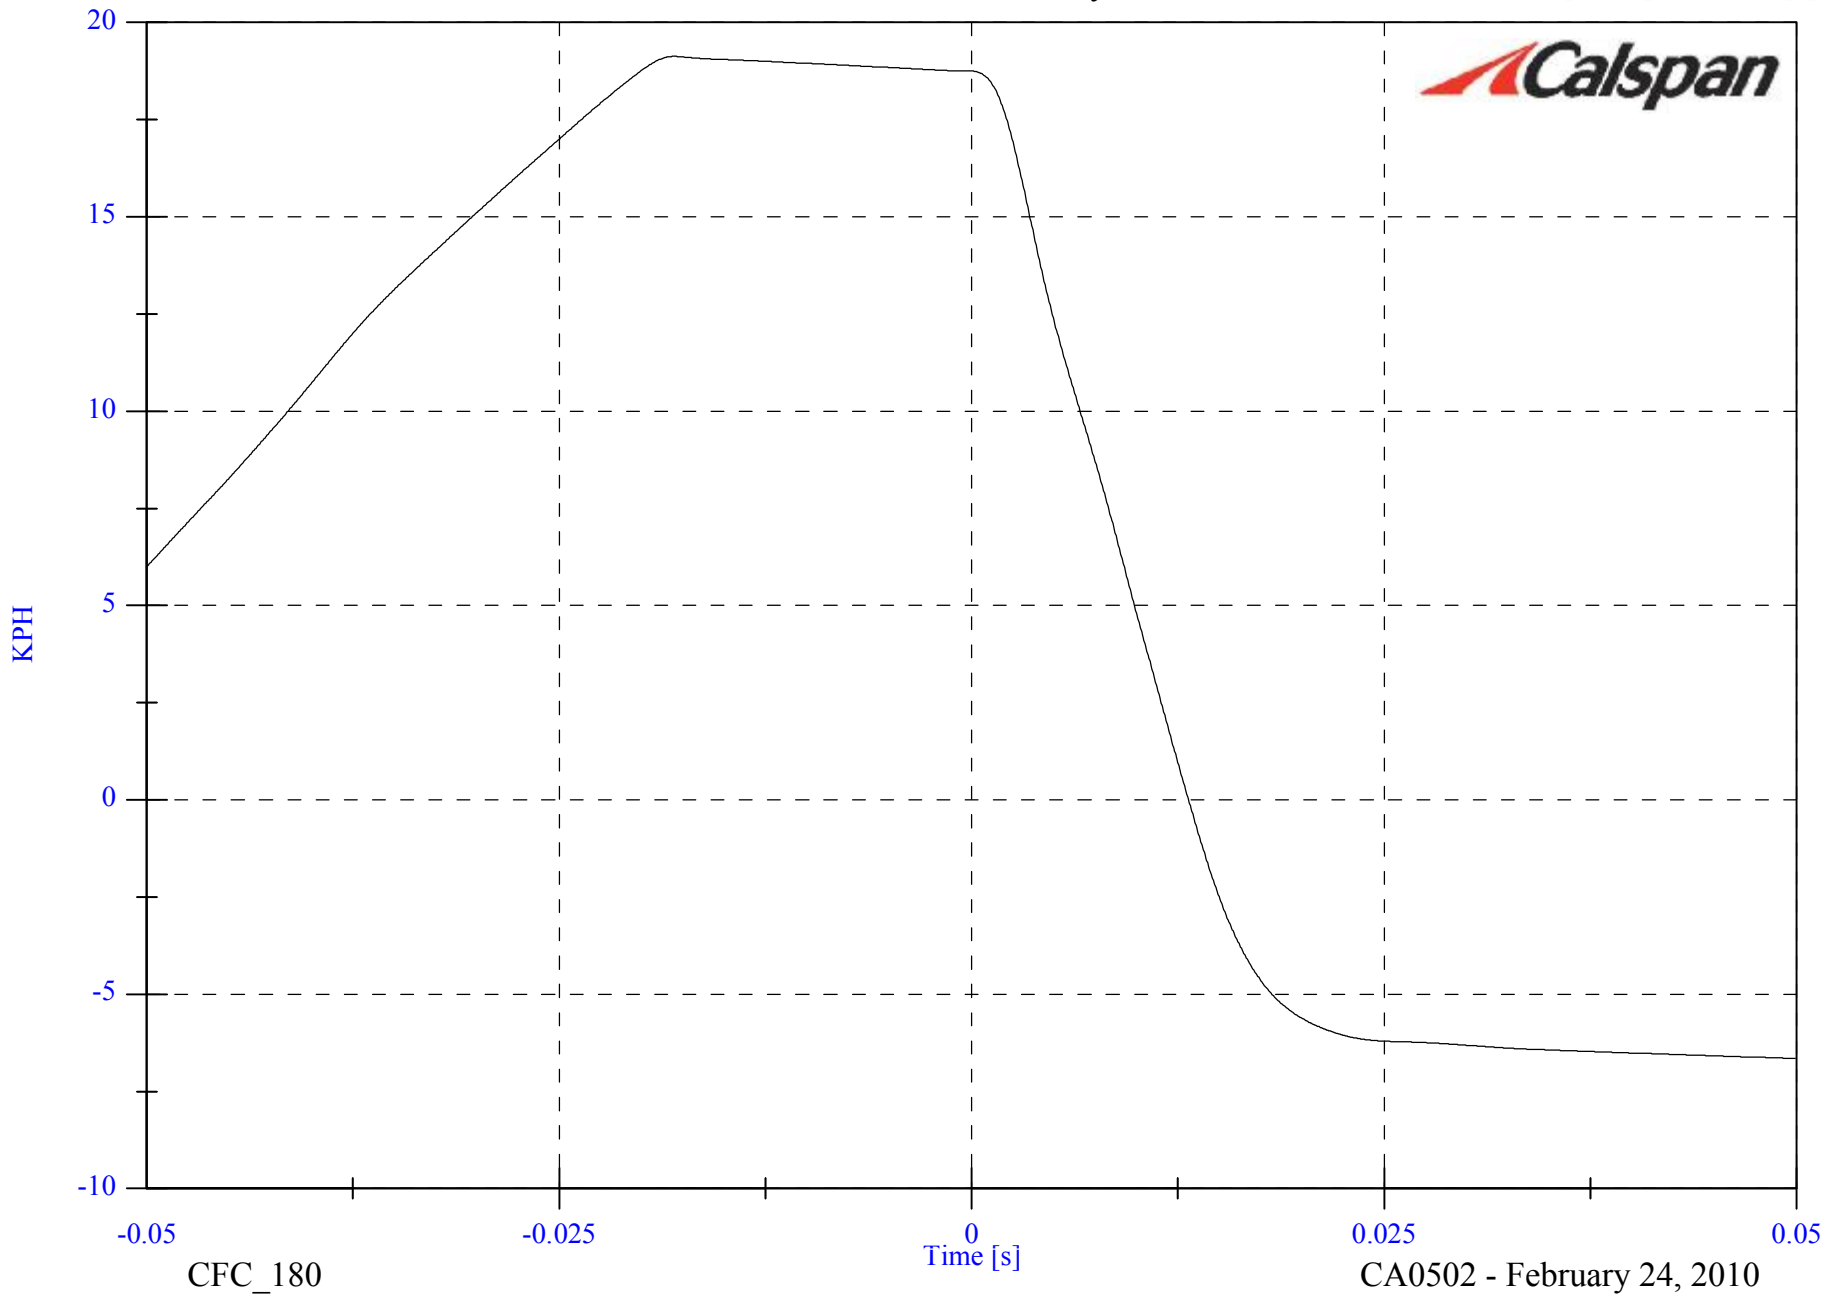
CA0502 DRIVER SIDE AP2 IMPACT PLOT #5

Headform Velocity

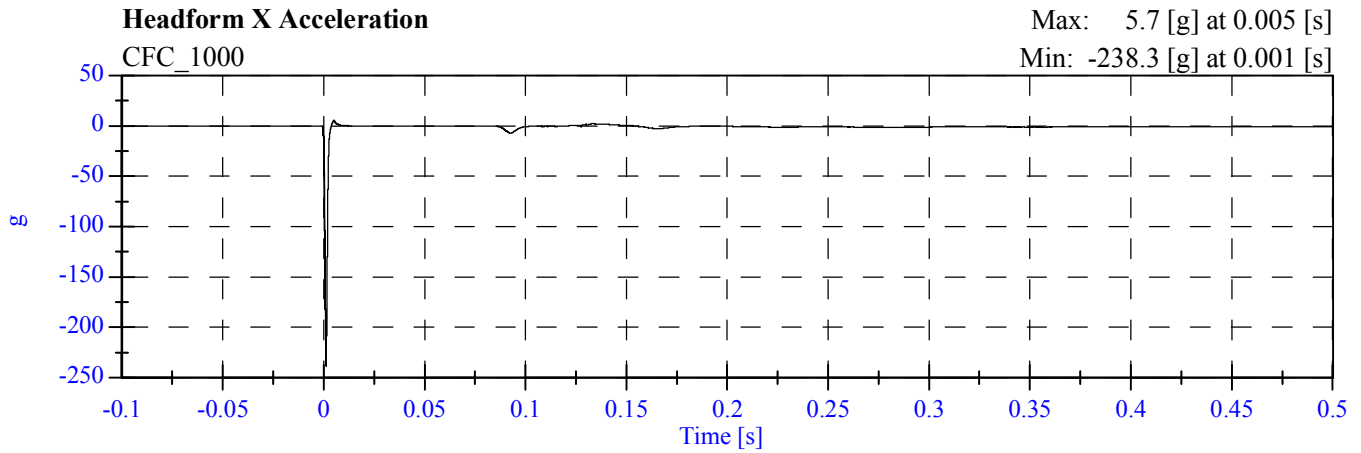
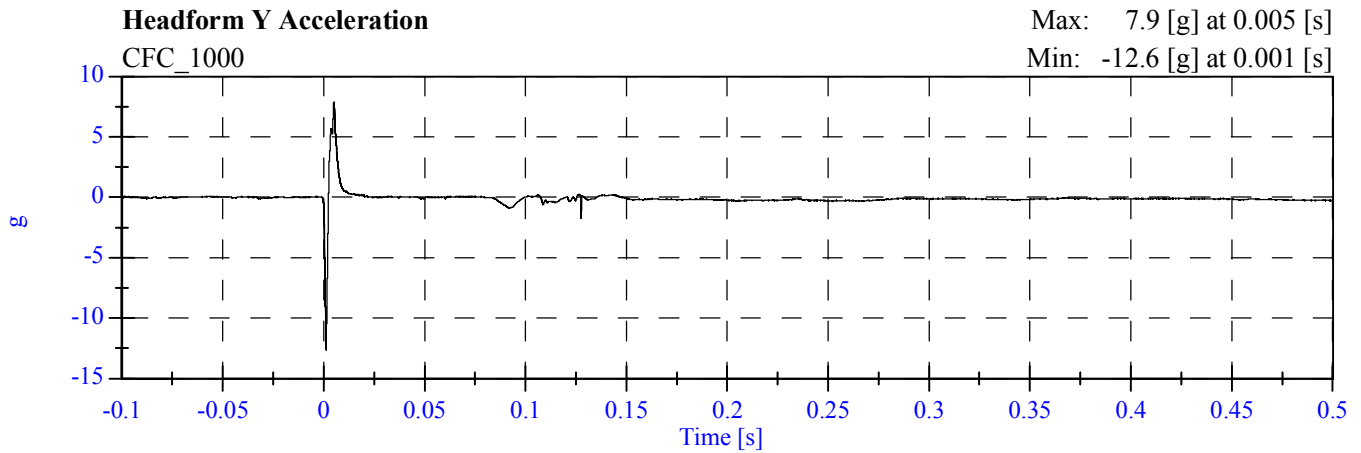
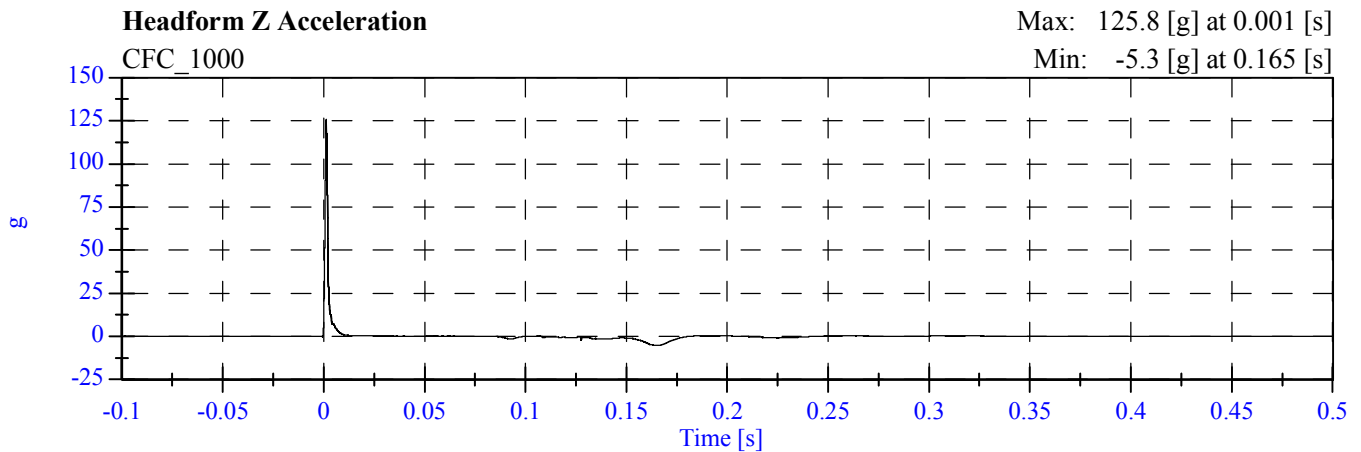
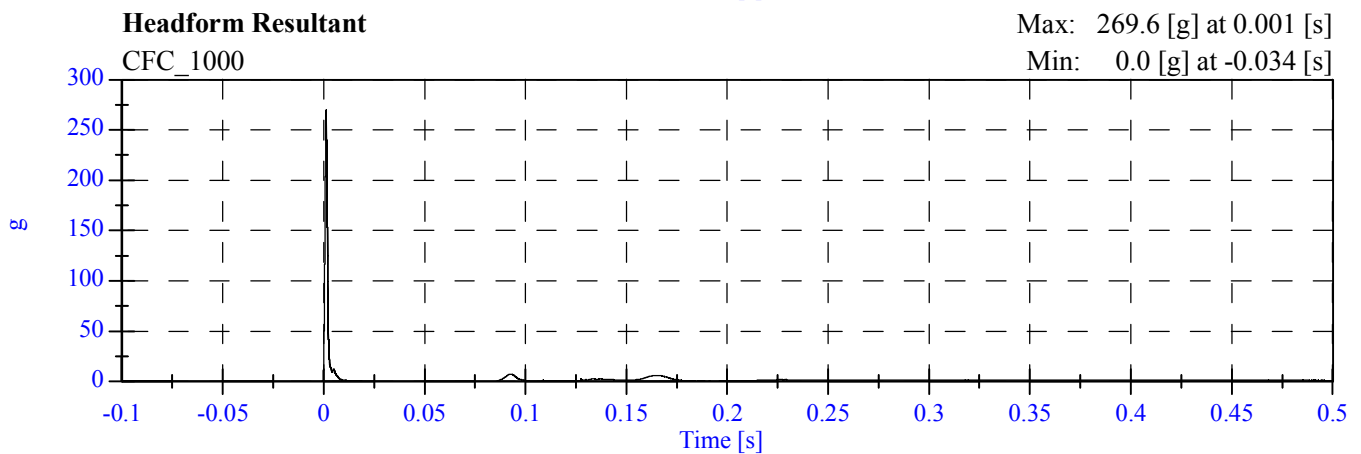
**PART 572L
HEAD DROP PRE-TEST**

MANUFACTURER:		DENTON ATD INC.	
SERIAL NUMBER:		0062	
CALIBRATION DATE:		February 11,2010	
TEST PARAMETER	SPECIFICATION	TEST RESULTS	
TEMPERATURE	19°C to 26°C	20	
RELATIVE HUMIDITY	10% to 70%	24	
PEAK RESULTANT ACCELERATION	225 Gs to 275 Gs	269.6	
PEAK LATERAL ACCELERATION	15 Gs Maximum	12.6	
IS ACCELERATION CURVE UNIMODAL?	YES	YES

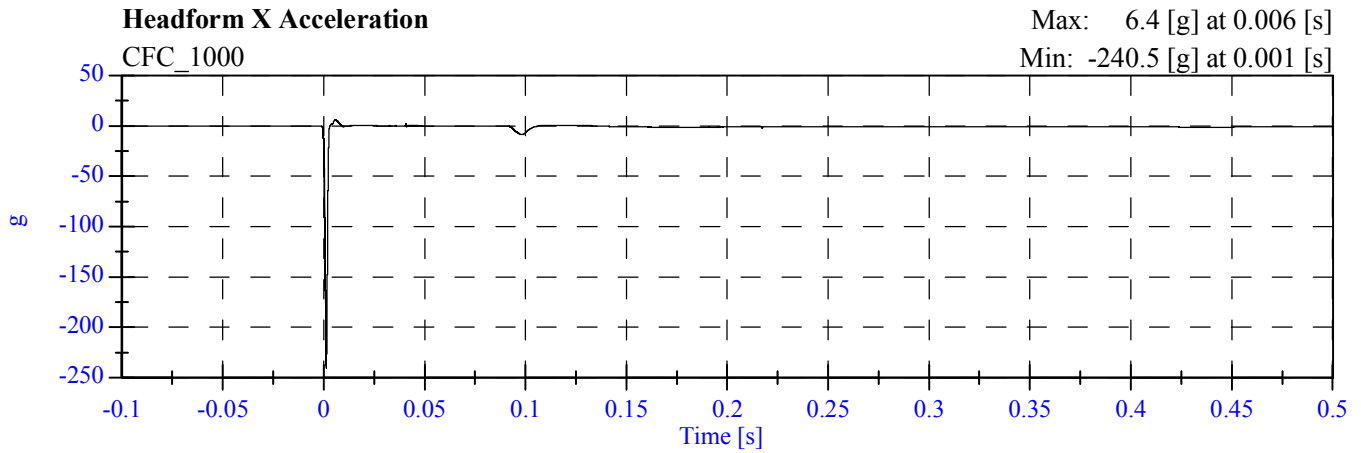
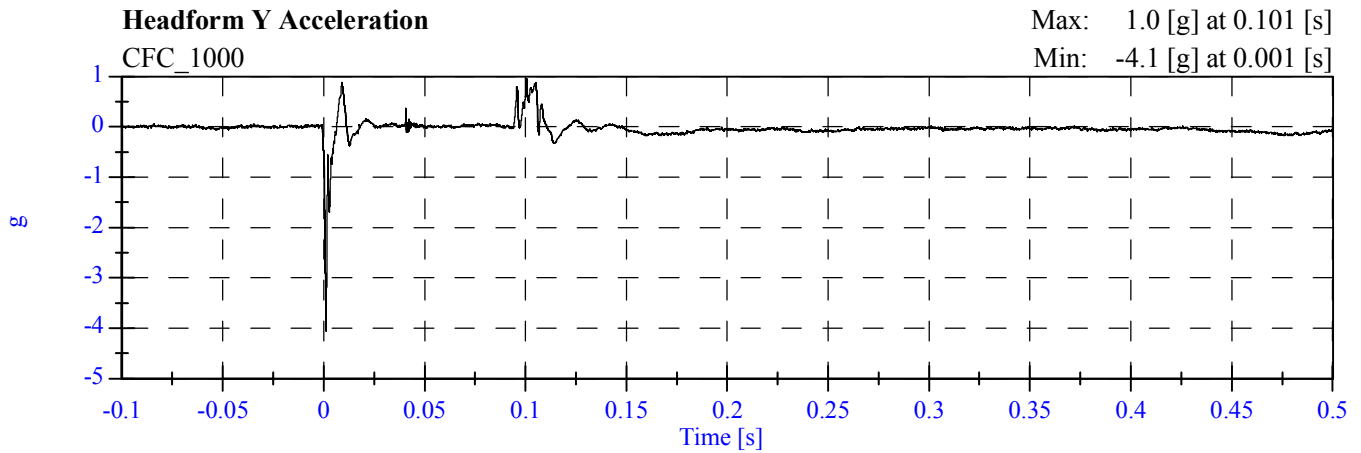
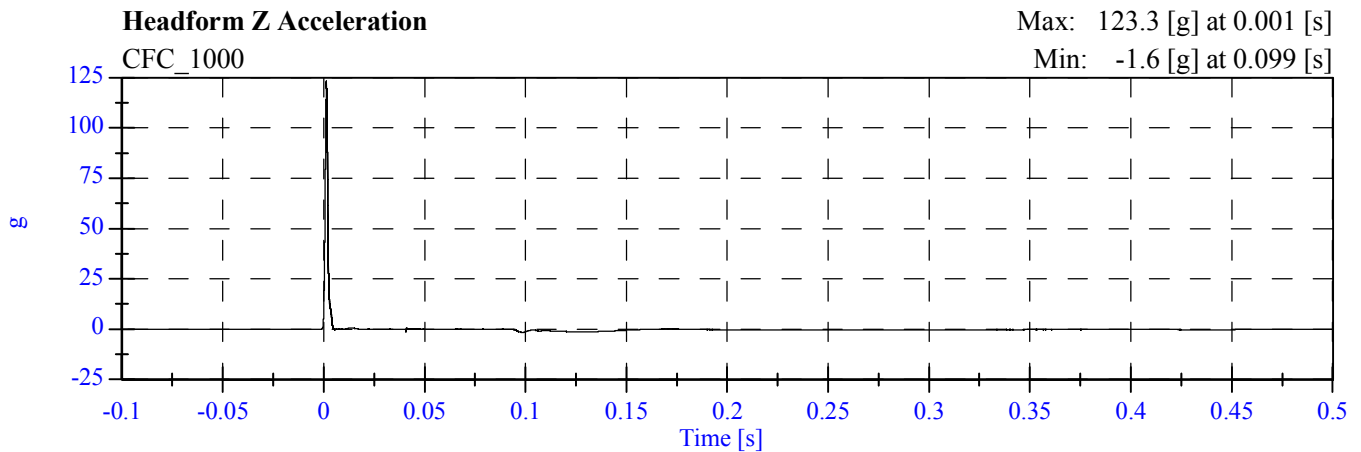
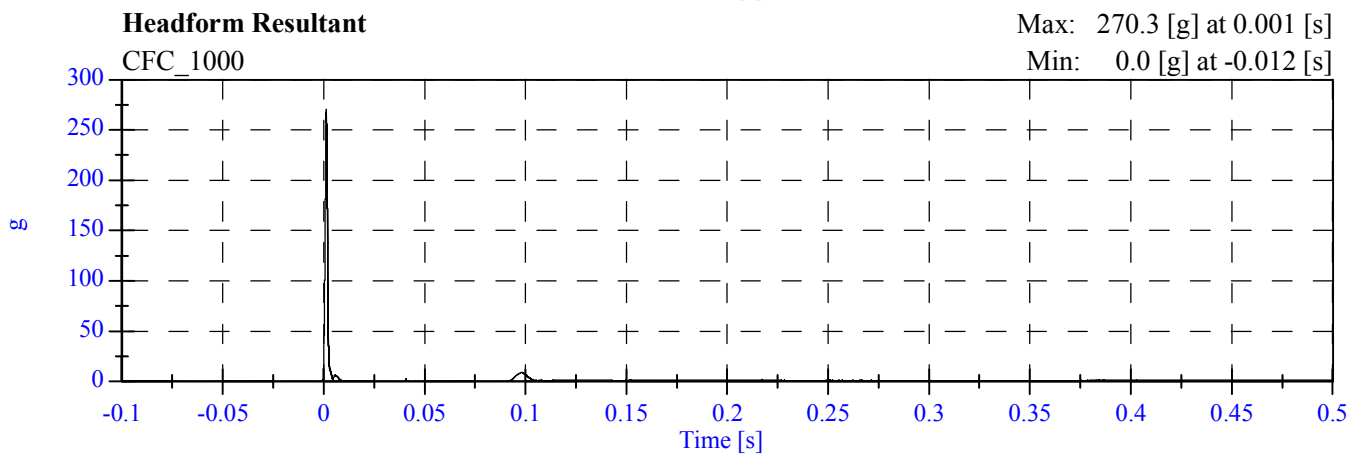
**PART 572L
HEAD DROP PRE-TEST**

MANUFACTURER:		FIRST TECHNOLOGY SAFETY SYSTEMS	
SERIAL NUMBER:		805	
CALIBRATION DATE:		February 11,2010	
TEST PARAMETER	SPECIFICATION	TEST RESULTS	
TEMPERATURE	19°C to 26°C	20	
RELATIVE HUMIDITY	10% to 70%	24	
PEAK RESULTANT ACCELERATION	225 Gs to 275 Gs	270.3	
PEAK LATERAL ACCELERATION	15 Gs Maximum	4.1	
IS ACCELERATION CURVE UNIMODAL?	YES	YES

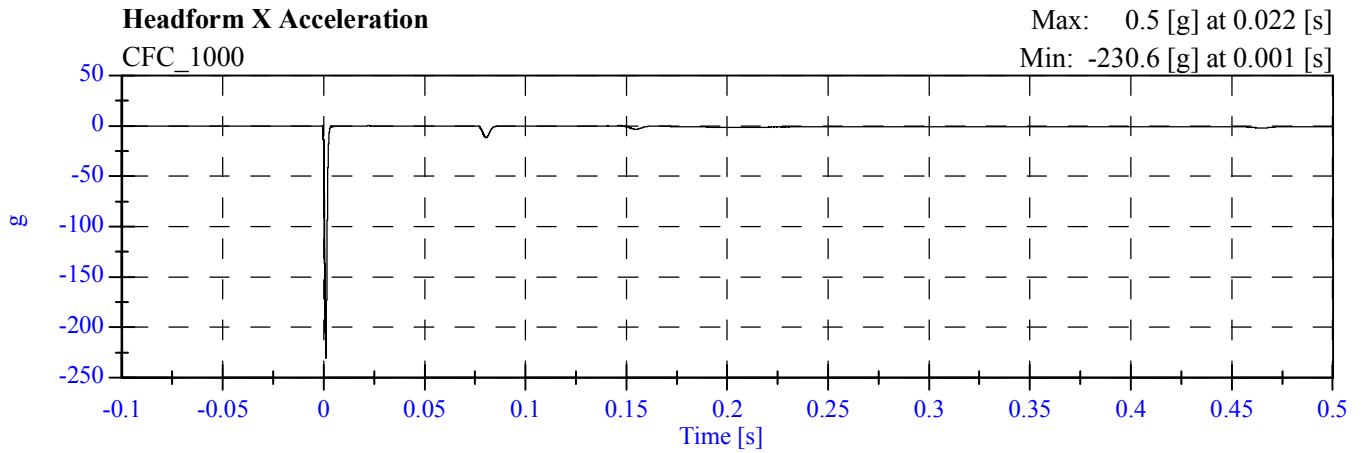
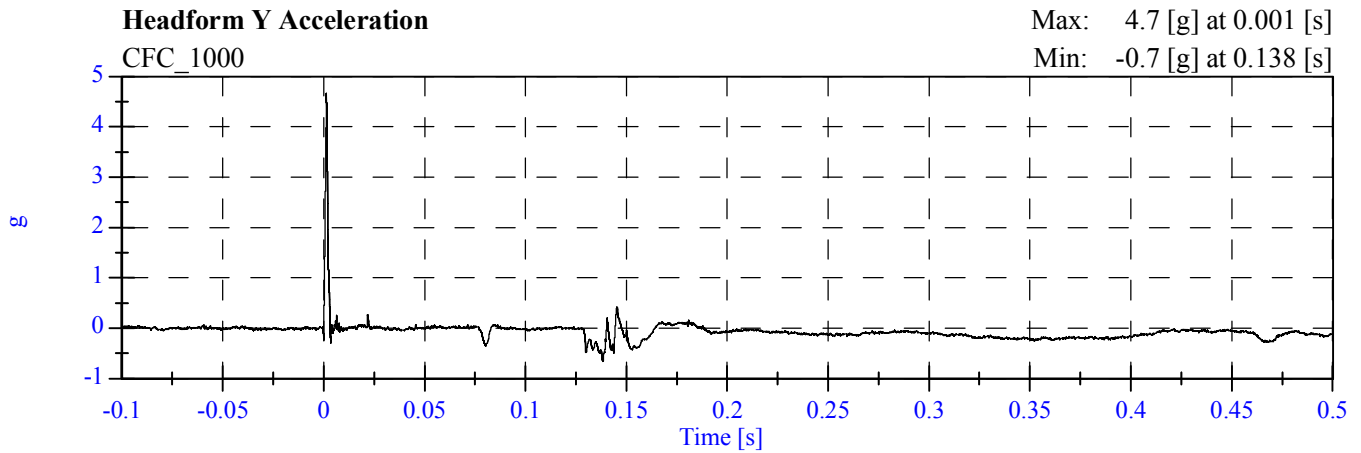
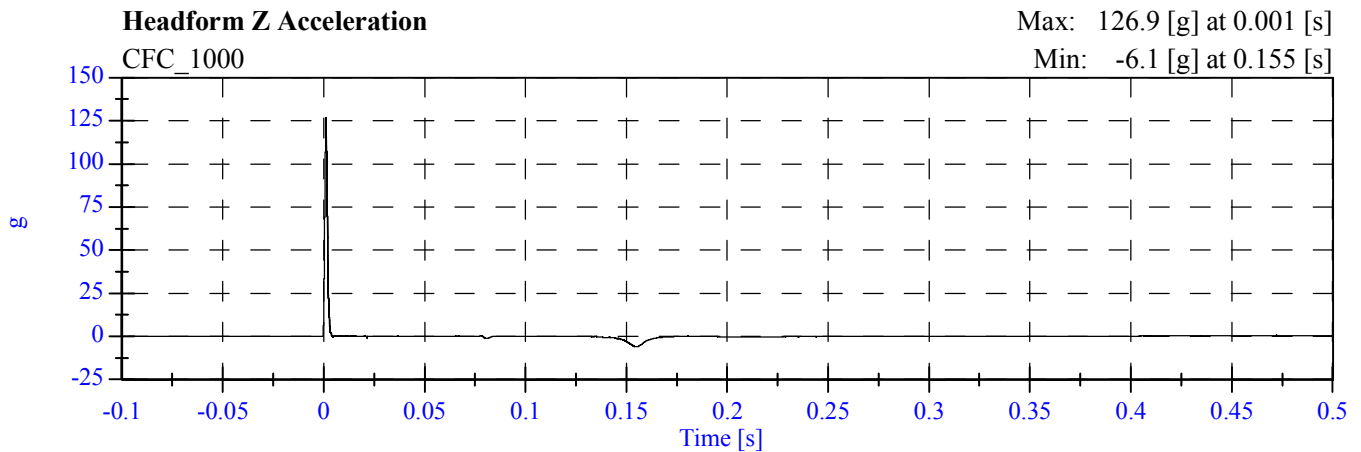
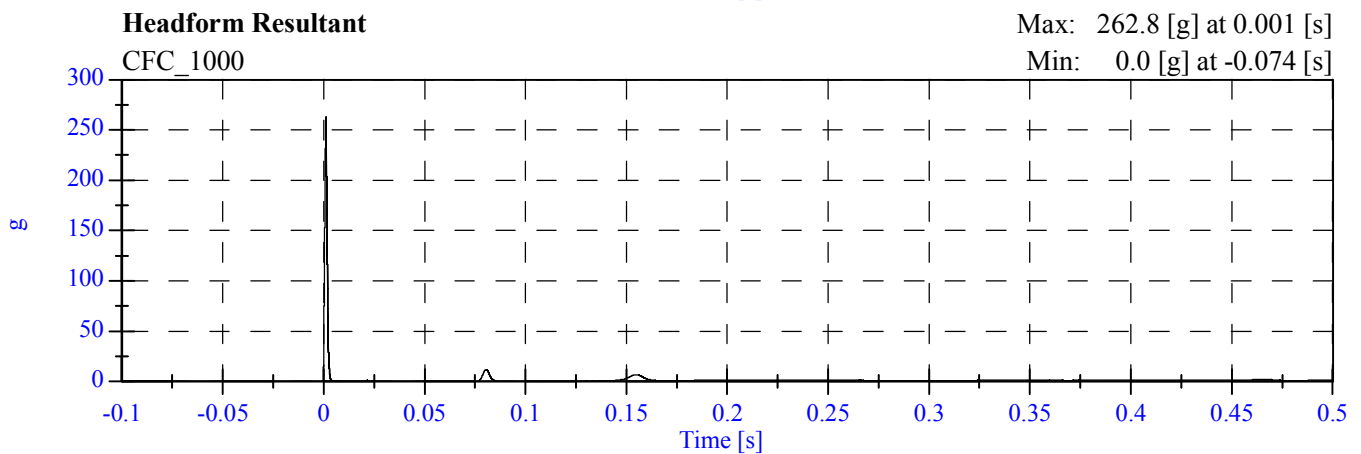
**PART 572L
HEAD DROP PRE-TEST**

MANUFACTURER:		DENTON ATD INC.	
SERIAL NUMBER:		0355	
CALIBRATION DATE:		February 11,2010	
TEST PARAMETER	SPECIFICATION	TEST RESULTS	
TEMPERATURE	19°C to 26°C	20	
RELATIVE HUMIDITY	10% to 70%	24	
PEAK RESULTANT ACCELERATION	225 Gs to 275 Gs	262.8	
PEAK LATERAL ACCELERATION	15 Gs Maximum	4.7	
IS ACCELERATION CURVE UNIMODAL?	YES	YES

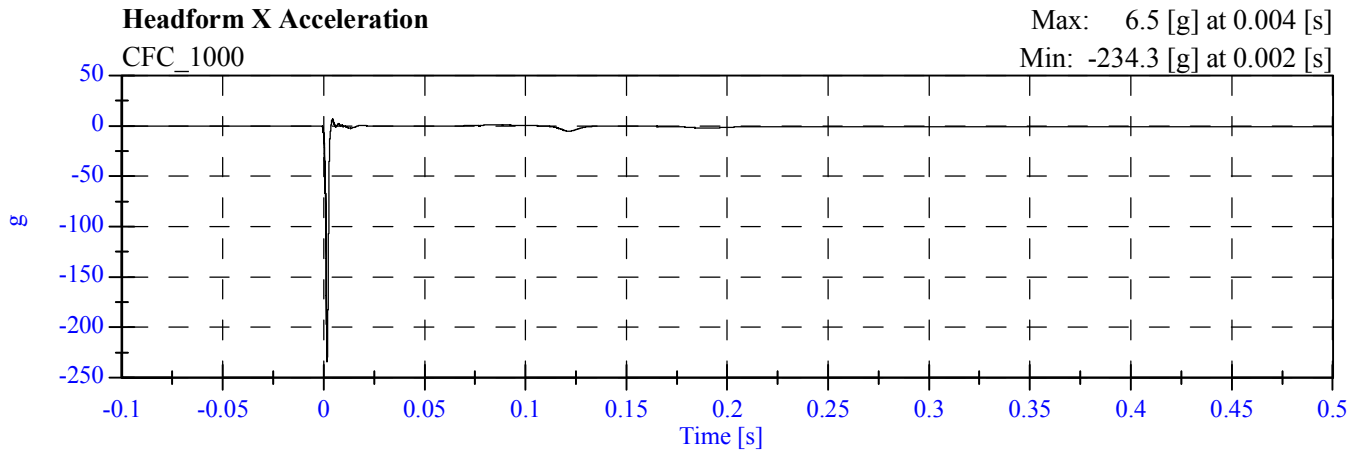
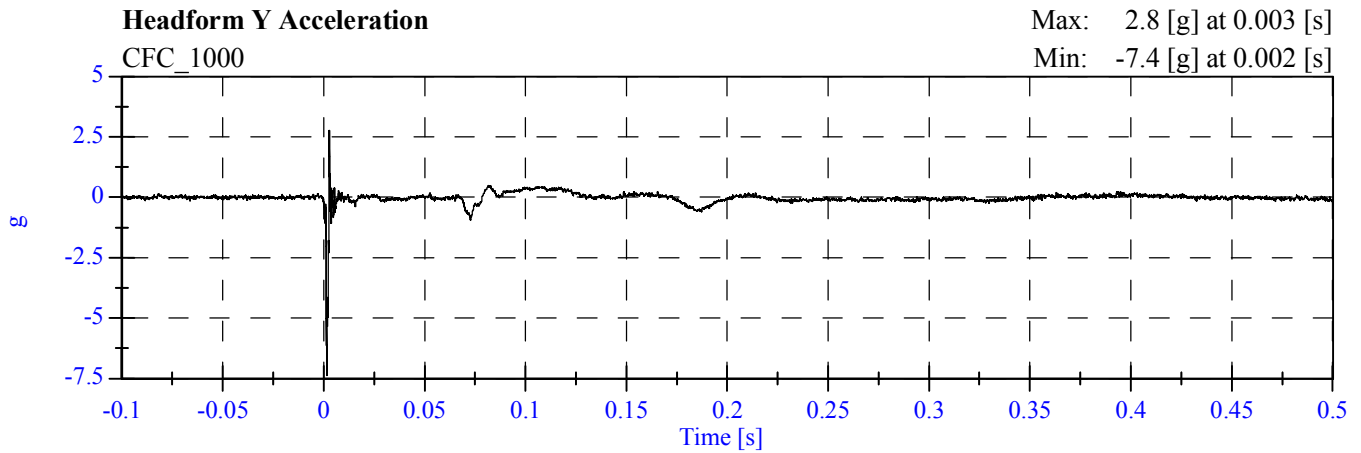
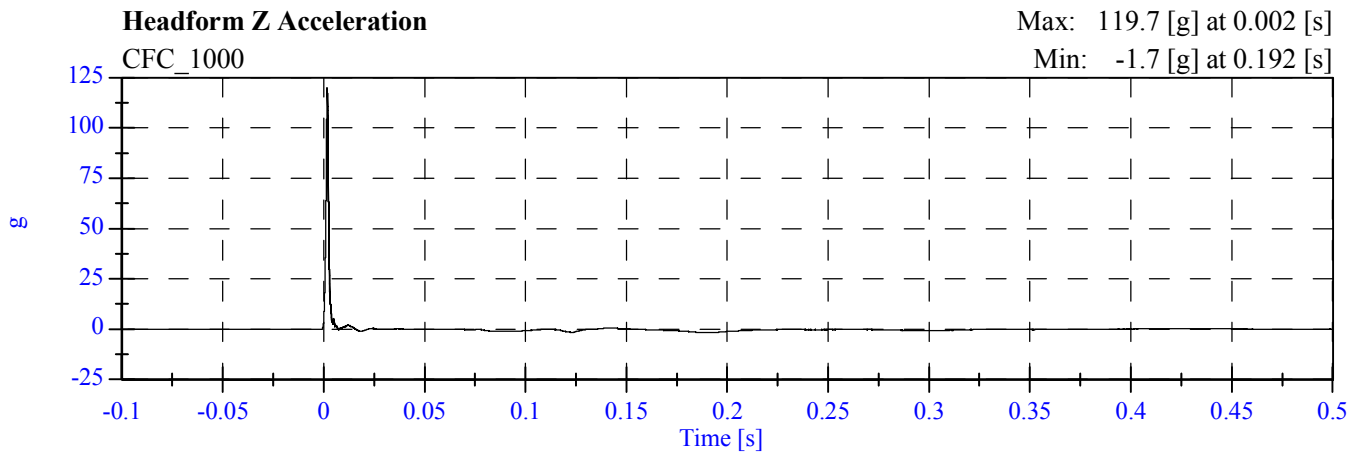
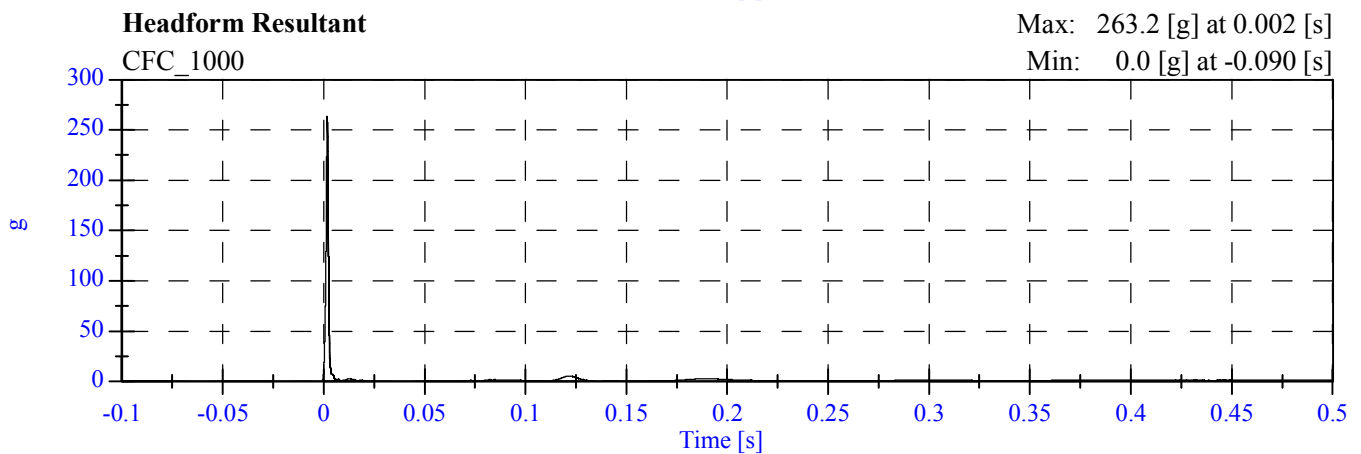
**PART 572L
HEAD DROP PRE-TEST**

MANUFACTURER:		FIRST TECHNOLOGY SAFETY SYSTEMS	
SERIAL NUMBER:		1140	
CALIBRATION DATE:		February 11,2010	
TEST PARAMETER	SPECIFICATION	TEST RESULTS	
TEMPERATURE	19°C to 26°C	20	
RELATIVE HUMIDITY	10% to 70%	24	
PEAK RESULTANT ACCELERATION	225 Gs to 275 Gs	263.2	
PEAK LATERAL ACCELERATION	15 Gs Maximum	7.4	
IS ACCELERATION CURVE UNIMODAL?	YES	YES

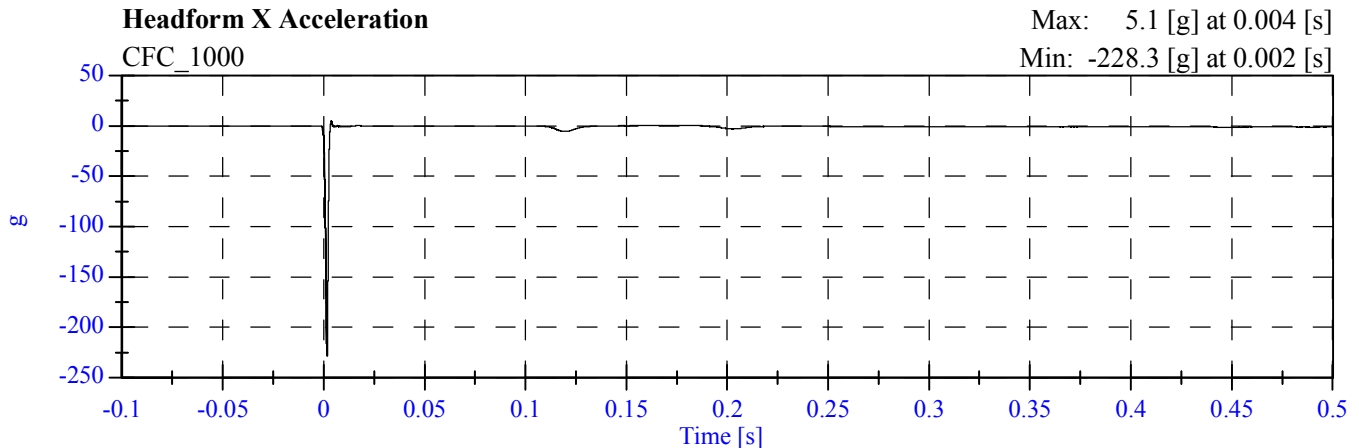
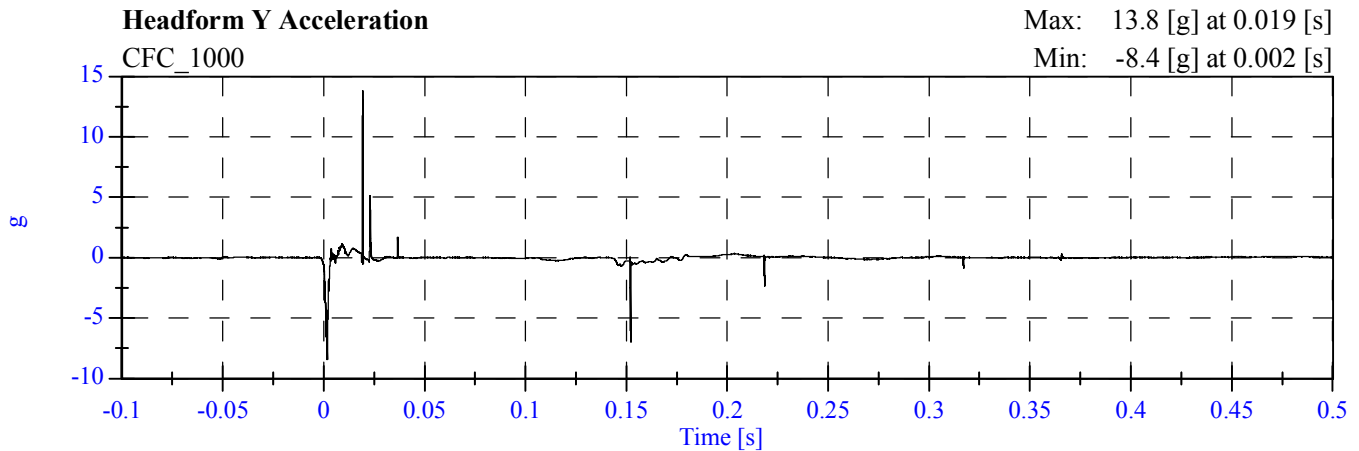
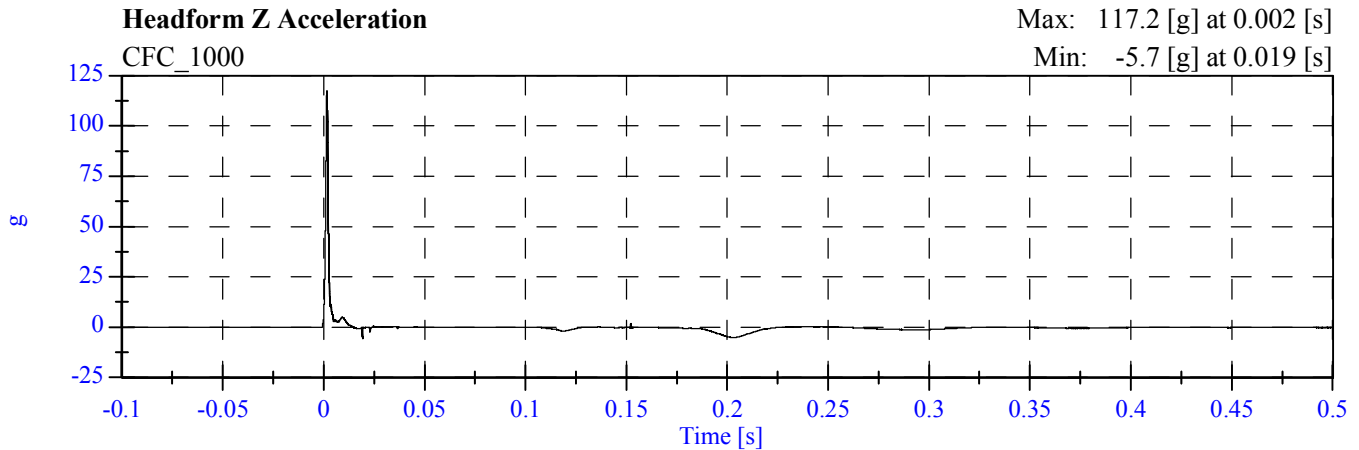
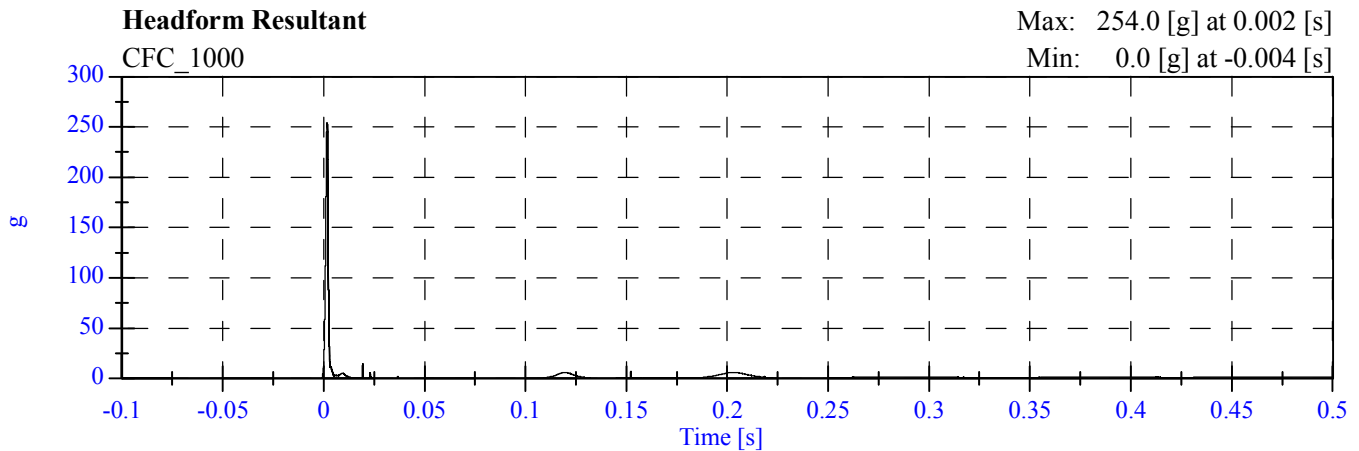
**PART 572L
HEAD DROP POST-TEST**

MANUFACTURER:		FIRST TECHNOLOGY SAFETY SYSTEMS	
SERIAL NUMBER:		1142	
CALIBRATION DATE:		March 1, 2010	
TEST PARAMETER	SPECIFICATION	TEST RESULTS	
TEMPERATURE	19°C to 26°C	21	
RELATIVE HUMIDITY	10% to 70%	28	
PEAK RESULTANT ACCELERATION	225 Gs to 275 Gs	254.0	
PEAK LATERAL ACCELERATION	15 Gs Maximum	13.8	
IS ACCELERATION CURVE UNIMODAL?	YES	YES

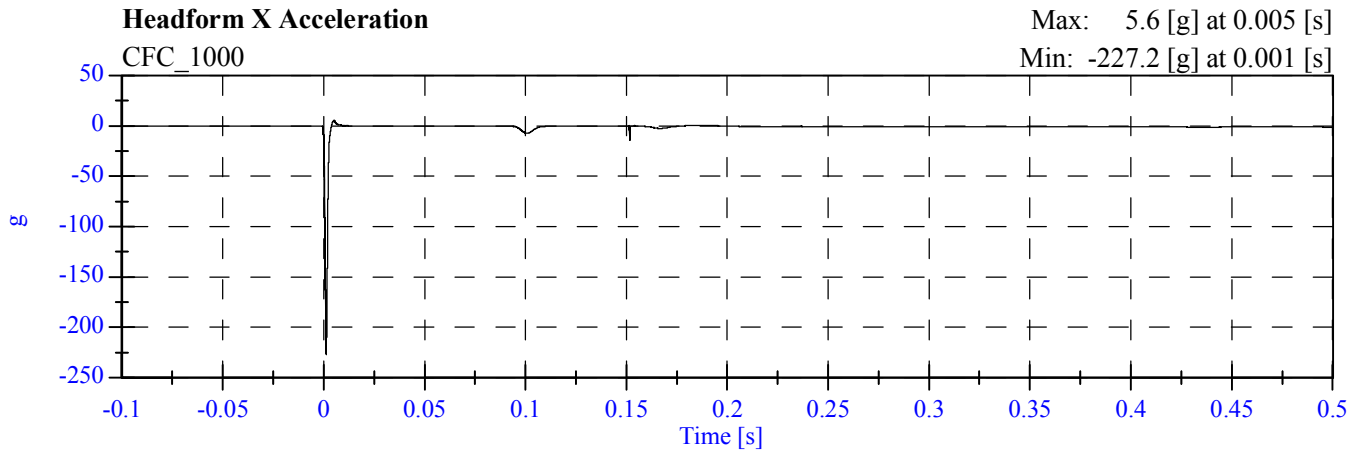
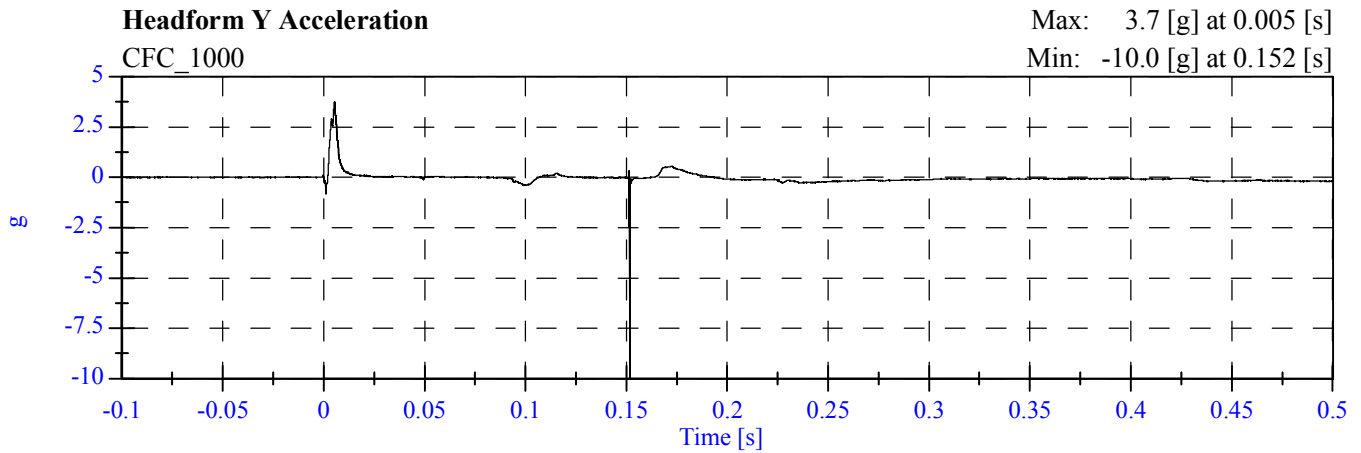
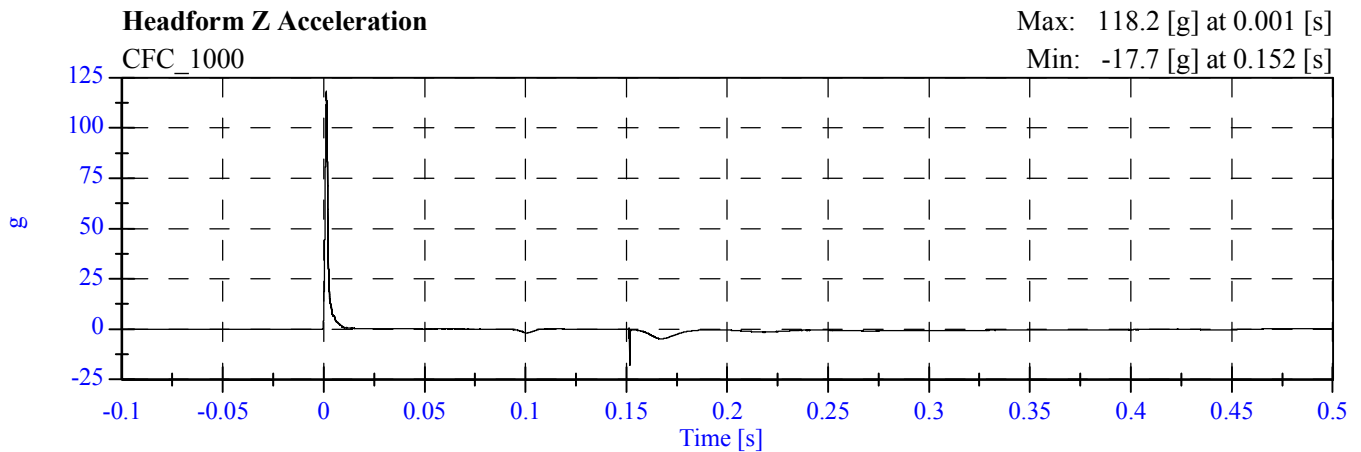
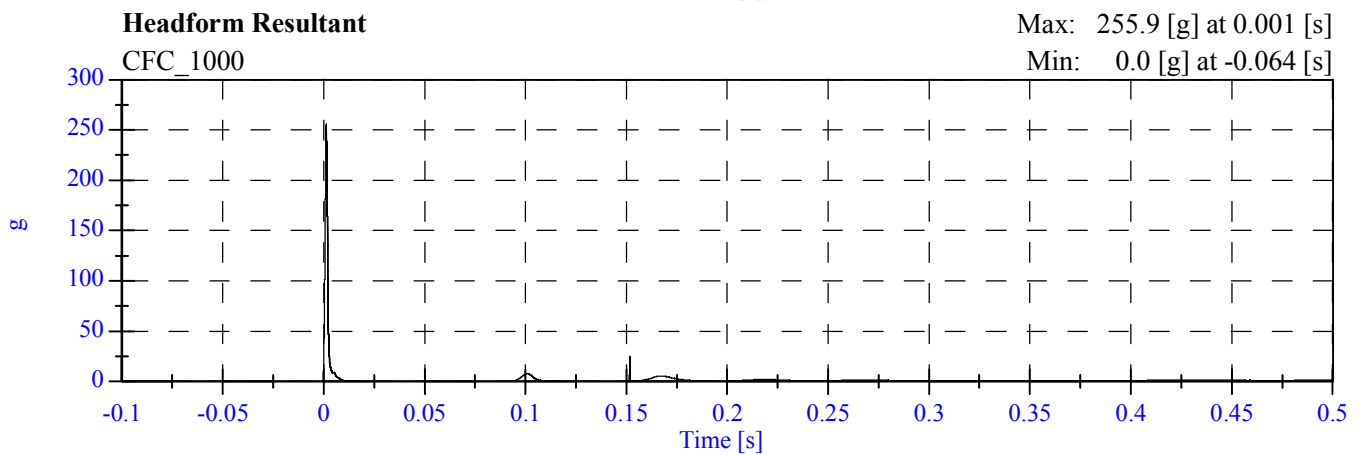
**PART 572L
HEAD DROP POST-TEST**

MANUFACTURER:		DENTON ATD INC.	
SERIAL NUMBER:		0062	
CALIBRATION DATE:		March 1, 2010	
TEST PARAMETER	SPECIFICATION	TEST RESULTS	
TEMPERATURE	19°C to 26°C	21	
RELATIVE HUMIDITY	10% to 70%	28	
PEAK RESULTANT ACCELERATION	225 Gs to 275 Gs	255.9	
PEAK LATERAL ACCELERATION	15 Gs Maximum	10.0	
IS ACCELERATION CURVE UNIMODAL?	YES	YES

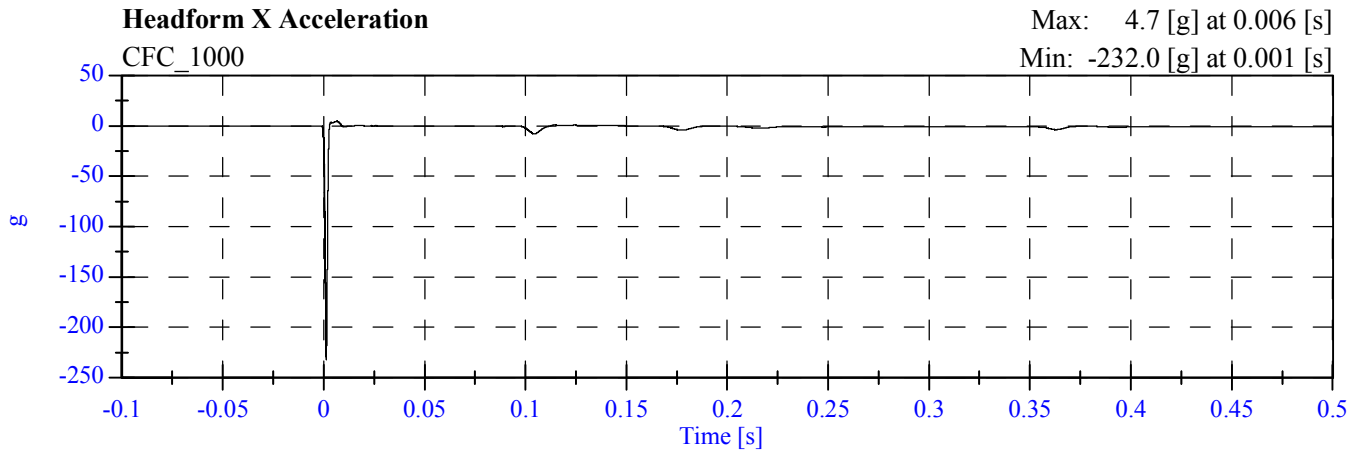
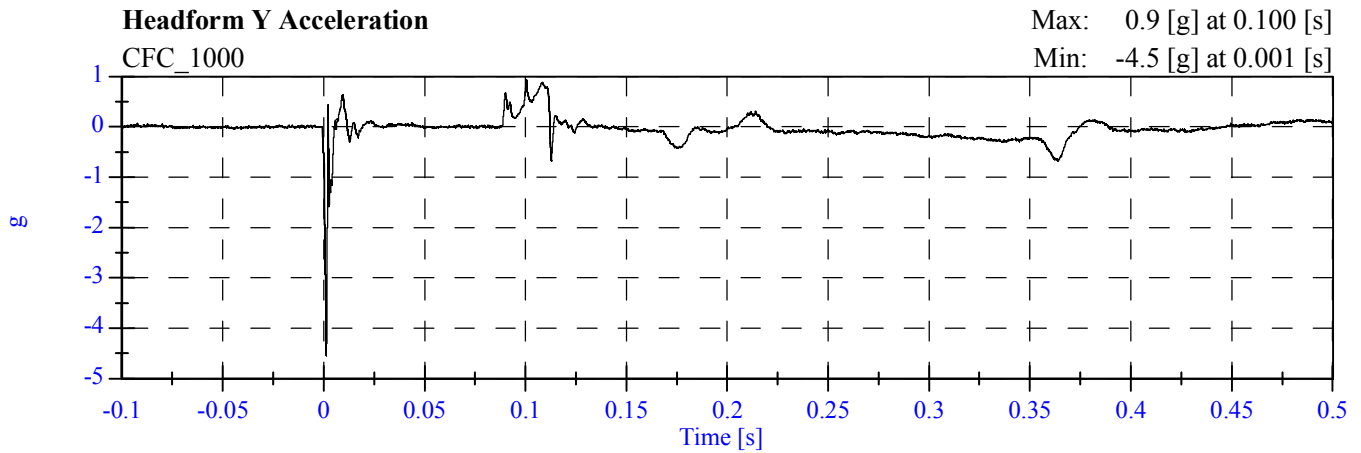
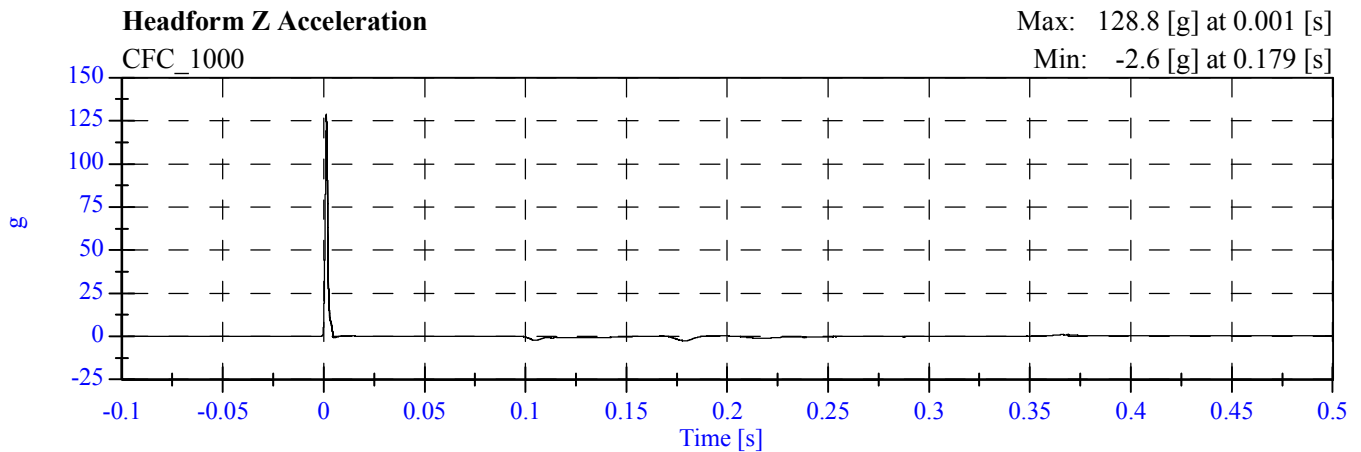
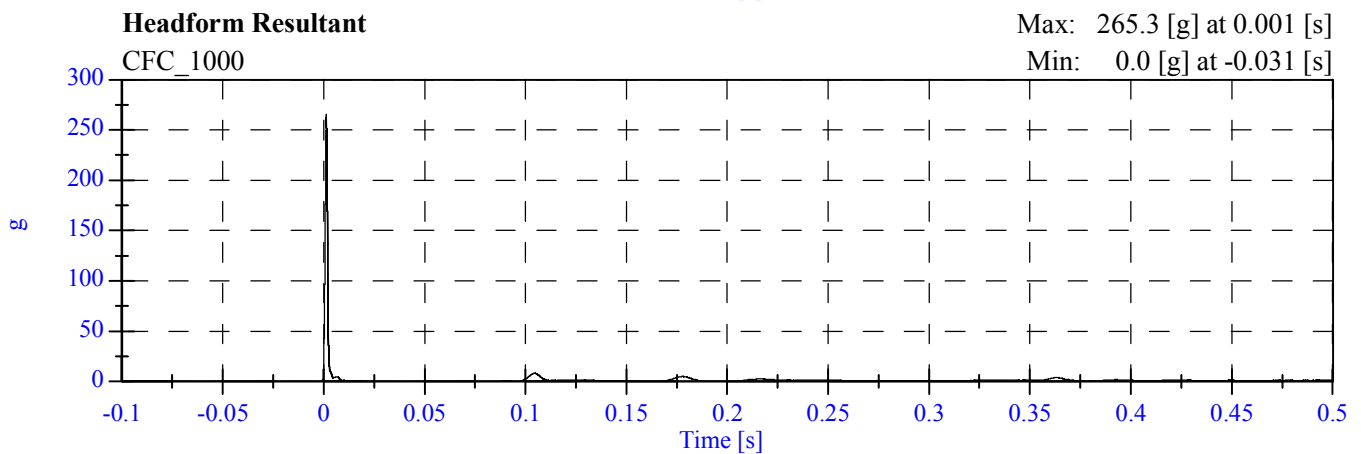
**PART 572L
HEAD DROP POST-TEST**

MANUFACTURER:		FIRST TECHNOLOGY SAFETY SYSTEMS	
SERIAL NUMBER:		805	
CALIBRATION DATE:		March 1, 2010	
TEST PARAMETER	SPECIFICATION	TEST RESULTS	
TEMPERATURE	19°C to 26°C	21	
RELATIVE HUMIDITY	10% to 70%	28	
PEAK RESULTANT ACCELERATION	225 Gs to 275 Gs	265.3	
PEAK LATERAL ACCELERATION	15 Gs Maximum	4.5	
IS ACCELERATION CURVE UNIMODAL?	YES	YES

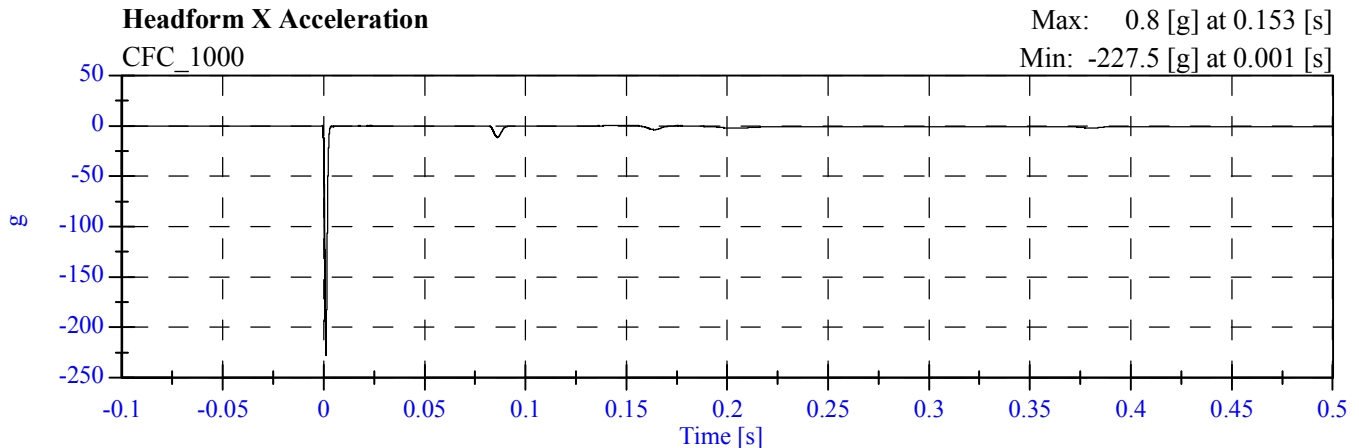
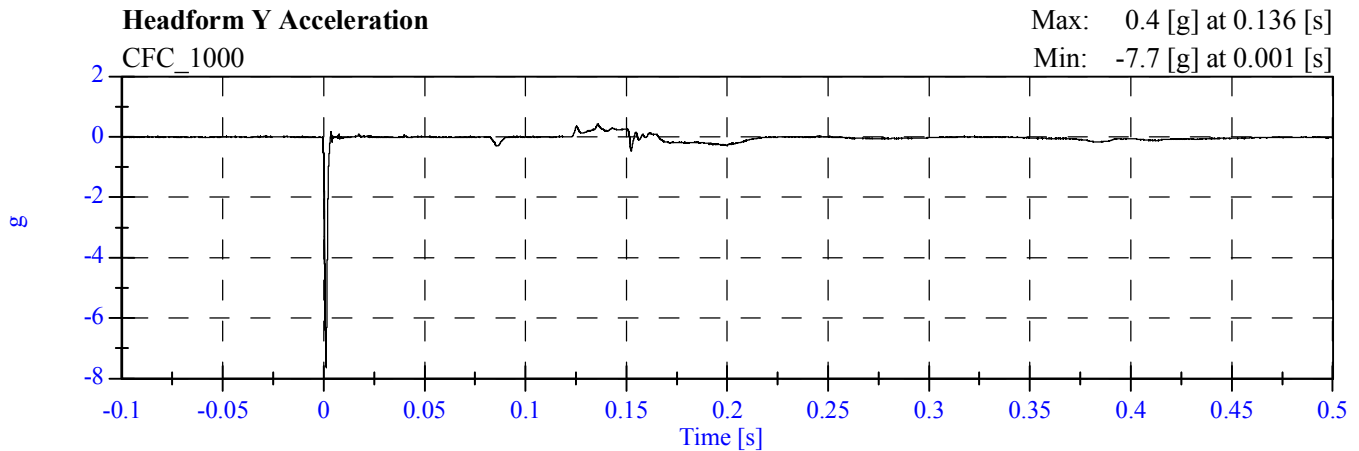
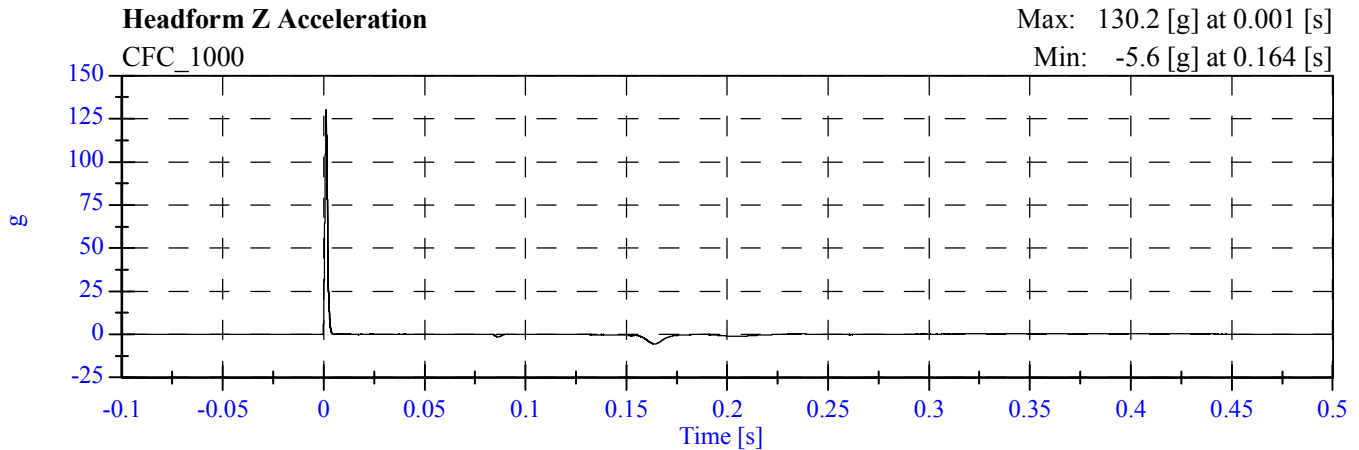
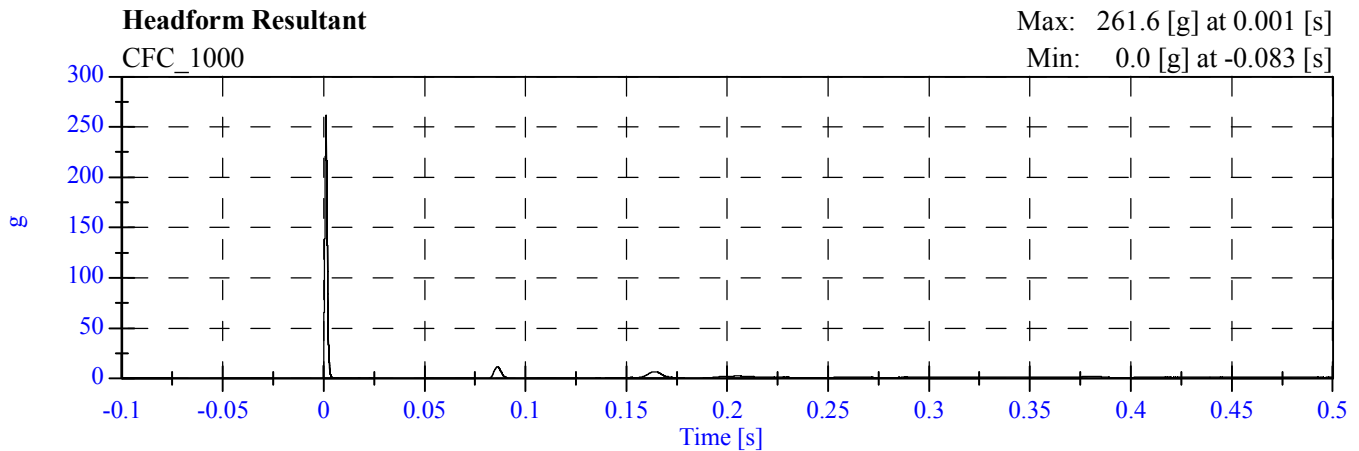
**PART 572L
HEAD DROP POST-TEST**

MANUFACTURER:		DENTON ATD INC.	
SERIAL NUMBER:		0355	
CALIBRATION DATE:		March 1, 2010	
TEST PARAMETER	SPECIFICATION	TEST RESULTS	
TEMPERATURE	19°C to 26°C	21	
RELATIVE HUMIDITY	10% to 70%	28	
PEAK RESULTANT ACCELERATION	225 Gs to 275 Gs	261.6	
PEAK LATERAL ACCELERATION	15 Gs Maximum	7.7	
IS ACCELERATION CURVE UNIMODAL?	YES	YES
