**REPORT NUMBER: 214P-MGA-2011-006**

**SAFETY COMPLIANCE TESTING FOR FMVSS 214  
DYNAMIC SIDE IMPACT PROTECTION  
RIGID POLE**

**CHRYSLER GROUP LLC  
2011 DODGE CHARGER SE 4-DR SEDAN  
NHTSA NUMBER: CB0305**

**PREPARED BY:  
MGA RESEARCH CORPORATION  
5000 WARREN ROAD  
BURLINGTON, WI 53105**

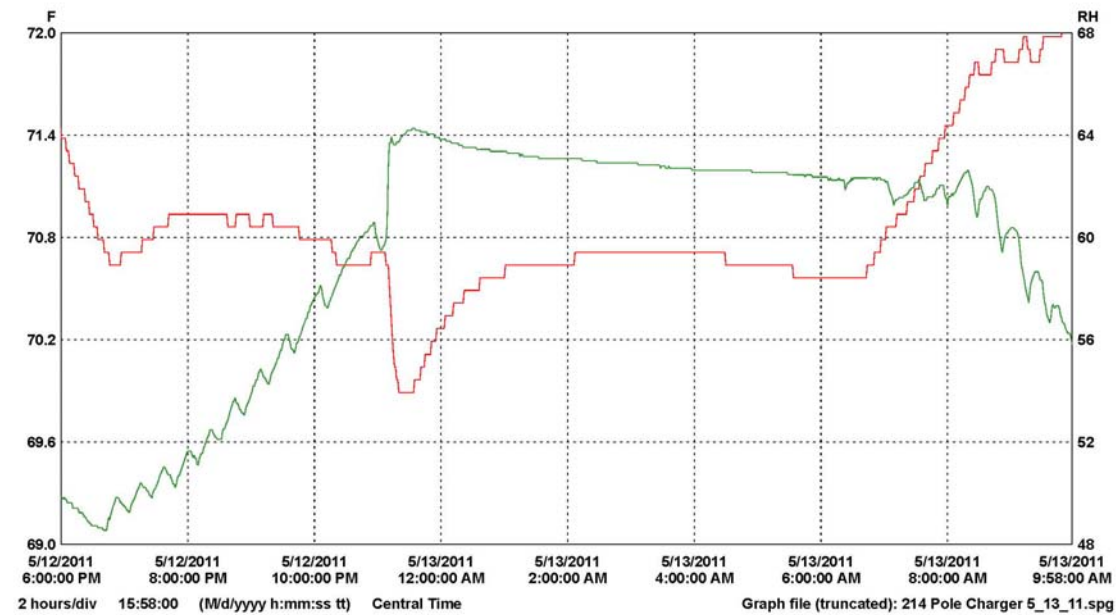
2 hours/div 15:58:00 (M/d/yyyy h:mm:ss tt) Central Time Graph file (truncated): 214 Pole Charger 5\_13\_11.spg

LN	Serial #	Description	CH	Value	Maximum	Average	Minimum	Units	CH description	Logger file
1	10102056	Vehicle Prep 1	1	72.05	70.85	69.89	F	Temperature	10102056_Vehicle_Prep.spl	
2	10102056	Vehicle Prep 2	2	64.3	59.4	48.6	RH	Humidity	10102056_Vehicle_Prep.spl

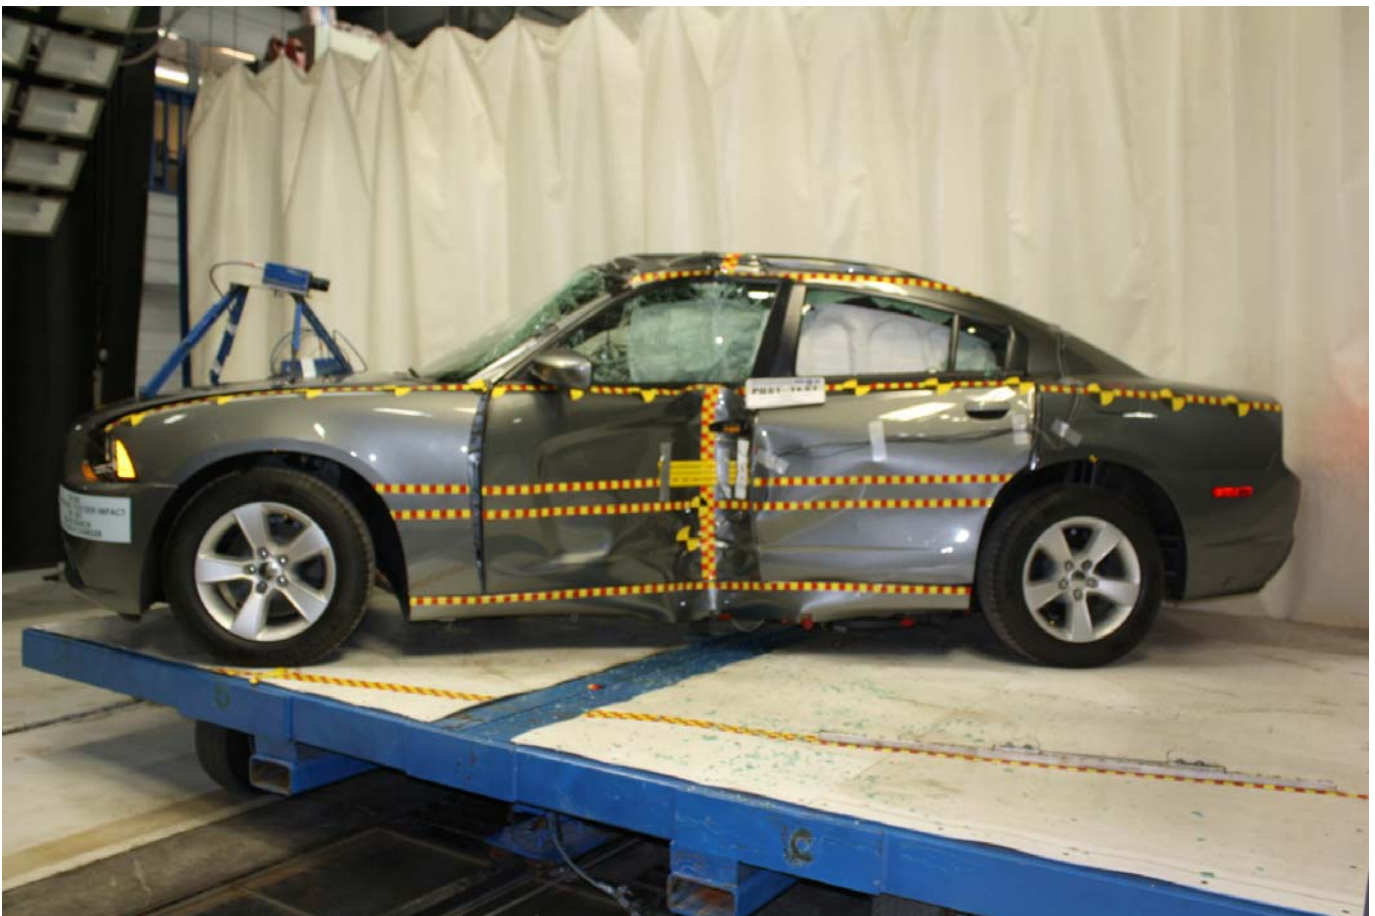
Post-Test Impacted Side View of Test Vehicle

Description	Front	Rear
Left Side Doors	Remained closed and jammed shut	Remained closed and jammed shut
Right Side Doors	Remained closed and operational	Remained closed and operational
Hatch and Other Doors		
Seat Movement	0	0
Seat Back Failure	None	None

Critical Areas of Performance	Observations and Conclusions
Pillar Performance	No Separation
Sill Separation	None
Windshield Damage	Cracked
Window Damage	Left Front Window Cracked / Left Rear Window Broke
Other Notable Effects	None

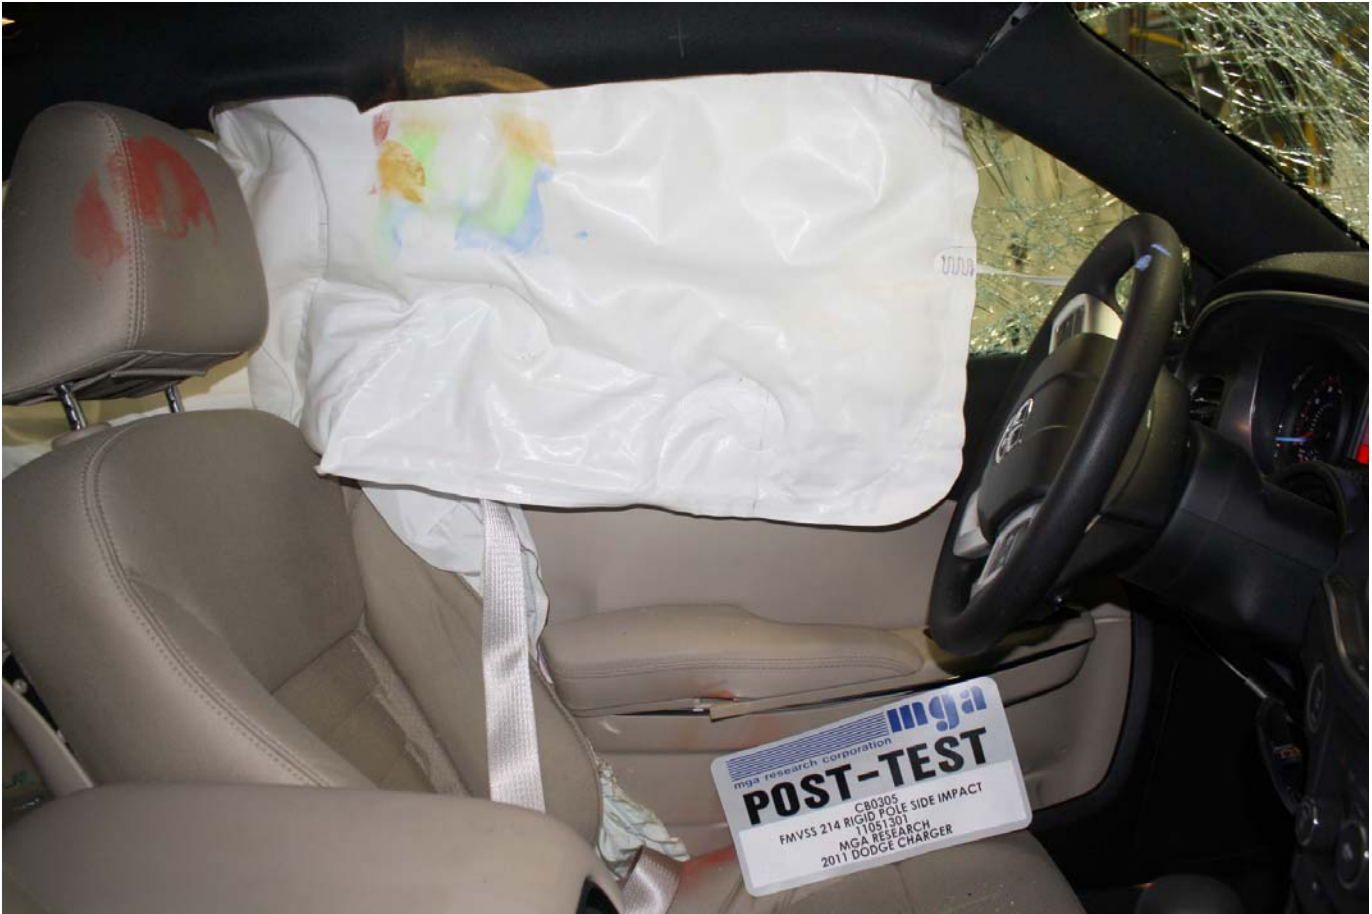
Post-Test Interior of Front Door Showing Dummy Impact Locations

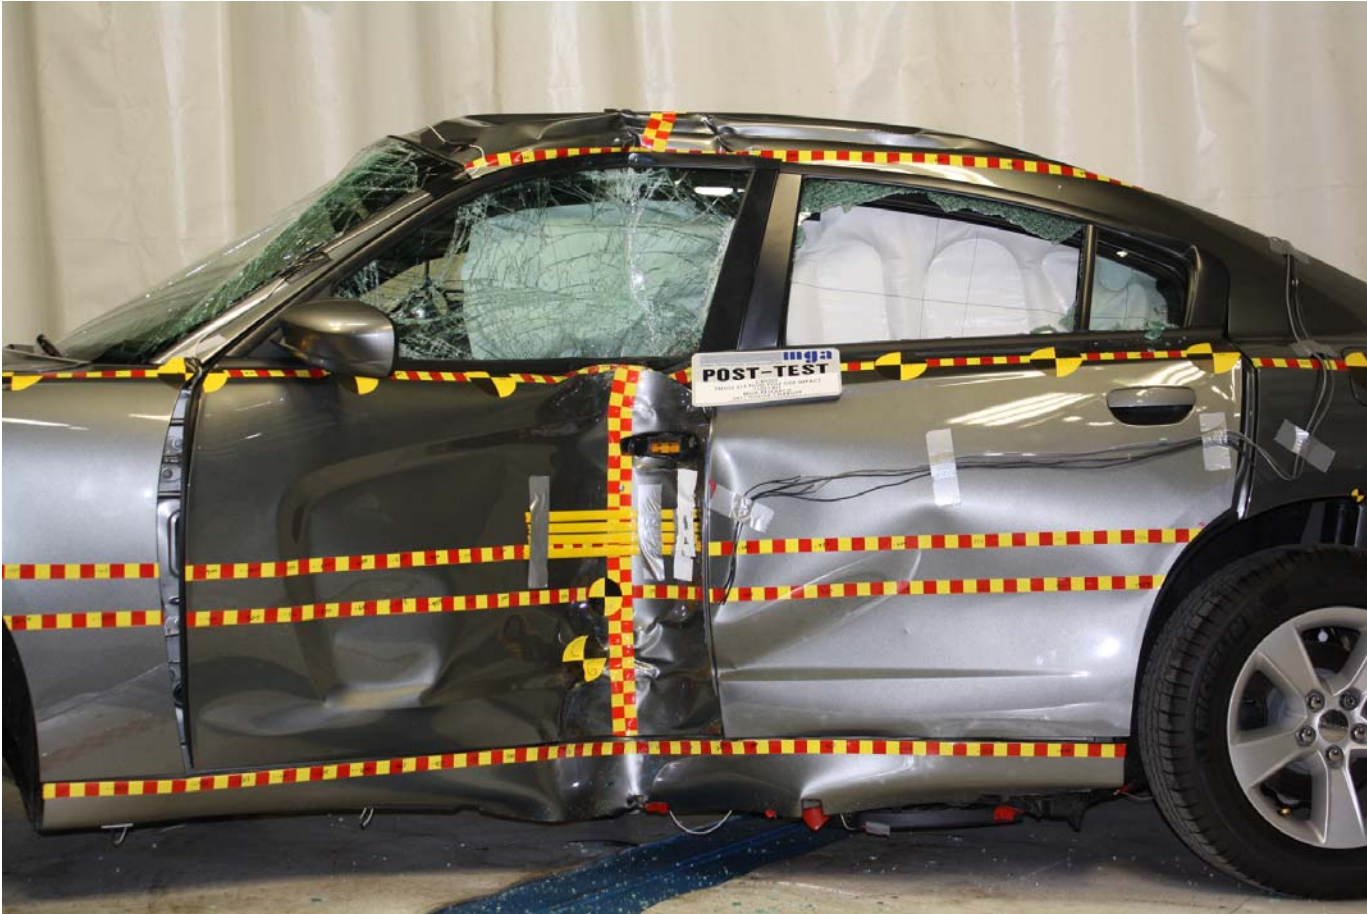
Post-Test Impact Zone Close-up View

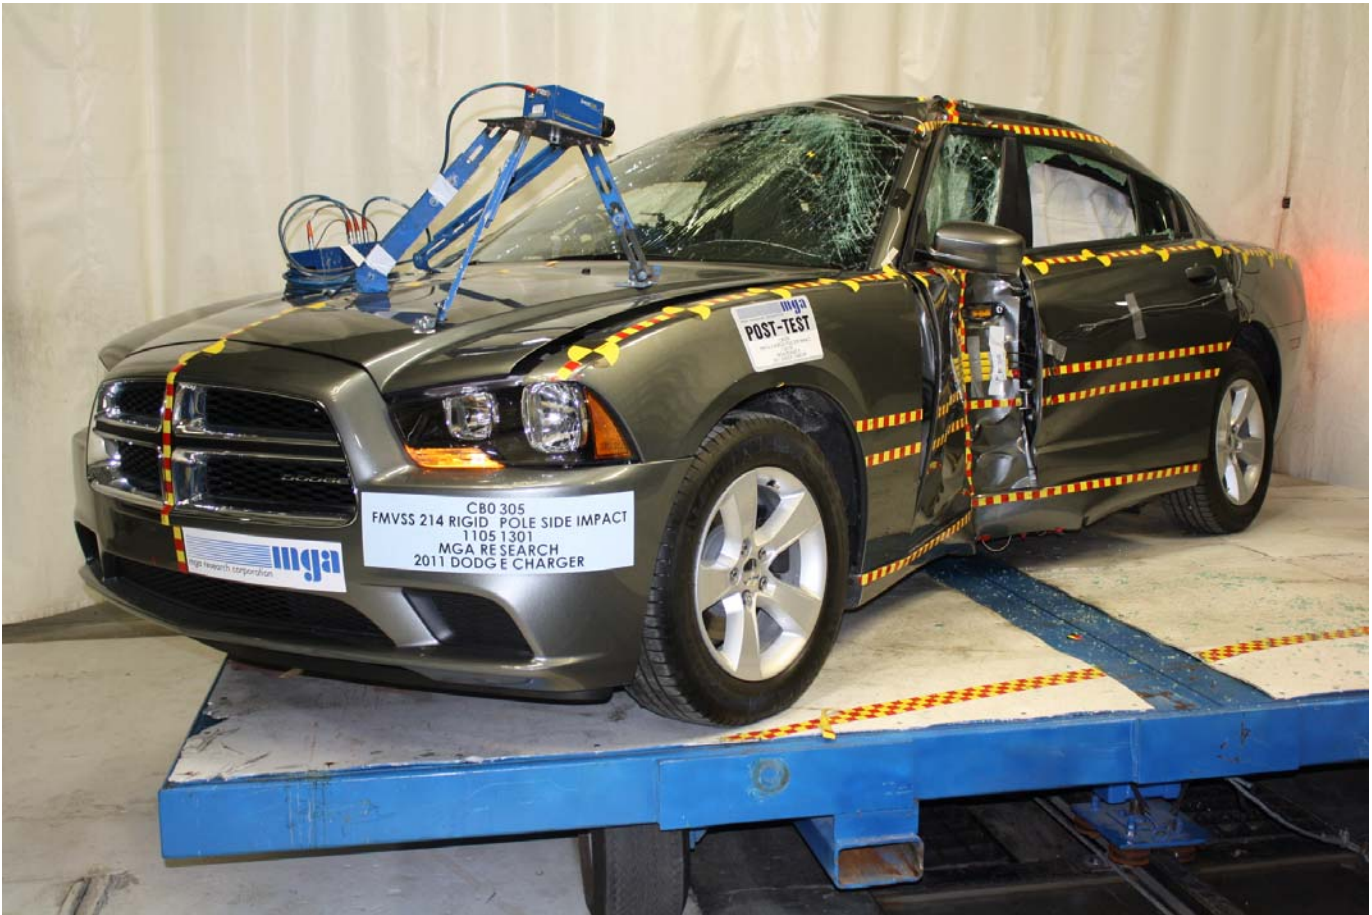
Post-Test  $\frac{3}{4}$  Front View of Impact Zone

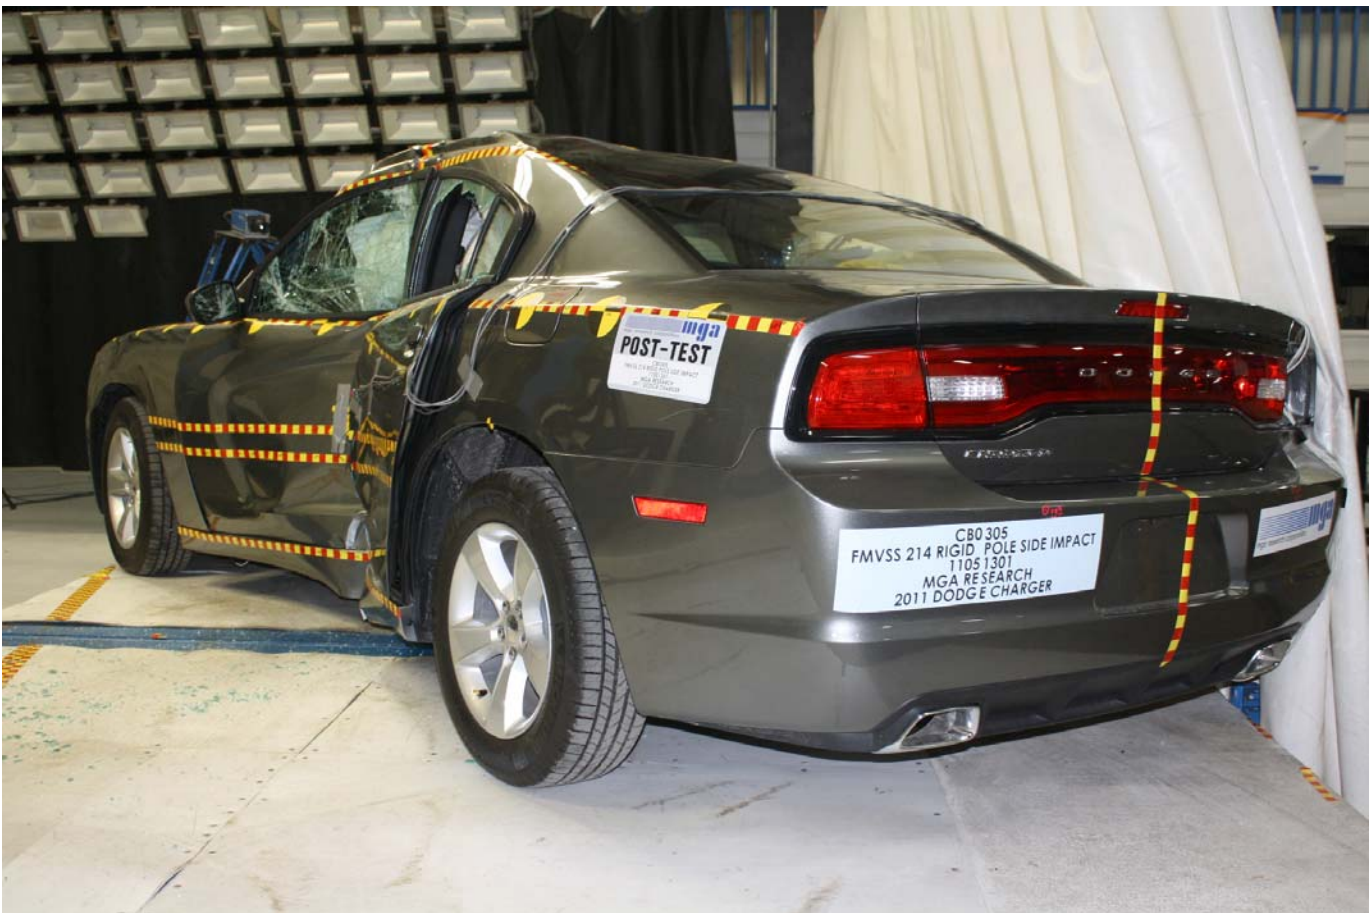
Post-Test  $\frac{3}{4}$  Rear View of Impact Zone

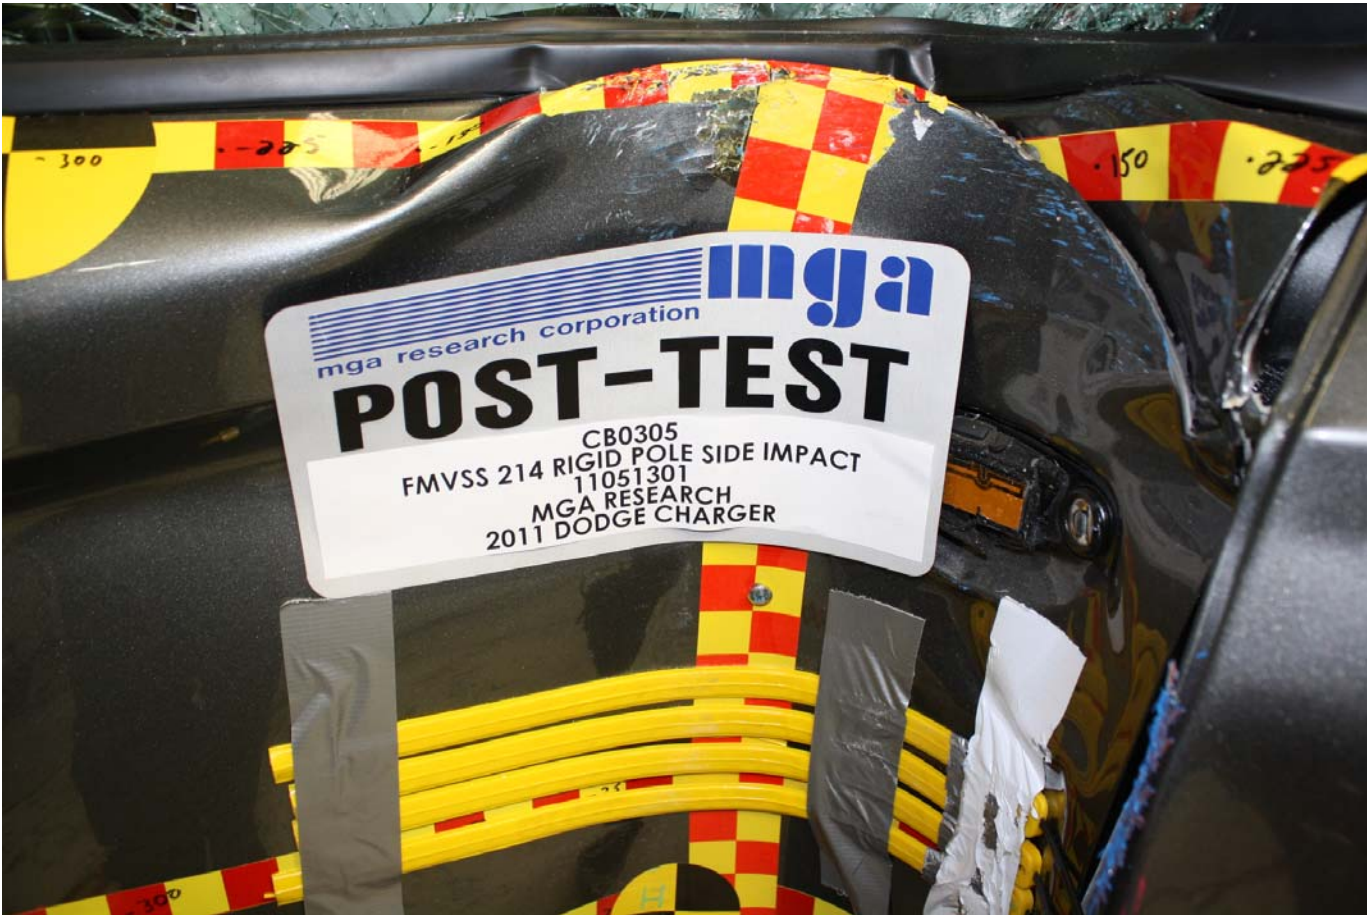
Post-Test Close-up View of Impact Point Target

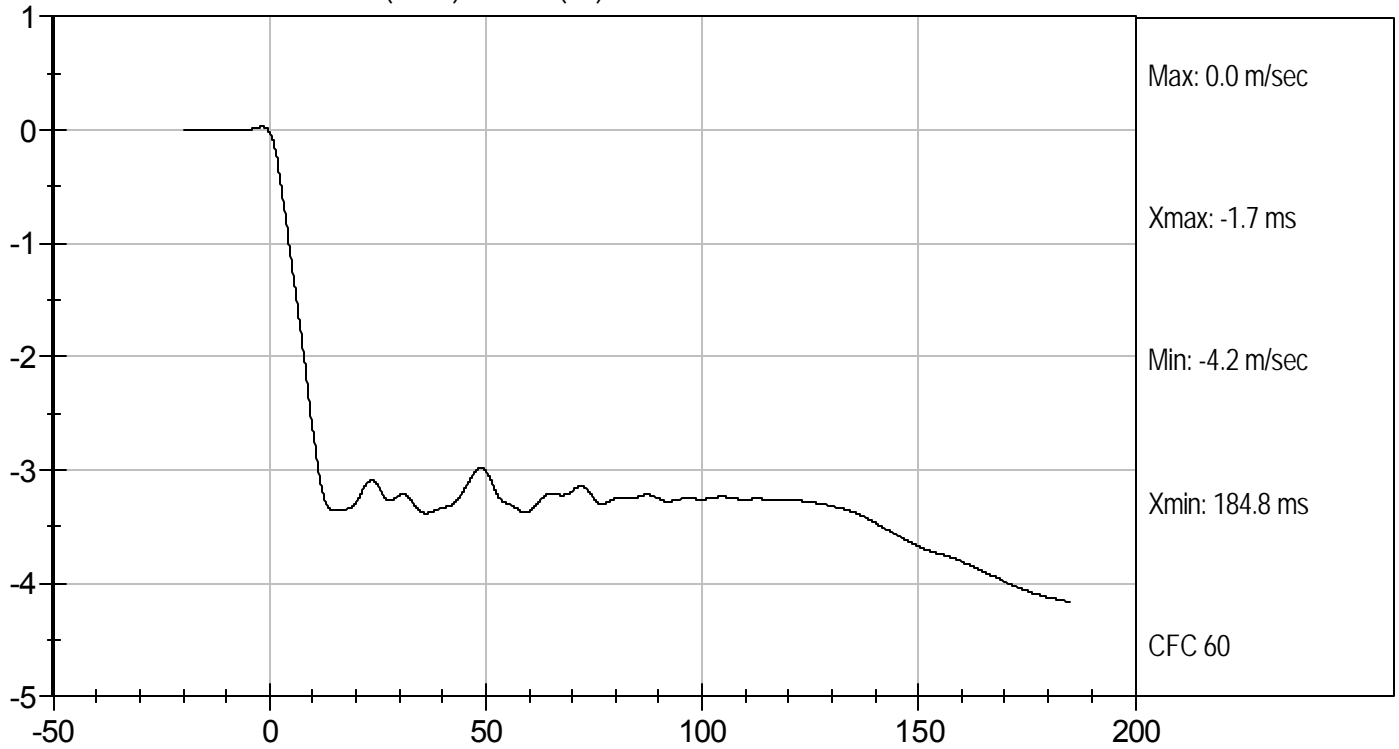
PENDULUM DECELERATION (m/sec) vs TIME (ms)

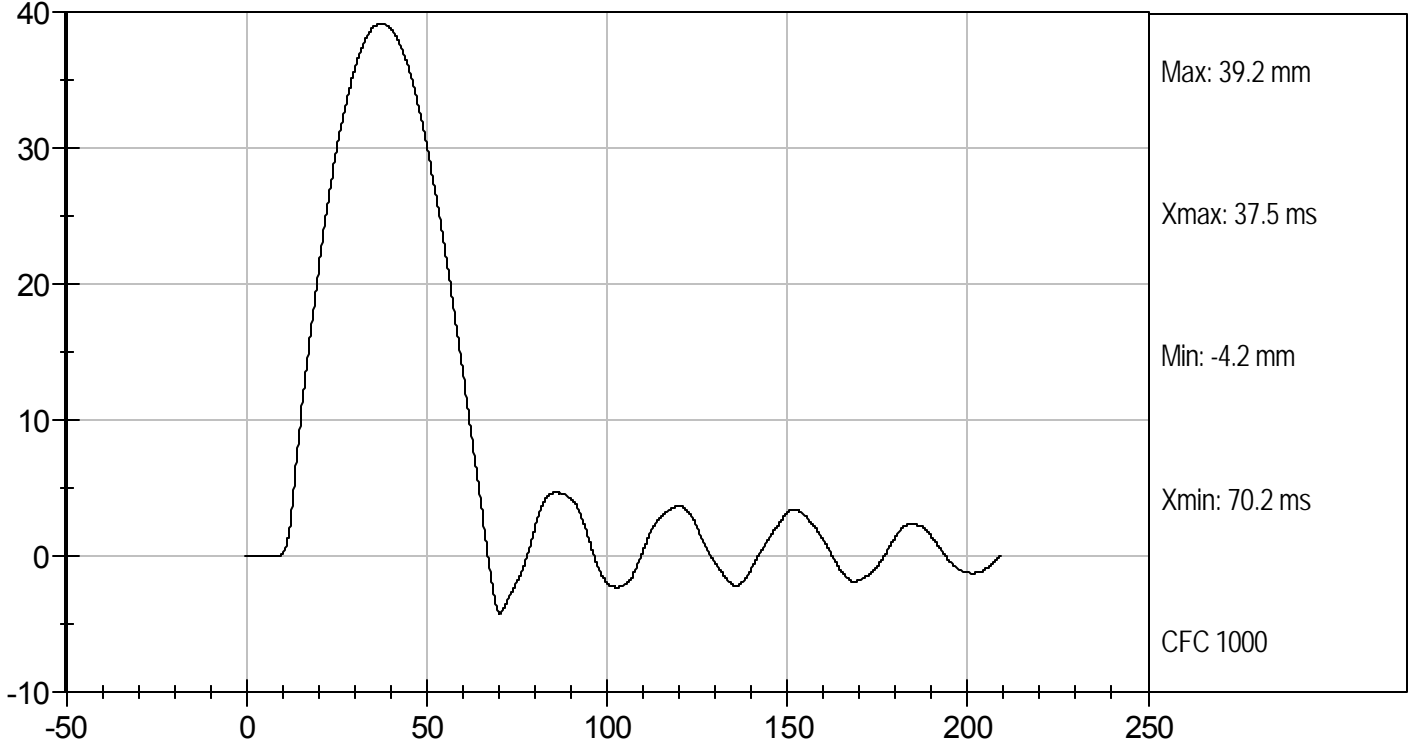
UPPER RIB DISPLACEMENT @ 3 M/SEC (mm) vs TIME (ms)

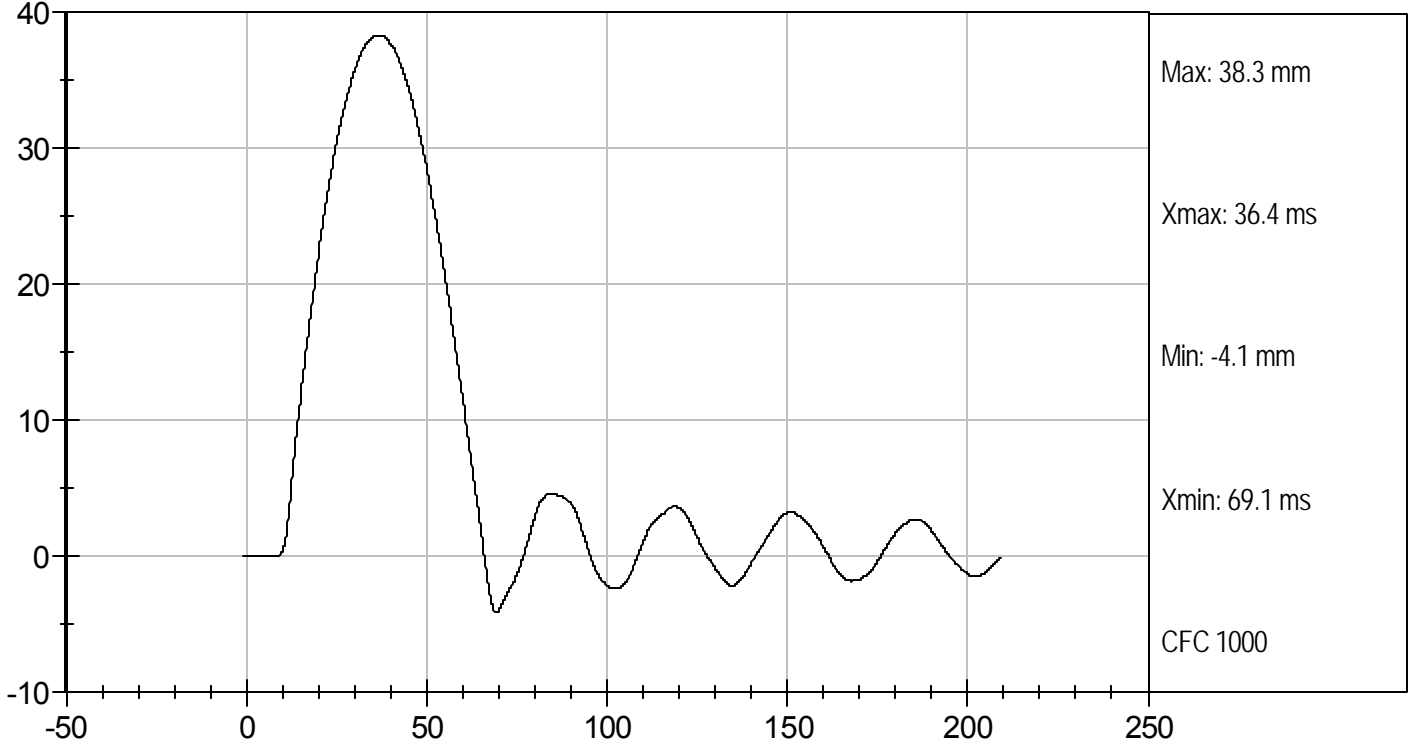
MID RIB DISPLACEMENT @ 3 M/SEC (mm) vs TIME (ms)

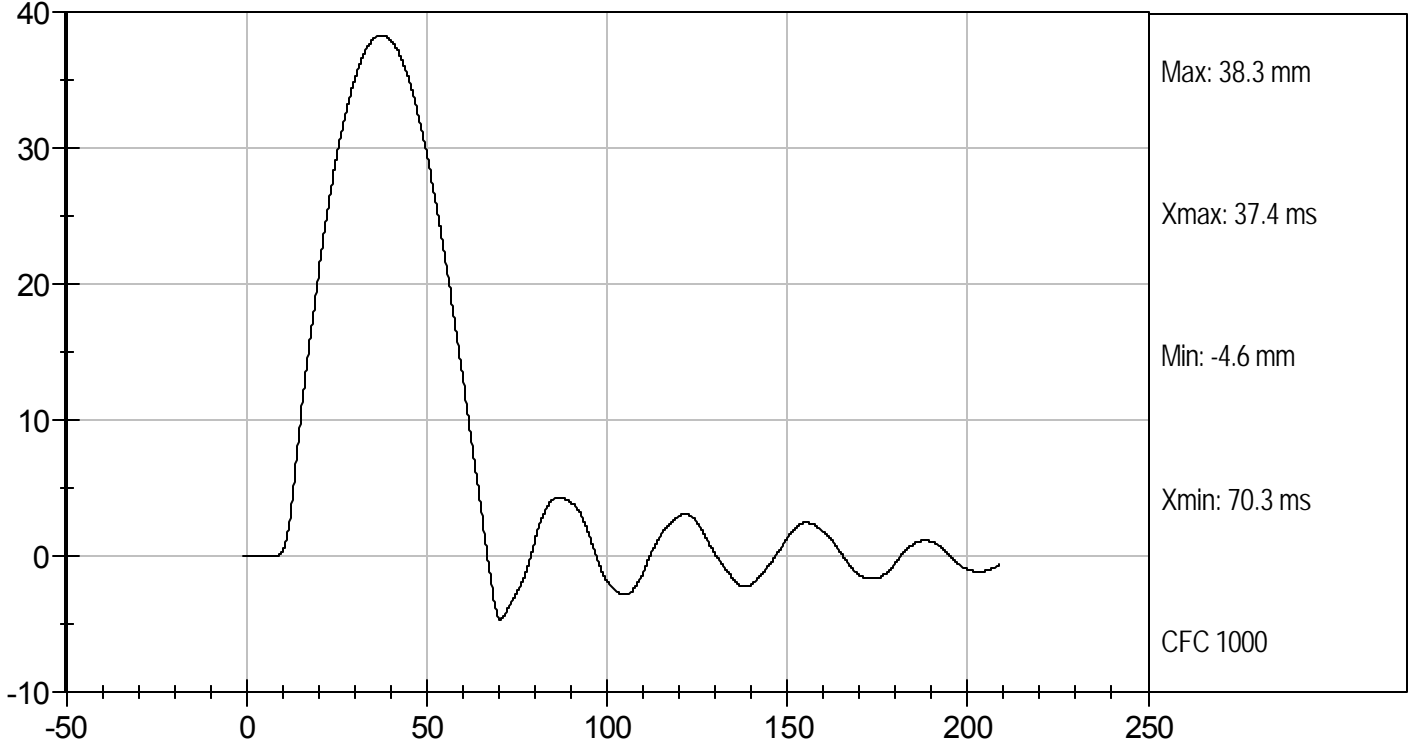
LOWER RIB DISPLACEMENT @ 3 M/SEC (mm) vs TIME (ms)

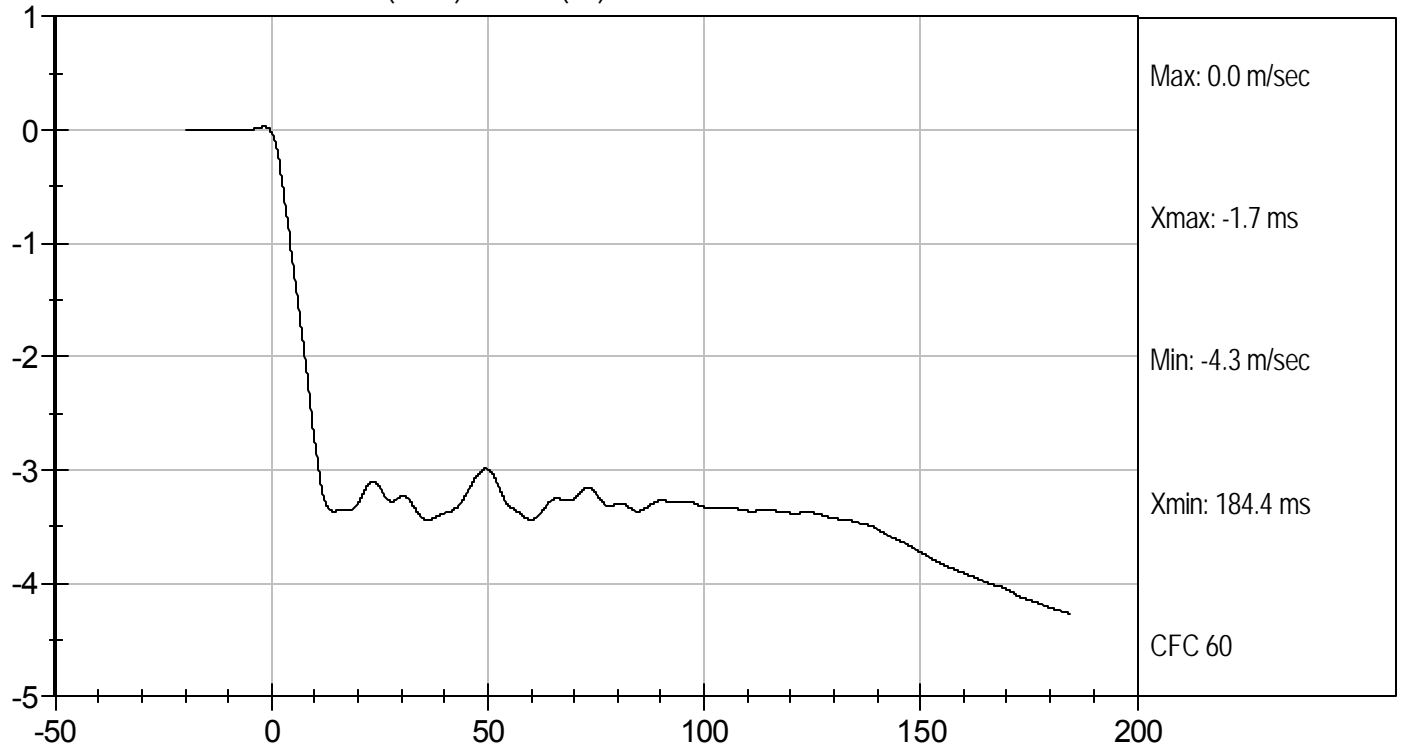
PENDULUM DECELERATION (m/sec) vs TIME (ms)

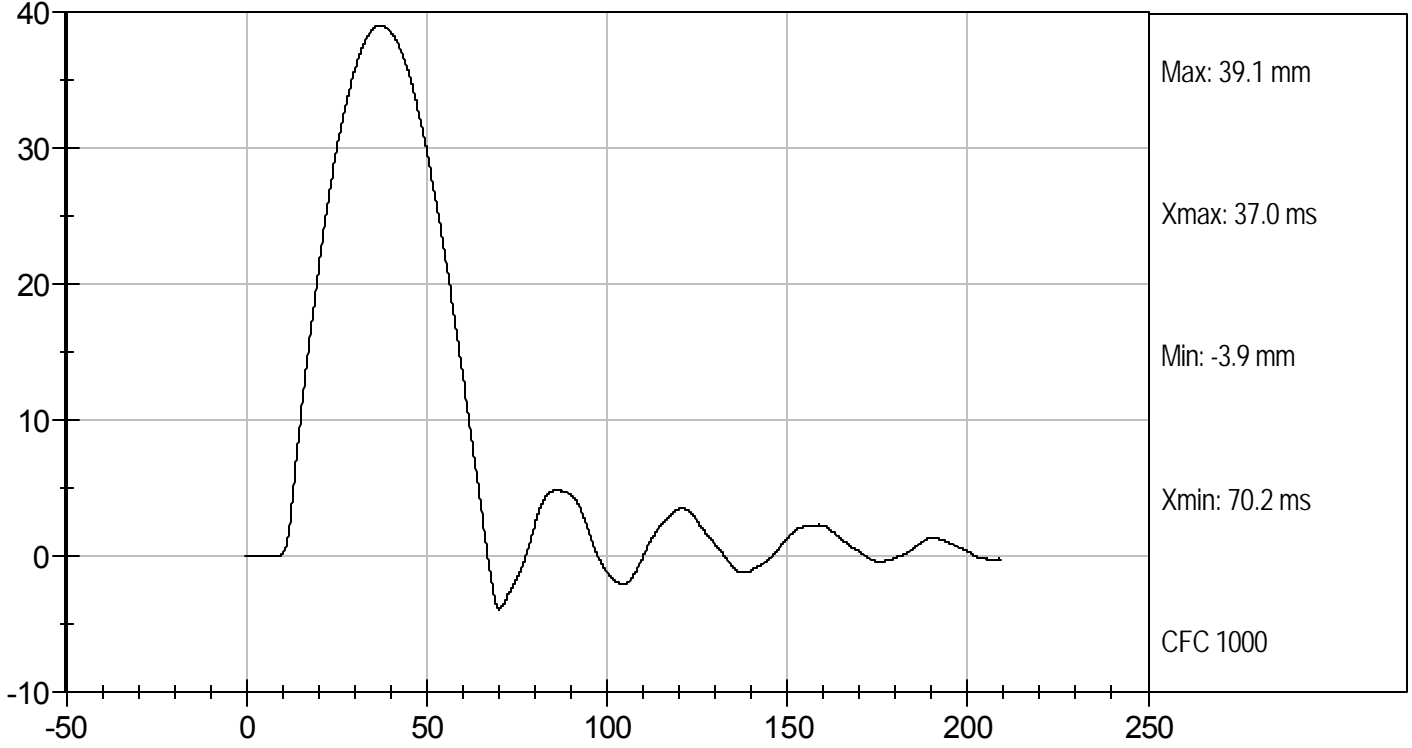
UPPER RIB DISPLACEMENT @ 3 M/SEC (mm) vs TIME (ms)

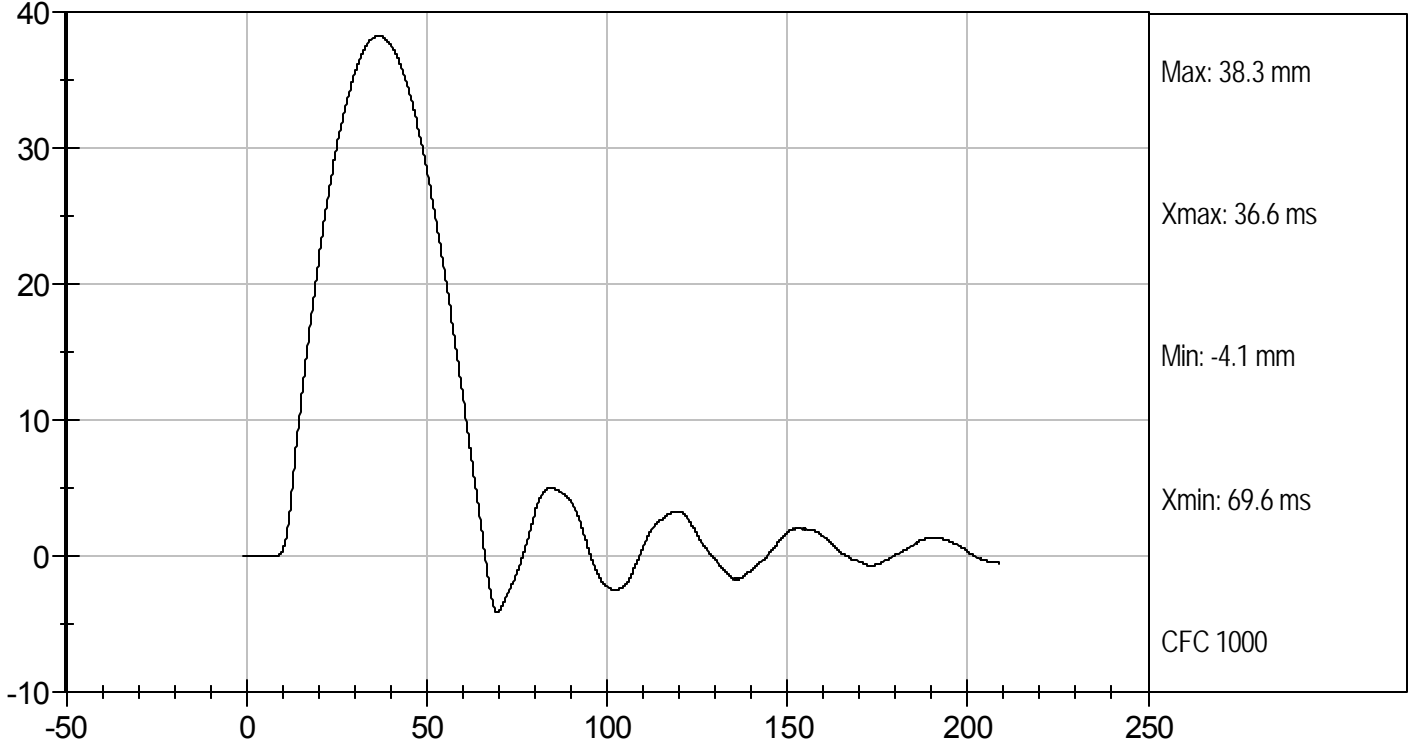
MID RIB DISPLACEMENT @ 3 M/SEC (mm) vs TIME (ms)

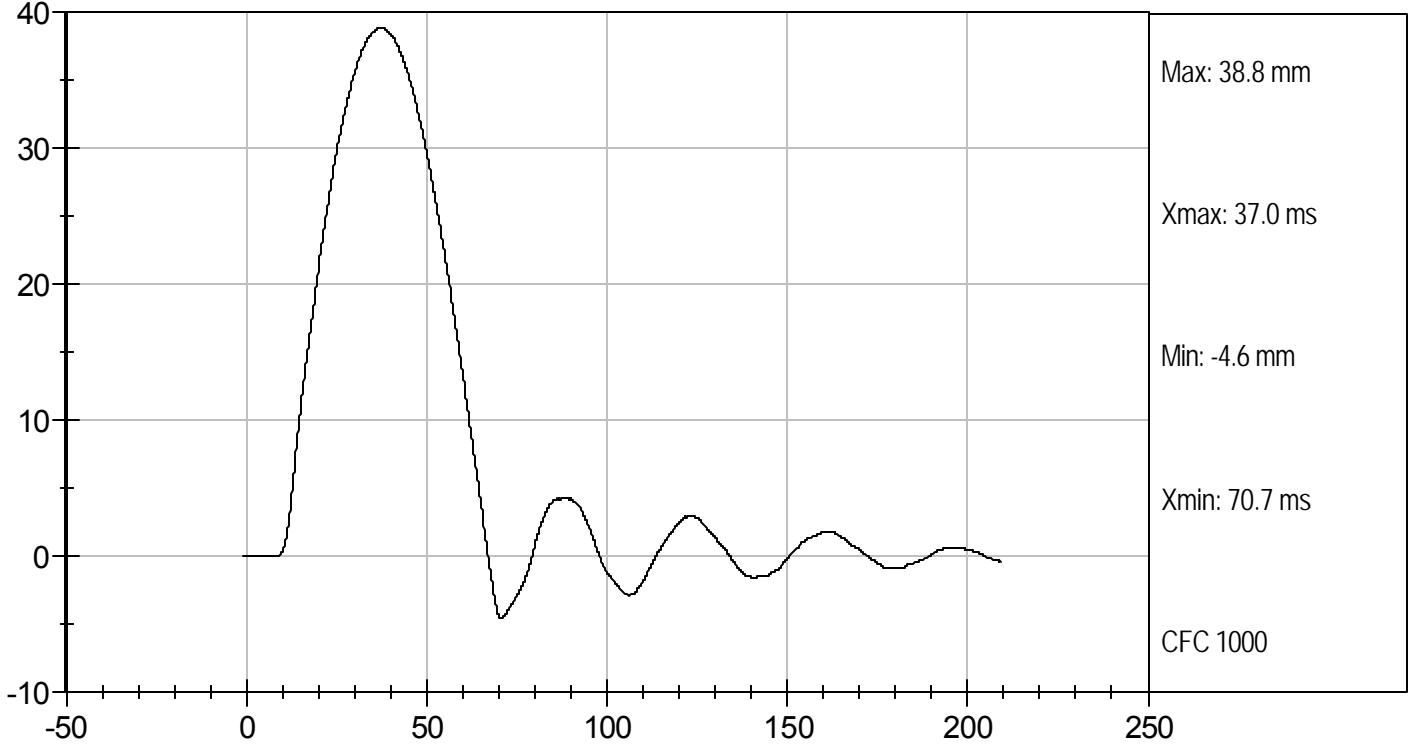
LOWER RIB DISPLACEMENT @ 3 M/SEC (mm) vs TIME (ms)

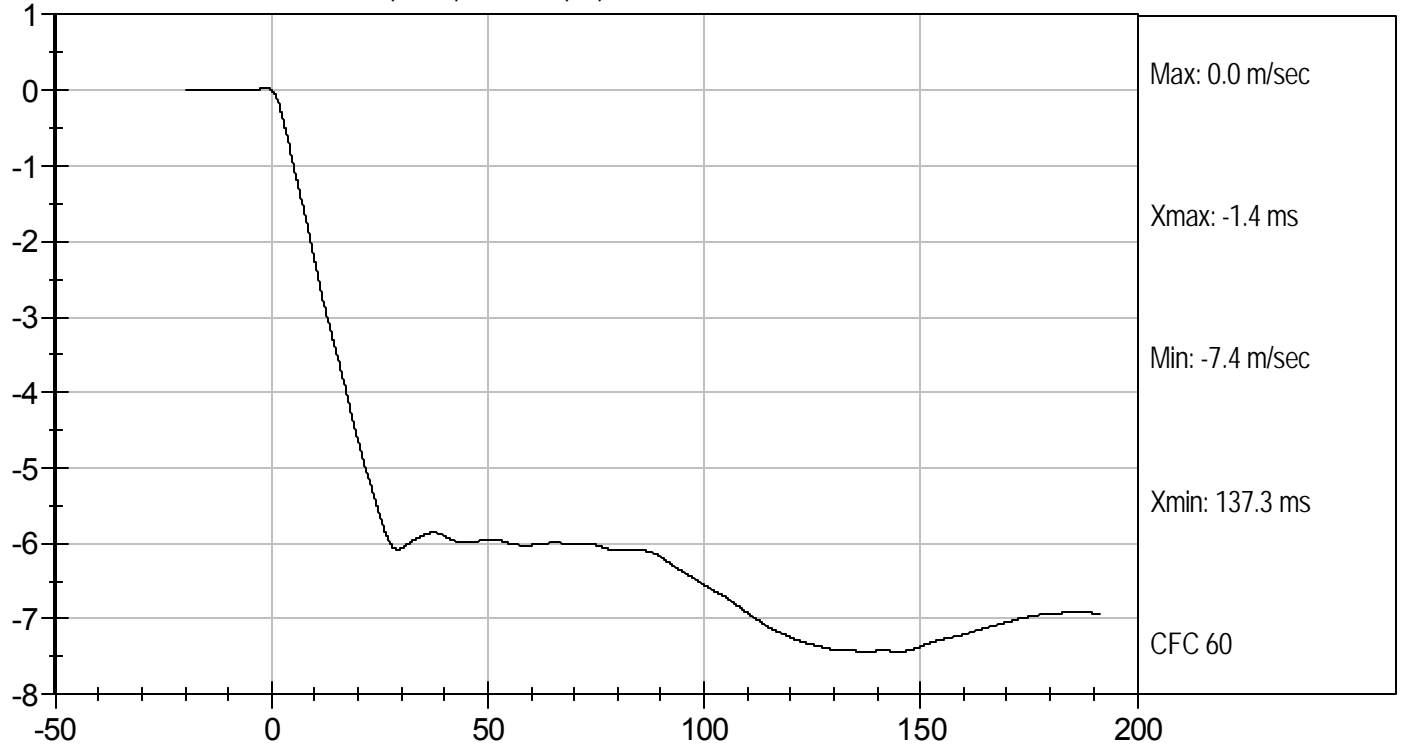
PENDULUM DECELERATION (m/sec) vs TIME (ms)
