FMVSS 212/219/301
ELECTRIC VEHICLE TESTING - GROUP V

JET INDUSTRIES INC.
1981 Electrica (Mercury Lynx)

TEST REPORT

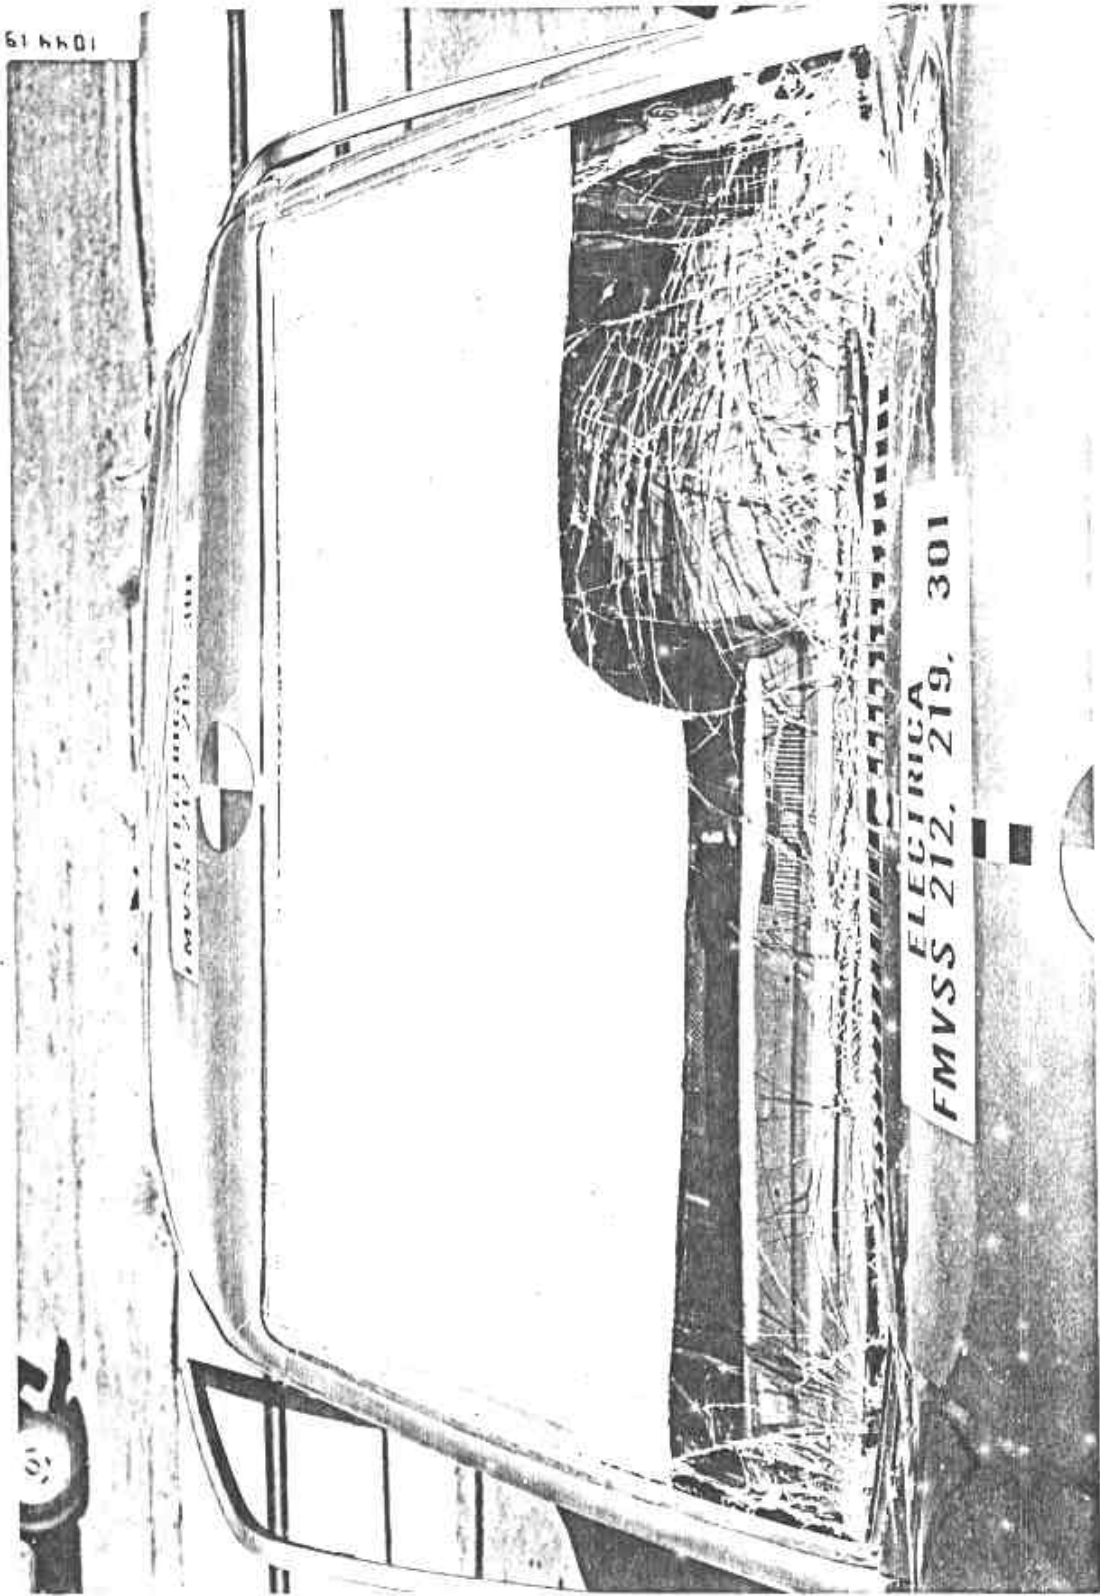
Backlight/Windshield windshield severely cracked along bottom three inches and left side. Moderate cracking of remainder.

AREA OF RETENTION FAILURE: None. Severe cracking in bottom
three inches. Entire windshield cracked.

FIGURE 4-10. POST-TEST VIEW OF WINDSHIELD WITH STYROFOAM - 1981 ELECTRICA (LYNX).

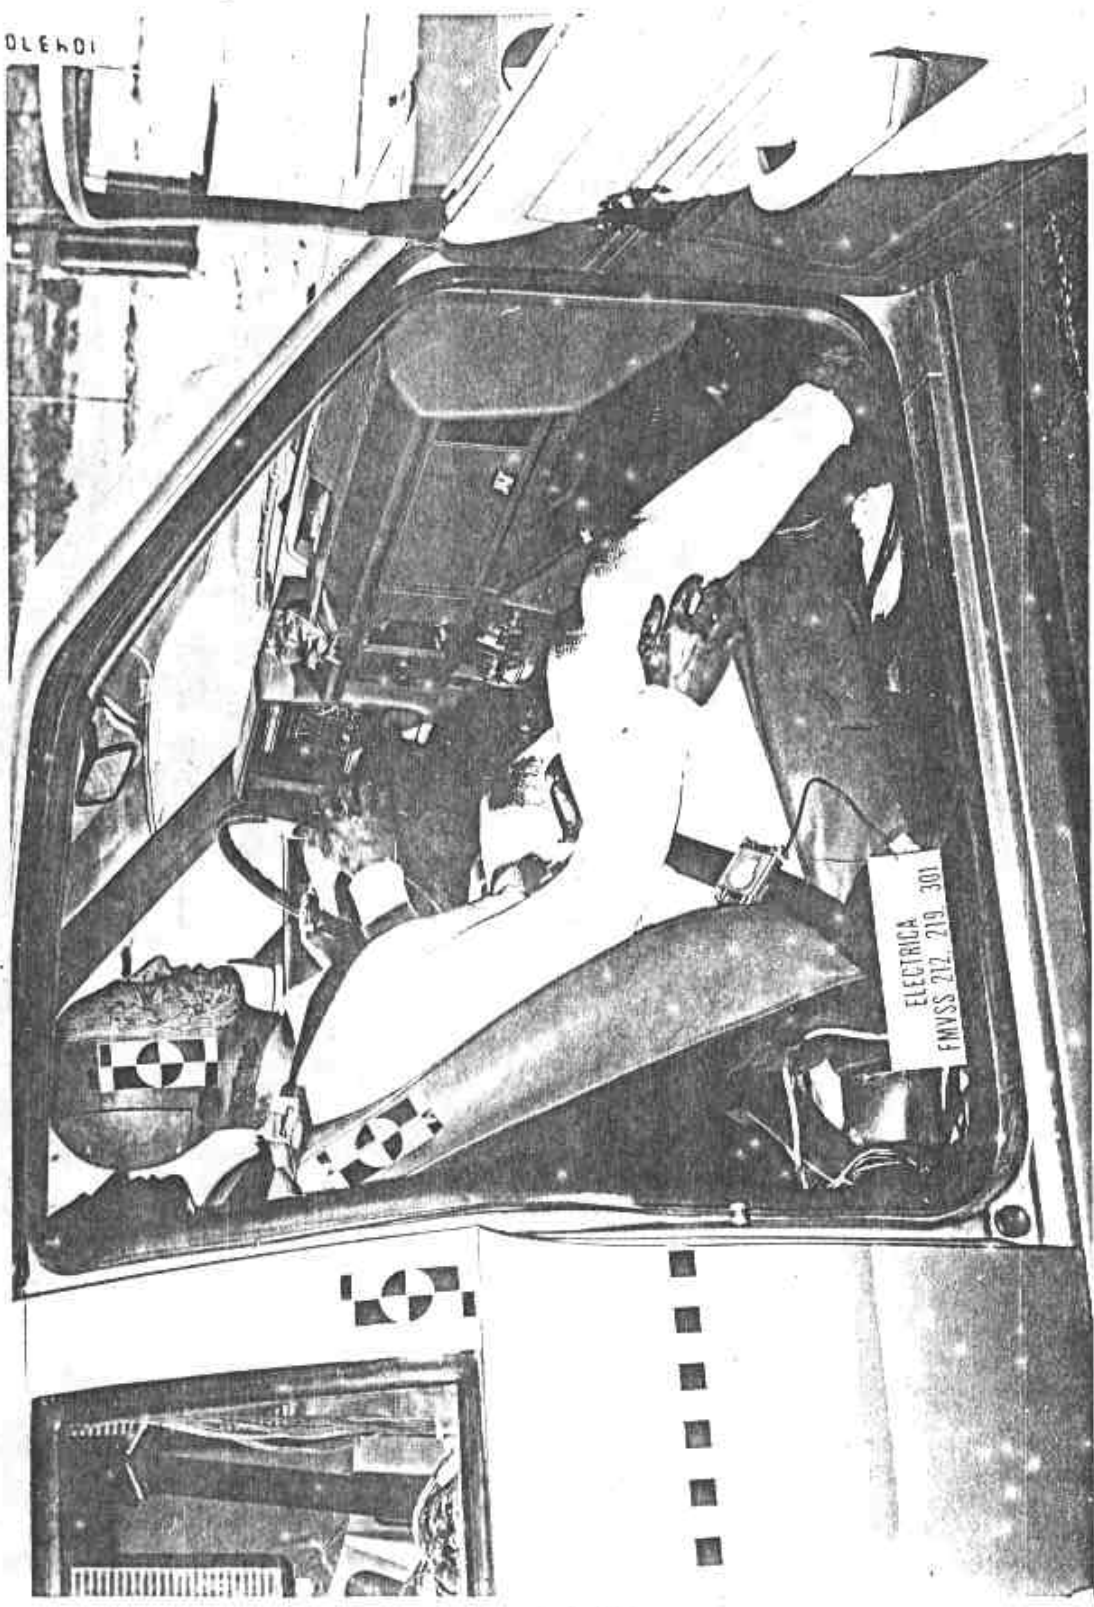
FIGURE 4-14. PRE-TEST VIEW OF PASSENGER DUMMY - 1981 ELECTRICA (LYNX).
