On scene Investigation / Vehicle to Vehicle
Dynamic Science, Inc. / Case Number: DS00003
2000 Ford Taurus
Texas
March, 2000

1. Report No. DS00-003	2. Government Accession No.		3. Recipient Catalog No.	
4. Title and Subtitle In-Depth Accident Investigation		5. Report Date December 26, 2000		6. Performing Organization Report No.

**Dynamic Science, Inc.
Accident Investigation
Case Number: DS00003**

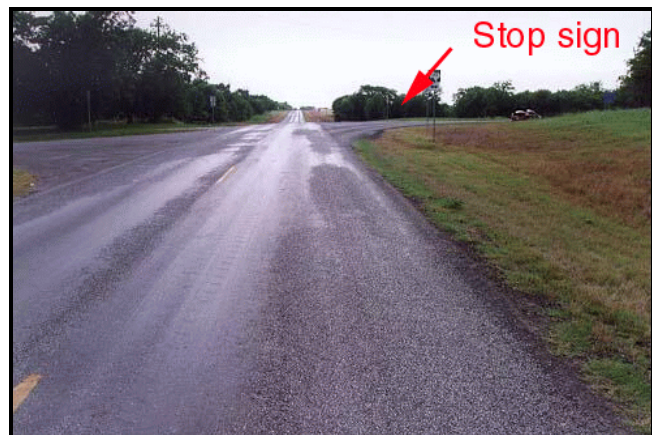
Figure 1. Path of Vehicle 1 (west)

The case vehicle, a 2000 Ford Taurus SE 4-door sedan driven by a restrained 33-year-old male, was traveling westbound at a driver reported speed of 97-105 km/h (60-65 mph).

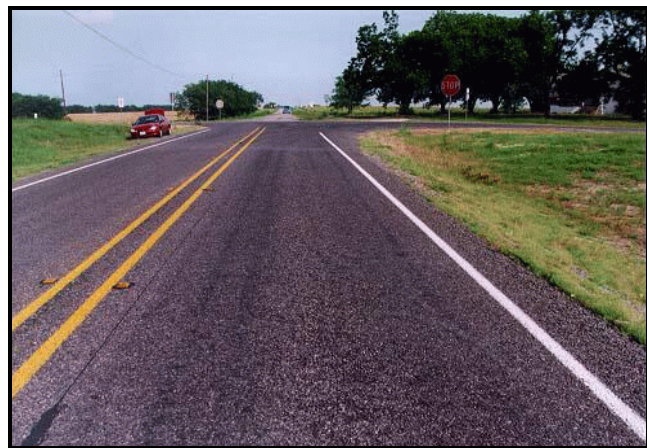
Figure 2. Path of Vehicle 2 (SE)

The other vehicle, a 1995 Ford Aerostar XL Van driven by a restrained 13-year-old female, was traveling southbound and accelerating into the intersection from a stop at an estimated speed of 20 km/h (12.5 mph)¹. She is reported to have been somehow distracted. The front right seat of this vehicle was occupied by a restrained male.

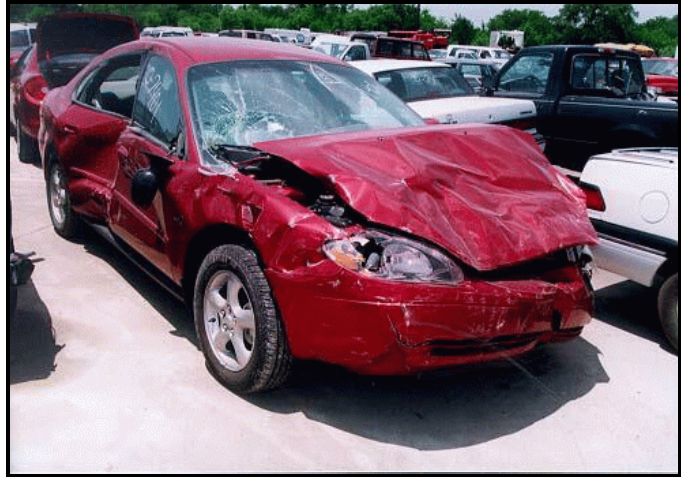
Figure 3. Exterior, Vehicle 1

As the driver of the other vehicle accelerated into the intersection, the front of the case vehicle (12FDEW2) struck the left-front side of the Ford van. The case vehicle sustained a longitudinal delta v of -61.8 km/h (-38.4 mph)² as computed by WinSmash. These results appear high. The downloaded Electronic Data Recorder (EDR) data indicates a cumulative longitudinal delta v of -40 km/h (-25 mph) at the 78 ms mark. The EDR report is included as an attachment to this report.

Description:	2000 Ford Taurus SE 4-door sedan	
VIN:	1FAFP55S0YGXXXXXX	
Odometer:	3,928 km (2,441 miles)	
Engine:	3.0L EFI DOHC V6	
Reported Defects:	None	
Cargo:	None	
Damage Description:	Moderate front to rear crush across front bumper. Hood and right fender damage. Right rear door damaged from second impact.	
CDC:	Impact #1: 12FDEW2 Impact #2: 09RPAW2	
Delta V (Impact #1):	Total	63.9 km/h (39.7 mph)
	Longitudinal	-61.8 km/h (-38.4 mph)
	Latitudinal	-16.6 km/h (-10.3 mph)
	Energy	57,110 joules (42,127 ft-lbs)

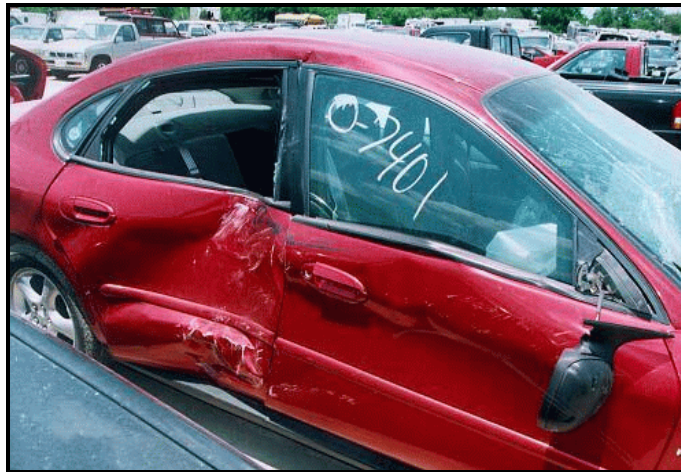
Figure 4. Exterior, Vehicle 1 (impact 2)

The impact caused the case vehicle to rotate in a counterclockwise direction and the other vehicle in a counterclockwise direction. The rear-right of the case vehicle (09RPAW2) "side slapped" the rear-left of the other vehicle. The rear right side glass was broken during this contact. Both vehicles continued moving in a south-west direction and ran off the roadway.

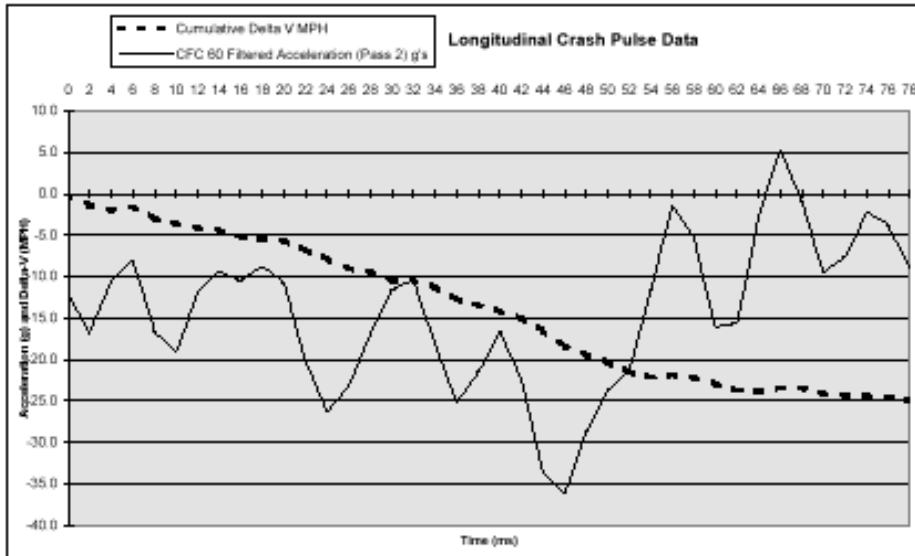
Longitudinal Cumulative Delta-V

Time (ms)	0	10	20	30	40	50	60	70	78
Delta-V (MPH)	-0.2	-3.6	-5.7	-10.3	-14.2	-20.3	-22.9	-24.1	-25.0

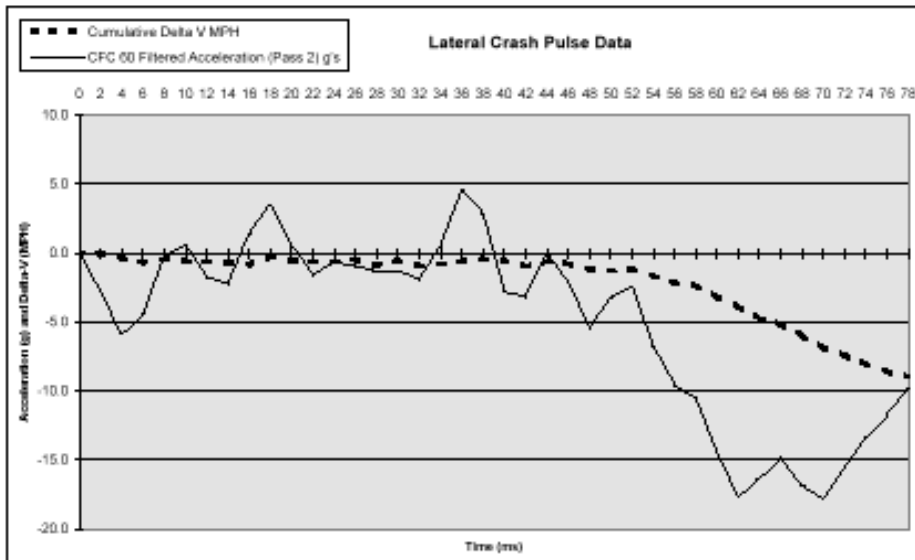
Lateral Cumulative Delta-V

Time (ms)	0	10	20	30	40	50	60	70	78
Delta-V (MPH)	0.0	-0.6	-0.5	-0.5	-0.5	-1.3	-3.2	-6.9	-9.0
