On-scene Investigation / Vehicle to Vehicle
Dynamic Science, Inc. / Case Number: DS00-008
2000 Mercury Sable LS
California
May, 2000

1. Report No. DS00-008		2. Government Accession No.		3. Recipient Catalog No.	
4. Title and Subtitle In-Depth Accident Investigation				5. Report Date	
				6. Performing Organization Report No.

Dynamic Science, Inc.
Accident Investigation
Case Number: DS00-008

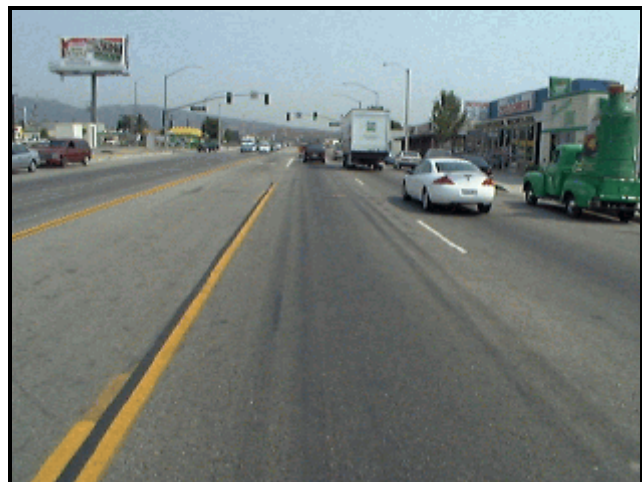
This two vehicle crash occurred in California in May, 2000 at 0835 hours. The crash took place on the approach to a four-leg intersection. The crash occurred on a five-lane, two-way, undivided roadway. The roadway is comprised of two northbound lanes, two southbound lanes, and a reversible center lane that becomes a left hand turn lane as it approaches the intersection.

Figure 1. Approach to area of impact

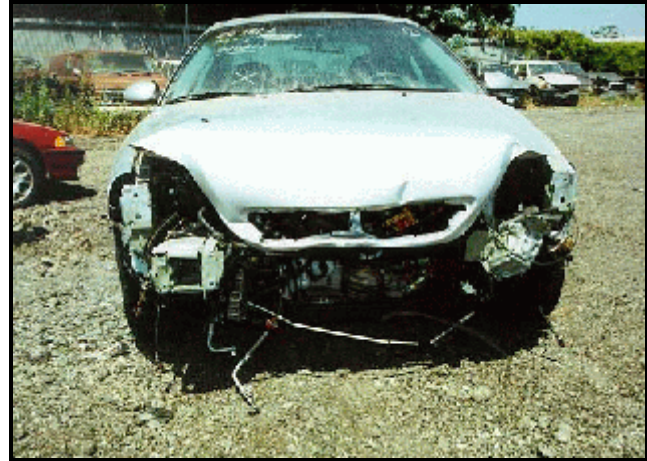
Figure 2. Front view, case vehicle

Description:	2000 Mercury Sable LS four-door	
VIN:	1MEFM55SXYAxxxxxx	
Odometer:	7,111 km (4,419 miles)	
Engine:	V6	
Reported Defects:	None	
Cargo:	None	
Damage Description:	Minor front to rear crush to front bumper and grille.	
CDC:	12FDEW1	
Delta V:	Total	18.9 km/h (11.7 mph)
	Longitudinal	-18.9 km/h (-11.7 mph)
	Latitudinal	0 km/h (0 mph)
	Energy	13,733 joules (10,124 ft-lbs)

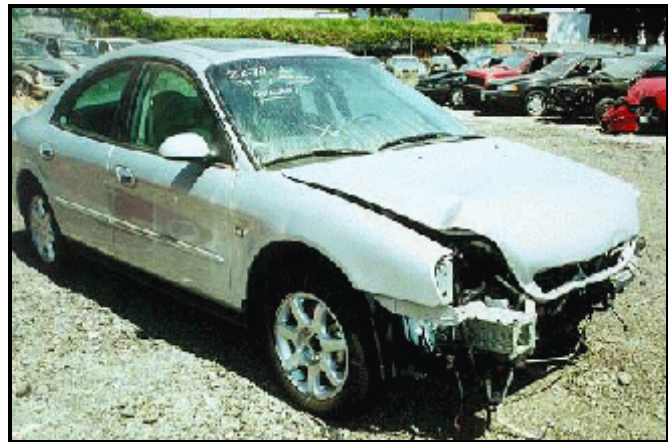
Figure 3. Front right quarter view, case vehicle

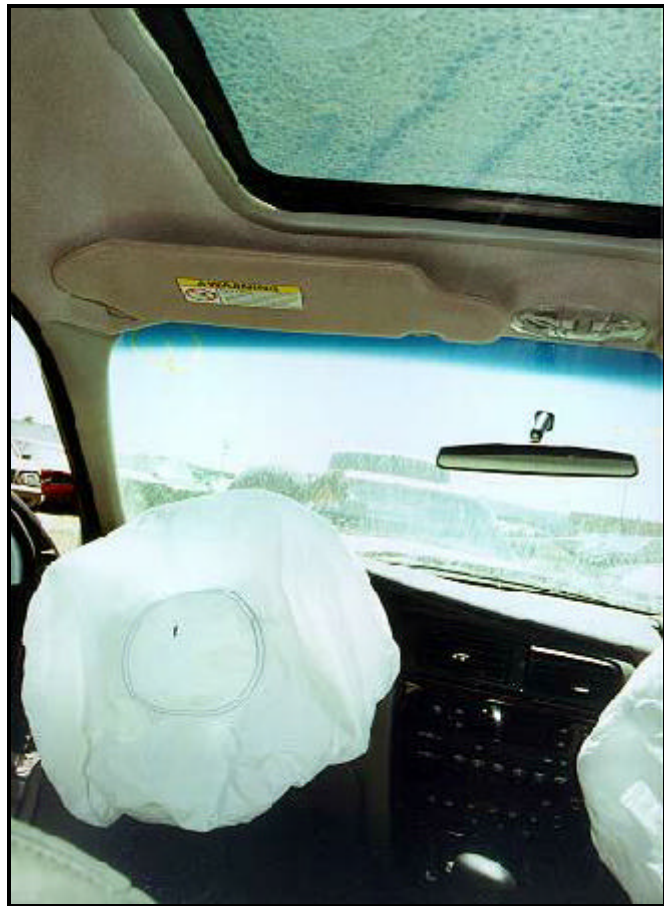
Figure 5. Driver's air bag.

The driver's air bag was circular and measured 43 cm (16.9 in.) in diameter. It was equipped with two tethers and two vent holes. There appeared to be 6 horizontal folds and possibly 11 vertical folds. There were no indications of occupant contact. The module cover opened in an "H" configuration. There were no indications of any damage to the cover.

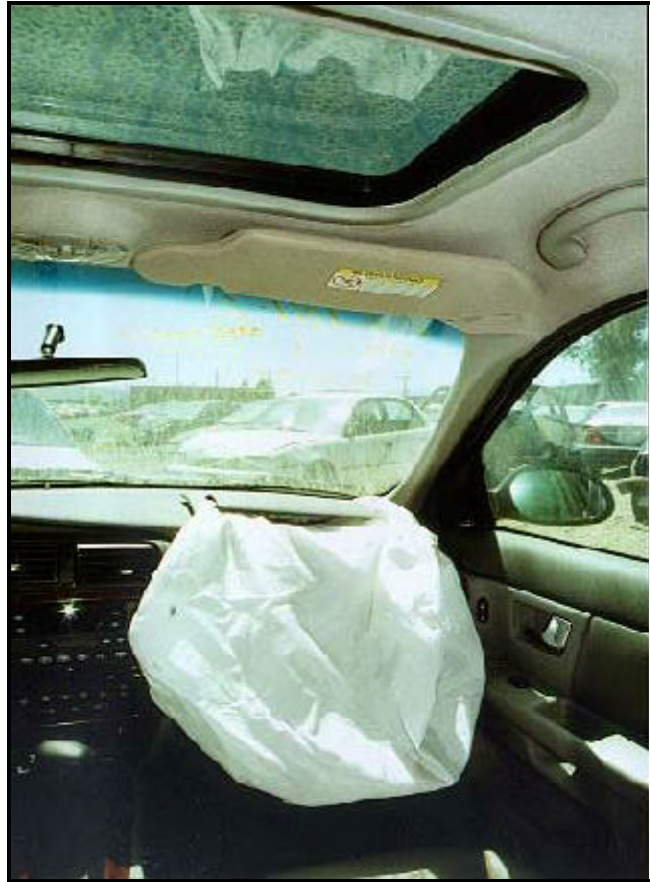
The front right occupant's frontal air bag was rectangular and measured 59 cm (22.8) laterally. It was equipped with two vent ports and did not have any tethers. On the face of the air bag there was cover-related scuffing. The single flap module did not sustain any damage.

Figure 6. Front right passenger's air bag

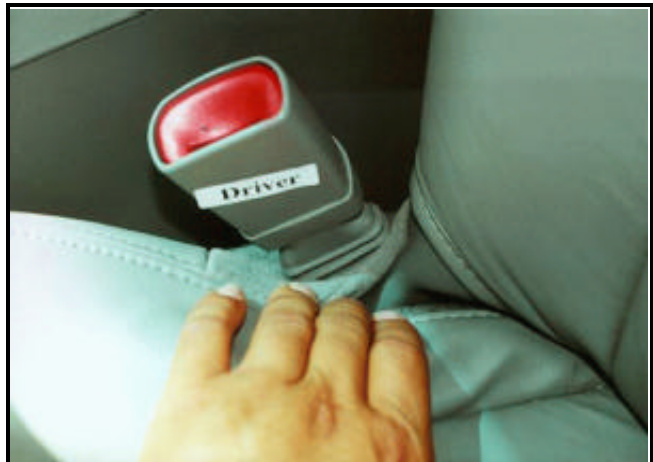
Both front seat positions were equipped with seat belt pretensioners. The pretensioner barrels were checked. The driver's pretensioner measured 5.6 cm (2.2 in)—indicating that it had fired. The passenger's pretensioner measured 10.8 cm (4.3 in.)—indicating that it had not fired.

Figure 7. Driver's seat belt pretensioner—in fired position

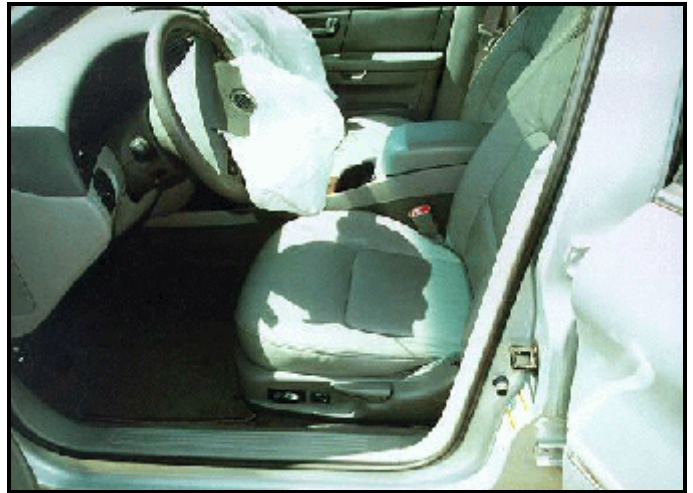
The driver of the case vehicle was seated in a normal, upright fashion. He was wearing the available lap and shoulder belt. The upper anchorage adjustment was in the full up position. The leather-covered bucket seat was adjusted to between the middle and rear most track positions. The seat back angle was 30E. He was wearing prescription glasses with metal frames and plastic lenses.

Figure 8. Driver's seated position

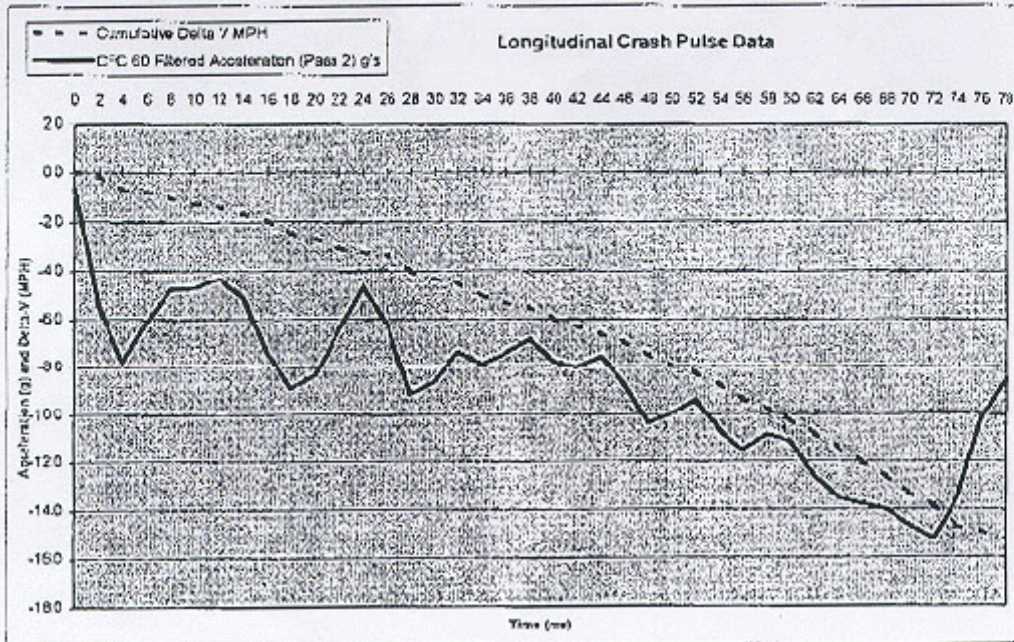
Longitudinal Cumulative Delta-V

Time (ms)	0	10	20	30	40	50	60	70	78
Delta-V (MPH)	0.0	-1.3	-2.7	-4.3	-6.0	-7.9	-10.3	-13.3	-15.3

The downloaded Electronic Data Recorder (EDR) data indicates a cumulative longitudinal delta v of -24.6 km/h (-15.3) and a lateral cumulative delta v of 0.8 km/h (0.5 mph) at the 78 ms mark.

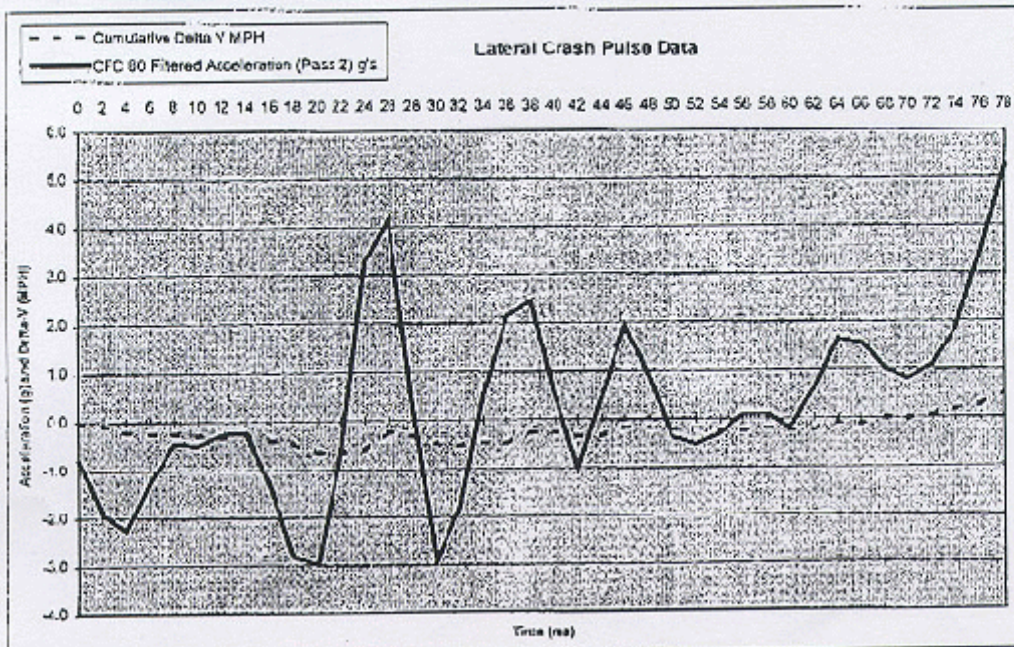
Lateral Cumulative Delta-V

Time (ms)	0	10	20	30	40	50	60	70	78
Delta-V (MPH)	0.0	-0.3	-0.7	-0.5	-0.3	-0.2	-0.3	0.0	0.5
