**VERIDIAN REMOTE SIDE IMPACT OCCUPANT  
PROTECTION SYSTEM INVESTIGATION  
VERIDIAN CASE NO. CA00-016  
VEHICLE: 1997 CADILLAC d'ELEGANCE  
LOCATION: CALIFORNIA  
CRASH DATE: NOVEMBER 1998**

14. <i>Sponsoring Agency Code</i>	
15. <i>Supplementary Notes</i> Remote investigation of a side impact air bag deployment crash that resulted in left rib fractures to the restrained 76 year old male driver.

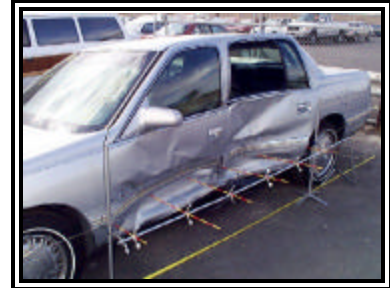
This remote investigation focused on the deployment of a door mounted side impact air bag and the driver injuries associated with the left side impact sequence (**Figure 1**). The crash involved a 1997 Cadillac DeVille d'Elegance that was occupied by a 76 year old male driver and a 76 year old female front right passenger. The Cadillac was equipped with frontal air bags for the driver and right passenger positions and front door mounted side impact air bags. The driver of the Cadillac was restrained by the manual 3-point lap and shoulder belt system. He attempted to enter a four-leg intersection and was struck on the left passenger compartment area by a 1988 Nissan passenger car. The lateral impact crushed the side structure of the Cadillac approximately 29 cm, resulting in 11 cm of intrusion of the front left door panel. The crash deployed the door mounted side impact air bag. The driver sustained an abrasion of the left lateral chest and lateral fractures of left ribs 6-8 with left anterior pneumothorax that resulted from the deployment of the driver's side impact air bag. The front right passenger sustained minor (unspecified) injuries.

**Figure 1. Left side damage to the Cadillac**

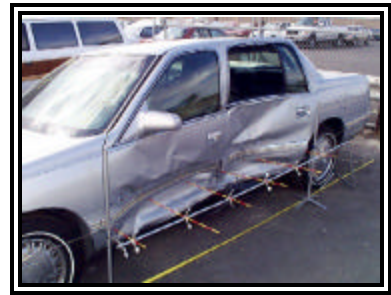
The left side of the Cadillac sustained moderate severity damage as a result of the intersection crash with the 1988 Nissan. The direct contact damage began at the leading edge of the left front door and extended rearward approximately 184 cm (72") to the trailing edge of the left rear door. Maximum crush was estimated at 29 cm, located on the left rear door, aft of the B-pillar. The Collision Deformation Classification (CDC) for this impact event was 09-LPEW-3 (**Figure 2**). Damaged components included both left doors, the left B-pillar, the left sill, and the left rear door glazing. All other glazing remained intact.

**Figure 2. Left side damage to the Cadillac.**

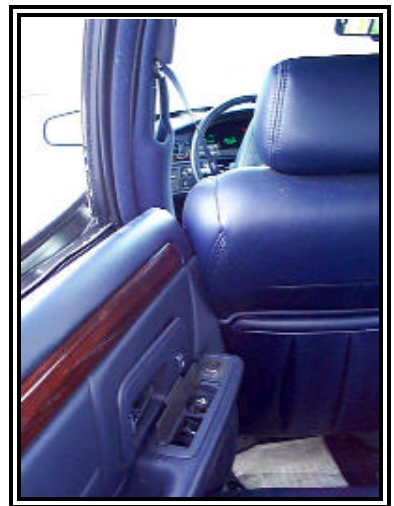
The interior of the Cadillac sustained moderate damage and was associated with intrusion and side impact air bag deployment. Maximum intrusion involved approximately 20 cm of lateral displacement of the left rear door panel. The left front door panel intruded approximately 11 cm into the driver's space. The left B-pillar was reportedly intruded approximately 14 cm laterally.

**Figure 3. Intrusion of the left door and B-pillar components.**

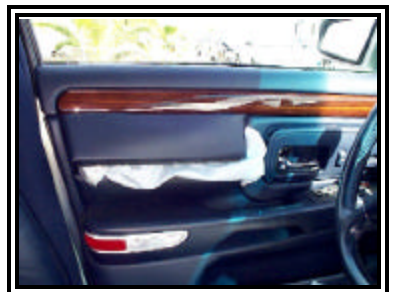
The side impact air bag system consisted of door mounted side air bag modules that were concealed by H-configuration cover flaps within the padded interior door panel (**Figure 4**). Side impact sensing was achieved by sensors located in the mid aspect of the front doors. The left side impact air bag deployed as a result of the intersection crash.

**Figure 4. Left side impact air bag module.**

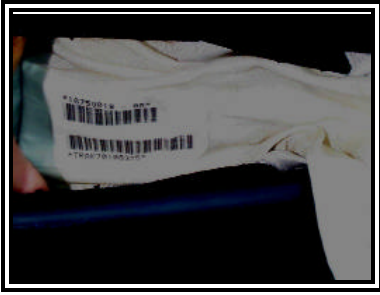
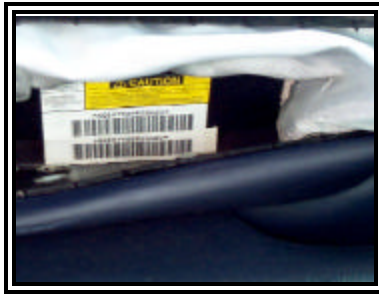
**Figure 5. Air bag nomenclature.**

**Figure 6. Nomenclature on the lower module cover flap.**

The left side impact air bag module was identified by the following nomenclature (**Figures 5 and 6**):

16759018-16  
TRAK70108375

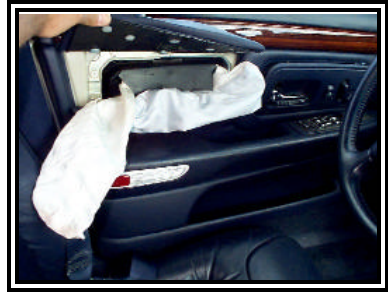
**Figure 7. Air bag membrane and the module flap system.**

The left side impact air bag membrane was folded and rolled into the module. A second flap system concealed the bag within the module (**Figure 7**). These H-configuration flaps opened at the designated seams. Data from General Motors listed the capacity of the side air bag at 12 liters with a “may” deploy threshold of 13 km/h (8 mph) and a must deploy threshold of 21 km/h (13 mph).

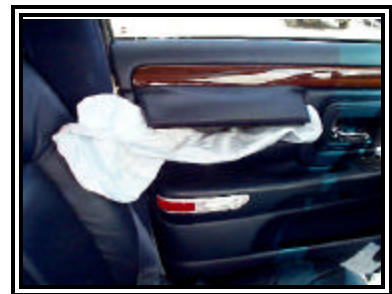
As the Cadillac was impacted on the left side by the Nissan, the left door mounted side impact air bag deployed. The door also intruded approximately 11 cm into the driver’s space. The left lateral chest of the driver was exposed to the expanding side impact air bag. As the bag deployed, the upper cover flap and the bag membrane (**Figure 8**) contacted the lateral chest of the driver which resulted in an abrasion of the lateral chest and fractures of left ribs 6-8 with minor left pneumothroax.

**Figure 8. Expanding side impact air bag.**
