**VERIDIAN REMOTE AIR BAG RELATED CHILD FATALITY INVESTIGATION  
SCI TECHNICAL SUMMARY REPORT**

**VERIDIAN CASE NO. CA00-051**

**SUBJECT VEHICLE - 1994 PLYMOUTH VOYAGER**

**CRASH DATE - DECEMBER 1999**

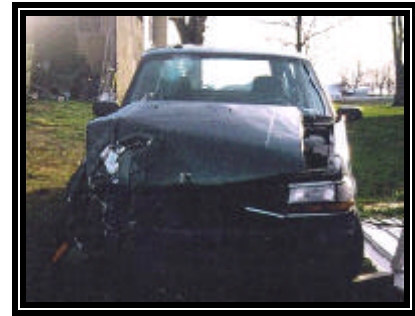
This remote investigation focused on a 1994 Plymouth Voyager (Figure 1) equipped with frontal air bags for the driver and front right passenger positions that deployed as a result of a frontal collision with the right side of the power unit of a tractor, semi-trailer. The Voyager was occupied by a 31-year-old female driver and an 8-year-old male front right child passenger. The driver of the Voyager stated that both occupants were restrained by the manual 3-point lap and shoulder belts, however restraint usage could not be confirmed. The 8-year-old child may have been seated forward on the front right seat cushion and was displaced forward from pre-crash braking. At impact, both occupants initiated forward trajectories. The driver probably contacted the deployed driver's air bag and the police reported that she did not sustain injury. The out-of-position child was projected vertically into the windshield by the expansion of the air bag. It is possible that he may have altered the deployment of the air bag into the windshield. He sustained closed head injuries and multiple cervical spine fractures. He was transported by ambulance to a local hospital and transferred by helicopter to a regional children's hospital. He expired the day following the crash.

**Figure 1. 1994 Plymouth Voyager**

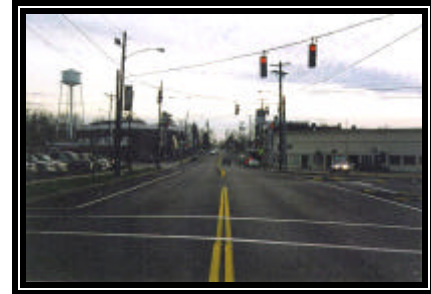
The 1994 Plymouth Voyager was southbound on the north leg of the intersection (**Figure 2**). The driver stopped at the flashing red traffic signal and proceeded into the intersection. The driver of the Voyager stated that she was distracted and had turned her head to look for something in the vehicle. The tractor, semi-trailer was northbound on the south leg of the intersection (**Figure 3**). The truck driver stopped at the flashing red traffic signal and initiated a left turn onto the one-way westbound roadway across the Voyager's path of travel. As the Voyager continued across the intersection, the driver realized the impending harmful event. According to the police report, she could not remember if she had applied the brakes or pressed the accelerator pedal, but it was likely that she applied the brakes. There did not appear to be any pre-impact skid marks within the Voyager's trajectory.

**Figure 2. Southbound approach for the Voyager**

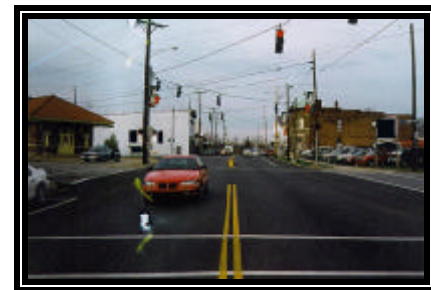
**Figure 3. Northbound approach for the truck**

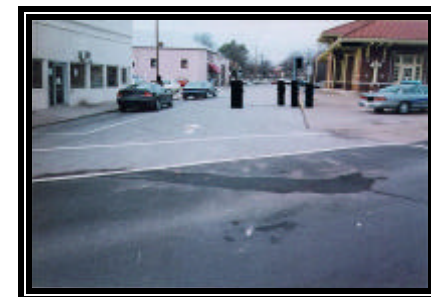
As the Plymouth Voyager traveled through the intersection, the front right area impacted the right leading drive axle of the power unit of the tractor, semi-trailer. Impact resulted in moderate damage to the Voyager and minimal damage to the tractor. The Voyager was redirected rearward in a slight clockwise (CW) rotation as the truck continued forward. The resultant direction of force was in the 11 o'clock sector for the Voyager. The barrier routine of the WinSMASH program calculated a barrier equivalent speed of 22.1 km/h (13.7 mph) based on an estimated crush profile of the Voyager. The longitudinal and latitudinal components were -19.1 km/h (-11.9 mph) and 11.0 km/h (6.9 mph), respectively. A gouge mark and a tire mark within the trajectory of the right front wheel of the Voyager were noted at the point of impact in the police photographs (**Figure 4**).

**Figure 4. Westbound view of the point of impact with the gouge mark and tire mark visible**

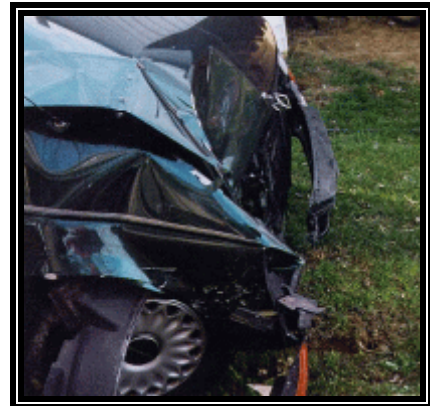
The 1994 Plymouth Voyager sustained moderate damage as a result of the impact with the truck (**Figure 5**). The front plastic bumper fascia was completely separated from the vehicle, and was fractured laterally in the center and fractured vertically approximately 46 cm (18") to the right of the centerline on the top aspect. Multiple abrasions were also noted on the right corner of the front bumper fascia. The bumper beam was fractured approximately 46 cm (18") to the right of the centerline, and the portion to the right of the fracture was completely separated. The lower radiator support was crushed rearward behind the bumper beam approximately 10 cm (4") on the front left and center aspects. The upper radiator support and radiator core were both crushed rearward. The maximum crush was estimated to be 25 cm (10") and located at C5, approximately 46 cm (18") to the right of the centerline (**Figure 6**). The hood was displaced to the right approximately 30 cm (12"), and buckled at the designated fold points. The right front fender was crushed rearward against the right front wheel and was displaced to the right. It appeared that the right front wheel was restricted in the police photographs. The right headlamp assembly was fractured and displaced. The Collision Deformation Classification (CDC) for this impact was 11-

**Figure 5. Lateral view of frontal damage**

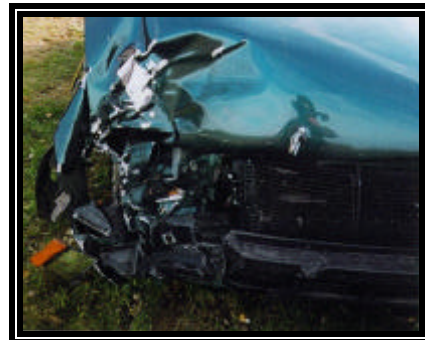
**Figure 6. Frontal damage showing maximum crush**

FREW-2. Six crush measurements were estimated at the level of the lower radiator support and were as follows: C1 = 5 cm (2"), C2 = 10 cm (4"), C3 = 15 cm (6"), C4 = 20 cm (8"), C5 = 25 cm (10"), C6 = 20 cm (8").

The police vehicle inspection indicated that the post-crash overall length was shortened by 46 cm (18"), and the wheelbase was shortened by 18 cm (7").

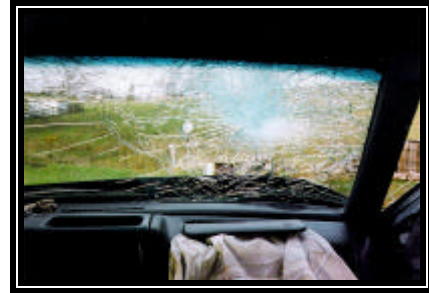
Interior damage to the 1994 Plymouth Voyager appeared to be moderate and was attributed to occupant contact. The windshield glazing was fractured in a spider-web fashion directly above the front right passenger's air bag module (**Figure 7**). The rearview mirror was separated from the windshield. The cargo drawer under the front right passenger's seat was displaced forward from impact forces. There did not appear to be any occupant contact to the instrument panel area.

**Figure 7. Interior view showing windshield damage**

The child passenger was placed out-of-position forward over the deployment path of the air bag due to pre-crash braking. At impact, the frontal air bag system deployed. The expansion of the air bag accelerated the child's forehead into the windshield, as evidenced by the spider-web type fracture in the glazing. The child may have received the closed head injury from the windshield strike as a result of the vertical air bag expansion. The spider-web fracture in the glazing appears consistent with a head strike, even though there was no hair or tissue transfers identified in the fractured windshield. It was not known what type of clothing the child was wearing, or if he may have been wearing a hat, which may have mitigated any transfers. As the air bag continued to expand against the child, his head was deflected rearward which hyper-extended the neck resulting in numerous cervical spine fractures. He probably rebounded rearward into the seat back and came to rest in the seat.

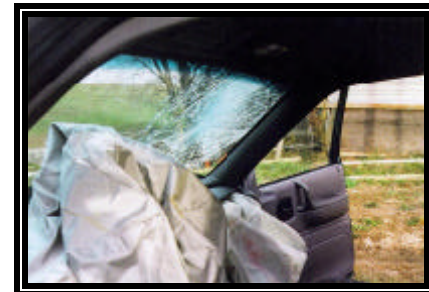
The 1994 Plymouth Voyager was equipped with frontal air bags for the driver and front right passenger positions that deployed as a result of the impact with the truck (**Figure 8**). The driver's air bag was housed in the center of the steering wheel with H-configuration module cover flaps.

**Figure 8. Frontal air bag system in the Voyager**

The front right passenger's air bag deployed from a top mounted module located in the right upper-instrument panel with a single cover flap design hinged at the forward aspect. The cover flap was rectangular in shape. Blood was identified on the front left aspect of the air bag in the police photographs.
