**REMOTE AIR BAG RELATED CHILD PASSENGER FATALITY INVESTIGATION  
SCI TECHNICAL SUMMARY REPORT**

**VERIDIAN CASE NO. CA00-055**

**VEHICLE - 1997 CHEVROLET CAVALIER**

**CRASH DATE - DECEMBER 1999**

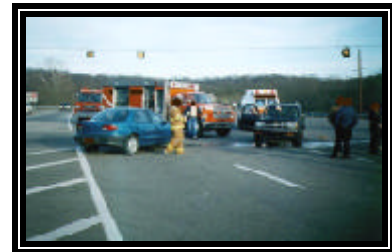
**Figure 1. Crash site showing the final rest positions of both vehicles**

As the Cavalier entered the intersection, the front area of the Cavalier impacted the left center area of the Chevrolet Blazer. Impact resulted in moderate damage to both vehicles. The principal direction of force was in the 1 o'clock sector for the Cavalier and in the 10 o'clock sector for the Blazer. The damage algorithm of the WinSMASH program computed velocity changes of 17.0 km/h (10.6 mph) for the Cavalier. The longitudinal and lateral components were -16.0 km/h (-9.9 mph) and -5.8 km/h (-3.6 mph), respectively. Impact induced deceleration was sufficient to deploy the frontal air bag system in the Cavalier. The damage algorithm of the WinSMASH program computed velocity changes of 13.0 km/h (8.1 mph) for the Blazer. The longitudinal and lateral components were -6.5 km/h (-4.0 mph) and 11.3 km/h (7.0 mph), respectively. The front left area of the Cavalier under rode the left side of the Blazer forward of the left rear wheel. This caused both vehicles to rotate in a counterclockwise (CCW) direction approximately 30 degrees before disengagement. The Cavalier rotated CCW approximately 90 degrees from impact to final rest, and the Blazer rotated CCW approximately 170 degrees from impact to final rest (**Figure 1**).

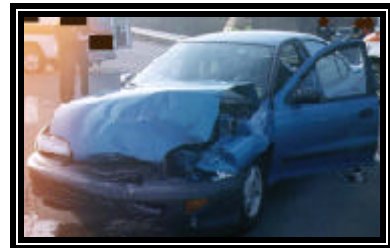
**Figure 2. Frontal damage to the Cavalier**

The 1997 Chevrolet Cavalier sustained moderate damage as a result of the impact with the Chevrolet Blazer. The Collision Deformation Classification (CDC) for the frontal impact to the Cavalier was 01-FYEW-2. The direct and induced damage involved the entire frontal width of the Cavalier (**Figure 2**). Direct contact damage along the front of the Cavalier began approximately 15 cm (6") to the right of the centerline and extended laterally to the left bumper corner. The bumper fascia was cracked on the lower aspect approximately 15cm (6") to the left of the centerline and had contact damage on the top aspect from the under ride to the Blazer. The left bumper corner was displaced rearward and downward. The left fender was displaced rearward and buckled toward the center of the Cavalier (**Figure 3**). The hood was buckled at the designated fold points. The direct and induced damage involved the entire frontal width of the Cavalier. Six crush measurements were estimated at the level of the bumper from the on-scene photographs: C1 = 40 cm (16"), C2 = 35 cm (14"), C3 = 25 cm (10"), C4 = 10 cm (4"), C5 = 5 cm (2"), C6 = 0 cm.

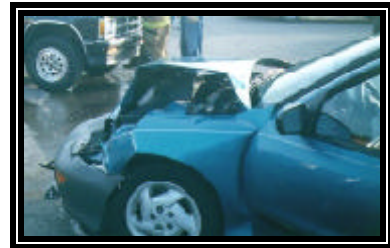
**Figure 3. Damage to the left bumper corner and left fender**

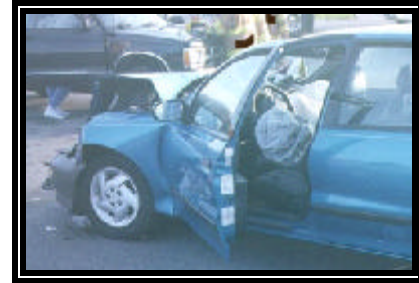
**Figure 4. Interior view through the left front door**

Interior damage to the 1997 Chevrolet Cavalier was based on exterior police photos, and appeared to be minimal (**Figure 4**). The windshield was cracked on the right side, but it was unknown if it was due to occupant contact.

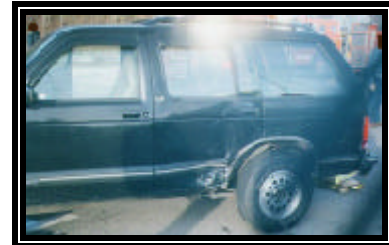
**Figure 5. Exterior damage to the Blazer**

The 1994 Chevrolet Blazer sustained moderate left side damage as a result of the impact with the Chevrolet Cavalier. The Collision Deformation Classification (CDC) was 10-LPEW-2. Direct contact damage began on the lower aspect of the left rear door, approximately 38 cm (15") aft of the B-pillar and extended approximately 30 cm (12") rearward to the left rear wheel. The direct damage extended vertically from the bottom edge of the left rear door approximately 45 cm (18"). The direct and induced damage involved the entire lower half of the left rear door (**Figure 5**). The left rear wheel was rotated counterclockwise (CCW) approximately 10 degrees, and the rear axle displaced rearward on the left side. Six crush measurements were estimated at the trim level on the left rear door: C1 = 0 cm, C2 = 4 cm(2"), C3 = 15 cm (6"), C4 = 10 cm (4"), C5 = 5 cm(2"), C6 = 0 cm.
