On-scene Investigation / Vehicle to Vehicle
Dynamic Science, Inc. / Case Number: DS01-003
2000 Ford Taurus
California
December, 2000

1. Report No. DS01-003		2. Government Accession No.		3. Recipient Catalog No.	
4. Title and Subtitle In-Depth Accident Investigation				5. Report Date	
				6. Performing Organization Report No.

Dynamic Science, Inc.
Accident Investigation
Case Number: DS01-003

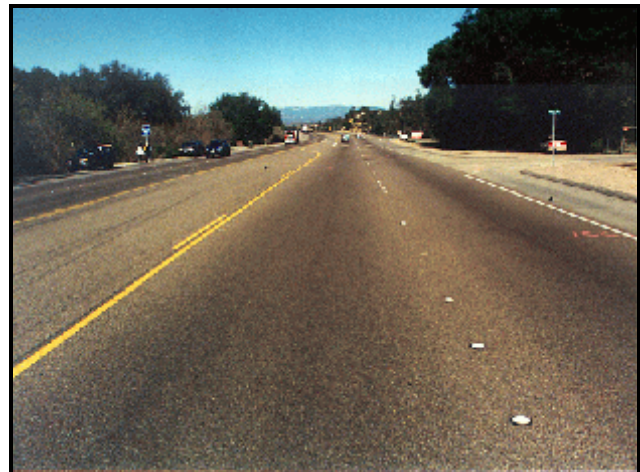
Figure 1. Approach to area of impact, case vehicle

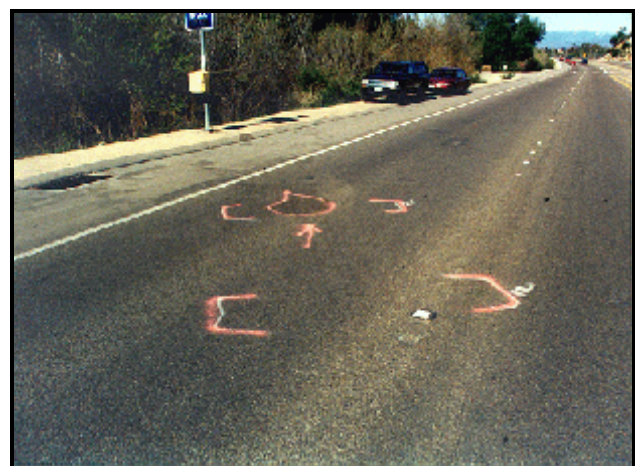
Figure 2. Final rest, case vehicle

After impact, the case vehicle rotated counterclockwise and came to final rest in the southbound travel lanes heading northwest. The Chevrolet rotated clockwise and came to final rest in the northbound travel lanes heading northeast.

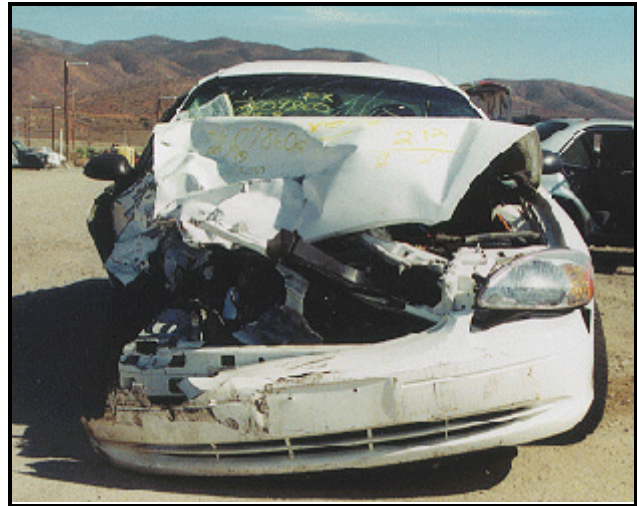
Figure 3. Front view, case vehicle

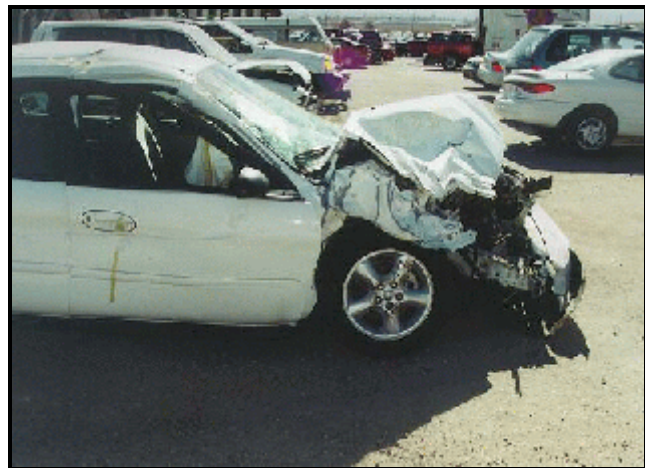
Figure 4. Right side, case vehicle

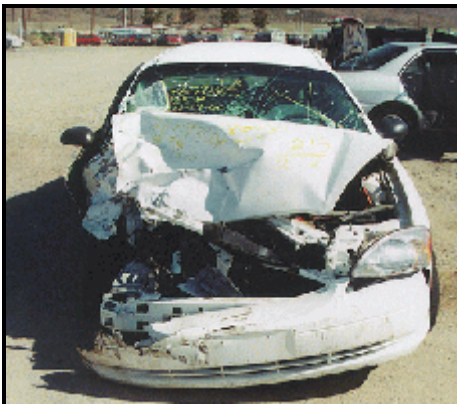
Description:	2000 Ford Taurus LX 4-door	
VIN:	1FAFP52UXYGxxxxxx	
Odometer:	24,526 km (15,240 miles)	
Engine:	3.0L 6 cyl	
Reported Defects:	None	
Cargo:	None	
Damage Description:	Moderate to major damage to front right. Wheelbase shortened by 12.5 cm (4.9 in.) on right side. Right door bowed outward.	
CDC:	01FZEW1	
Delta V:	Total	39.0 km/h (24.2 mph)
	Longitudinal	-33.8 km/h (-21.0 mph)
	Latitudinal	-19.5 km/h (-12.1 mph)
	Energy	25,483 joules (18,795 ft-lbs)

Figure 6. Front, case vehicle

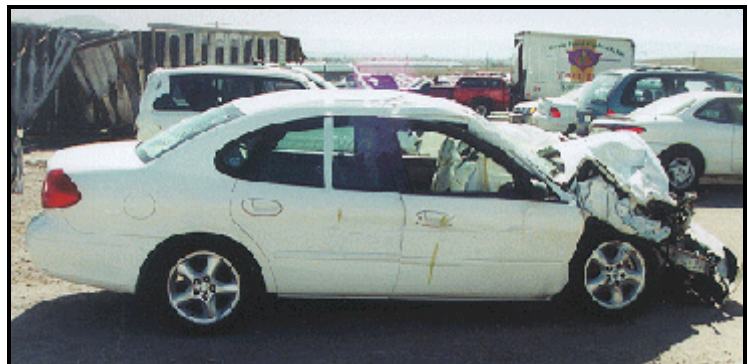
Figure 7. Right side, case vehicle

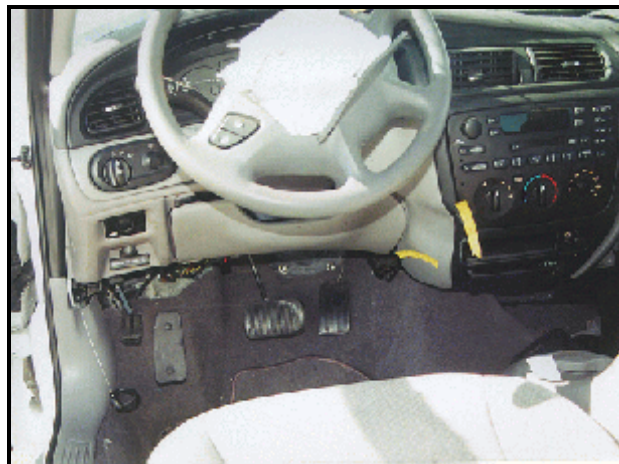
The 30-year-old male driver of the case vehicle was seated in a normal, upright fashion in the fabric-covered bucket seat. He was wearing the available lap and shoulder belt. The EDR showed that the seat buckle was engaged. The anchorage was adjusted to the mid position. The seat was adjusted to between the middle and rear most track position. At impact, the driver responded to the 30 degree direction of force by moving forward and to the right. He loaded the lap and shoulder belt as the pretensioners fired. Both knees contacted the lower instrument panel—deforming it. His right foot deformed the gas pedal to the right. The driver engaged the deployed air bag with his head and torso. As he loaded the bag and the steering wheel, the steering column shear capsules were stroked 0.2 cm (0.08 in) on the right and 0.7 cm (0.3 in) on the left. It seems likely that the air bag contacted both of his hands—causing the bilateral abrasions.

Figure 8. Driver position, case vehicle

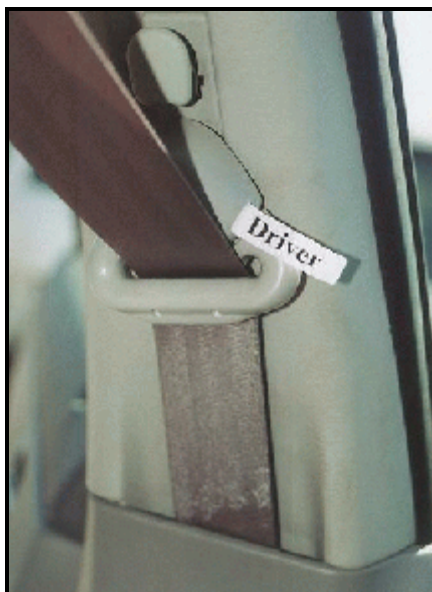
Figure 9. Load marks to driver's seat belt

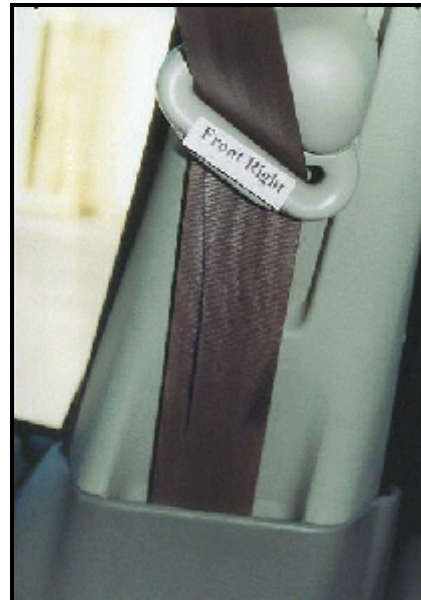
The 39-year-old male front right passenger was seated in a normal, upright fashion in the fabric-covered bucket seat. He was wearing the available lap and shoulder belt. The EDR showed that the seat buckle was engaged. The anchorage was adjusted to the full up position. The seat was adjusted to the rear most track position. At impact, this occupant responded to the 30 degree direction of force by moving forward and to the right. He loaded the lap and shoulder belt. It appears that his legs engaged the glove box, causing some deformation. As the impact continued, he rode down the impact—causing a depression in the front right seat. He engaged the air bag with his face—causing some pain but no injuries. He rebounded backward and deformed the seat back rearward.

Figure 10. Load marks to front right passenger seat belt

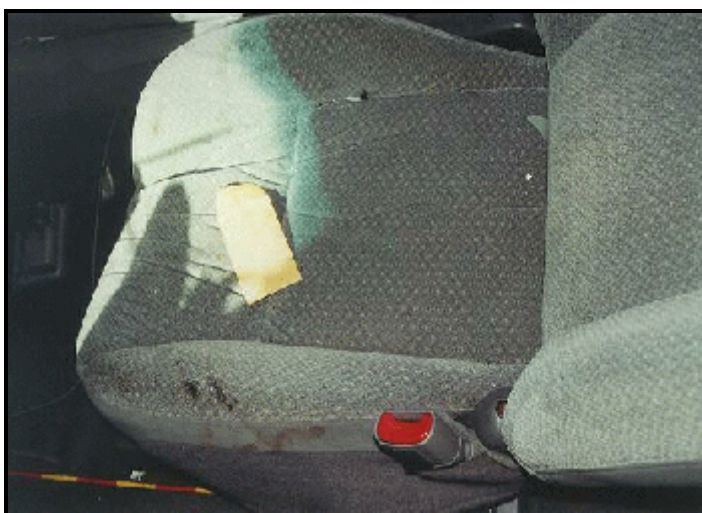
Figure 11. Ride-down pattern in front right seat

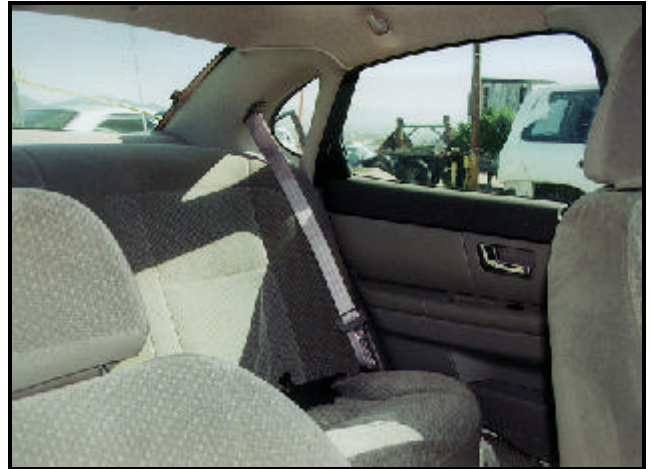
Figure 12. Rear right seating position

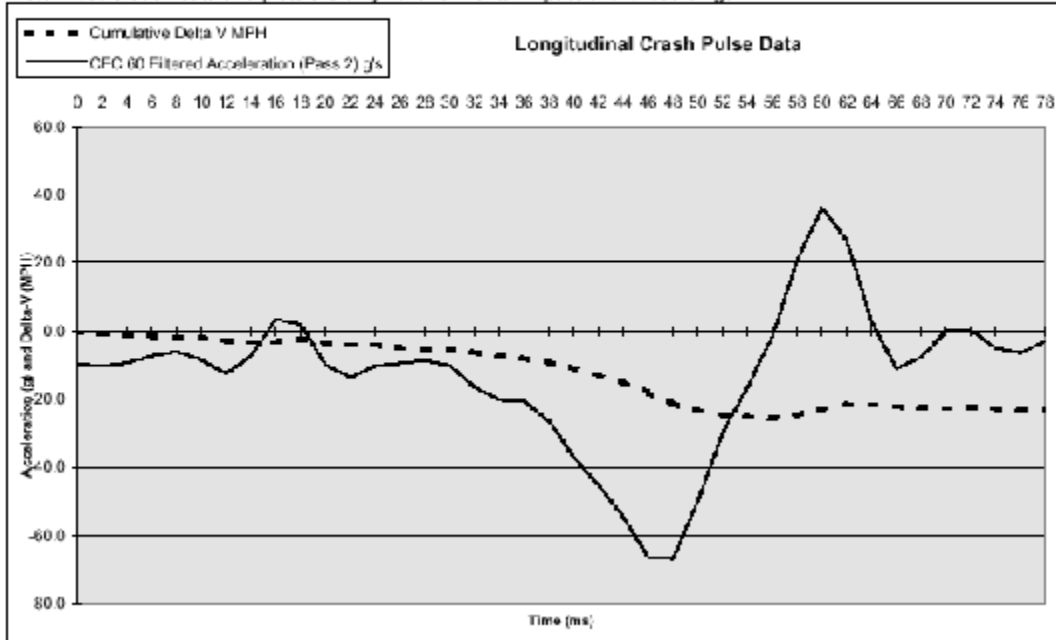
Longitudinal Cumulative Delta-V

Time (ms)	0	10	20	30	40	50	60	70	78
Delta-V (MPH)	-0.4	-2.0	-3.6	-5.5	-11.0	-23.2	-23.0	-22.6	-23.1

On impact, both front air bags in the case vehicle deployed. The case vehicle sustained a longitudinal delta v of -33.8 km/h (-21.0 mph) and a lateral delta v of -19.5 km/h (-12.1 mph). The Electronic Data Recorder showed a longitudinal delta v of -37.1 km/h (-23.1 mph) and a lateral delta v of -25.2 km/h (-15.7 mph) at the 78 ms mark. The pulse was leveling off at this point.

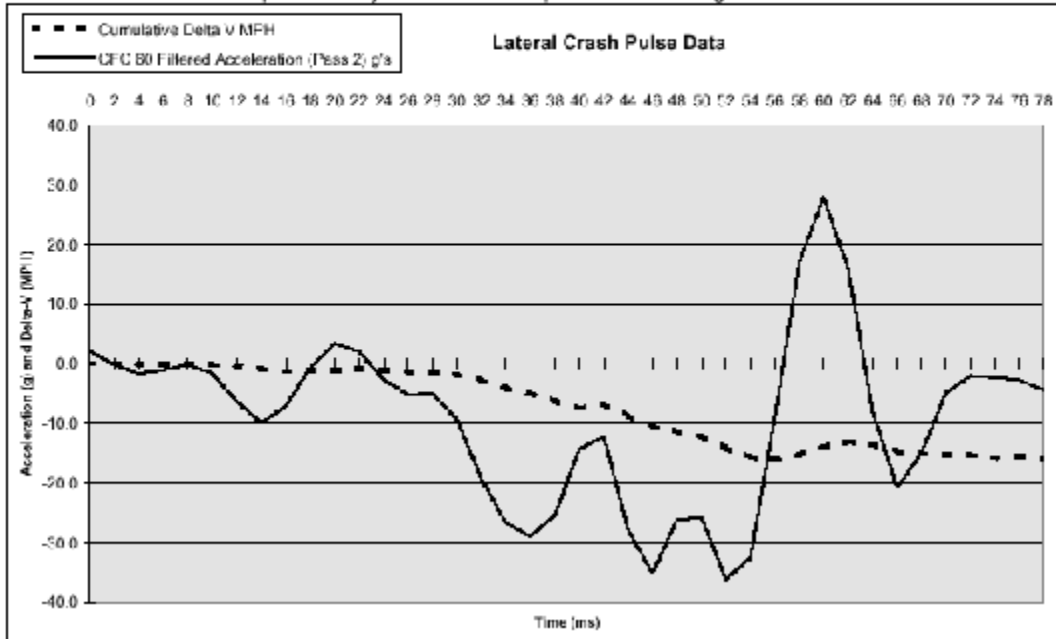
Lateral Cumulative Delta-V

Time (ms)	0	10	20	30	40	50	60	70	78
Delta-V (MPH)	0.1	-3.1	-1.1	-1.8	-7.4	-12.2	-15.5	-15.3	-15.7
