On-scene Investigation / Vehicle to Vehicle
Dynamic Science, Inc. / Case Number: DS01-005
2000 Ford Taurus SE 4-door
Texas
January, 2001

1. Report No. DS01-005		2. Government Accession No.		3. Recipient Catalog No.	
4. Title and Subtitle In-Depth Accident Investigation				5. Report Date .

**Dynamic Science, Inc.
Accident Investigation
Case Number: DS01-005**

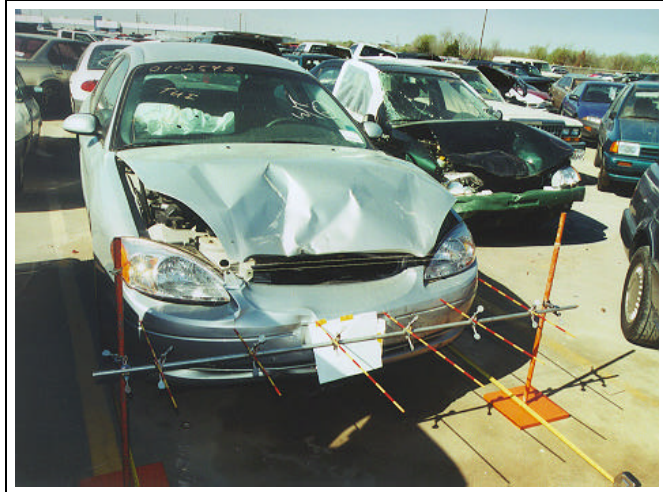
Figure 3. Exterior damage to case vehicle.

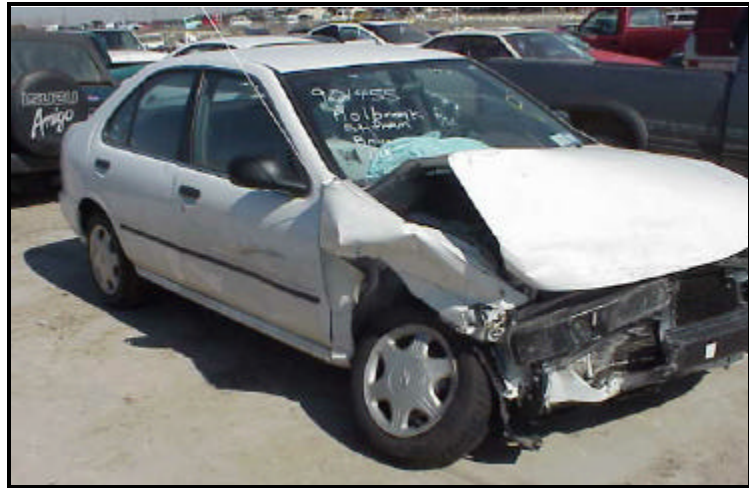
Figure 4. Exterior damage, other vehicle (Nissan Sentra)

Description: 1998 Nissan Sentra
 VIN: 3N1AB41D8WLXXXXXX
 Odometer: Unknown
 Engine: 1.6 L 4 cylinder
 Reported Defects: None
 Cargo: Unknown
 Damage Description: Moderate frontal damage from initial impact. Bumper, grille, hood. Moderate front right fender damage from second impact.

(Impact 1 v. Buick) 12FDEW1 (estimated from photo)
 (Impact 2 v. case vehicle): 04RFEW2

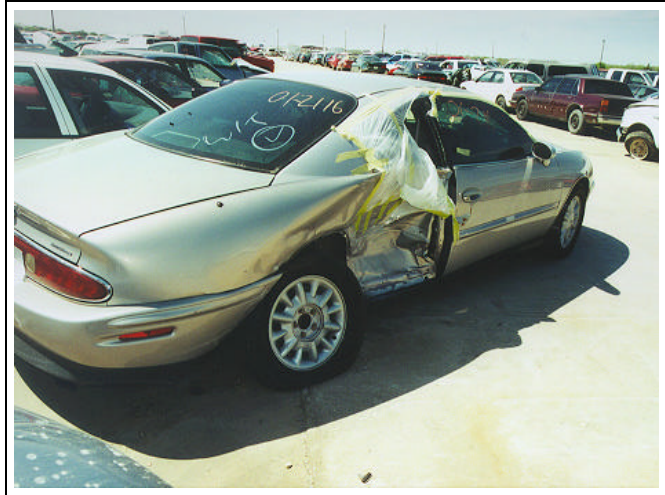
Figure 5. Exterior damage to other vehicle (Buick Riviera).

Description:	1997 Buick Riviera	
VIN:	G4GD2211V4xxxxxx	
Odometer:	84,900 km (52,756 miles)	
Engine:	3.8 L V6	
Reported Defects:	None	
Cargo:	None	
Damage Description:	Moderate lateral crush to right rear.	
CDC:	02RZEW4	
Delta V:	Total	14.9 km/h (9.2 mph)
	Longitudinal	-9.5 km/h (-5.9 mph)
	Latitudinal	-11.4 km/h (-7.1 mph)
	Energy	25,606 joules (18,898 ft-lbs)

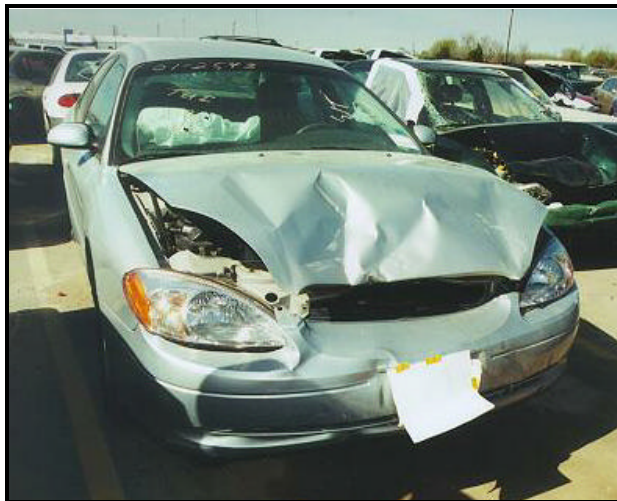
Description:	2000 Ford Taurus SE	
VIN:	1FAFP53U9YGxxxxxx	
Odometer:	28,203 km (17,525 miles)	
Engine:	3.0 L V6	
Reported Defects:	None	
Cargo:	None	
Damage Description:	Moderate frontal damage. Bumper, grille, radiator. Vehicle towed from scene.	
CDC:	12FDEW1	
Delta V:	Total	24.3 km/h (15.1 mph)
	Longitudinal	-23.9 km/h (-14.8 mph)
	Latitudinal	4.2 km/h (2.6 mph)
	Energy	14,591 joules (10,767 ft-lbs)

Figure 7. Front right, case vehicle, Ford Taurus

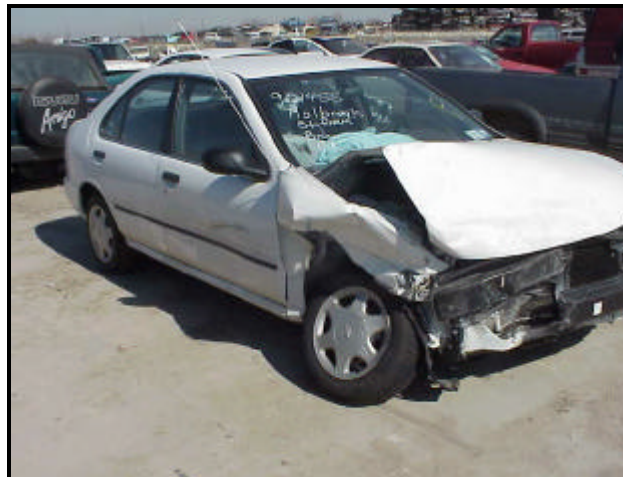
Delta V (Impact 2 v. case vehicle):	Total	34.2 km/h (21.2 mph)
	Longitudinal	22.0 km/h (13.6 mph)
	Latitudinal	-26.2 km/h (-16.3 mph)
	Energy	84,019 joules (61,970 ft-lbs)

Figure 8. Front right, Nissan Sentra

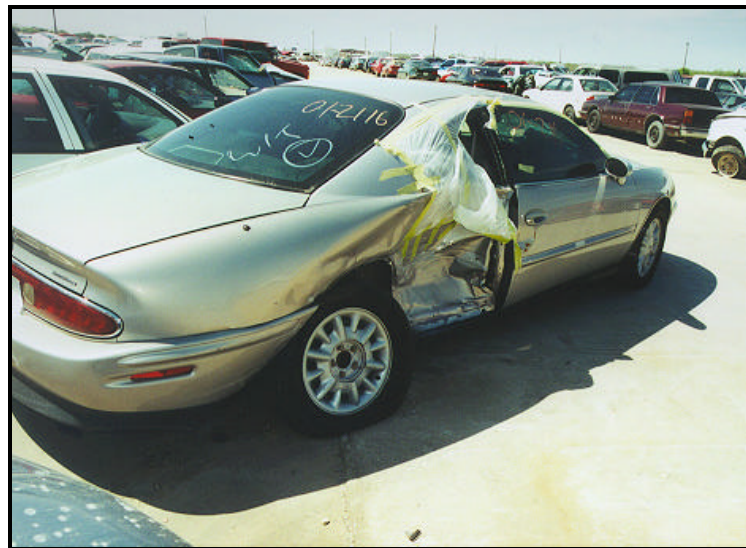
Figure 9. Right side, Buick Riviera

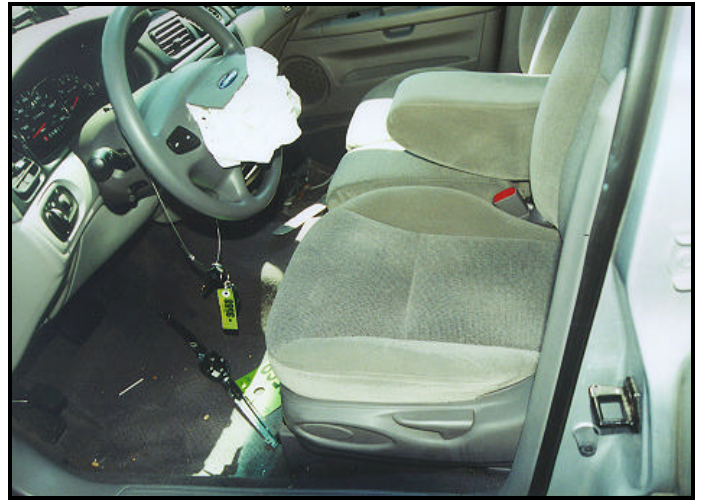
The 49-year-old male driver (173 cm/68 in, 84 kg/185 lbs) of the case vehicle was seated in a normal, upright fashion. He was wearing the available lap and shoulder belt. The upper anchorage adjustment was in the mid position. The fabric-covered bucket seat was adjusted to the rear most track position. The seat back angle was adjusted at 73 degrees from horizontal. He was wearing glasses. His right foot was on the accelerator. At impact, the driver responded to the 350 degrees direction of force by moving straight forward. The lap and shoulder belts restricted this forward motion—causing the left shoulder sprain. His face came into contact with the deployed air bag—causing the cervical strain as his head loaded the air bag and also causing the driver to bite his tongue. The driver reported that he felt a stinging sensation as the air bag contact his face. His glasses were knocked off his face but were not damaged. He also reported seeing a lot of smoke in the vehicle and hearing a loud bang from the air bag. He was transported to a hospital by the local fire department personnel where he was treated and released after three hours.

Figure 10. Driver's seated position

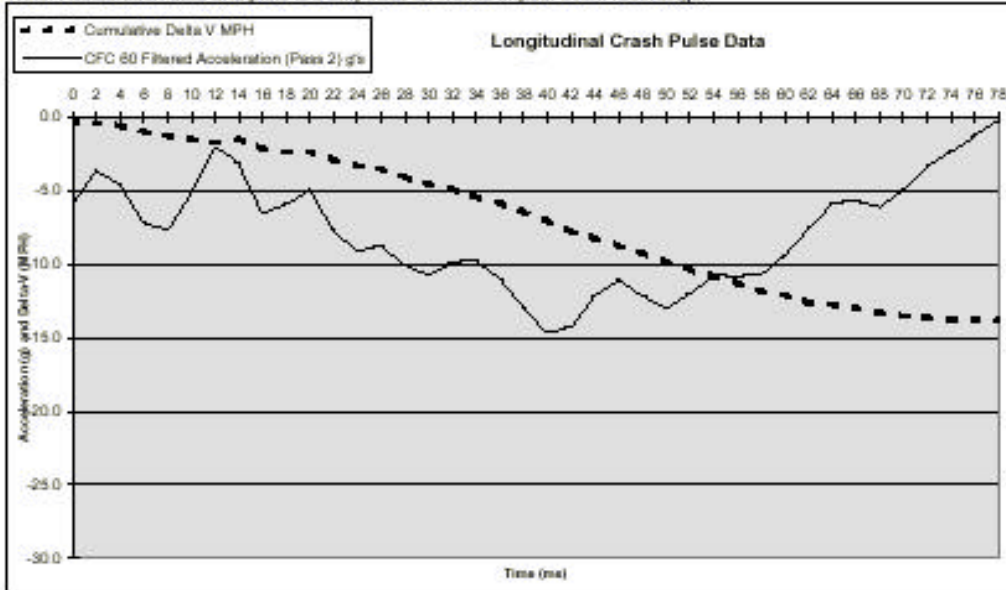
Longitudinal Cumulative Delta-V

Time (ms)	0	10	20	30	40	50	60	70	78
Delta-V (MPH)	-0.4	-1.6	-2.3	-4.4	-7.1	-9.9	-12.1	-13.5	-13.8

At impact the case vehicle sustained a total delta v of 24.3 km/h (15.1 mph), a longitudinal delta v of -23.9 km/h (-14.8 mph), and a latitudinal delta v of 4.2 km/h (2.6 mph) as computed by WinSmash. The downloaded Electronic Data Recorder (EDR) data indicates a cumulative longitudinal delta v of -22.2 km/h (-13.8 mph) at the 78 ms mark. There is a reasonable match between the WinSmash results and the EDR data. The EDR report is included as an attachment to this report.

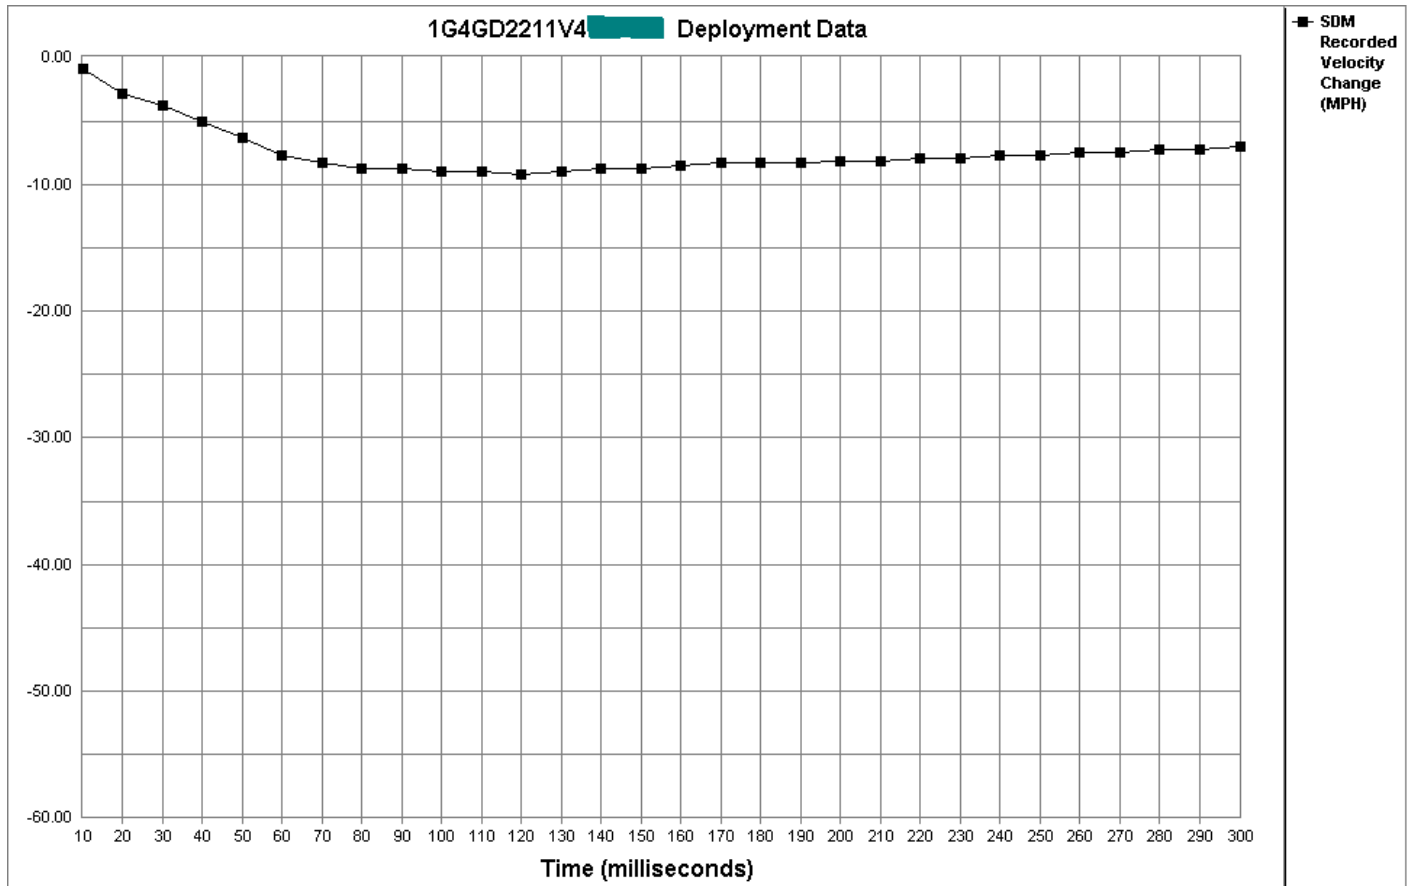
Attachment 2. SDM Report (Buick)

1G4GD2211V4 [REDACTED] System Status At Deployment	
SIR Warning Lamp Status	OFF
Driver's Belt Switch Circuit Status	UNBUCKLED
Passenger Front Air Bag Suppression Switch Circuit Status	ON
Ignition Cycles At Deployment	8966
Ignition Cycles At Investigation	8974
Time From Algorithm Enable To Deployment Command (msec)	15
Time From Near Deployment To Deployment (msec)	N/A

Time (milliseconds)	10	20	30	40	50	60	70	80	90	100	110	120	130	140	150
Recorded Velocity Change (MPH)	-0.88	-2.85	-3.73	-5.05	-6.36	-7.68	-8.34	-8.78	-8.78	-9.00	-9.00	-9.21	-9.00	-8.78	-8.78
Time (milliseconds)	160	170	180	190	200	210	220	230	240	250	260	270	280	290	300
Recorded Velocity Change (MPH)	-8.56	-8.34	-8.34	-8.34	-8.12	-8.12	-7.90	-7.90	-7.68	-7.68	-7.46	-7.46	-7.24	-7.24	-7.02

The Sensing and Diagnostic Module (SDM) data was downloaded from the Buick using the Vetronix Crash Data Retrieval system. The data indicates a recorded maximum velocity change of -14.8 km/h (-9.21 mph) at the 120 ms mark. The data indicates that the driver was unbuckled. The SDM report is included as an attachment to this report. The Buick sustained a total Δv of 14.9 km/h (9.2 mph)¹.
