On-scene Investigation / Vehicle to Vehicle
Dynamic Science, Inc. / Case Number: DS01015
1994 Ford Probe
California
August, 2001

1. Report No. DS01015		2. Government Accession No.		3. Recipient Catalog No.	
4. Title and Subtitle In-Depth Accident Investigation				5. Report Date	
				6. Performing Organization Report No.

Dynamic Science, Inc.
Accident Investigation
Case Number:DS01015

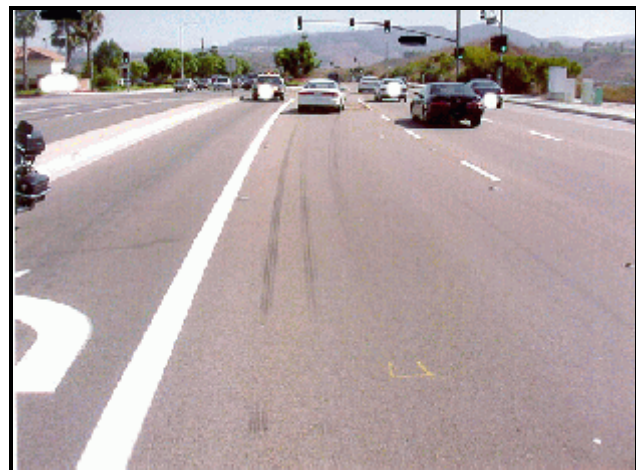
Figure 1. Final rest, case vehicle, south

The driver of the other vehicle had seen the crash coming and had taken his foot off the brake. After impact, his vehicle was pushed into the intersection where it came to rest. The case vehicle came to rest in the third lane facing its initial path of travel.

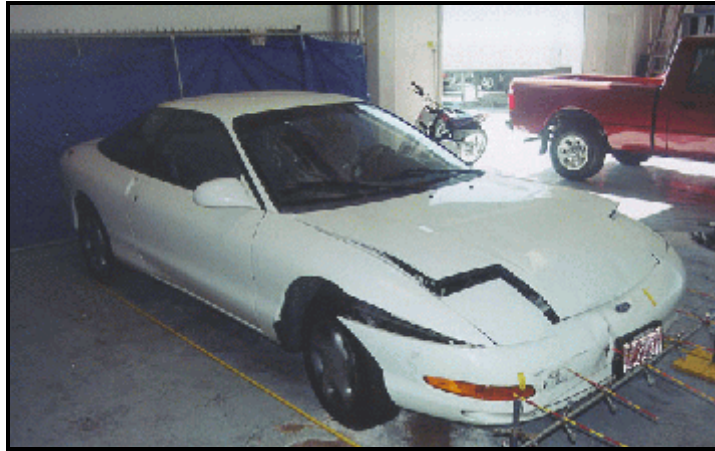
Figure 2. Front right, case vehicle

Description:	1994 Ford Probe two-door sedan	
VIN:	1ZVLT20A9Rxxxxxxx	
Odometer:	Unknown	
Engine:	2.0 l I4	
Reported Defects:	None	
Cargo:	Approximately 45 kg (100 lbs) (carriage, clock, chair)	
Damage Description:	Moderate front contact to front bumper, hood buckled, right front fender buckled. Windshield damaged by air bag module cover.	
CDC:	12FZEW1	
Delta V:	Total	13.4 km/h (8.3 mph)
	Longitudinal	-13.4 km/h (-8.3 mph)
	Latitudinal	0 km/h (0 mph)
	Energy	2,646 joules (1,950 ft-lbs)

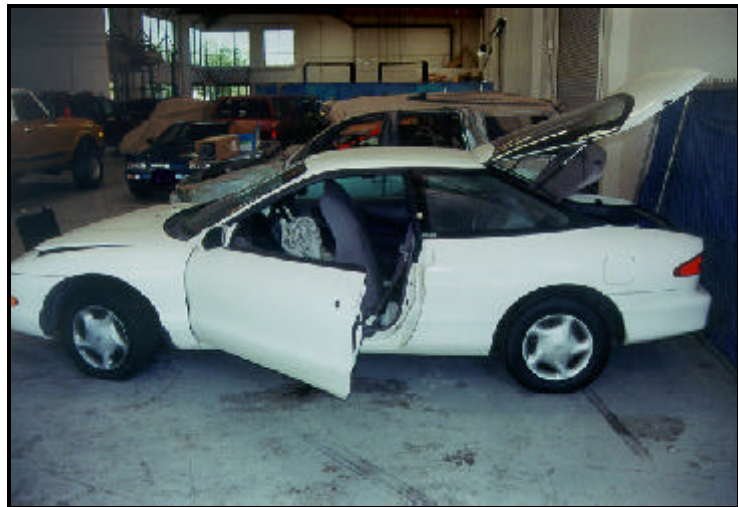
Figure 3. Left side, case vehicle

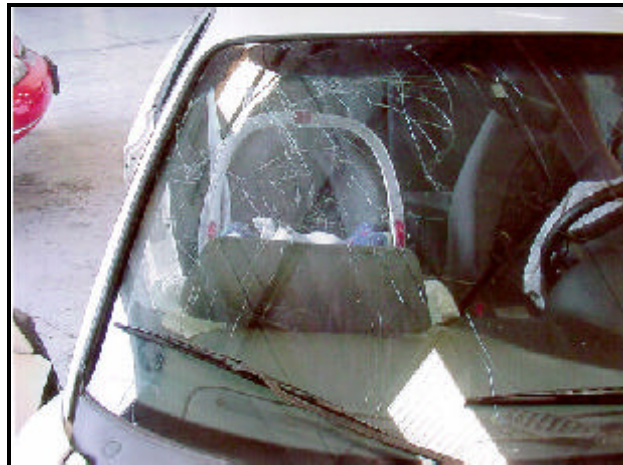
The vehicle and Evenflo infant seat were examined by a deputy who has undergone the child passenger safety training provided by the NHTSA shortly after the crash. The child was within the height and weight parameters for the seat design. The angle indicator on the seat was “green”, indicating that the seat was at the proper inclination. Regardless of the placement of the CSS in front of the air bag, the seat base was found improperly attached with the vehicle’s lap and shoulder belts. This vehicle was equipped with emergency locking retractor seatbelts with sliding latchplates. To properly install the infant seat base in this vehicle requires the use of a locking clip. The locking clip was still attached to the back of the infant seat and was not used.

Figure 4. Front view, infant seat in vehicle

Investigating officers determined that there was 7.6 cm (3 in) of lateral movement in the seat when buckled in place. The carry handle was found in the upright locked position. The retainer clip was attached to the left side only. This position is normal when placing an infant in or taking an infant out of the seat. The infant seat was found to be properly attached to the removable base. The left side harness adjustment clip was found removed from the locking position on the back of the seat. The red release handle on the left side on the back of the seat was damaged and out of adjustment. The locking clip was still attached to the back of the seat. The instruction manual was available. There were air bag placement warnings on the seat belt and the visor.

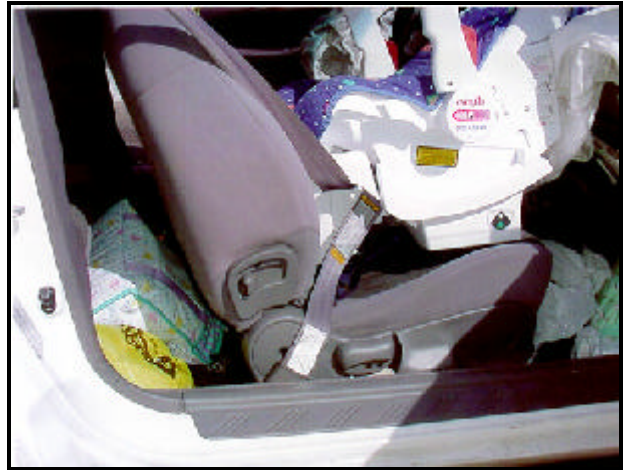
Figure 5. Side view, infant seat in vehicle

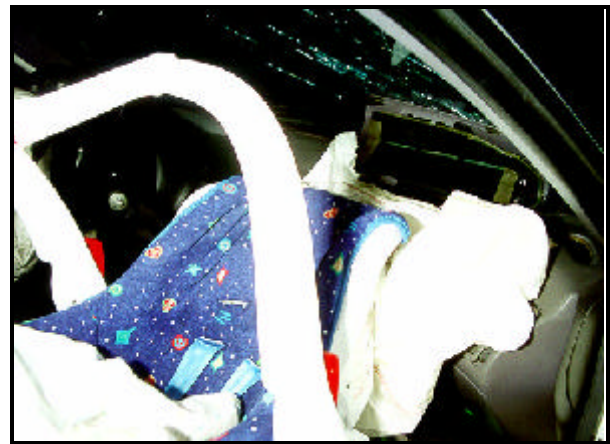
third position from the front. The seat back was 68 cm (26.7 in.) from the air bag opening. The maximum deflated excursion of the air bag was 70 cm (27.5 in.). The driver, who was the grandmother of the male child, had told the investigating officers that she had purchased the case vehicle used (two years earlier) and didn't know it had air bags.

Figure 6. Infant seat, proximity to air bag

The front right fabric-covered bucket seat was occupied by a 2 month/19 day old male child (63 cm/25 in., 7.7 kg/17 lbs). The child had been placed in a rear-facing Evenflo Discovery Adjust Right infant seat. The infant seat had been incorrectly attached to the vehicle. This vehicle was equipped with emergency locking retractor seatbelts with sliding latchplates. To properly install this infant seat in this vehicle requires the use of a locking clip. The locking clip was still attached to the back of the infant seat and was not used. Investigating officers determined that there was 7.6 cm (3 in) of lateral movement in the seat when buckled in place. The front right seat has four possible track positions; the seat had been adjusted to the third position from the front. The seat back was 68 cm (26.7 in.) from the air bag opening. The maximum deflated excursion of the air bag was 70 cm (27.5 in.).

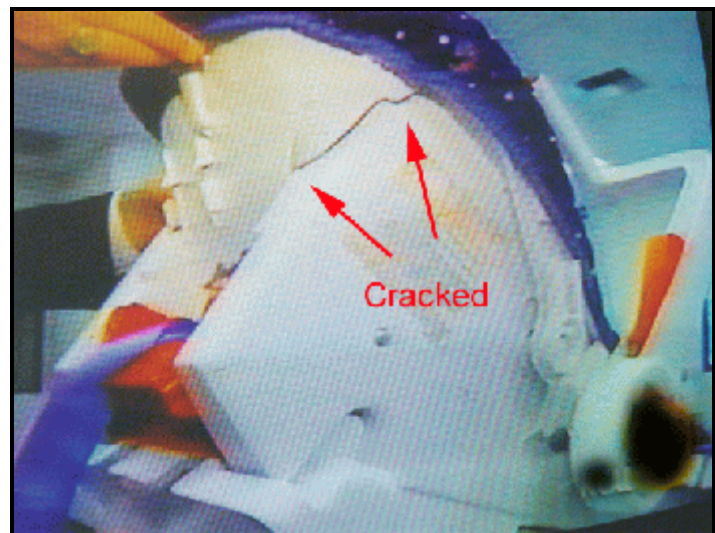
Figure 7. Infant seat (image from news video)

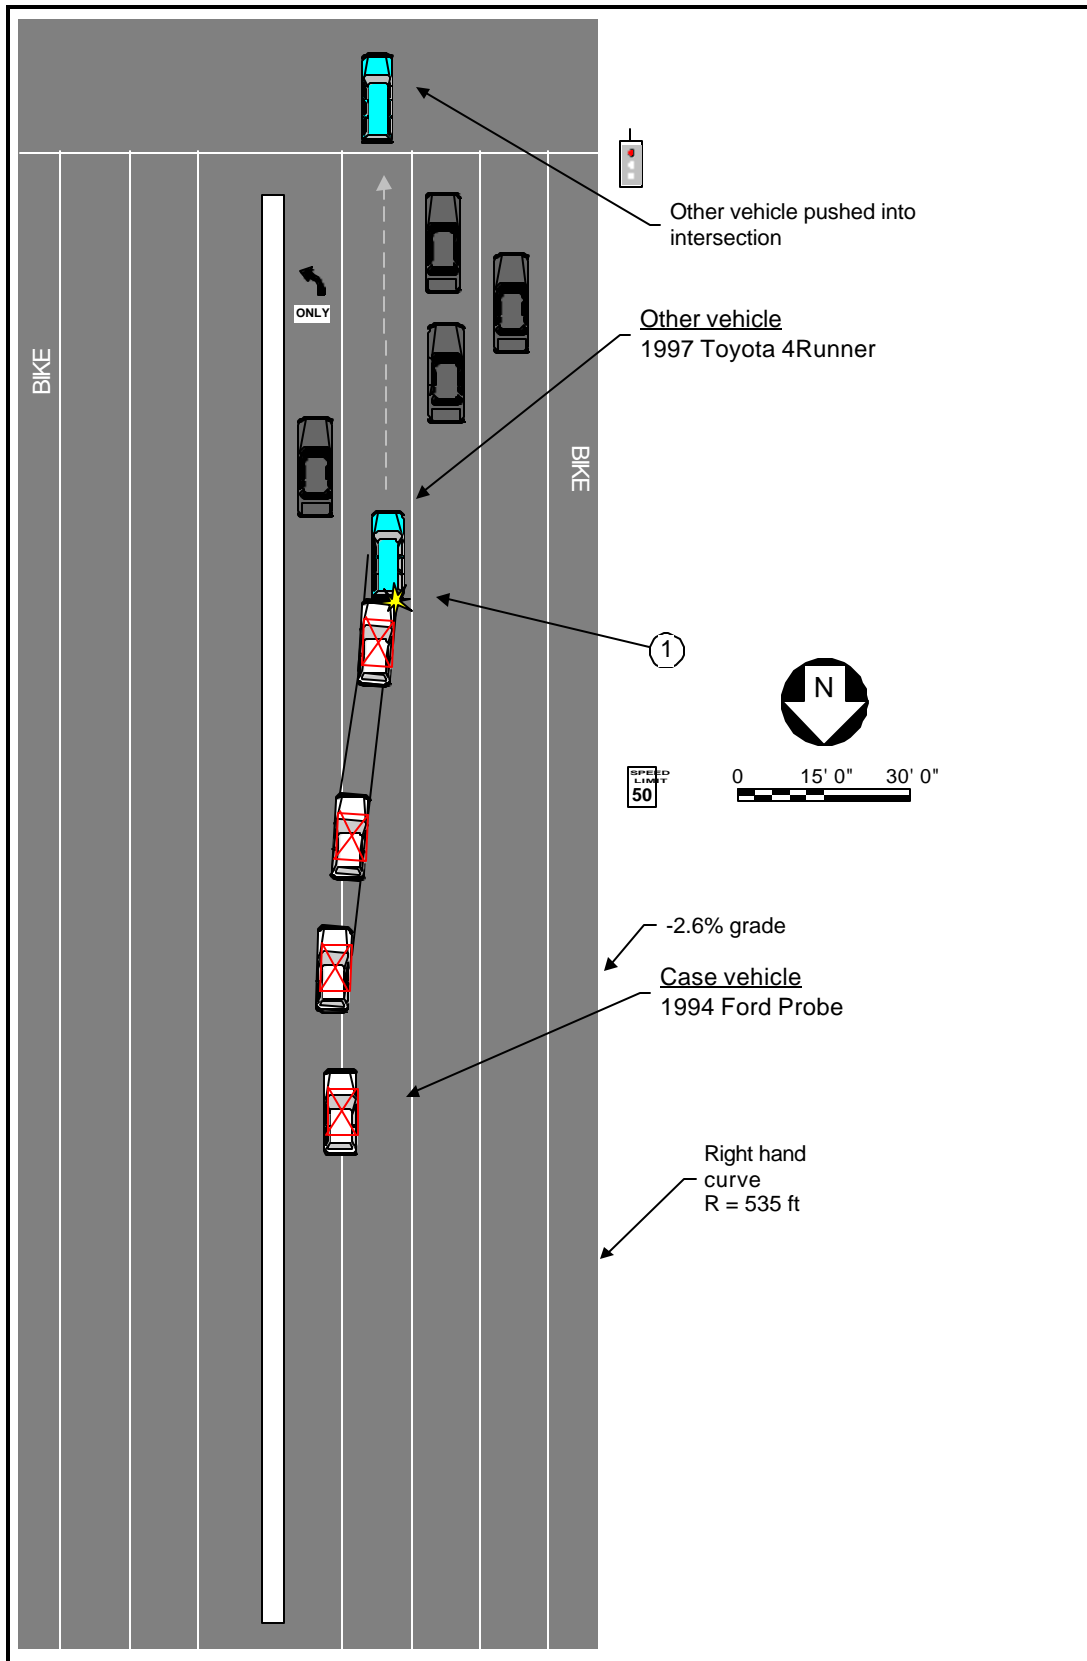
Figure 8. Scene diagram

COLLISION MEASUREMENTS						
Reference point:	North curb line					
Reference line:	West curb line					
Data Point	Distance and Direction from RP			Distance and Direction from RL		
	ft	m	d	ft	m	d
BLF - V1	116.6	35.5	N	48.1	14.7	E
Intermediate LF - V1	92.3	28.1	N	41	12.5	E
ELF - V1	70.9	21.6	N	40.5	12.3	E
BRF - V1	140.9	42.9	N	42.75	13	E
Intermediate RF - V1	92.3	28.1	N	37.7	11.5	E
ERF - V1	71.5	21.8	N	35.7	10.9	E
Gouge on roadway from V1 undercarriage	86.2	26.3	N	38.7	11.8	E
Final rest - RF - V1	71.5	21.8	N	35.7	10.9	E
Final rest - RR - V1	79.9	24.4	N	36.2	11	E
Grade = -2.9%						
Bituminous-recently repaved						
Right hand curve						
Chord	30	9.1				
Middle ordinate	.20	0.1

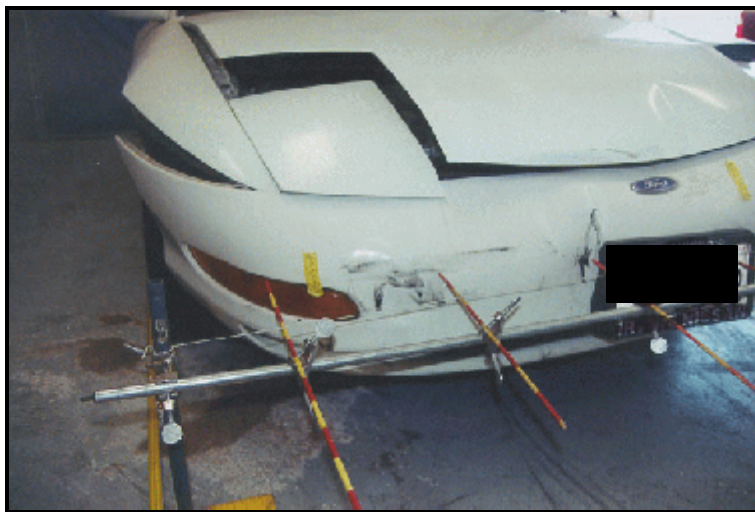
Figure 9. Close up, front of case vehicle

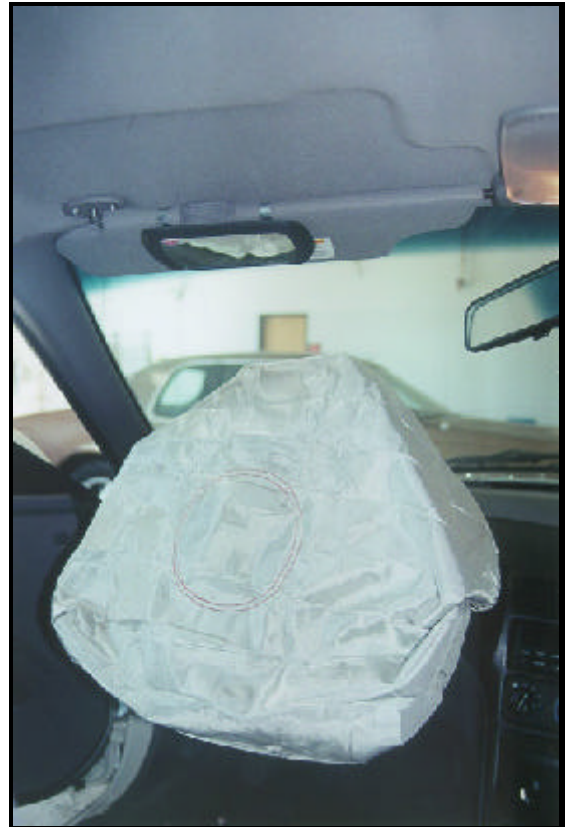
The front left fabric-covered bucket seat was occupied by a 39-year-old female (170 cm/67 in., 70 kg/155 lbs). She was wearing the available lap and shoulder belt. The front left seat has four possible track positions; the seat had been adjusted to the third position from the front. Initially, this occupant was not looking forward. She had turned to the right to feed the front right seat child occupant. As the case vehicle neared the area of impact, she looked up and saw traffic slowing and stopped in front of her. She applied the brakes at this point and likely braced as she steered to the right. After skidding 28.9 m (95 ft), the front of the case vehicle struck the rear of the other vehicle. She responded to the 0 degree direction of force and pitched straight forward. She loaded the seat belt at this time—likely causing the pain she report to her left shoulder and rib cage. As the steering wheel mounted air bag deployed, she engaged it with her face—causing some swelling. She was able to exit the vehicle on her own and later accompanied the front right occupant to the hospital.

Figure 10. Driver seated position

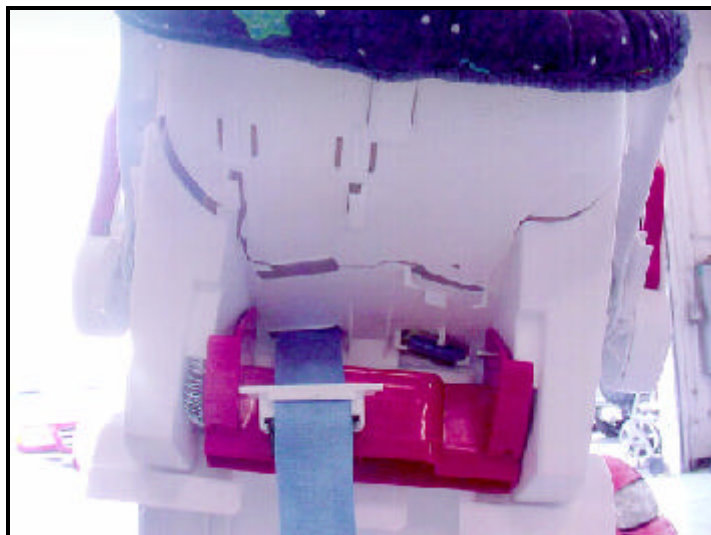
The case vehicle sustained a longitudinal delta v of $-13.4 \text{ km/h} (-8.3 \text{ mph})^2$. Both the driver's air bag and the front right passenger's air bag deployed. The deploying passenger air bag struck the rear of the infant seat. The impact fractured the back of the seat horizontally. The crack extends completely from left to right. The seat back struck the back of the child's head. According to the autopsy report, he

After skidding 28.9 m (95 ft), the front of the case vehicle struck the rear of the other vehicle. The front right occupant responded to the 0 degree direction of force by moving forward into the shell of the infant seat. The deploying air bag struck the back of the infant seat. There was no contact between the air bag module cover and the infant seat. The force of the air bag collapsed/fractured the plastic shell accelerating the shell rearward into the back of the child's head. The impact with the infant seat shell accelerated by air bag forces caused the multiple skull fractures.

Figure 11. Back side of infant seat
