**GENERAL DYNAMICS REMOTE ADVANCED OCCUPANT PROTECTION SYSTEM
INVESTIGATION
SCI TECHNICAL SUMMARY REPORT**

NASS/SCI COMBO CASE NO. 02-45-137E

**VEHICLE – 2002 LEXUS SC430
LOCATION - STATE OF TENNESSEE**

CRASH DATE – AUGUST 2002

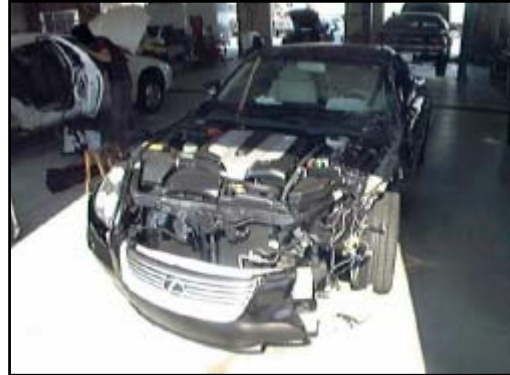
Figure 1. Lexus SC430

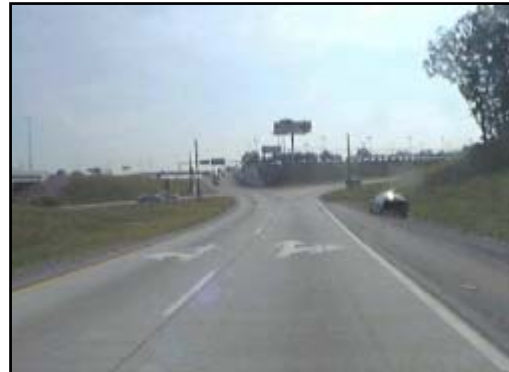
The 40-year-old male driver of the 2002 Lexus SC430 was operating the vehicle eastbound on the off-ramp approaching the intersection (**Figure 2**). The driver of the 2002 Dodge Ram was stopped at the intersection. Although the driver of the Lexus braked prior to impact, there was no pre-impact physical evidence was noted at the crash site. The EDR pre-crash data indicated that the Lexus was traveling at 126.0 km/h (78.3 mph) five seconds prior to Algorithm Enable (AE) and the Lexus had slowed to 85.9 km/h (53.4 mph) 0.9 seconds prior to AE. The NASS scene schematic is included as **Figure 11** of this report.

Figure 2. Eastbound approach to intersection.

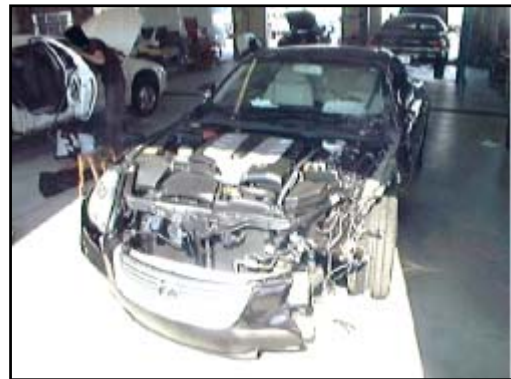
The 2002 Lexus SC430 sustained moderate frontal damage as a result of the impact with the 2002 Dodge Ram (**Figure 4**). The damage to the Lexus had been altered by the repairs prior to the NASS inspection, therefore no damage measurements were obtained. The front left bumper fascia, frame rail, hood, and fender engaged the rear of the Dodge; however, these components were removed and were not inspected. The front of the Lexus underrode the rear of the Dodge resulting in damage to the left A-pillar. The underride damaged consisted of crushing at the base of the A-pillar extending upward approximately half the length of the A-pillar. The windshield exhibited damage from underride contacted with the Dodge and the displaced A-pillar. The damage to the windshield consisted of several cracks beginning at the base of the windshield at the A-pillar extending to the top. The right side of the windshield was damaged from the deployment of the front right air bag. The remainder of the vehicle glazing was not damaged. The Collision Deformation Classification for the frontal impact to the Lexus was 12-FLAA6.

Figure 4. Damage altered by repairs.

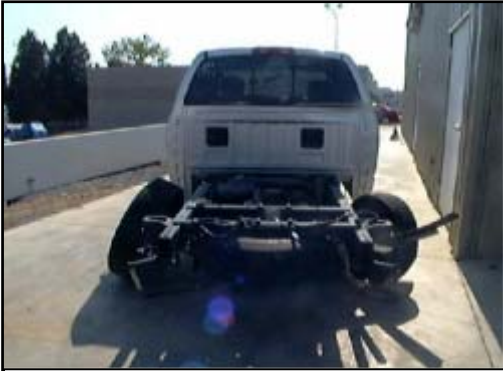
The 2002 Dodge Ram was under repair at the time of the inspection (**Figure 5**). The cargo bed and other rear components had been removed from the frame for repairs (**Figure 6**). No crush measurements were obtained by the NASS researcher. The vehicle did exhibit longitudinal displacement of the bed and rear axle. As a result of the longitudinal displacement, the front of the bed contacted the rear right of the cab. The bed appeared to have underride damage from the impact with the Lexus. The Collision Deformation Classification for this impact was 06-BREE5.

Figure 5. Rear of Dodge under repair.

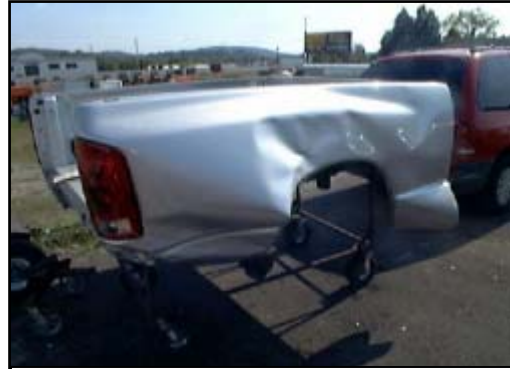
Figure 6. Damaged bed.

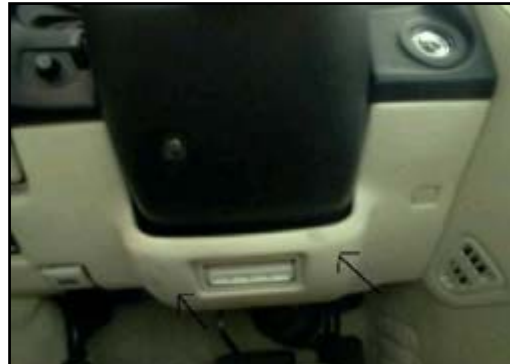
The 2002 Lexus SC430 sustained minor interior damage as a result of the crash. The damage consisted of occupant contacts to the interior. At impact, the driver initiated a forward trajectory. His knees contacted the knee bolster evidenced by two scuffs (**Figure 7**). There was no intrusion of the interior components.

Figure 7. Occupant contacts to the lower left instrument panel.

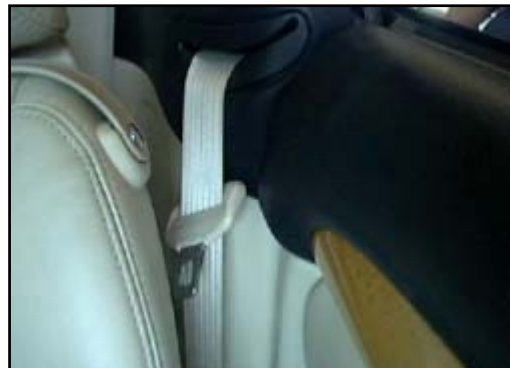
The 2002 Lexus SC430 was equipped with manual 3-point lap and shoulder belts for all four seating positions. The front safety belts were equipped with retractor-mounted pretensioners, which fired as a result of the crash (**Figure 8**). The driver's safety belt was configured with a sliding latch plate and a belt-sensitive Emergency Locking Retractor (ELR). The EDR indicated that both front safety belts were buckled. However, no occupant was present in the front right seat. The lack of occupant loading and the deployment of the safety belt pretensioners in the stowed position

Figure 8. Fired front left safety belt pretensioner.

indicates no usage for the driver. The remaining safety belts were configured with sliding latch plates and belt-sensitive switchable ELR/Automatic Locking Retractors (ALR).

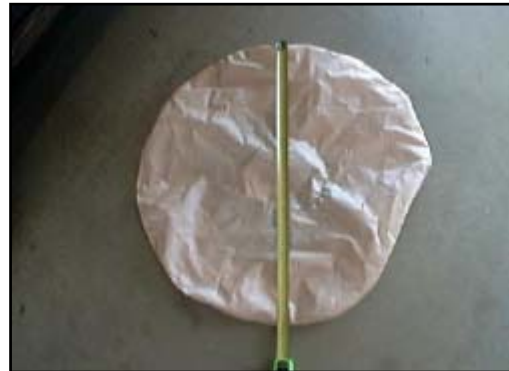
The 2002 Lexus SC430 was equipped with an AOPS that consisted of dual-stage frontal air bags for the driver and front right passenger positions. The EDR data did not indicate if the deployment was a single or dual stage deployment. The repair facility had cut the front left air bag out of the module (**Figure 9**) and the NASS researcher inspected the air bag in this condition. The front left air bag deployed from the center of the steering wheel hub and measured 65.0 cm (25.6”) in diameter. The front left air bag module had a triangular cover flap configuration with a horizontal tear seam that was measured by the NASS researcher as 14.6 cm (5.7”) in width. The air bag was configured with two tethers and two vent ports that vented the air bag at the 11 and 1 o’clock positions.

Figure 9. Driver’s air bag cut out of module.

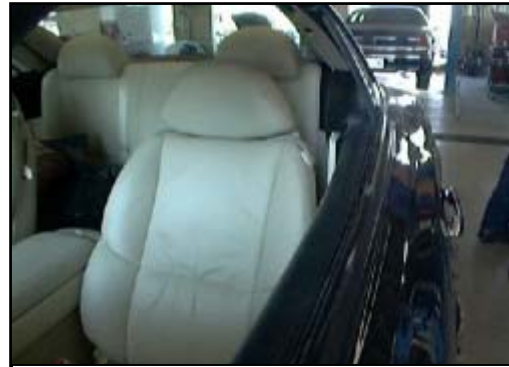
The 2002 Lexus SC430 was equipped with side impact air bags that were located in the front outboard seat backs (**Figure 10**). The side impact air bag crash sensors were located in the lower B- pillars and the center of the lower doors. The side impact air bags did not deploy in this crash.

Figure 10. Location of side impact air bag.
