On-scene Investigation / Vehicle to Vehicle  
Dynamic Science, Inc. / Case Number: DS02005  
1996 Mazda Protege 4-door  
Colorado  
March, 2002

1. Report No. DS02005		2. Government Accession No.		3. Recipient Catalog No.	
4. Title and Subtitle In-Depth Accident Investigation				5. Report Date	
				6. Performing Organization Report No.

**Dynamic Science, Inc.**  
**Accident Investigation**  
**Case Number: DS02005**

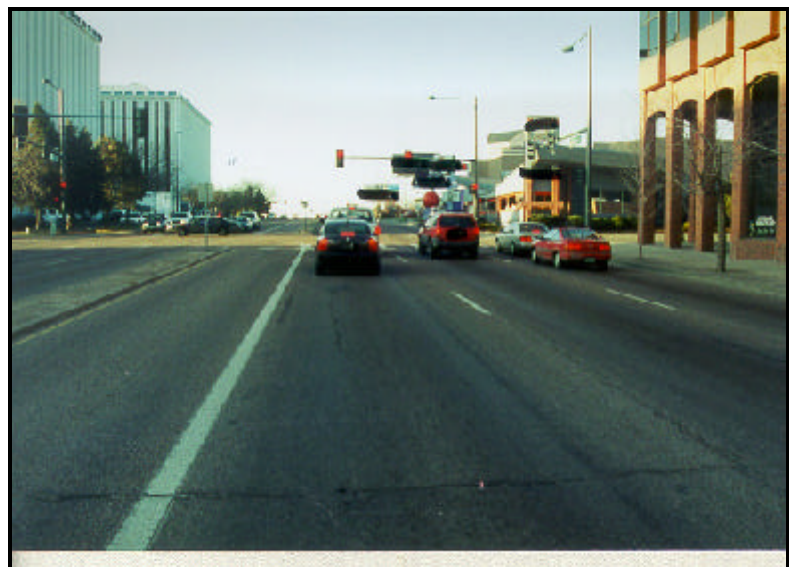
**Figure 1.** Approach to area of impact (south)

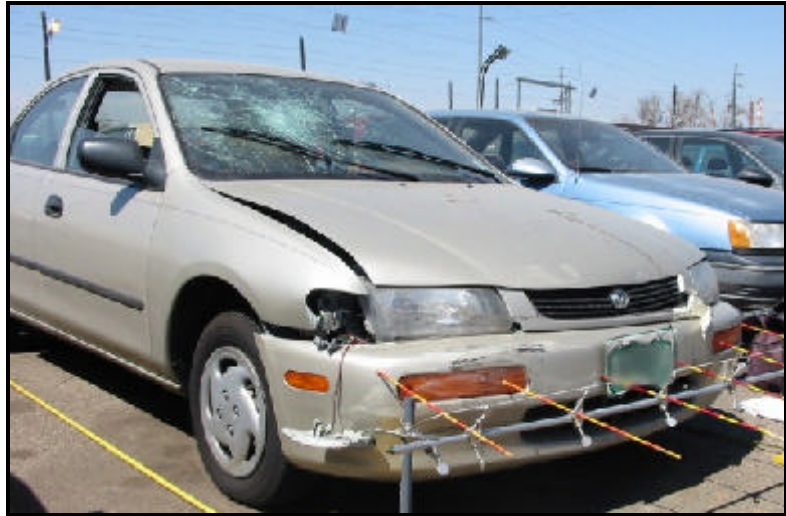
**Figure 2.** Front right, case vehicle (Mazda)

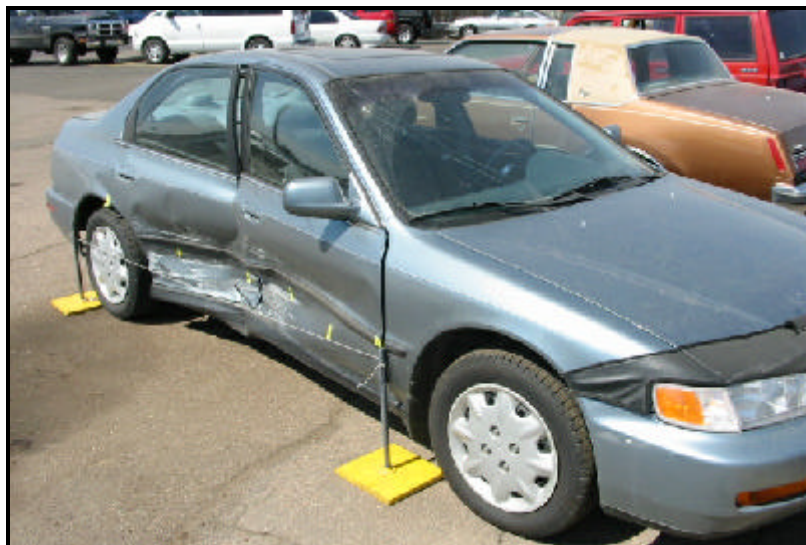
**Figure 3.** Right side, other vehicle (Honda)

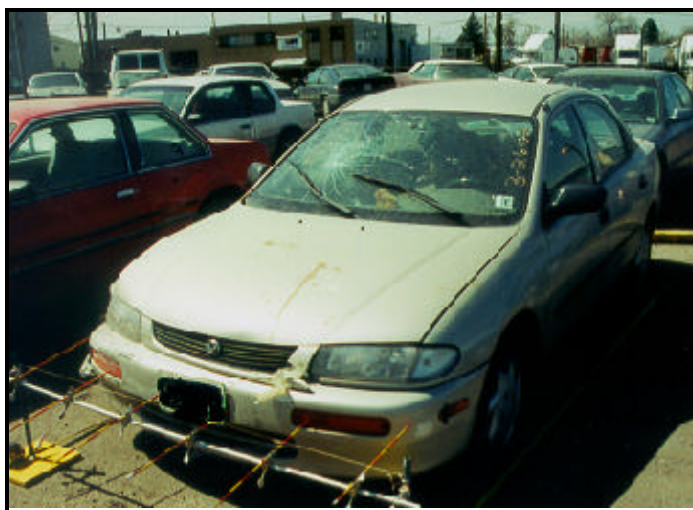
Description: 1996 Mazda Protege 4-door  
VIN: JM1BB14171T0xxxxxx  
Odometer: 155,317 km (96,512 miles)  
Engine: 91 CID, 4 cylinder  
Reported Defects: None noted  
Cargo: Child safety seat  
Damage Description: Minor bumper contact beginning at front right bumper corner. Right side of windshield damaged from occupant contact.

**Figure 5.** Front, case vehicle

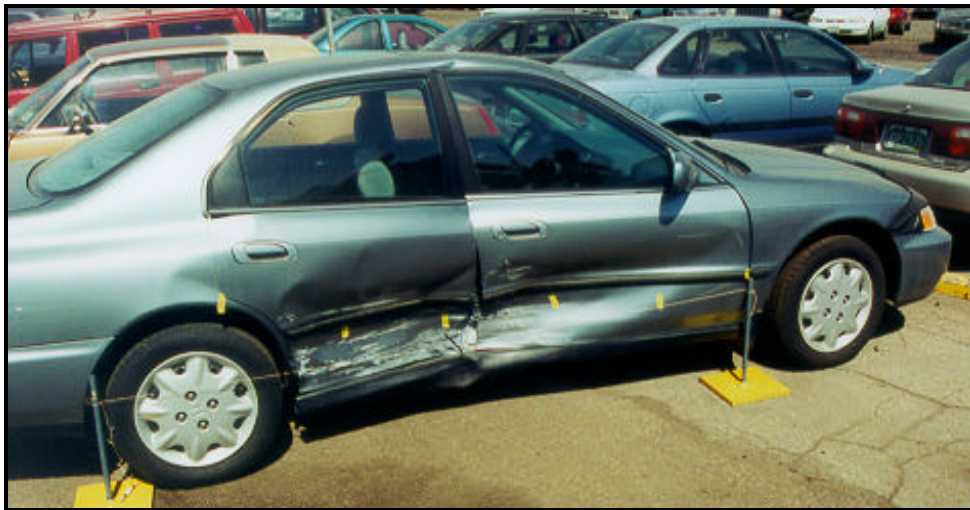
Description: 1996 Honda Accord four-door  
VIN: 1HGCD5637TAxxxxxx  
Odometer: Unknown  
Engine: 2.1 L (132 CID), 4 cylinder  
Reported Defects: None  
Cargo: None  
Damage Description: Moderate lateral crush to right side beginning 29 cm (11.4 in) forward of rear axle. Both right side doors were jammed shut.  
CDC: 02RPEW2  
Delta V:  
Total 18.0 km/h (11.2 mph)  
Longitudinal -11.6 km/h (-7.2 mph)  
Latitudinal -13.8 km/h (-8.6 mph)  
Energy 41,615 joules  
(30,684 ft-lbs)

**Figure 6.** Right side, other vehicle

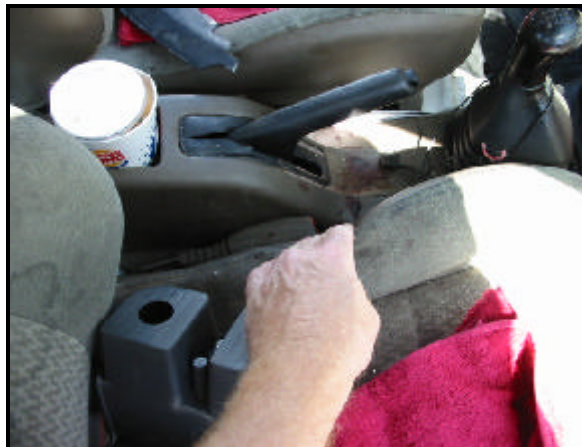
It is this investigator’s opinion that the front right occupant was not using the available lap and shoulder belt. There were no indications of usage in this crash and very little indication of any usage in the past. Both front seat belt latch plates were jammed into the space between the seats and the center console.

**Figure 7.** Location of front right passenger seat belt latch

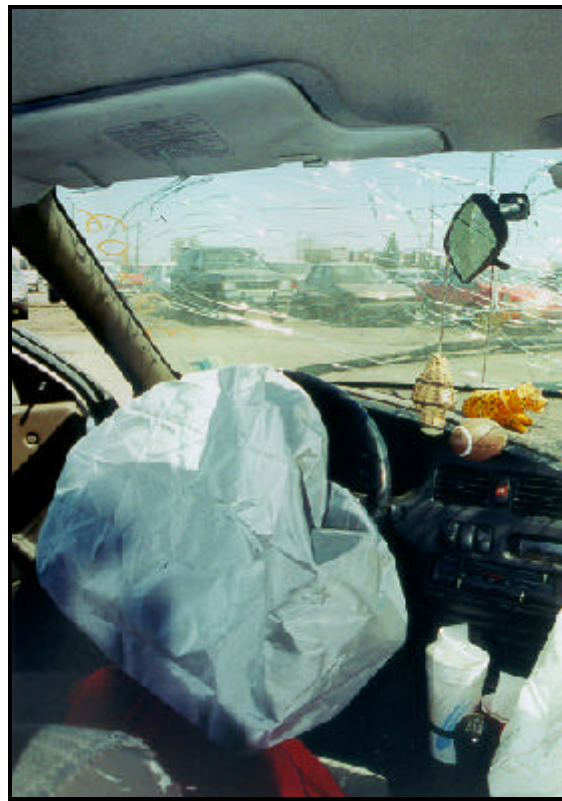
The driver's air bag is 54 cm wide. There were no tethers. There were two vent holes (11 and 1 o'clock positions). There was no damage to the air bag or the module cover.

**Figure 8.** Driver's air bag

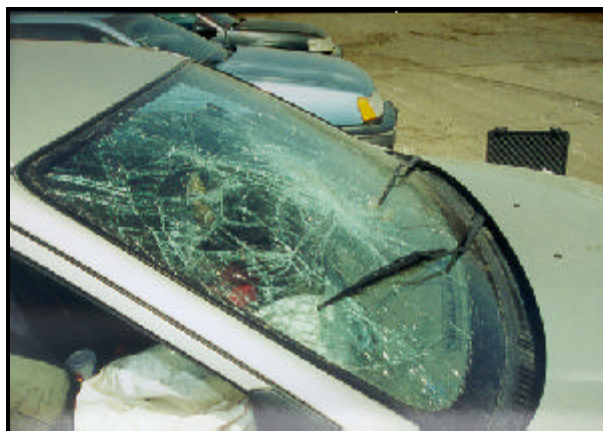
**Figure 9.** Exterior view of occupant contact to windshield

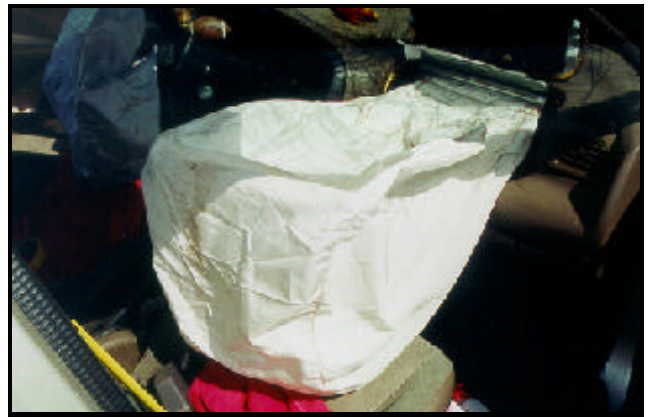
The front right passenger air bag is 43 cm (16.9 in) wide, 50 cm (19.6 in) tall, and had a maximum post-crash excursion of 77 cm (30.3 in). There were no tether straps. There were two vent holes (3 and 9 o'clock positions). There was no damage to the air bag or the module cover.

**Figure 11.** Front right passenger air bag

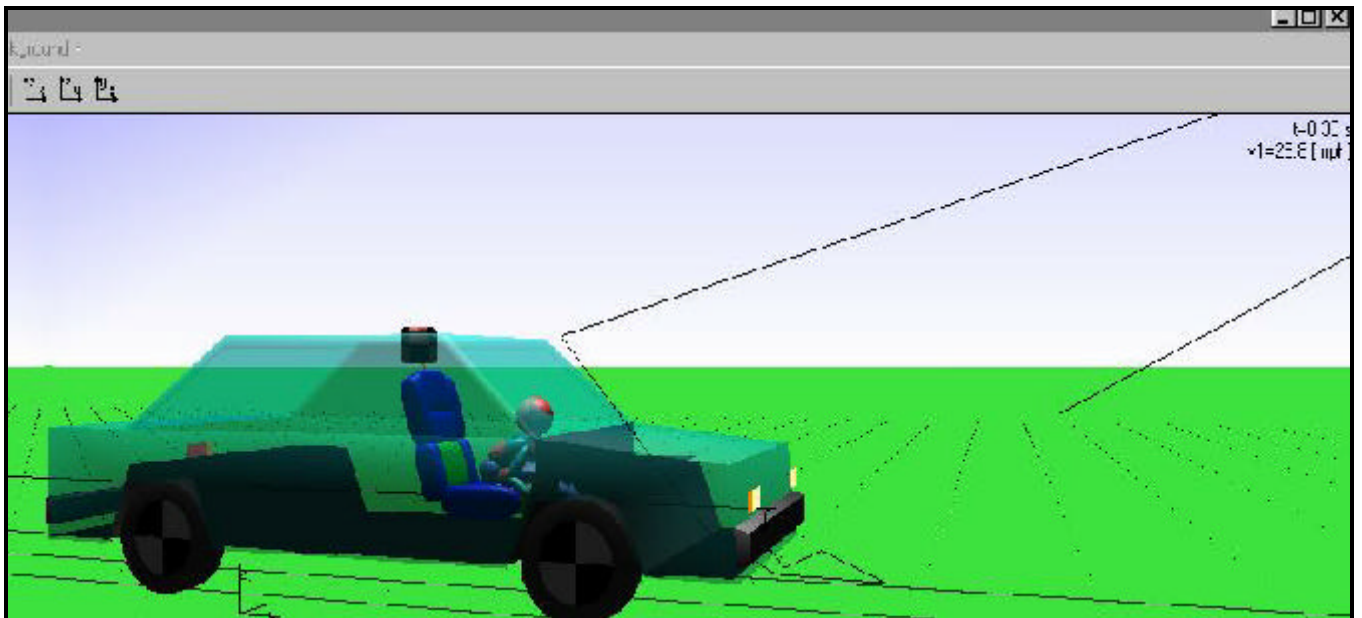
The front right seat was occupied by an unrestrained 3-year-old female (116 cm/45.5 in, 19 kg/42 lbs). The front right seat was adjusted to the full forward track position. This occupant was seated in an upright fashion, facing the front. Prior to impact, the driver braked hard. The unrestrained front right occupant pitched straight forward and struck the windshield with the crown of her head<sup>5</sup> and the right instrument panel with her torso. There was hair and skin evidence found in the windshield fracture and scuffing to the face of the right instrument panel. As she rebounded from this contact the front of the case vehicle struck the right side of the other vehicle and passenger air bag deployed. There was no contact to the air bag module cover. As the air bag continued to deploy the top and face of the air bag engaged this occupant's neck. There was a significant amount of skin transfer found on the air bag—extending 29 cm (11.4 in) longitudinally on the top of the bag and 37 cm (14.6 in) vertically on the face of the air bag. The width of the contact was approximately 10 cm (3.9 in). This contact hyperflexed the occupant's neck—causing the atlanto-occipital dislocation and the resultant spinal cord transection. The air bag also struck this occupant's chest—causing the diaphragm and lung contusions.

**Figure 13.** Position of front right occupant early into braking sequence
