On-site Child Safety Seat Investigation / Vehicle to Vehicle  
Dynamic Science, Inc. / Case Number: DS02010  
1996 Toyota Camry four-door  
California  
June, 2002

1. Report No. <b>DS02010</b>		2. Government Accession No.		3. Recipient Catalog No.	
4. Title and Subtitle <b>On Site Child Safety Seat Investigation</b>			5. Report Date <b>September 2, 2003</b>

**Dynamic Science, Inc.**  
**Accident Investigation**  
**Case Number: DS02010**

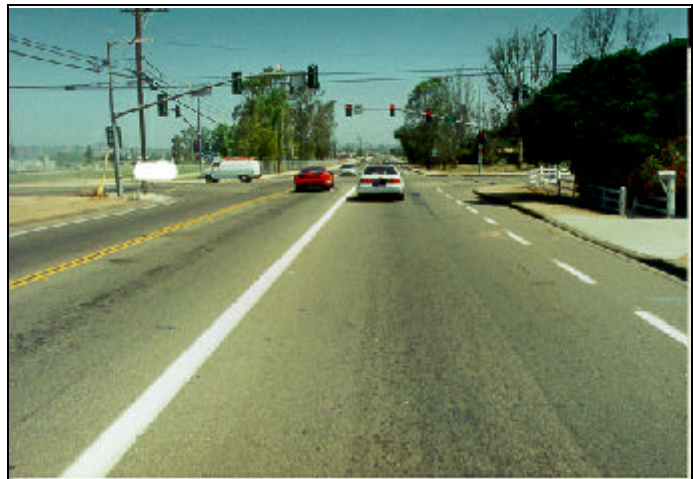
**Figure 1.** Approach to area of impact–case vehicle

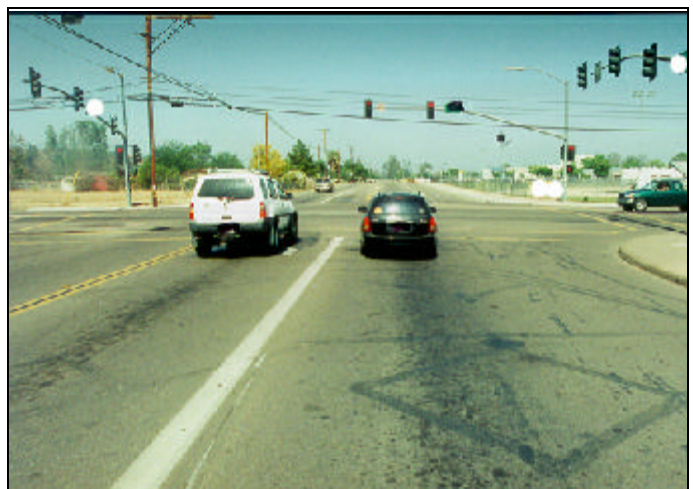
**Figure 2.** Approach to area of impact-other vehicle

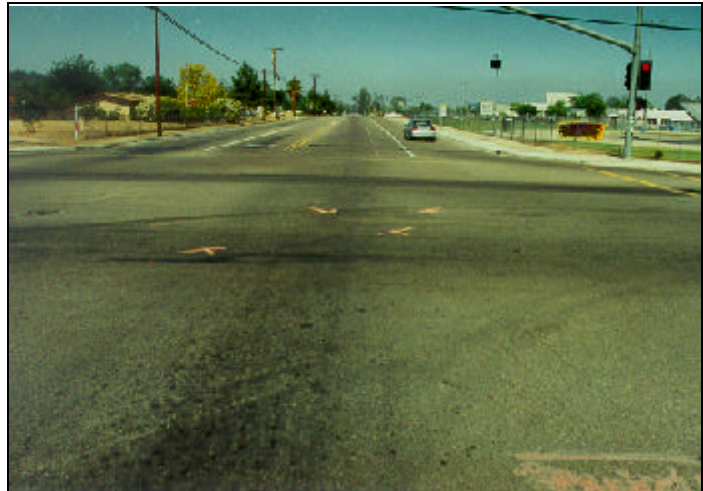
**Figure 3.** Area of impact/final rest—west

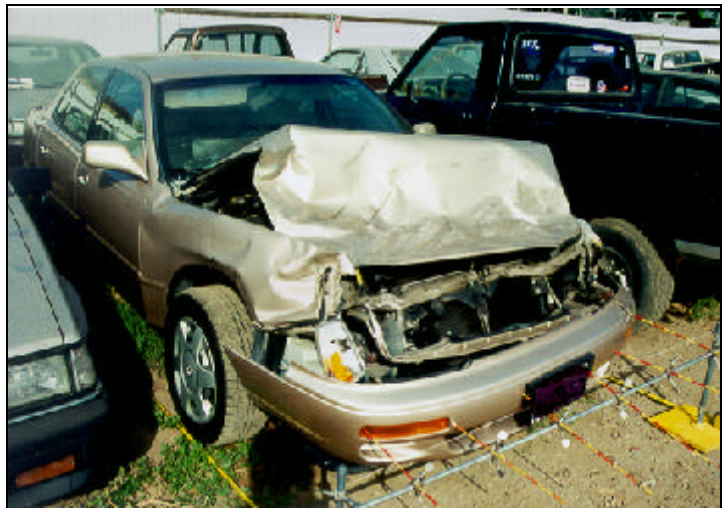
**Figure 4.** Front right, case vehicle

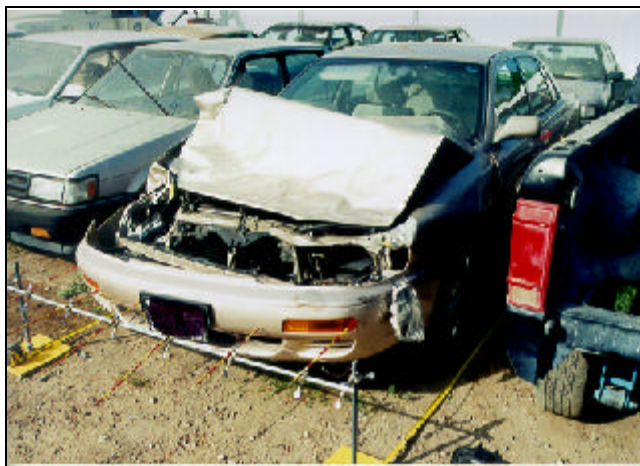
**Figure 6.** Left front, case vehicle

The case vehicle sustained 144 cm (57 in) of direct contact damage that extended across the entire frontal end width of the vehicle. The residual crush was measured at both the bumper and above bumper levels (radiator support). The averaged maximum crush was 17 cm (7 in) at C5. The principle direction of force was within the 1 o'clock sector and was an estimated 20 degrees. The impact energy was managed by the forward structures of the vehicle. The damaged components included the bumper fascia and reinforcement bar, upper radiator supports, grille, and hood.

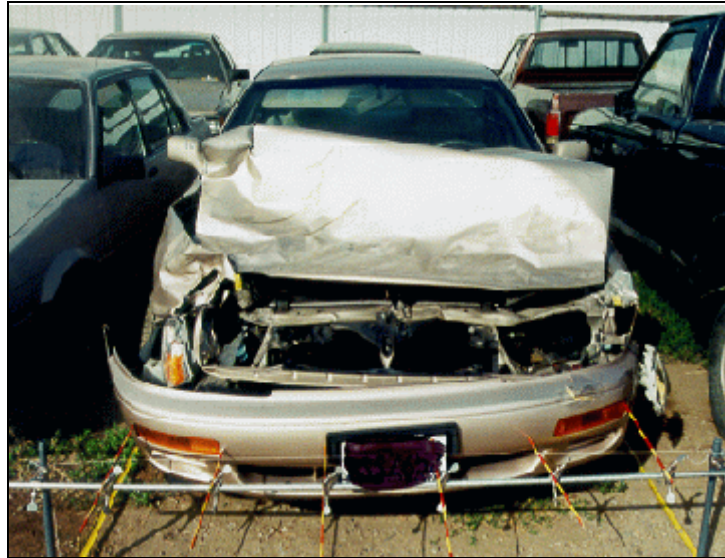
**Figure 7.** Front of case vehicle

There was no measured change in the wheelbase dimensions. There was impact related glazing damage to the right side of the windshield. There was a star shaped occupant contact to the driver's side of the windshield. All four doors remained closed and operational.

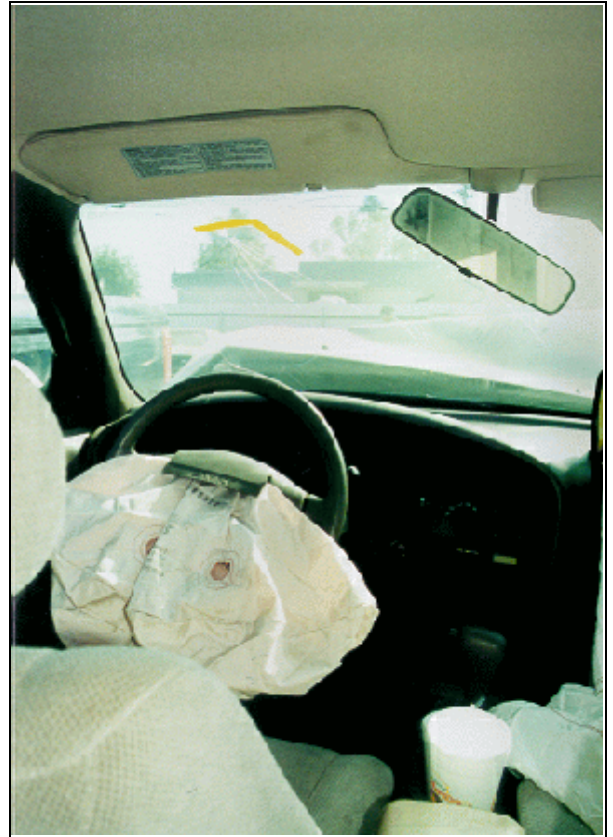
The 49-year-old female driver (165 cm/65 in, 59 kg/130 lbs) of the case vehicle was seated in normal, upright fashion. She was wearing the available lap and shoulder belt. The shoulder belt upper anchorage was adjusted to the full down position. The fabric covered bucket seat was adjusted to between the middle and rear most track positions. Prior to impact, the driver began braking with her right foot. This action caused her to pitch forward to some degree and likely preloaded the lap and shoulder belt. Upon impact, the driver's air bag deployed. The driver responded to the 1 o'clock direction of force by exhibiting a forward and slight right trajectory and loading the lap and shoulder belt. Her face and torso likely engaged the deployed air bag, but there were no indications of contact. Her left hand came off the steering wheel and struck and cracked the windshield (Figure 9). These contacts did not result in any reported injury. There was no steering wheel rim or column deformation.

Figure 8. Driver's seated position

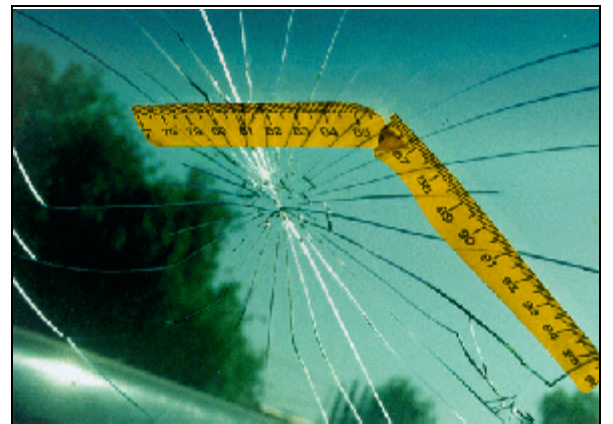
Figure 9. Windshield contact

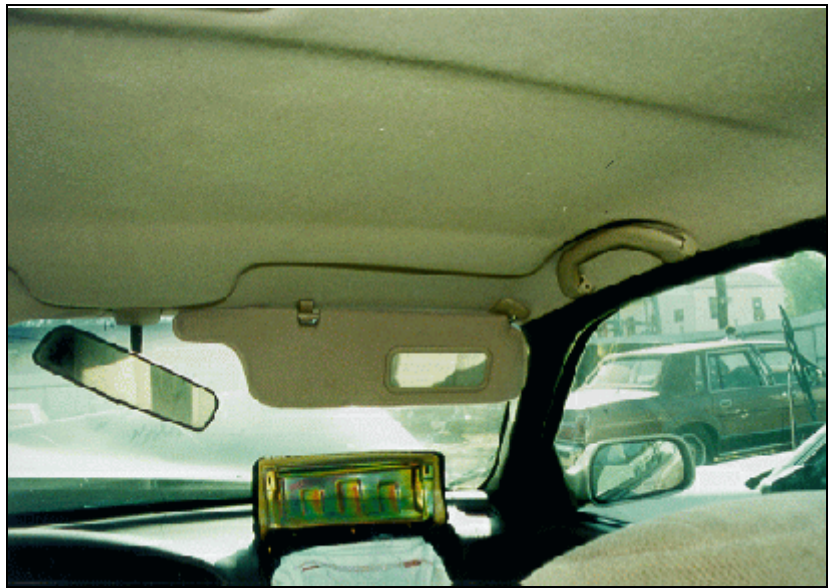
The front right seat was occupied by a 4-year-old female who was seated in an unknown type booster seat. The fabric covered bucket seat was adjusted to between the middle and rear most track positions. A 3-point lap and shoulder belt was available and was being used in conjunction with an unknown type booster seat. The belt was equipped with a dual mode locking retractor, but it is not known if it was being used in the ALR or ELR mode. There were indications of seat belt loading. Prior to impact, the driver began braking with her right foot. This action caused this occupant to pitch forward to some degree and likely pre-loaded the lap and shoulder belt. Upon impact, the front right passenger air bag deployed. This occupant responded to the 1 o'clock direction of force by exhibiting a forward and slight right trajectory and loading the lap and shoulder belt. Her face engaged the deploying air bag—causing the facial and corneal abrasions and the concussive injury. There stains found on the left face of the passenger air bag (Figure 11), but no indications of occupant contact.

**Figure 10.** Front right seating position

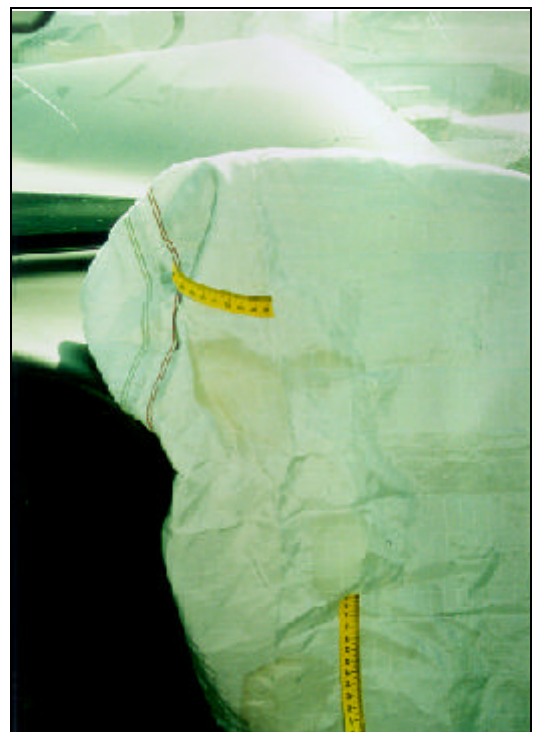
The rectangular front right air bag was mounted in the top of the instrument panel and measured 47 cm (19 in) wide by 60 cm (24 in) high. The air bag was equipped with two vents. The vent ports were at the 3 and 9 o'clock positions. The air bag had a maximum post-crash excursion of 90 cm (35 in). The maximum excursion matched the distance to the seat back. The single module cover flap opened at the designed tear points and there was no damage to the cover. There was a stain found on the left side of the face of the air bag that measured 14 cm (6 in) wide by 9 cm (4 in) high.

Given the fact that the air bag had a maximum post-crash excursion of 90 cm (35 in), and this excursion matched the distance to the seat back, it would have been impossible for the bag to fully inflate before this occupant engaged the air bag.

**Figure 11.** Front right passenger air bag
