AIR BAG RELATED CHILD PASSENGER SERIOUS INJURY INVESTIGATION

VERIDIAN CASE NO.: CA02-058

VEHICLE: 1995 TOYOTA CAMRY

CRASH DATE: NOVEMBER 2002

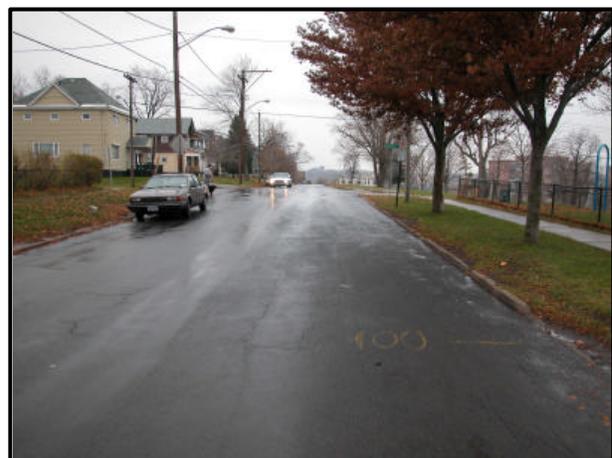
This two-vehicle crash occurred during daylight hours in November 2002. At the time of the crash, it was snowing and the road surface was wet. The crash occurred at the four-leg intersection of a two lane north/south road and a two lane east/west road in an urban residential setting. Residential housing bordered the east side of the road. The intersection was controlled by a stop sign for traffic in the east/west direction. The speed limit in the area of the crash was 56 km/h (35 mph). **Figure 1** is a southbound trajectory view approximately 30 m (100 ft) north of the intersection.

Figure 1: Southbound trajectory view.

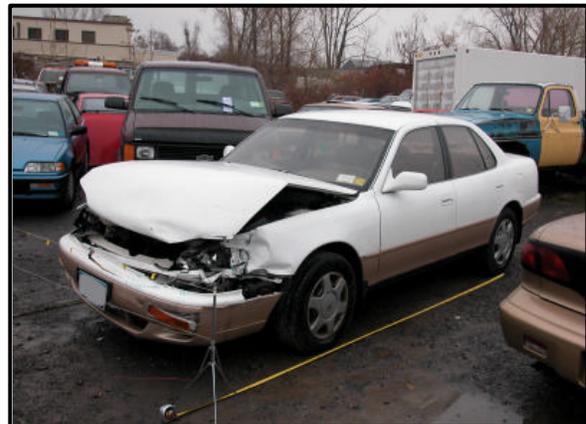
The 1995 Toyota Camry LE, **Figure 2**, was identified by the Vehicle Identification Number 4T1GK12E9SU (production sequence deleted) and was manufactured in April 1995. The vehicle was equipped with a 3.0 liter, V-6 engine linked to a four speed automatic transmission. The manual restraint system consisted of 3-point lap and shoulder belts in the four outboard positions. The center rear position was equipped with a lap belt. The Supplemental Restraint System consisted of driver and front right passenger air bags that deployed as a result of the impact. The odometer read 158,887 km (98,730 miles) at the time of the inspection.

Figure 2: Left front view of the Toyota.

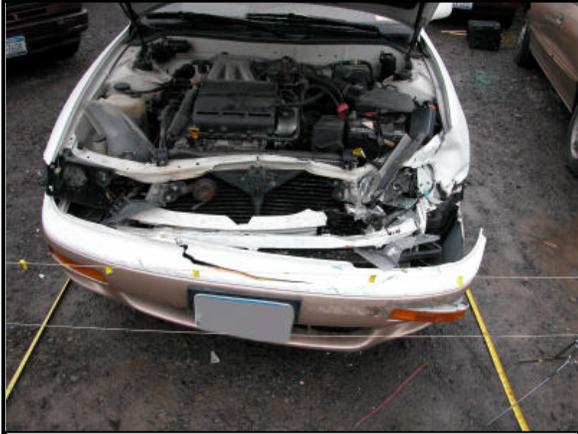
Figures 3 and 4 are the front and left lateral views of the frontal damage. The front plane of the Toyota sustained 119 cm (47 in) of direct contact damage that began 43 cm (17 in) right of center and extended to the left front corner. The combined width of the direct and induced damage extended across the vehicle's entire 152 cm (60 in) end width. The residual crush profile of the Toyota was measured along the bumper reinforcement bar and the upper radiator support to document the vehicle's direct frontal and underride engagement. The averaged crush profile used as the input to the WINSMASH model to estimate the crash severity was as follows: C1=6 cm (2.3 in), C2=6 cm (2.3 in), C3=6 cm (2.3 in), C4=7 cm (2.9 in), C5=6 cm (2.3 in), C6=0. The hood was buckled and veed. There was no measurable reduction in the wheelbase dimensions. All the doors remained operational. There were no glazing fractures and the windshield was intact. The Collision Deformation Classification was 11-FDEW-1. The total delta V of the Toyota calculated by the Damage Only Algorithm of the WINSMASH model was 17.0 km/h (10.6 mph). The longitudinal and lateral delta V components were -16.0 km/h (-9.9 mph) and 5.8 km/h (3.6 mph), respectively.

Figure 3: Front view.

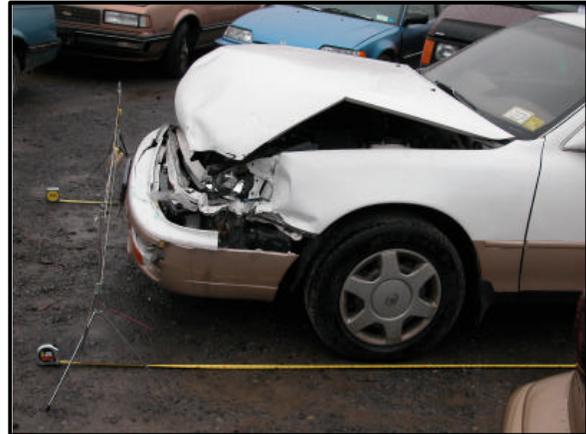
Figure 4: Left lateral view.

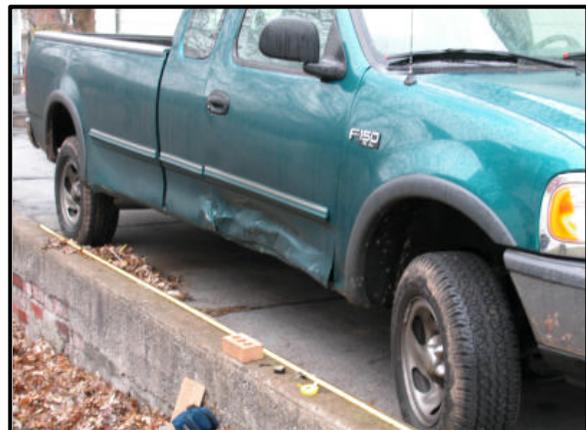
Figure 5 is a front right view of the minor impact damage. The initial contact was approximately centered on the right door and resulted in a maximum measured crush of 10 cm (4 in). Inspection of the vehicle undercarriage revealed a direct contact scuff to the right frame rail. The length of this contact measured 30 cm (12 in). There was no lateral deformation of the rail. As the Ford traveled laterally across the front of the Toyota, the secondary contact extended rearward to the leading edge of the rear wheel well. The secondary damage consisted of minor scratches and abrasions to the body panel. The Collision Deformation Classification (CDC) of the impact was 02-RPEW-2.

Figure 5: Right front view.

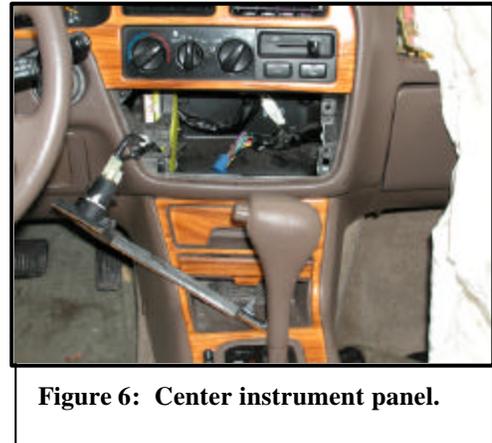
Figure 6: Center instrument panel.

The electronics were mounted in the center radio stack, **Figure 6**. Reportedly, the TV was a small flat screen mounted on a swivel/fold down base located on the top of the instrument panel. The driver of the Ford F150 reported that the Toyota's driver and child passenger were watching the TV at the time of the crash.

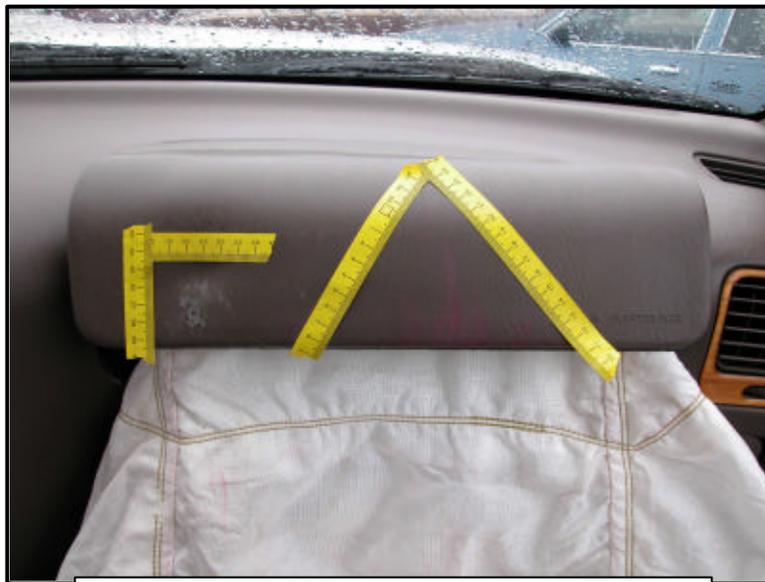
The front right passenger air bag was a mid-mount design located in the right aspect of the instrument panel. The module cover flap was rectangular in shape and was hinged on its top forward surface. The flap was constructed of 16 mm (5/8 in) thick vinyl with a sheet metal backer. The sheet metal deformed during the deployment sequence and formed the hinge. The module cover flap was contoured to the shape of the instrument panel. The overall dimensions of the flap measured 35.6 cm x 14.0 cm (14.0 in x 5.5 in), width by height. The right and center aspects of the cover flap exhibited evidence of direct contact to the child's chest. A triangular patterned red fabric transfer was identified. The transfer began 8.6 cm (3.4 in) inboard of the right edge of the flap and ended 21.1 cm (8.3 in) inboard of the right edge. The height of the pattern measured 8.4 cm (3.3 in). This contact pattern was consistent with direct contact to the child's chest and was the mechanism causing his right lung contusion. A partial interview with the child's mother at the hospital revealed the child was, in fact, wearing a red coat at the time of the crash. A second contact pattern to the flap was also identified. This contact measured approximately 3.8 cm (1.5 in) in diameter and was located 29.0 cm (11.4 in) inboard of the right edge of the flap. The center of this contact was depressed approximately 6 mm (0.25 in). This contact may have resulted from contact with the child's left hand but did not result in any injury. **Figure 7** is a view of the flap contacts.

Figure 7: View of the cover flap contacts.

The child was struck in the chest by the front right air bag module cover flap as it rotated open in an upward direction. This contact was evidenced by the red fabric transfers to the center aspect of the flap and resulted in a right lung contusion. The child's mother indicated he was wearing a red coat at the time of the crash. The contact with the flap, and the deploying air bag stopped the child's forward trajectory and displaced the child rearward. The expanding air bag also contacted the child evidenced by the aforementioned transfers during his rebound trajectory. The contact with the expanding air bag membrane did not result in further external soft injury, probably due to the rebound trajectory of the child. It was noted that the medical records specifically indicated there were no external soft tissue injuries. However, the child did sustain an unspecified closed head injury/traumatic brain injury from the force of the bag expansion. At some point during the crash sequence, the child bit his tongue evidenced by the minor laceration. The child came to rest in the vehicle's front right seat unconscious and unresponsive.

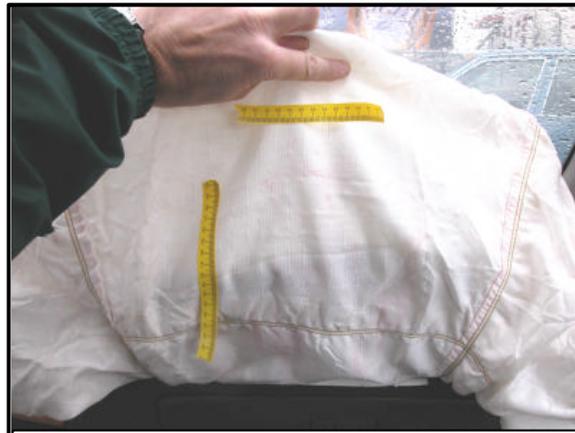
The deployed air bag exhibited contact evidence to its bottom, face, and top surfaces. The contact to the bottom surface of the air bag consisted of red fabric transfers consistent with the

pattern on the cover flap. The contact area measured 15.7 cm x 15.2 cm (6.2 in x 6.0 in), width by height, and began 6.4 cm (2.5 in) rearward of the instrument panel, **Figure 8**.

Figure 8: Contact to the bottom surface of the air bag.

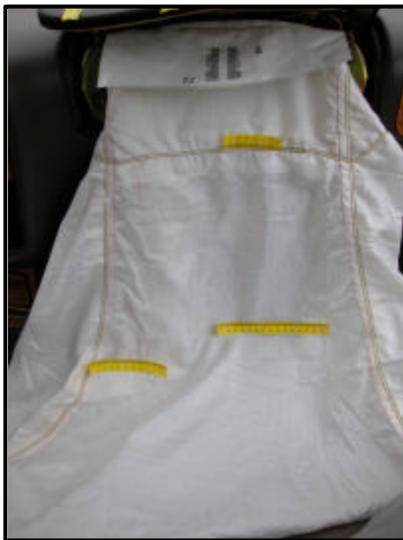
Multiple short red fabric transfers were identified on the top surface of the bag. These transfers were not as concentrated as the bottom surface transfers and were dispersed over a large area. The extent of the contact area measured 90 cm x 26.7 cm (14 in x 10.5 in). This contact pattern began 10 cm (4 in) rearward of the instrument panel and was biased to the inboard side of the bag. Refer to **Figure 9**. The face of the air bag exhibited a brown transfer that measured approximately 18 cm x 30 cm (7 in x 12 in), width by height. This contact pattern was approximately centered on the face of the bag and is depicted within the yellow circle of **Figure 10**. This contact was not consistent with a direct contact to the child passenger and may have resulted from a possible interaction with the driver.

Figure 9: Contact evidence to the top surface of the air bag.

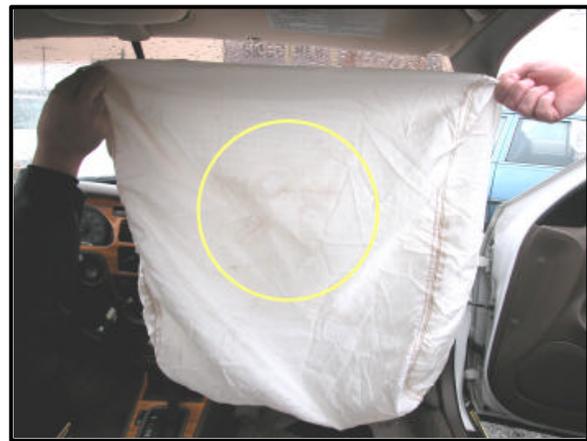
Figure 10: Contact evidence to the face of the air bag.

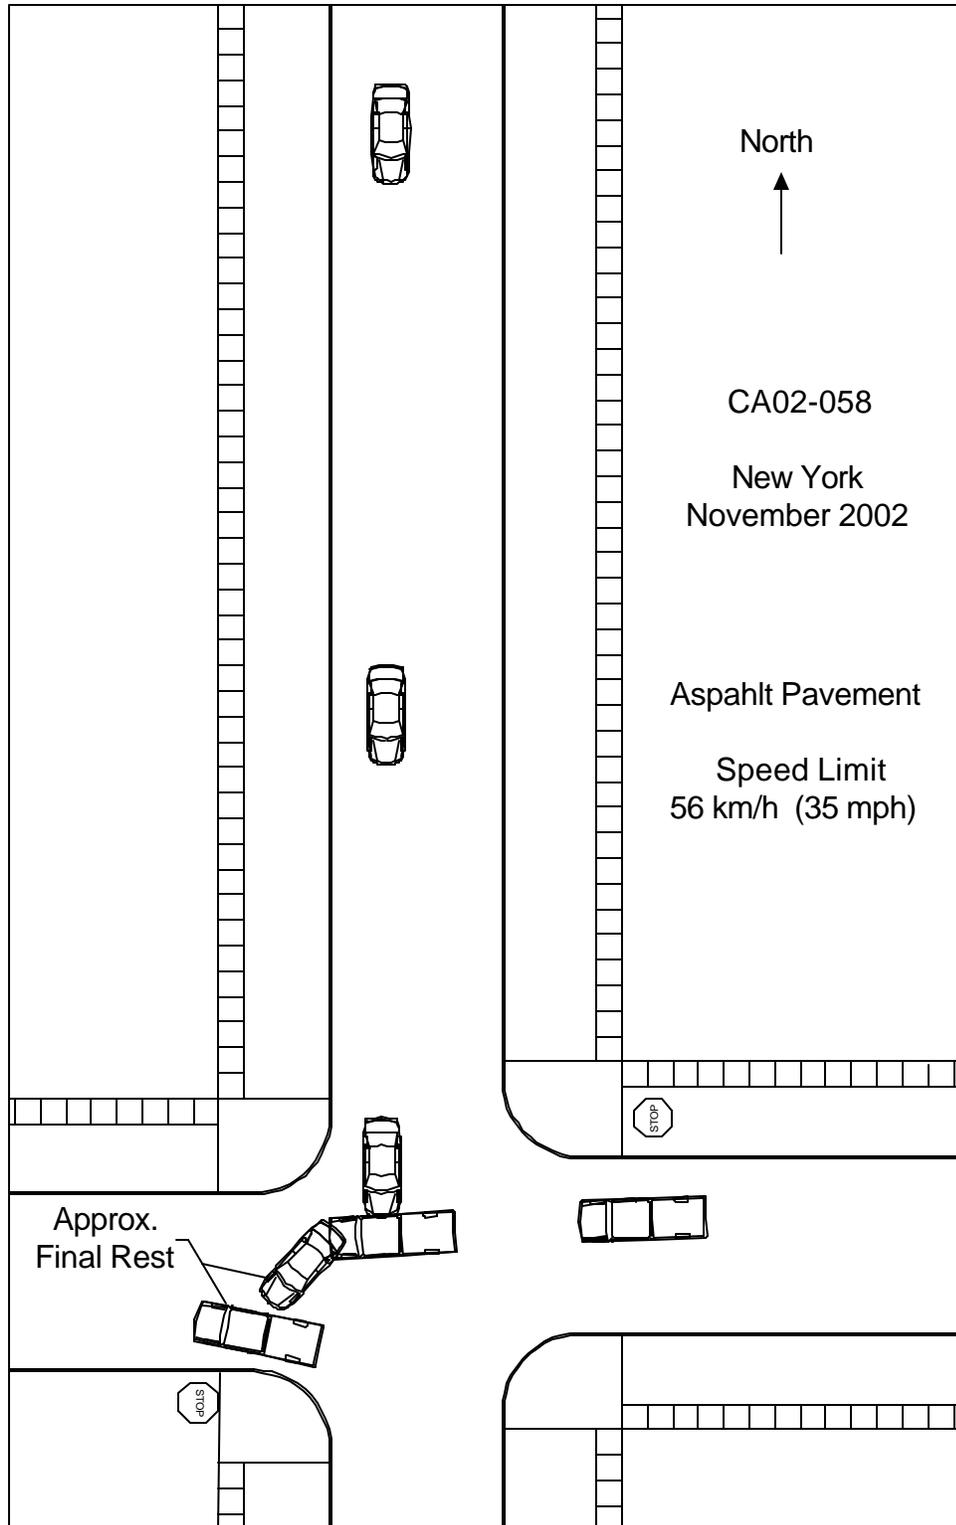
The on-scene police investigation did not find any physical evidence related to the crash due to the wet road conditions. The area of impact and the vehicles' final rest locations were not documented. No physical evidence was identified during the subsequent SCI scene inspection. A generalized schematic of the crash sequence is depicted as **Figure 11** at the end of this report.

Figure 11: Crash schematic.
