Driver Air Bag Fatality Investigation / Vehicle to Vehicle
Dynamic Science, Inc. / Case Number: 2003-082-086B
1997 Toyota Camry
Washington
July, 2003

1. Report No. 2003-082-086B	2. Government Accession No.		3. Recipient Catalog No.	
4. Title and Subtitle Driver Air Bag Fatality Investigation		5. Report Date June 28, 2004

Investigation Type: Driver Air Bag Fatality

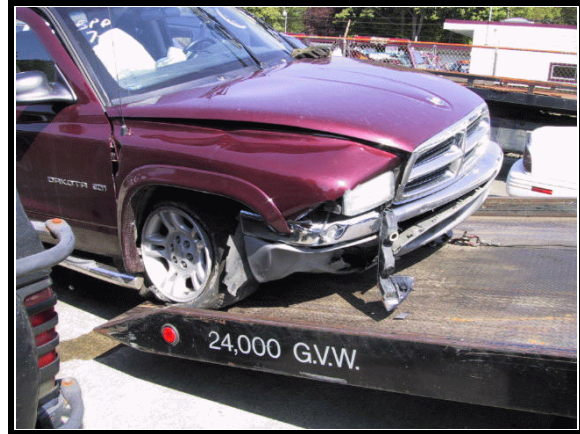
Figure 2. Front right, Dodge Dakota

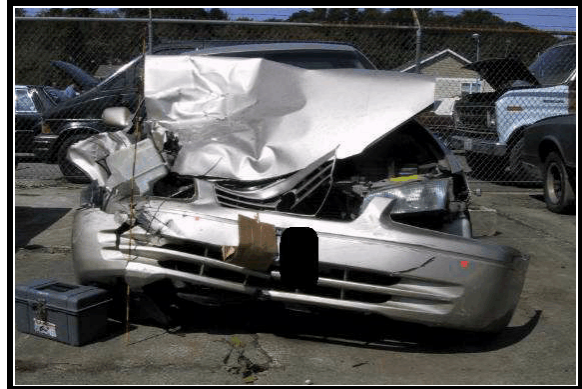
The direct damage to the Toyota Camry from the impact with the Dodge Dakota began at the right front corner and extended to the left 52.0 cm (20.5 in). There was damage to the bumper, grille, right fender, and hood. The bumper fascia was knocked off. The direct and induced damaged involved the entire front width of this vehicle. The right wheelbase was shortened by 7.0 cm (2.7 in). The right front tire was restricted. Six crush measurements were taken along the bumper and were averaged with above bumper measurements as follows: C1=0 cm (0 in), C2=12.0 cm (4.7 in), C3=29.0 cm (11.4 in), C4=37.0 cm (14.6 in), C5=30.0 cm (11.8 in), C6=25.0 cm (9.8 in).

Figure 3. Front, Toyota Camry

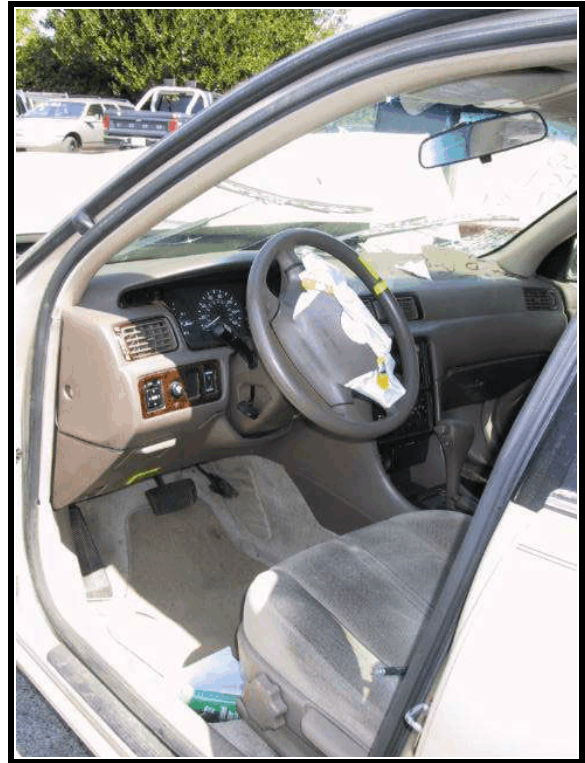
Interior damage to the Camry was minor and was attributed to vehicle intrusion and occupant contacts. There was minor center instrument panel intrusion. All the doors remained closed and operational. There was no integrity loss. The upper rim of the steering wheel rim had 2.0 cm (0.8 in) of deformation. The windshield was cracked from the air bag and impact forces. There was no occupant glazing contacts or damage. The left and center instrument panel was scuffed and scratched by occupant contact. The gas pedal was deformed to the right.

Figure 4. Overview of driver's seated area, Toyota Camry

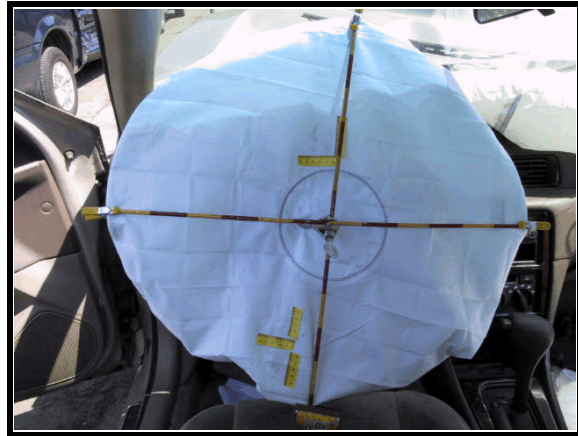
The driver's air bag was mounted in the steering wheel hub. The driver's air bag was circular and measured 60.0 cm (23.6 in.) in diameter. The air bag was equipped with two tethers and two vent ports. The vent ports were located at the 11 and 1 o'clock positions. There were smudges found on the top right and bottom right of the air bag face. The face of the air bag exhibited 12 horizontal and 8 vertical folds. The dual module cover flaps opened in an "H" type configuration. The top flap measured 16.0 cm (6.3 in) wide by 6.0 cm (2.4 in). The bottom flap measured 16.0 cm (6.3 in) wide by 8.0 cm (3.1 in) high. There were no indications of any damage to the module cover flaps.

Figure 5. Driver's air bag, top is at the bottom of the picture

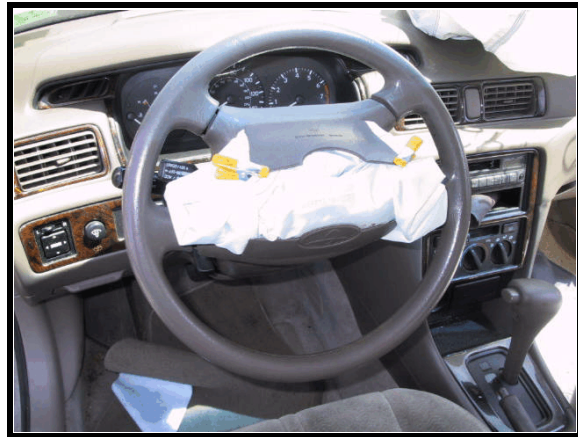
Figure 6. Driver's air bag module cover

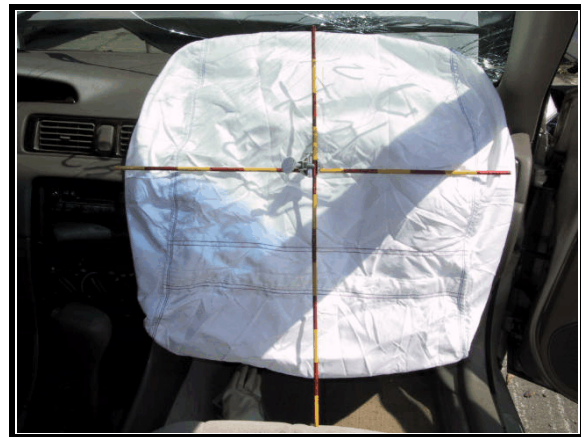
The front right passenger air bag was mounted in the top of the instrument panel. The air bag was generally rectangular in shape and measured 60.0 cm (23.6 in) high by 45.0 cm (17.7 in) wide. It was equipped with two internal tethers and there were no vent ports. There were no contacts or damage to the air bag face. The module cover was vaguely in an "H" configuration. The top flap was 22.0 cm (8.7 in) wide by 3.0 cm (1.2 in) high on the left and 5.0 cm (1.9 in) on the right. The bottom flap was 22.0 cm (8.7 in) wide by 7.0 cm (2.8 in) high on the right and 9.0 cm (3.5 in) high on the left. There were no contacts or damage to the module covers.

Figure 7. Front right passenger's air bag

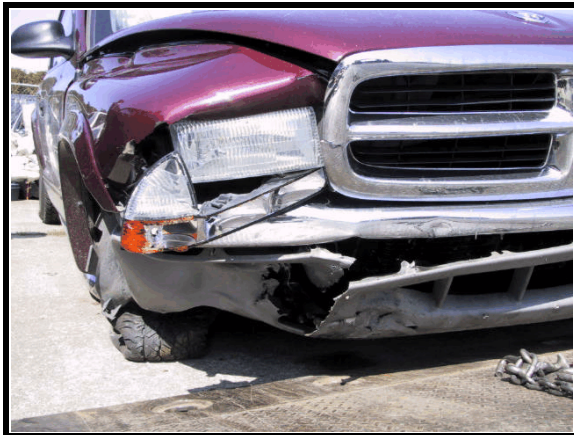
Description:	2001 Dodge Dakota pickup	
VIN:	1B7GG22N81Sxxxxxx	
Odometer:	Unknown	
Engine:	4.7 L, 8 cylinder	
Reported Defects:	None noted	
Cargo:	5 kg, per vehicle inspection	
Damage Description:	Moderate front end damage. Front right tire restricted. Vehicle towed due damage.	
CDC:	12FZEW2	
Delta V:	Total	25.0 km/h (15.5 mph)
	Longitudinal	-25 km/h (-15.5 mph)
	Latitudinal	-4.0 km/h (-2.5 mph)
	Energy	57,270 joules (42,240 ft-lbs)

Figure 8. Front right bumper corner

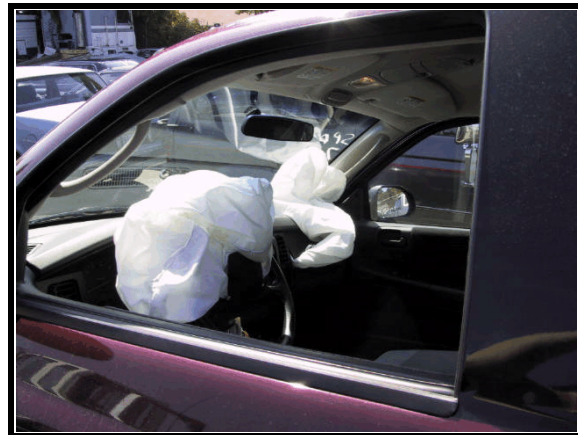
Figure 9. Interior view of Dodge Dakota, showing deployed frontal air bags

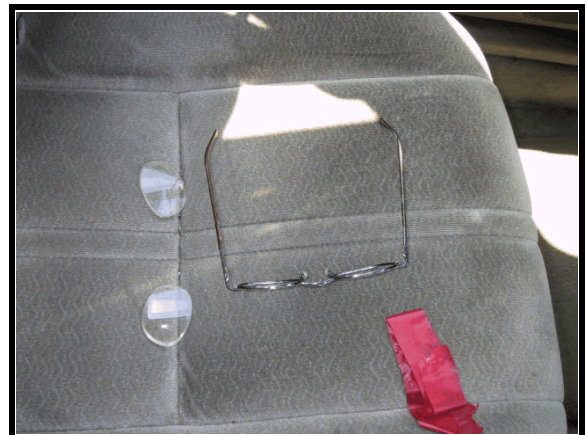
Figure 11. Glasses and lenses for driver of case vehicle

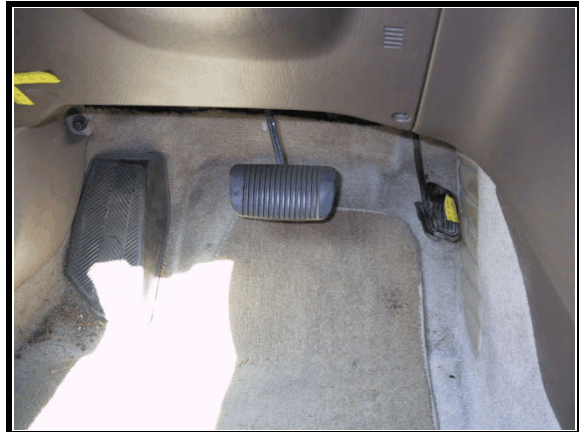
Figure 12. Displaced gas pedal, left knee contact to left instrument panel

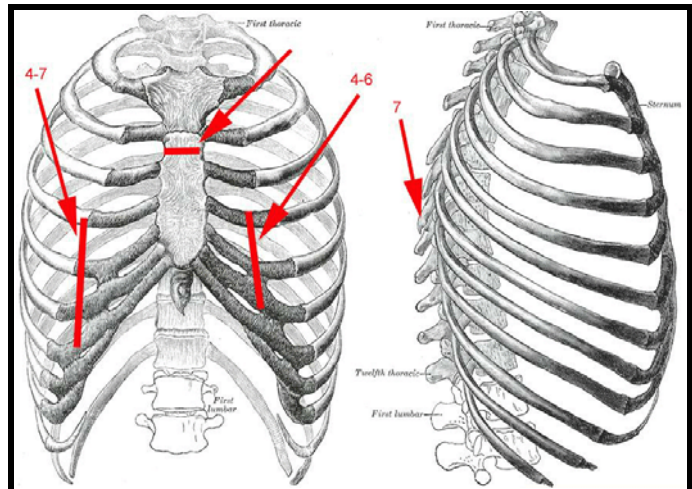
- Rib fractures, left 4th through 6th, anteriorly
- Rib fractures, right 4th through 7th, anteriorly
- Sternal fracture, at the level of second intercostal space
- Thoracic vertebral body fracture, 7th, with hemorrhage in surrounding soft tissues

Figure 13. Overview of rib fracture vertical locations

As stated earlier, this occupant underwent CPR both on-scene, en route, and upon arrival at the trauma center. It appears likely that the rib and sternal fractures may have been exacerbated by the CPR activity. The most common resuscitation-related injuries include rib fracture, collapsed lung, ruptured stomach, and broken teeth. Little information is available about the incidence of resuscitation-related injuries, but one study of 63 survivors of cardiopulmonary arrest found such injuries in over 25 percent of the patients⁵. Elderly patients, because they are more likely to
