**CALSPAN ON-SITE ADVANCED OCCUPANT PROTECTION
SYSTEM CRASH INVESTIGATION**

SCI CASE NO.: CA03-015

VEHICLE: 2003 FORD CROWN VICTORIA POLICE INTERCEPTOR

CRASH DATE: FEBRUARY 2003

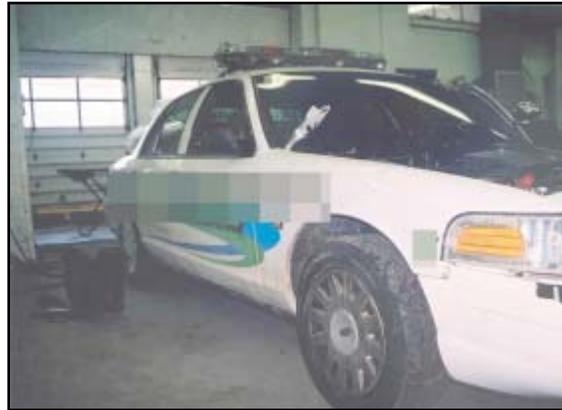
Figure 1. 2003 Ford Crown Victoria Police Interceptor.

This on-site investigation focused on the performance of the Advanced Occupant Protection System (AOPS) that deployed in a 2003 Ford Crown Victoria Police Interceptor (**Figure 1**). The Crown Victoria was equipped dual stage driver and front right passenger air bags, a driver seat track position sensor, front safety belt retractor pretensioners, front safety belt buckle switch sensors, and a front right occupant presence sensor. The Crown Victoria was also equipped with an Event Data recorder (EDR) that was downloaded during the on-site investigation. The EDR output is included as **Attachment A** of

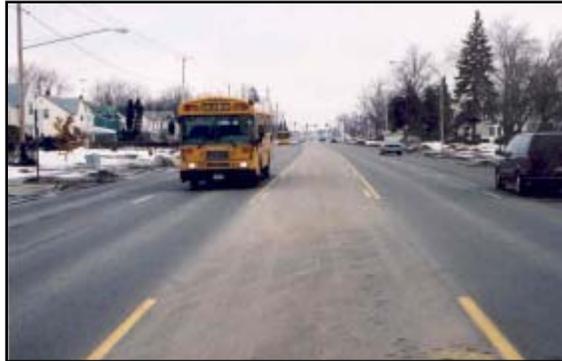
Figure 2. Ford's pre-impact travel in the center median.

The 39-year-old male driver of the Ford was operating the vehicle northbound on the roadway and was in pursuit of a traffic violator. The police officer driver of the Ford had activated the siren and overhead emergency lights at the on-set of this pursuit. As the driver of the Ford continued the northbound travel, he entered the center median to bypass non-contact traffic (**Figure 2**). Coincident to this, the 2002 Jeep operated by a 25-year-old female initiated a left turn from a driveway on the east roadside and entered the roadway. The Jeep traversed the northbound lanes, entered

the center median and stopped due to on-coming traffic in southbound lanes. At this point, the Ford was passing the non-contact traffic in the center median. The driver of the Ford observed the Jeep entering the median and applied a rapid right steering input and a level of braking in an attempt to avoid an impact with the Jeep.

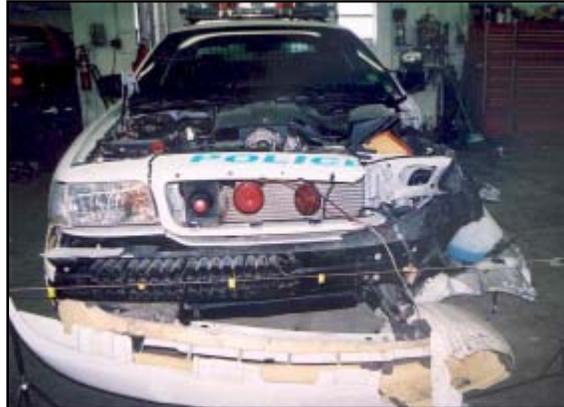
Figure 3. Resultant frontal damage to the Ford.

The 2003 Ford sustained moderate severity damage to the frontal area as a result of the crash with the Jeep (**Figure 3**). The damage was contained within the front left area of the vehicle. The direct contact damage measured 79 cm (31") and began 3 cm (1") right of the centerline and extended to the front left bumper corner. The maximum crush measured 14 cm (5.4") and was located at the left end of the bumper beam. A crush profile was documented across the 140 cm (55.5") width front bumper beam and was as follows: C1 = 14 cm (5.4"), C2 = 1 cm (0.5") C3 = 0 cm, C4 = 0 cm, C5 = 0 cm, C6 = 0 cm. The Collision Deformation Classification (CDC) for this impact was 12-FYEW-1. The secondary impact with the parked Jeep did not result in residual damage to the Ford. This resulted in the assignment of a partial CDC of 12-F999-9.
