Child air bag fatality Investigation / Vehicle v. Tree
Dynamic Science, Inc. / Case Number: DS03028
1992 Ford Taurus
Ohio
July, 2003

1. Report No. DS03028		2. Government Accession No.		3. Recipient Catalog No.	
4. Title and Subtitle On Site Child Air Bag Fatality Investigation				5. Report Date October 30, 2003

**Dynamic Science, Inc.
Crash Investigation
Case Number: DS03028**

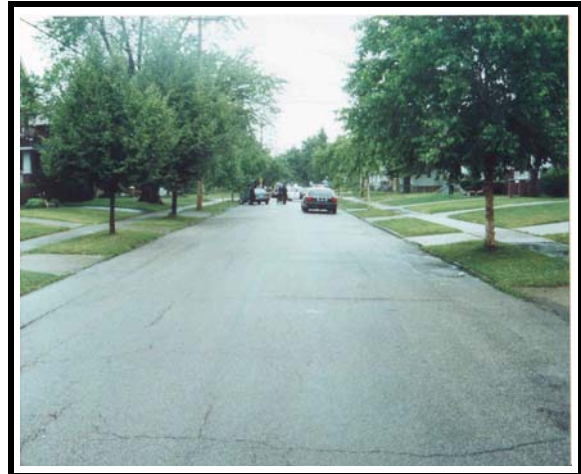
Figure 1. Approach to area of tree impact

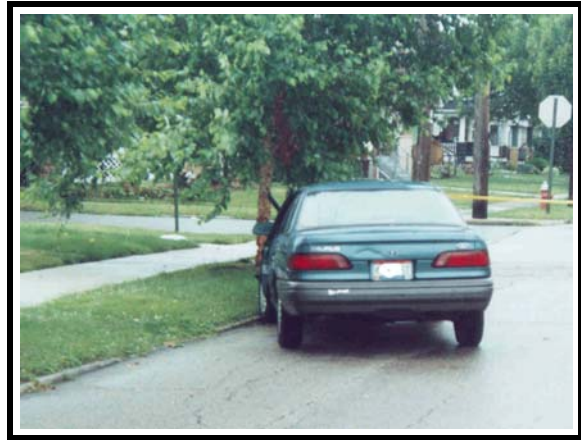
Figure 2. Case vehicle at final rest

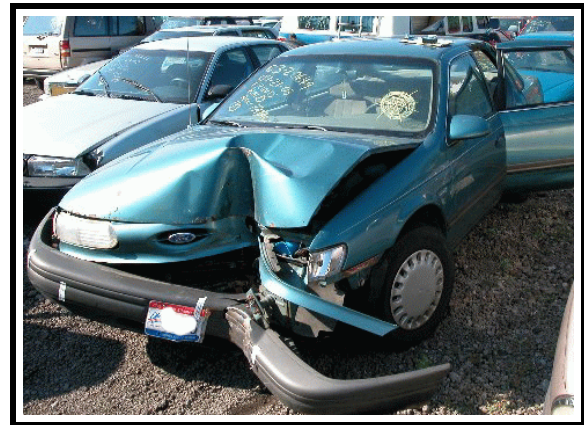
Figure 3. Front left, case vehicle

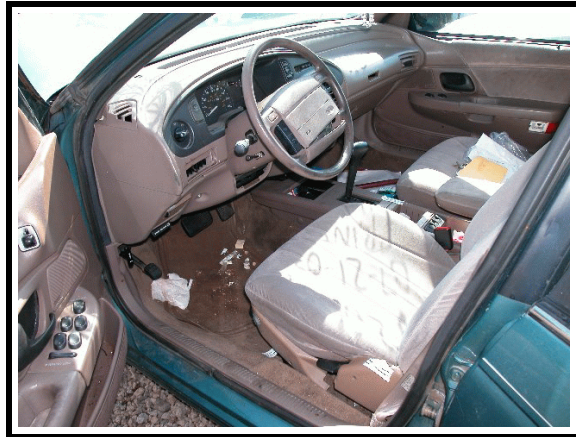
Figure 4. Driver's seated position (air bag had been removed)

The child appears to have been seated on the fabric covered bucket seat, facing forward, with one foot on the accelerator. The seat was adjusted to the middle track position (three stops from full forward). The child was able to start the vehicle. The vehicle was taken out of PARK and put into DRIVE. This is a multi step process. This first requires that the left side shift lever button on the center console mounted shifter be pressed. It next requires that the brake pedal be depressed before actually shifting. The vehicle was equipped with a Brake Shift Interlock safety feature (See Attachment 1). This feature prevents the shift lever from being moved from the PARK position until the brake pedal is depressed. This feature is only active when the ignition switch is in the RUN position¹. It appears likely that the interlock was working correctly before the crash took place but this could not be verified. The vehicle shifted freely without having to use the brake, but the vehicle was without power.

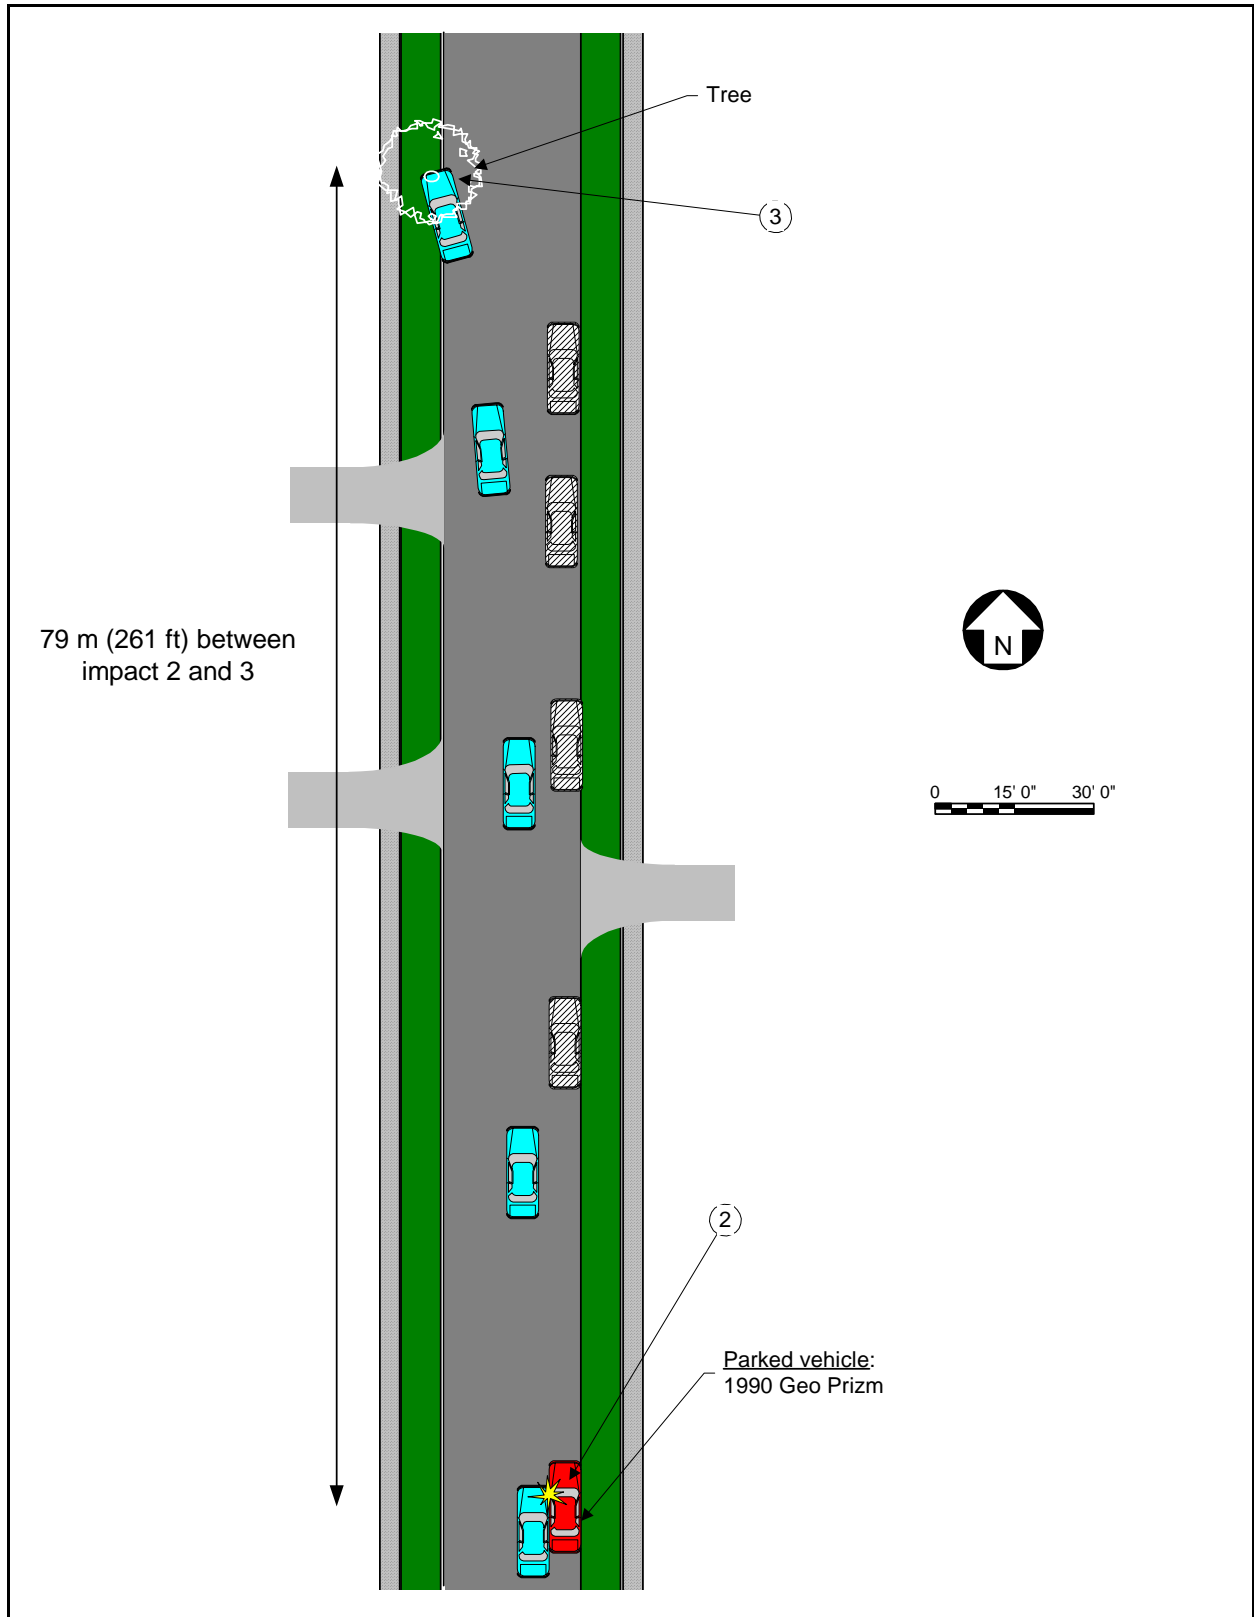
Figure 6. Scene diagram (impacts 2 and 3)

The case vehicle continued northbound for 266 m (874 ft) until veering right and sideswiping a parked 1990 Chevrolet Prizm with its front right side. The case vehicle continued going northbound for 79 m (261 ft) until it veered to the left, over-ran the small curb, and struck a 16.0 cm (6.3 in) wide tree with its front end (12FYEN2). The tree remained upright. The total velocity change for the case vehicle as calculated by the Barrier algorithm of the WinSmash collision model was 29.0 km/h (18.0 mph). The longitudinal and lateral delta V components were -29.0 km/h (-18.0 mph) and 0 km/h (0 mph), respectively. The driver's air bag deployed at this point.

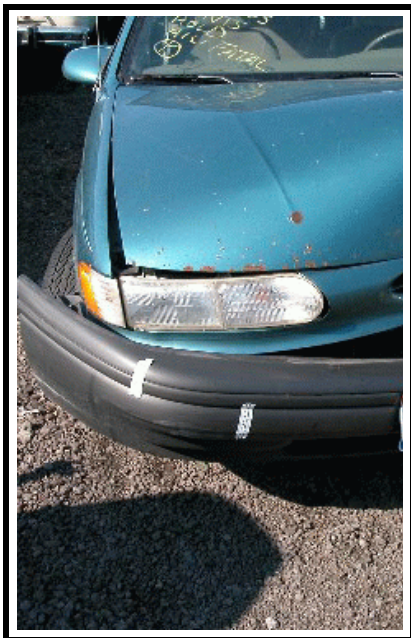
Figure 7. Front, impact with parked vehicle (impact 1)

This vehicle sustained 22.0 cm (8.6 in) of direct contact to the right front bumper corner from the impact with the first parked vehicle (impact 1). This damage was altered by a subsequent impact. The vehicle sustained 110.0 cm (43.3 in) of direct contact to the right fender from the impact with the second parked vehicle (impact 2). The vehicle sustained 34.0 cm (13.4 in) of direct contact damage to the bumper that began 30.0 cm (11.8 in) from the left front bumper corner from the impact with the tree (impact 3). The residual crush measured along the bumper was as follows: C1=0 cm (0 in), C2=0 cm (0 in), C3=47.0 cm (18.5 in), C4=34.0 cm (13.4 in), C5=0 cm (0 in), C6=0 cm (0 in). The maximum crush was measured at C3. The principle direction of force was within the 12 o'clock sector and was an estimated 0 degrees. The damaged components included the bumper fascia and reinforcement bar, hood, grille, and radiator. Both front and rear doors remained closed and operational. There was no glazing damage.

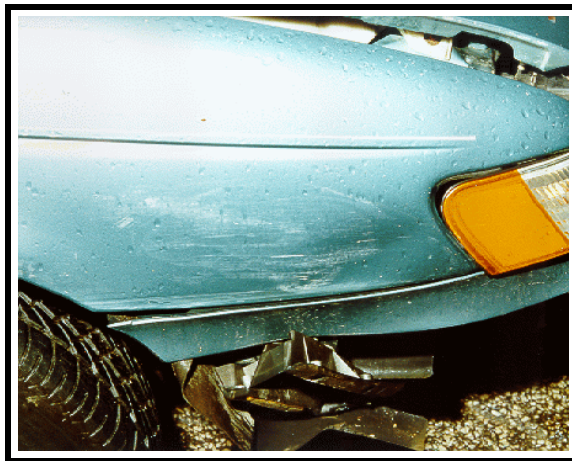
Figure 8. Right side impact with second parked vehicle (impact 2)

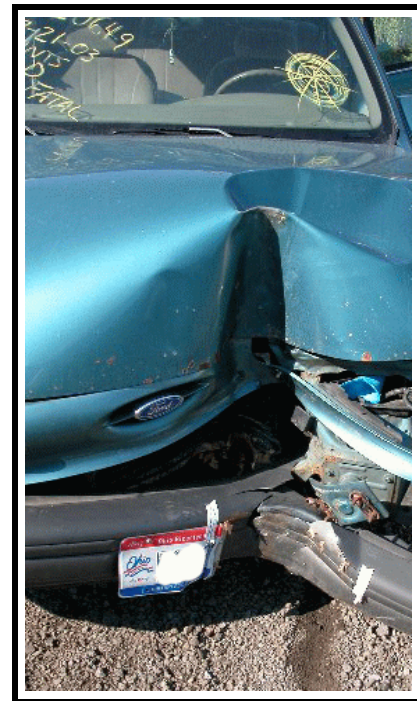
Damage Description:	Moderate frontal contact damage from tree impact. Light scraping to right front bumper and right fender from impacts to parked vehicles.	
CDC:	Impact 1: 12FREE1 Impact 2: 12RFES1 Impact 3: 12FYEN2	
Delta V (Impact 3):	Total	29.0 km/h (18.0 mph)
	Longitudinal	-29.0 km/h (-18.0 mph)
	Latitudinal	0 km/h (0 mph)
	Energy	47,084 joules (34,727 ft lbs)

Figure 9. Front, tree impact (impact 3)

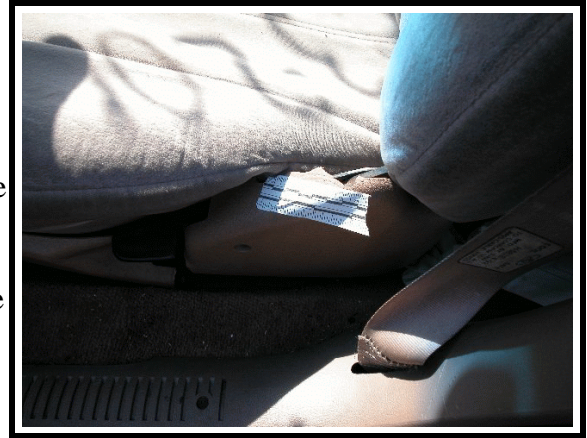
There was minimal interior damage to the Ford Taurus. There was no intrusion and all the glazing remained intact. There was no steering column movement or steering wheel rim deformation. There was a plastic panel beneath the steering column that was missing. The plastic cover near the hinge point on the left side of the driver's seat was cracked. The center console was slightly displaced. This damage appears to be related to vehicle usage.

Figure 10. Cracked plastic on driver's seat

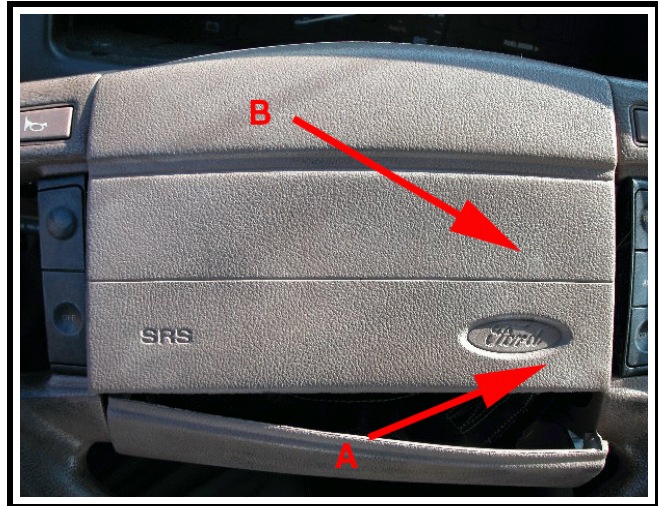
The case vehicle was equipped with a steering wheel mounted driver's air bag. The deployed air bag was circular with a diameter of 69.0 cm (27.2 in). There were four vertical folds, a single tether, and two vent ports. The module cover had an "H" configuration. The top cover measured 20.5 cm (8.1 in) wide by 12.0 cm (4.7 in) high. The bottom cover measured 20.5 cm (8.1 in) wide by 3.0 cm (1.2 in) high. A blood spot was found by police on the lower right cover (see A in upper figure), but that had been removed by forensic personnel prior to this contractor's inspection. There was a possible skin contact on the right side of the upper module cover (see B in the upper figure). A faint skin contact was found on the back of the air bag, on the left side if facing forward in the vehicle.

Figure 11. Top of driver's air bag module cover

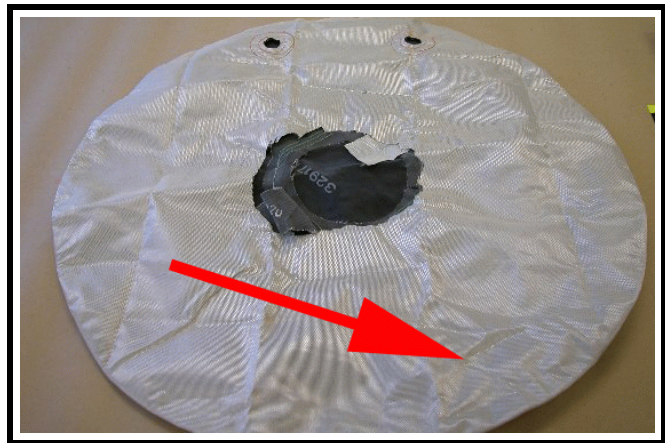
Figure 12. Driver's air bag, back. Probable skin contact to bottom left side (facing forward in vehicle).

At impact with the tree, the unrestrained child pitched forward. The air bag began deploying. The driver's right arm may have contacted the upper module cover, causing abrasions to the forearm and elbow. As the air bag continued to deployed, the bottom back side of the air bag engaged the child's face and neck and began forcing his head rearward. The movement likely continued as the bag fully inflated. The driver's neck was hyperextended—causing the C2/C3-C4 fractures and the spinal injury. The driver was likely forced rearward into the seat back—causing the brain/head injuries-- and rebounded into the area below the steering wheel.

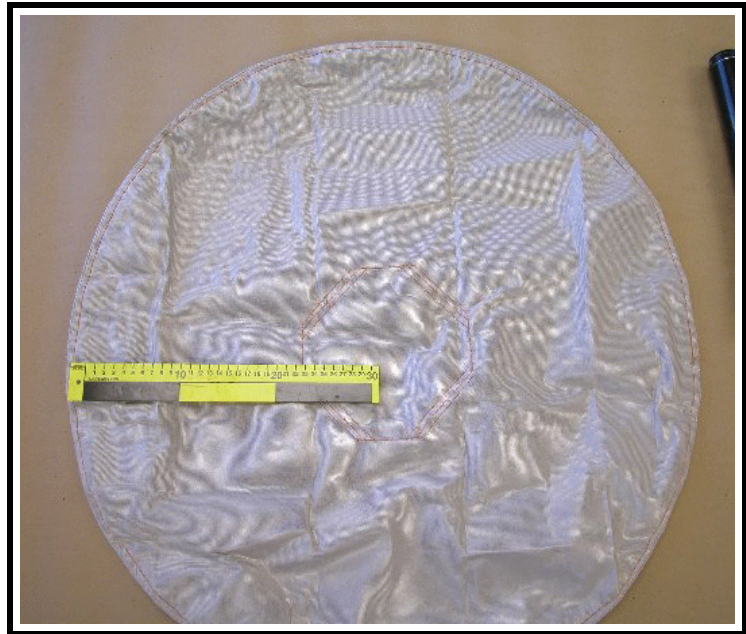
Figure 13. Driver's air bag, front

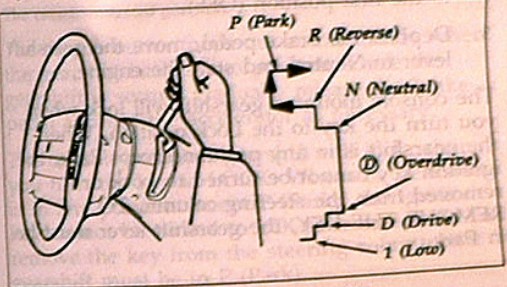
If your gearshift is on the column, you can use any of the following positions:

The positions of the column-mounted gearshift
