REMOTE CHILD AIR BAG-RELATED FATALITY INVESTIGATION

CASE NUMBER - IN-03-031
LOCATION - Florida
VEHICLE - 1993 LINCOLN TOWN CAR
CRASH DATE - December 2001

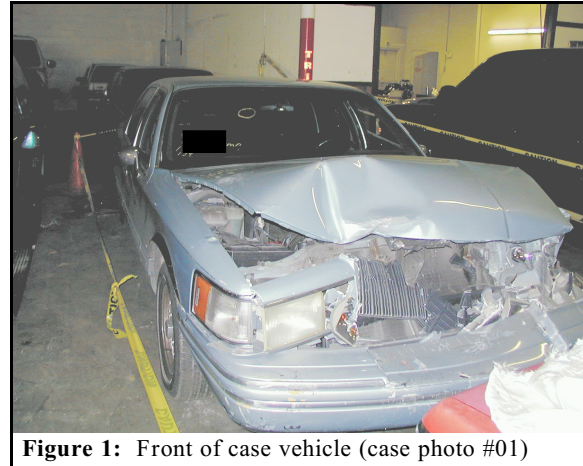
The case vehicle sustained direct contact damage beginning at the right edge of the grille and extending leftward across the front. The available photographs do not show the entire front end, but it appears that there was only minor contact on the bumper, with most of the contact and crush

above the bumper in a classic front underride damage configuration (**Figure 1**). The right headlamp assembly was partially broken and displaced, with the grille and radiator crushed rearward and the left headlamp assembly shattered and broken away. The leading edge of the hood was folded downward and crushed rearward. There was some light scratching on the bumper. The windshield had a stress crack on the right side. The police report indicated that none of the tires were deflated or restricted.

Figure 1: Front of case vehicle (case photo #01)

The CDC was estimated from photographs as **12-FDEW-2 (0)**. The WinSMASH reconstruction program, missing vehicle algorithm with CDC-only, was used on the case vehicle's single impact. The total, longitudinal and lateral delta Vs are, respectively: 24.0 km.p.h. [14.9 m.p.h.], -24.0 km.p.h. [-14.9 m.p.h.] and 0 km.p.h. [0 m.p.h.]. This is a borderline reconstruction but the results appears reasonable. This was a crash of moderate severity (24-40 km.p.h. [15-25 m.p.h.]) for the case vehicle.

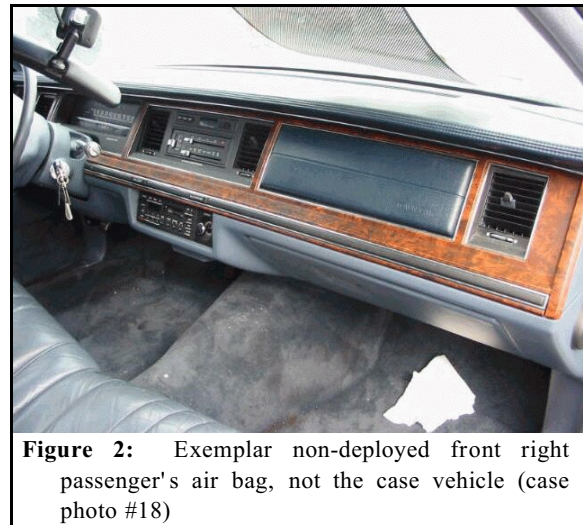
Figure 2: Exemplar non-deployed front right passenger's air bag, not the case vehicle (case photo #18)

The front right passenger's air bag was mounted in the mid-instrument panel position (**Figure 2** shows an exemplar non-deployed air bag from an identical vehicle in the NASS database). There were two module cover flaps with a seam horizontally across the middle. The police noted a possible skin transfer on the front of the air bag fabric and cut the air bag out of the vehicle (**Figure 3**). There is no other information about the front right passenger's air bag.

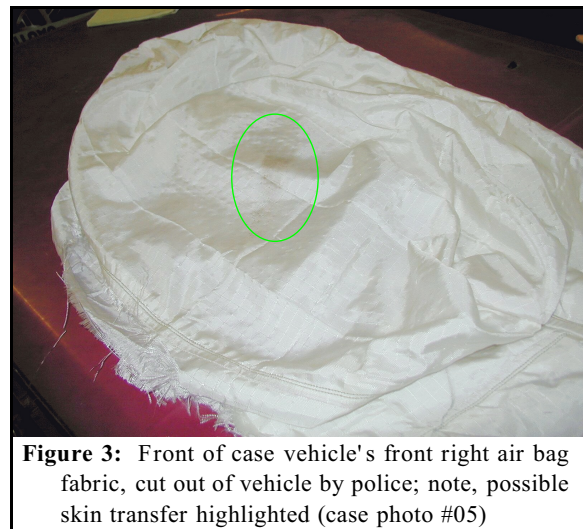
Figure 3: Front of case vehicle's front right air bag fabric, cut out of vehicle by police; note, possible skin transfer highlighted (case photo #05)
