**CALSPAN REMOTE SIDE IMPACT INFLATABLE OCCUPANT PROTECTION  
INVESTIGATION**

**NASS/SCI COMBO CASE NO: 04-041-066C**

**VEHICLE: 2004 JAGUAR S-TYPE**

**CRASH DATE: JUNE 2004**

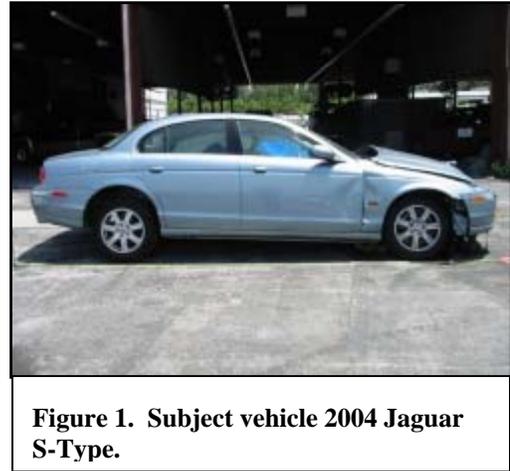
This remote investigation focused on the performance of the side impact inflatable occupant protection system in a 2004 Jaguar S-Type (**Figure 1**). The system consisted of seat back mounted side impact air bags for the front seating positions and curtain air bags for the four outboard seating positions. In addition, the Jaguar was equipped with advanced frontal air bags, buckle mounted safety belt pretensioners for the front safety belts, and retractor pretensioners for the rear safety belts. The Jaguar was occupied by a restrained 46-year-old male driver. The Jaguar was involved in an intersection crash with a 2002 Chevrolet Cavalier. The 2002 Chevrolet Cavalier was occupied by a 19-year-old male driver and 33-year-old male front right occupant.

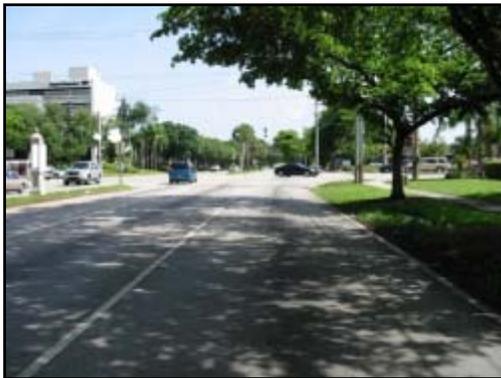
The restrained 46-year-old male driver of the Jaguar was operating the vehicle northbound on the outboard lane approaching the intersection (**Figure 2**). The 19-year-old male driver of the Chevrolet was operating the vehicle eastbound on the outboard lane approaching the same intersection (**Figure 3**). The driver of the Jaguar stated to the NASS researcher that he could not see the traffic signal due to tree foliage that was near the intersection. The driver of the Jaguar proceeded into the intersection on a red traffic signal phase.

**Figure 2. Jaguar's northbound approach to the intersection.**

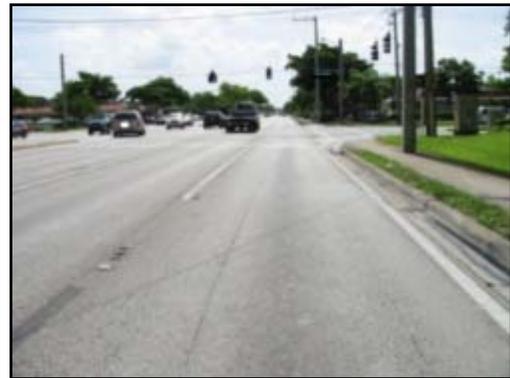
**Figure 3. Chevrolet's eastbound approach to the intersection.**

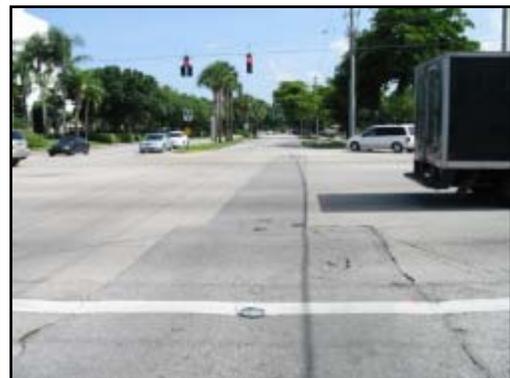
As the Jaguar entered the intersection, the front of the Chevrolet impacted the left front side of the Jaguar in the southeast quadrant of the intersection (**Figure 4**). The resulting directions of force were 10 o'clock for the Jaguar and 2 o'clock for the Chevrolet. The WINSMASH missing vehicle algorithm was used to calculate a delta V for this impact due to the multiple overlapping frontal impacts to the Chevrolet. The total calculated delta V for the Jaguar was 20.0 km/h (13.0 mph). The longitudinal and lateral components were -12.9 km/h (-8.0 mph) and 15.3 km/h (6.2 mph), respectively. The total calculated delta V for the Chevrolet was 28.0 km/h (17.4 mph). The longitudinal and lateral components were -21.4 km/h (-13.3 mph) and -18.0 km/h (-11.2 mph).

**Figure 4. Area of impact from the Jaguar's northbound travel lane.**

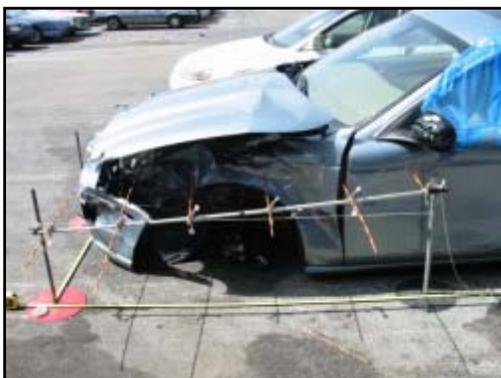
The 2004 Jaguar S-Type sustained moderate severity damage as a result of the initial impact with the Chevrolet (**Figure 5**). The direct contact damage began at the front left corner and extended rearward 145.0 cm (57.1"). The maximum crush measured 55.0 cm (21.7") and was located rear of the front left corner. Six equidistant measurements were used to document the crush at the mid-door level using a combined direct and induced damage width of 171.0 cm (67.3") and were as follows: C1 = 4.0 cm (1.6"), C2 = 7.0 cm (2.8"), C3 = 29.0 cm (11.4"), C4 = 55.0 cm (21.7"), C5 = 54.0 cm (21.3"), C6 = 28.0 cm (11.0"). The Collision Deformation Classification (CDC) for this impact was 10-LYEW-4.

**Figure 5. Front left damage from the initial impact with the Chevrolet.**

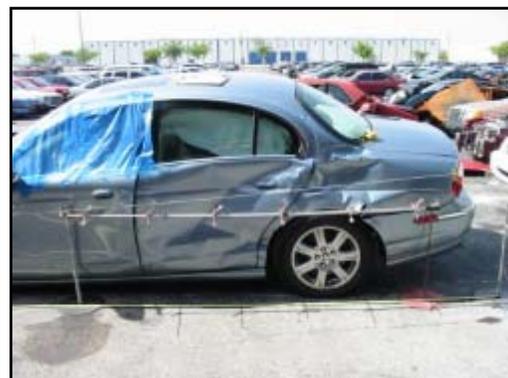
**Figure 6. Left side damage from the secondary impact with the Chevrolet.**

The Jaguar sustained minor severity damage as a result of the side-slap with the Chevrolet (**Figure 6**). The direct contact damage began on the left rear door and extended rearward 181.0 cm (71.3"). The maximum crush measured 10.0 cm (3.9") and was located on the center of the left rear door. Six measurements were used to document the crush using a combined direct and induced damage width of 199.0 cm (78.3") and were as follows: C1 = 0.0 cm, C2 = 6.0 cm (2.4"), C3 = 9.0 cm (3.5"), C4 = 10.0 cm (3.9"), C5 = 2.0 cm (0.8"), C6 = 3.0 cm (1.2"). The CDC for this impact was 09-LZEW-1.

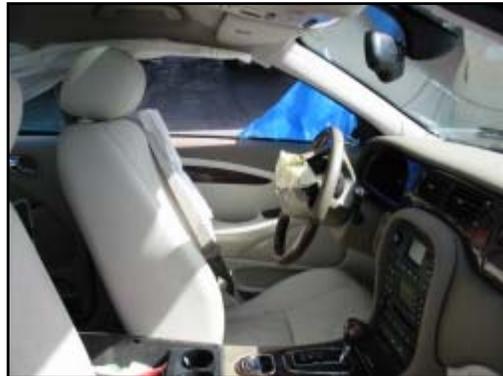
The 2004 Jaguar S-Type sustained minor damage as a result of occupant contacts. There was no intrusion of the passenger compartment. The occupant contacts points consisted of two scuffs that were noted to the driver's seat back from contact with the driver's upper left arm and upper right arm. Body fluid was noted on the driver's frontal air bag from possible contact with the driver's face. A scuffmark on the driver's safety belt was identified from contact with the driver's chest. A scuffmark was present on the knee bolster from probable contact with the driver's right knee. Additionally, a contact was noted to the front left windowsill that was evidenced by a scuff. The scuff was most likely a result of interaction between the left curtain air bag deployment and the windowsill. **Figure 7** is an overall of the driver's area.

**Figure 7. Overall view of the driver's area.**

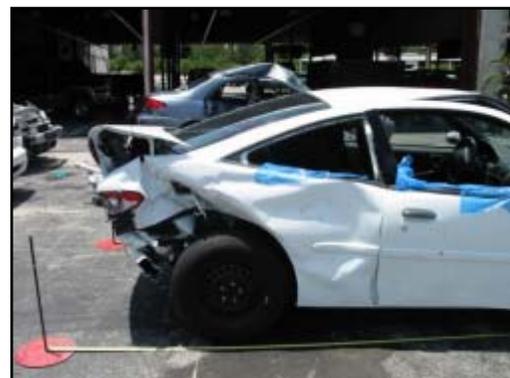
**Figure 9. Right side damage from the secondary impact with the Jaguar. Damage was overlapped by a rear impact.**

The Chevrolet sustained moderate severity damage as a result of the secondary impact with the Jaguar (**Figure 9**). The NASS researcher was unable to differentiate the direct damage from this impact due to a subsequent rear impact that resulted in overlapping damage. The CDC for this impact was 03-RZEW-9.

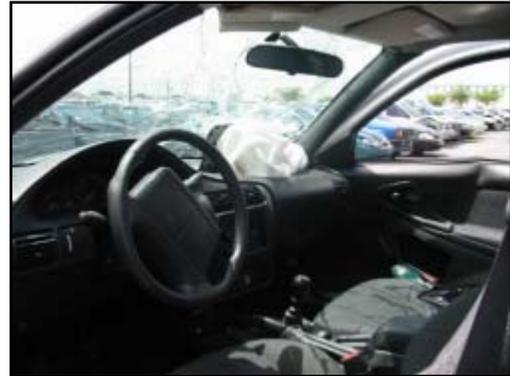
The 2002 Chevrolet Cavalier was equipped with redesigned frontal air bags. The air bags were monitored and controlled by a Sensing and Diagnostic Module (SDM) that was equipped with an Event Data Recorder (EDR). The NASS researcher downloaded the EDR, which recorded a Deployment file and a Non-Deployment file. The EDR printout is included as **Attachment A** of this report. The EDR data indicated that the driver’s safety belt was buckled and the maximum-recorded delta V was -34.1 km/h (-21.2 mph). In the subject crash, the SDM deployed the front right air bag and suppressed the driver’s frontal air bag (**Figure 10**). According to the EDR, the Supplemental Inflatable Restraint (SIR) warning lamp was in the on position at the time of Algorithm Enable (AE), which probably resulted in the non-deployment of the driver’s frontal air bag. The non-deployment event occurred 30 ignition cycles prior to the deployment event; therefore, it was not associated with this crash.

**Figure 10. View of the non-deployed driver's air bag and the deployed front right air bag.**

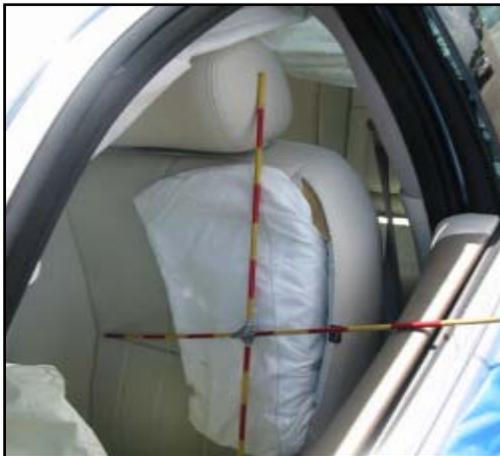
The 2004 Jaguar S-Type was equipped with seat back mounted side impact air bags for the front seating positions and curtain air bags for the outboard seating positions. In the subject crash, the left seat back mounted side impact air bag and the left side curtain air bag deployed. The seatback mounted air bag module was located in the outboard aspect of the seatback. The air bag measurements were obtained from an exemplar vehicle, which were 39.0 cm (15.4”) in height and 20.0 cm (7.9”) in width in its deflated state (**Figure 11**). The side impact air bag was not tethered and was vented by a single vent port on the lower aspect of the forward edge. No occupant contacts or failures were noted to the air bag.

**Figure 11. Deployed left side seat back mounted side impact air bag.**

The seatback mounted side impact air bag measured 20.0 cm (7.9") in width, which did not extend the full width of the front left door panel. Therefore, the forward trajectory caused the driver's torso to be displaced away from the deploying seatback mounted side impact, which allowed in his torso to contact the exposed portion of the front left door panel. The door panel contact resulted in the left 6<sup>th</sup> rib fracture (midaxillary, spiral, slightly displaced) and the left chest contusion.

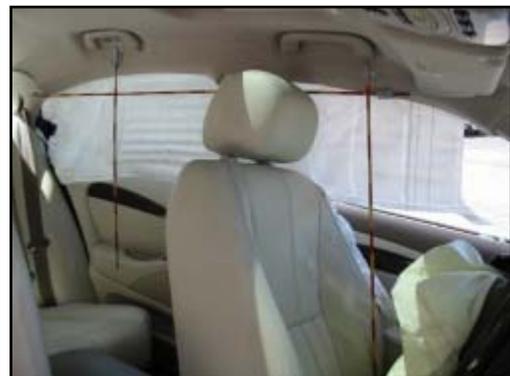
**Figure 12. Deployed left side curtain air bag.**

The curtain air bag deployed downward from the left roof side rail and extended from the A-pillar to the C-pillar (**Figure 12**). A single tether at the A-pillar and two tethers at the C-pillar tethered the curtain air bag. The air bag membrane from an exemplar vehicle measured 132.0 cm (52.0”) in width and 27.0 cm (10.6”) in height in its deflated state. The NASS researcher did not note any occupant contacts or failures to the air bag.

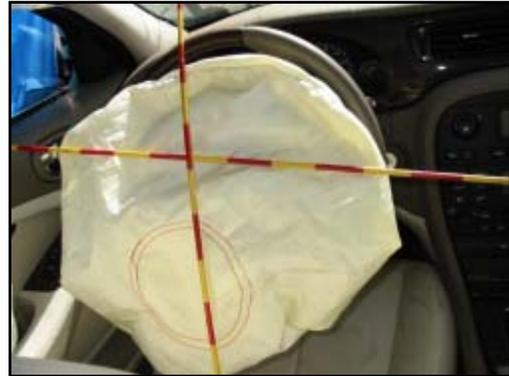
The 2004 Jaguar S-Type was equipped with advanced frontal air bag system. The system utilized dual stage inflators, driver seat track position sensor, safety belt buckle sensors, ultrasonic position sensing for the right front seat, and a weight sensor in the front right seat to deploy the appropriate safety system. In the subject crash, the driver’s frontal air bag deployed (**Figure 13**). The driver’s frontal air bag was located in the center of the steering wheel hub. The air bag contained one tether and was vented by two circular vent ports that were located at the 11 and 1 o’clock positions on the rear aspect. The NASS researcher noted body fluid on the air bag from possible contact with the driver’s face. No failures were noted to the air bag.

**Figure 13. Deployed driver's frontal air bag.**

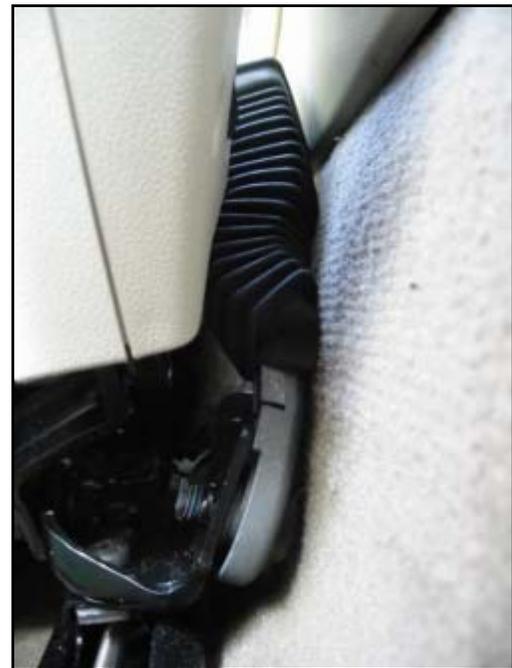
The 2004 Jaguar S-Type was equipped with continuous loop manual 3-point lap and shoulder safety belts for the five seating positions. The driver’s safety belt was configured with a sliding latch plate, an Emergency Locking Retractor (ELR), and buckle mounted safety belt pretensioner that fired as a result of the crash (**Figure 14**). The driver’s used the safety belt in the crash, which was evidenced by the loading on the safety belt. The front right safety belt was configured with a sliding latch plate, a switchable Emergency Locking Retractor/Automatic Locking Retractor (ALR), and a buckle mounted pretensioner. Although the front right seat was not occupied, the safety belt pretensioner fired during the crash. The rear safety belts were configured with sliding latch plates, switchable ELR/ALR, and retractor pretensioners, which fired as a result of the crash.

**Figure 14. Fired driver's safety belt pretensioner.**
