**CALSPAN REMOTE ALTERNATIVE FUEL VEHICLE CRASH
INVESTIGATION**

CASE NO: 2004-43-141G

VEHICLE: 2002 TOYOTA PRIUS

CRASH DATE: MAY 2004

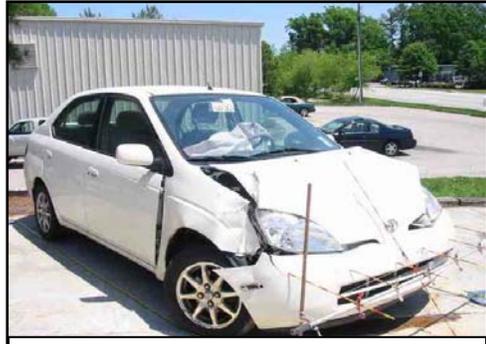
This remote investigation focused on the performance of the alternative fuel system that was present in a 2002 Toyota Prius (**Figure 1**). The Prius was equipped with a hybrid drive train, which consisted of a 1.5-liter gasoline engine coupled with an electric motor. The vehicle was designed to run on battery power, gasoline, or a combination of both dependant on throttle input and desired speed. The 2002 Toyota was

Figure 1 - Subject vehicle 2002 Toyota Prius.

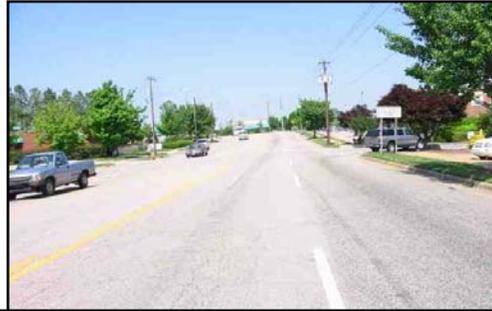
This crash occurred on a five-lane, north/south roadway in a residential area during daylight hours (**Figure 2**). The roadway was configured with two northbound and two southbound lanes separated by a center left lane turn bay. The roadway was surfaced with asphalt and was delineated by solid yellow lines contiguous to the turn bay and broken white lines separating the four north/south lanes. The travel lanes were 3.5 m (11.5') in width and the center turn bay was 3.8 m (12.5') wide; paved shoulders that were 0.5 m (1.6') in width bordered the roadway.

Figure 2 - Overall view of north/south roadway.

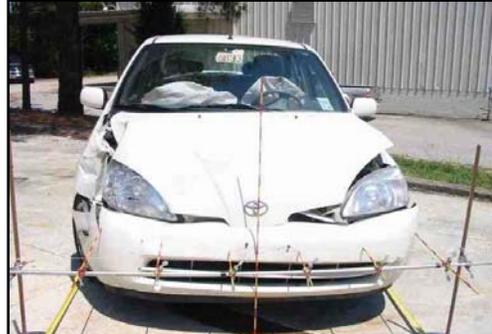
The 2002 Toyota Prius sustained moderate damage as a result of the impact with the 1992 Nissan pickup truck (**Figure 3**). The NASS vehicle inspection reported that the maximum crush as at the right front bumper corner and measured 18 cm (7.1"). The SCI revised direct contact damage extended from the left bumper corner to the right bumper corner and measured

Figure 3 - Frontal damage to the 2002 Toyota Prius.

145 cm (57.1"). The Field L measurement was also 145 cm (57.1"). The crush profile measured to the bumper was as follows: C1 = 10 cm (3.9"), C2 = 9 cm (3.5"), C3 = 9 cm (3.5"), C4 = 11 cm (4.3"), C5 = 17 cm (6.7"), C6 = 18 cm (7.1"). The SCI revised Collision Deformation Classification (CDC) was 01-FDEW-1.

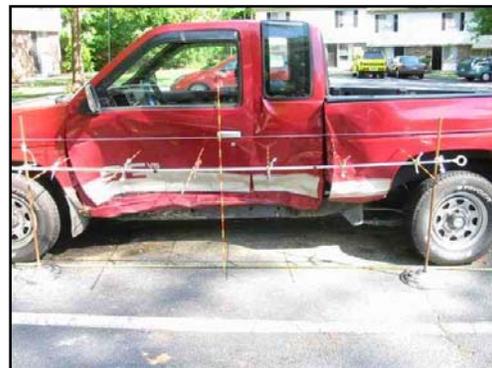
The 1992 Nissan pickup truck sustained moderate damage as a result of the impact with the 2002 Toyota Prius (**Figure 4**). The NASS inspection reported that the maximum crush to the Nissan was located 250 cm (98.4") forward of the left rear axle and measured 20 cm (7.9") in depth. The direct contact damage reportedly began 96 cm (37.8") forward of the rear left axle and measured 130 cm (51.1") in width.

Figure 4 - Left side damage to 1992 Nissan Pick-Up.

The Field L measurement was reported to have began 44 cm (17.3") forward of the rear left axle and measured 206 cm (81.1") in width.

The crush profile measured at the mid-door level was as follows: C1 = 0 cm, C2 = 2 cm

(0.8”), C3 = 17 cm (6.7”), C4 = 20 cm (7.9”), C5 = 18cm (7.1”), C6 = 0 cm. The CDC for this impact was 10-LZEW-2.

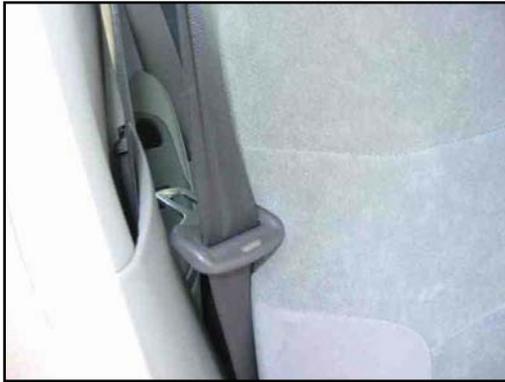
The 2002 Toyota Prius was equipped with 3-point continuous loop safety belt systems for all five seating positions. It should be noted that the NASS investigation determined that the three occupants in the Prius, seated in the front left, front right, and rear right positions, were restrained by the 3-point manual safety belts. The SCI reinvestigation does not support belt use. The driver’s safety belt was configured with a sliding latch plate, Emergency Locking Retractor (ELR), and an adjustable D-ring, which was in the full-down position at the time of the NASS inspection. The front right belt was configured with a sliding latch plate, a switchable ELR/Automatic Locking Retractor (ALR), and an adjustable D-ring, which was in the full-down position. Both frontal safety belts were restricted in an unused position taught along the B-pillar as a result of the retractor pretensioner actuation. It was determined by the SCI reinvestigation as not used during the crash (**Figures 5 and 6**).

Figure 5 - LF latch plate and restricted belt along the B-pillar.

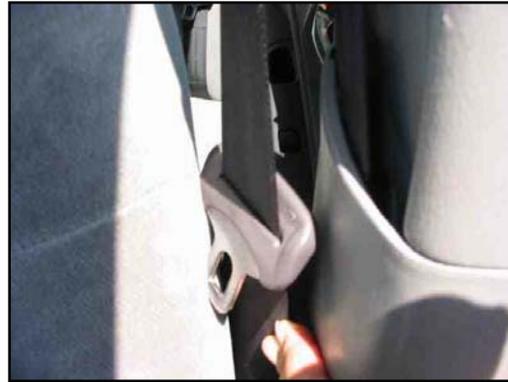
Figure 6 - Right front seat belt latch plate and restricted belt along the B-

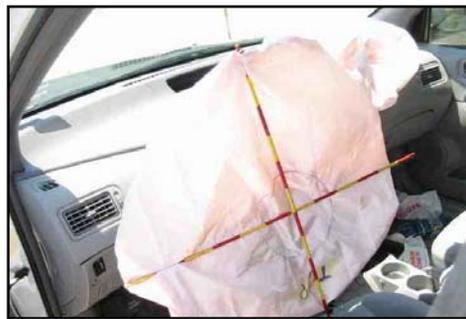
The 2002 Toyota Prius was equipped with redesigned frontal air bags for the driver and front right seating positions. The Prius was also equipped with side impact air bags mounted in the front seat backs. The frontal air bags deployed as a result of the impact with the 1992 Nissan truck. The driver’s air bag (**Figure 7**) deployed through a tri-fold module cover flap

Figure 7 - Driver's air bag.

configuration with the one-piece upper flap of trapezoidal shape and the lower flaps triangular in shape and separated by a center vertical seam. The upper flap measured 15 cm (5.9”) in width and 18 cm (7.1”) in height. The lower flaps were 8 cm (3.1”) in width and 8 cm (3.1”) in height. The cover flaps opened at the designated tear points. The driver’s air bag measured 52 cm (20.0”) in its deflated state and contained two internal tether straps. Two ports located at the 11 and 1 o’clock sectors vented the bag. There was no discernable loading evidence to the air bag.

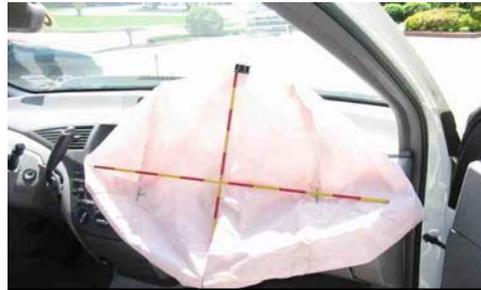
The front right air bag (**Figure 8**) deployed from a top-mount H-configuration module cover flap with the upper flap measuring 20 cm (7.9”) in width and 7 cm (2.8”) in height and the bottom flap measuring 21 cm (8.3”) in width and 8 cm (3.1”) in height. The deployed right air bag measured 68 cm (26.8”) horizontally and 48 cm (18.9”) vertically in its deflated state. The bag was vented by two ports located at the lateral aspects of the bag in the 10 and 2 o’clock positions.

Figure 8 - Right front passenger air bag.

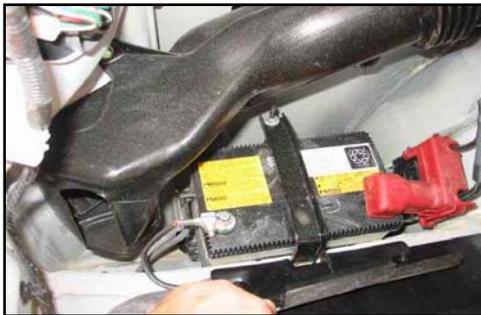
The battery system was a Nickel Metal-Hydride battery that was mounted in the rear cargo floor, aft of the second row seat. This high-voltage battery system was mounted lateral to the vehicle and was concealed and protected by an aluminum cover that was

bolted to the rear floor of the vehicle. A protected wiring harness extended along the left side of the Prius, which transferred electrical power to the motor and provided the transfer of power from the generator to recharge the battery system. The Prius was also equipped with a regenerative braking system that utilized the motor to decelerate the vehicle and convert power back into the batteries for recharging purposes.

There was no intrusion of the battery pack area or damage to the area of the left side harness. The engine compartment was not damaged. This crash did not expose a risk to the driver. There was no evidence of damage or procedures initiated by the first responders to the crash site.

Figure 9 - Hybrid engine battery.

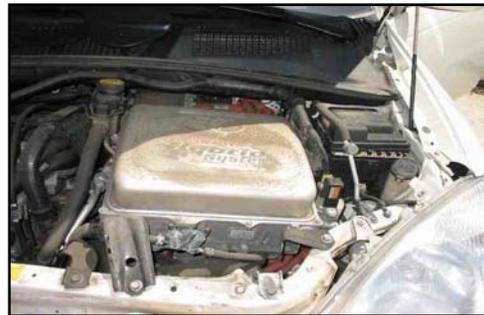
The Prius was designed with a 1.5 liter, transversely mounted gasoline engine that produced 76 HP. This engine was linked to a permanent magnet AC synchronous electric motor that was capable of producing 67 HP. Both units were conventionally mounted in the front of the vehicle and were linked to an electronically controlled continuously variable transmission (CVT) with front wheel drive. A generator was mounted between the engine and the electric motor that converted the gasoline engine power to electric power to drive the electric motor and recharge the onboard battery system (**Figure 9**). The gasoline engine was positioned on the right side of the engine compartment with the electric motor (**Figure 10**) mounted left of the engine and the CVT transmission mounted left of the electric motor.

Figure 10 - Electric hybrid motor.

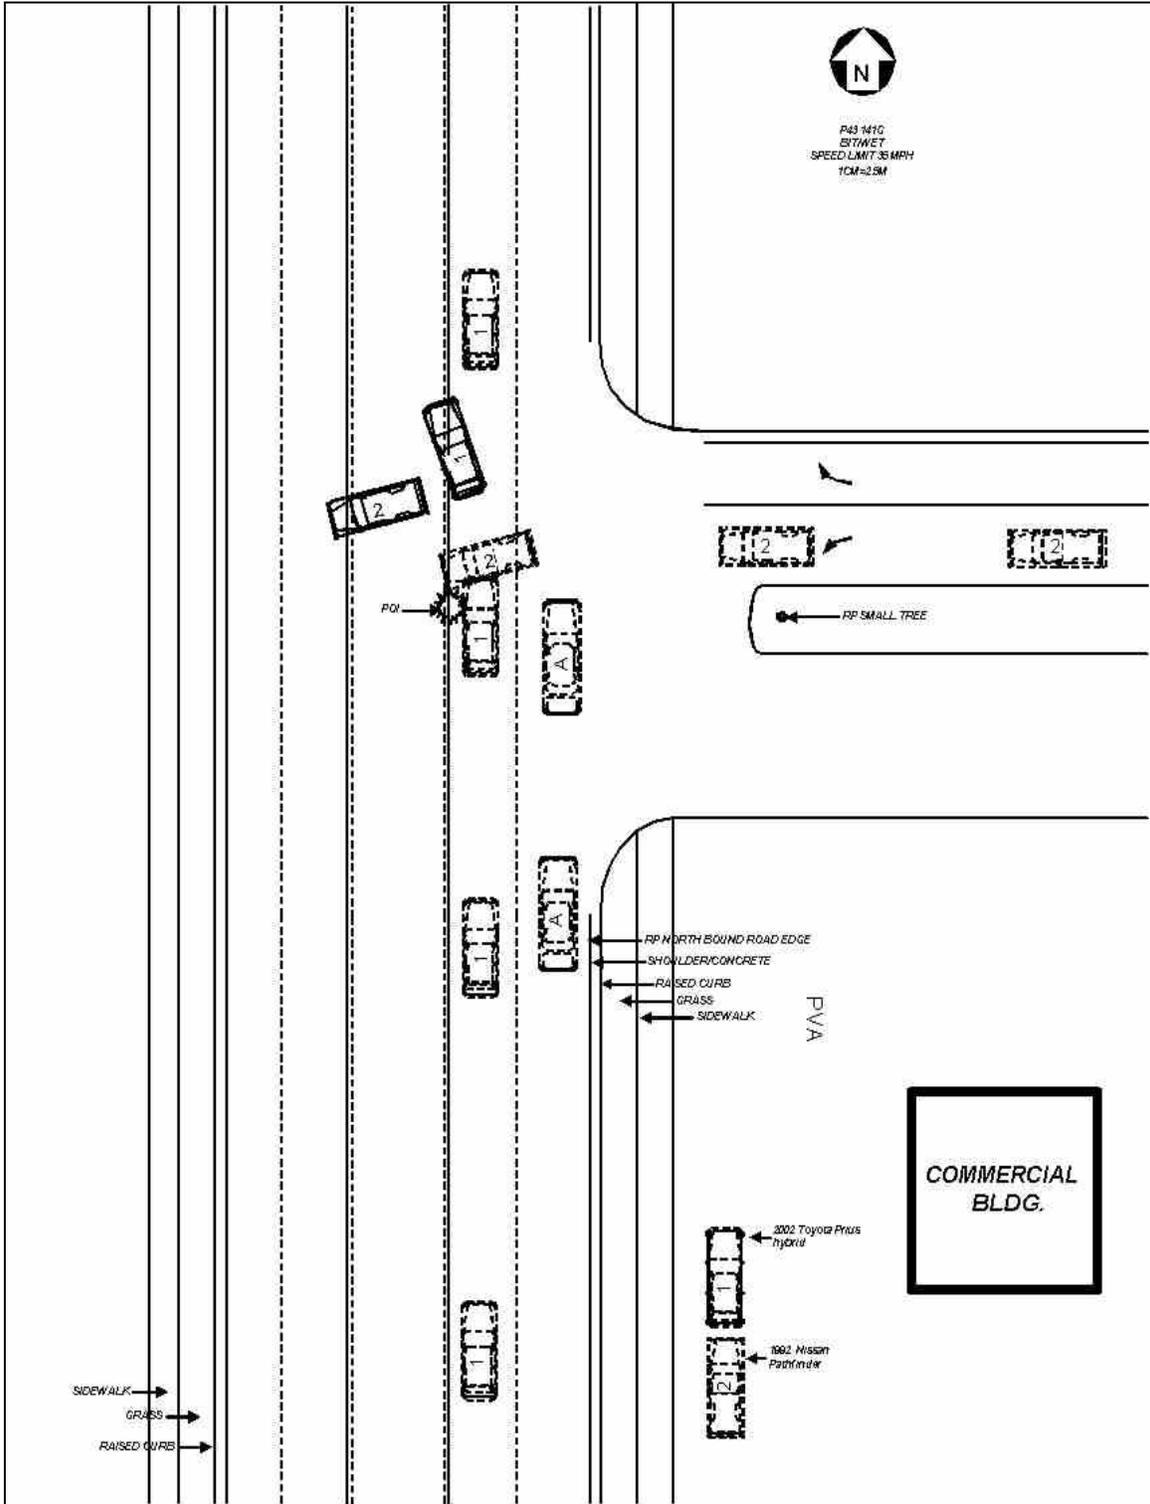
Figure 11 – Scene Schematic

The driveway that the Nissan was exiting was configured with an entrance to a professional plaza that was 7.6 m (19.3') in width and two exit lanes, each 3.0 m (9.8') wide, and was separated by a raised median containing a landscape design. The environment along the north/south roadway consisted of residential homes and commercial properties. At the time of the crash, the road surface was wet and it was raining. The Prius was traveling in a northerly direction on a straight and level roadway while the Nissan was traveling west and exiting a paved driveway attempting to turn left and travel south. The speed limit for the north/south roadway was posted at 89 km/h (55 mph). The Crash Schematic is included as **Figure 11** at the end of this narrative report.
