Passenger Air Bag Child Fatality Investigation / Vehicle to Vehicle
Dynamic Science, Inc. / Case Number: DS04006
1995 Ford Windstar
Idaho
April, 2004

1. Report No. DS04006	2. Government Accession No.	3. Recipient Catalog No.	
4. Title and Subtitle Passenger Air Bag Child Fatality Investigation		5. Report Date March 14, 2006

This on-site investigation focused on the performance of the front air bags that were installed in a 1995 Ford Windstar minivan. The 1995 Ford Windstar was occupied by a 42-year-old male driver, a 3-year-old front right seat occupant, and 7-year-old rear seat occupant. The Windstar struck the right side of a 1993 Chevrolet Corsica in an intersection crash. The impact resulted in sufficient longitudinal deceleration of the Windstar to command the deployment of the frontal air bags. The Windstar was deflected slightly to the right and came to rest facing north in the intersection. The Corsica was pushed in a clockwise rotation and came to rest facing generally west in the western leg of the intersection. The driver of the Windstar was not injured. The front right seat child occupant sustained a complete atlanto-occipital disarticulation of the spine with a fract

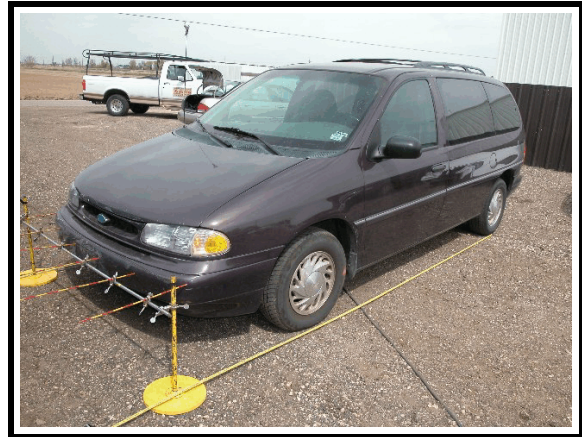
Figure 1. Front left, 1995 Ford Windstar van

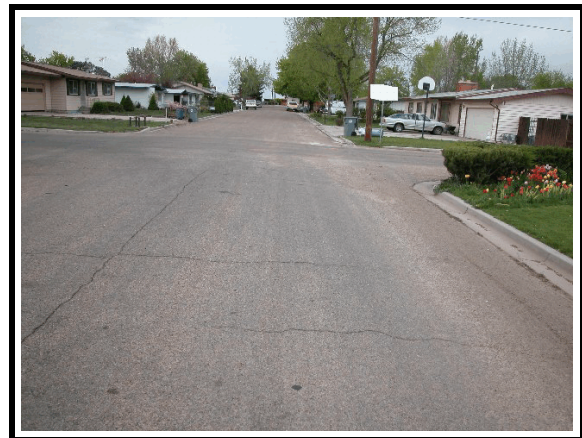
Figure 2. Approach to point of impact, north

This two-vehicle crash occurred at a four-leg intersection of two local roadways in April 2004 at 0850 hours. At the time of the crash, there were no adverse weather conditions and the asphalt roadway surface was dry. Both roadways are two-way and are undivided. There are no traffic controls. The speed limit in both directions is 32 km/h (20 mph).

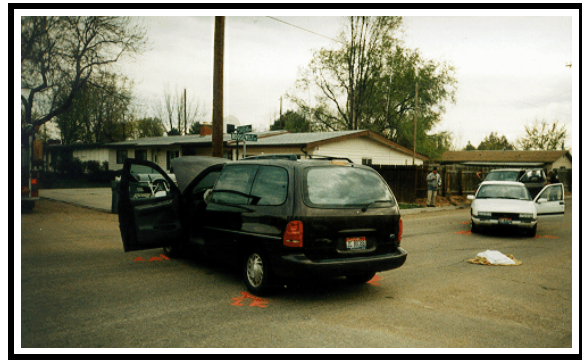
Figure 3. Final rest, viewed to the northeast

The front of the Windstar struck the right side of the Corsica near the right rear tire. The impact severity was minor and resulted in the deployment of the frontal air bag system in the Windstar. The missing vehicle routine of the WinSmash program computed a total delta V of 9.0 km/h (5.6 mph) based on the Windstar's front crush profile. The longitudinal and lateral components were -8.9 km/h (-5.5 mph) and 1.6 km/h (1.0 mph), respectively. The barrier equivalent speed was 12.5 km/h (7.8 mph). The Windstar was deflected slightly to the right and came to rest facing north in the intersection. The Corsica was pushed in a clockwise rotation and came to rest facing generally west in the western leg of the intersection. After coming to rest, the Corsica rolled backwards slightly.

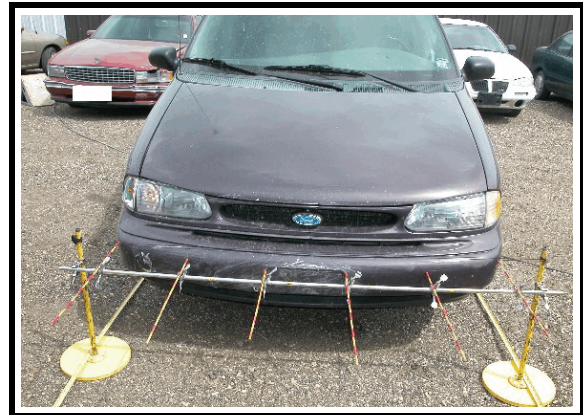
Damage Description: The 1995 Ford Windstar sustained minor front end damage as a result of the impact with the Chevrolet Corsica. The hood on the right side had shifted slightly. There were white paint transfers across the front end and the right light was cracked. The windshield was cracked, but this appeared to be existing damage and not related to this crash. All the doors remained closed and operational.

The direct damage began at the front left bumper corner and extended 160.0 cm (62.9 in) laterally across the entire front end of the vehicle. Six crush measurements were documented as follows: C1 = 3.0 cm (1.1 in), C2 = 0.0 cm (0.0 in), C3 = 0.0 cm (0.0 in), C4 = 0.0 cm (0.0 in), C5 = 0.0 cm (0.0 in), C6 = 4.0 cm (1.6 in).

Figure 4. Front, 1995 Ford Windstar

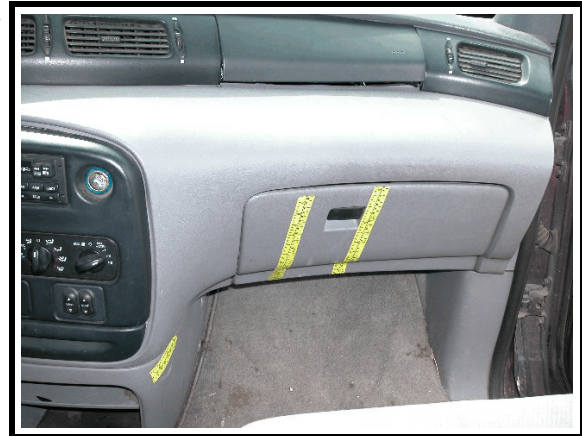
The Ford Windstar sustained minor interior damage as a result of occupant contacts. There were white scuffs/transfers to the center console and the glove box. The scuffing on the glove box measured 9.0 cm (3.5 in) wide by 28.0 cm (11.0 in) long. The mirror was not found in the vehicle.

Figure 5. White transfers to glove box

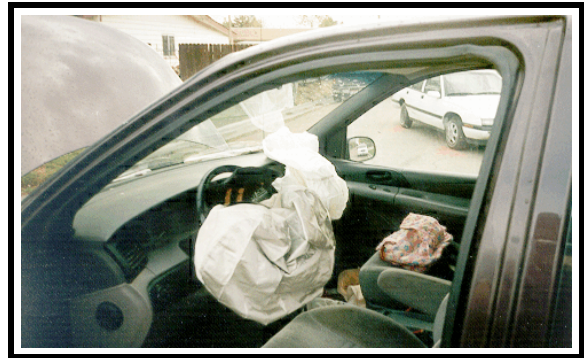
The driver's air bag deployed from the center of the steering wheel hub through H-configuration module cover flaps. The top flap measured 21.0 cm (8.3 in) wide by 17.0 cm (6.7 in) high. The bottom flap measured 21.0 cm (8.3 in) by 10.0 cm (3.9 in) high.

Figure 6. Driver's air bag, police photo

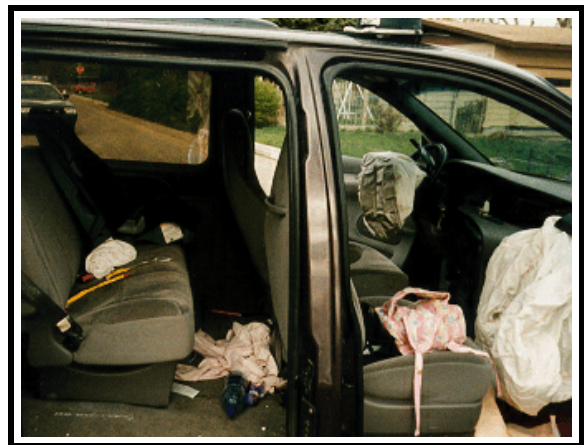
The front right passenger's air bag deployed from a front mount module with a rectangular cover flap that was hinged at the top. The module cover flap measured 33.0 cm (12.9 in) wide and 13.0 cm (5.1 in) high.

Figure 7. Front right passenger's air bag, police photo

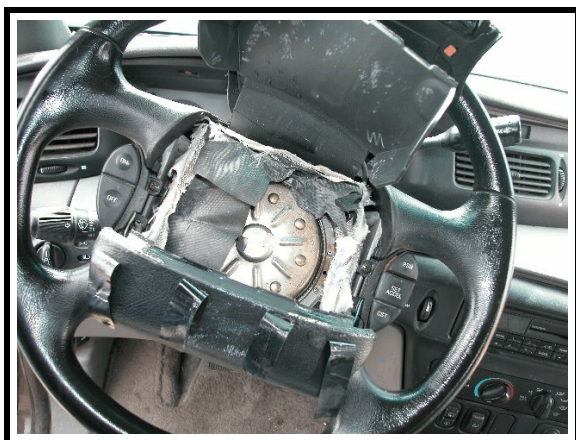
Figure 8. Driver's air bag module

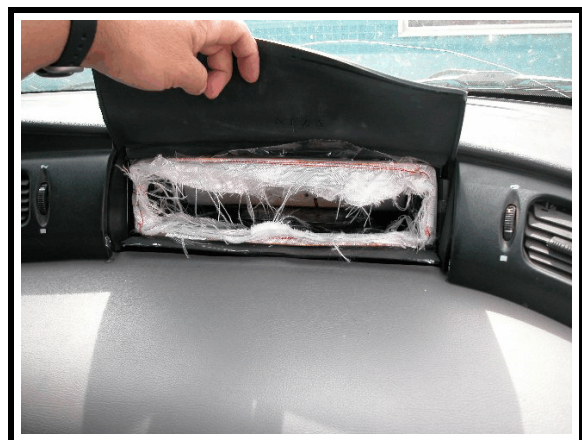
Figure 9. Front right passenger's air bag module

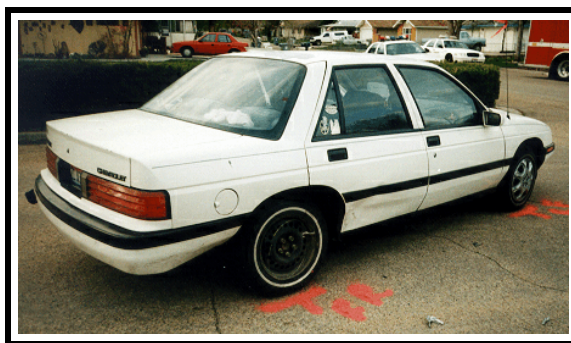
Description: 1993 Chevrolet Corsica four door sedan
VIN: 1G1LT53T4PYXXXXXX
Odometer: Unknown
Engine: 3.1 liter, V6
Reported Defects: None noted
Cargo: Unknown
Damage Description: Minor contact damage to right rear quarter panel. Police estimate cost of damage at \$250.
CDC: 03RZEW1 - from police photographs
Delta V:
Total 14.0 km/h (8.7 mph)
Longitudinal -2.4 km/h (-1.5 mph)
Latitudinal -13.8 km/h (-8.6 mph)
Energy 34,574 joules
(25,51 ft lbs)

Figure 10. 1993 Chevrolet Corsica, right side damage

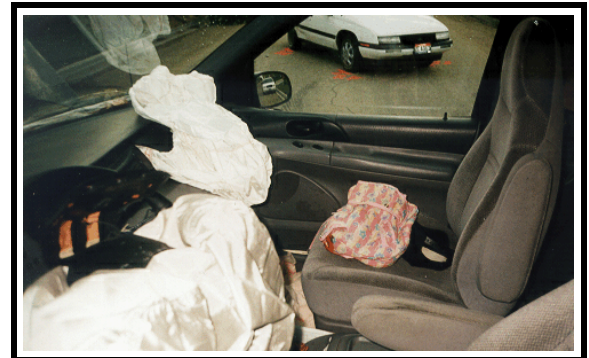
The 3-year-old female front right passenger was most likely seated in an upright posture (based on her facial injuries). Her seated height was approximately 54.7 cm (21.5 in). She was not wearing the manual 3-point lap and shoulder belt. Witnesses report that the child had come to rest on the front floorboard. The child apparently had a backpack, but it is not known if it was being worn at the time of the crash. The seat was adjusted to the rearmost track position. The seat back was at an 83 degree angle. Prior to impact, the driver began braking. The 3-year-old began pitching forward in response to vehicle braking. At impact, the frontal air bags deployed. This occupant initiated a forward and slightly lateral trajectory and engaged the deploying air bag with her face. This contact likely caused the facial and mouth

abrasions/contusions. Her legs or shoes may have contacted the glove compartment. This occupant's head was forced rearward, causing a complete atlanto-occipital disarticulation and the accompanying fractures and lacerations. She was forced rearward in the seat back and then rebounded, coming to rest on the floor board. There were no indications of contact to the seat back. She was initially picked up by her father moments after the crash. She was unresponsive when the paramedics arrived. The paramedics began CPR. She was transported by ambulance to a local hospital. Upon arrival, her pupils were fixed and dilated. She was transferred to the pediatric intensive care unit of an area trauma center where she expired two days later.

Figure 11. Overview of front right passenger's seated area

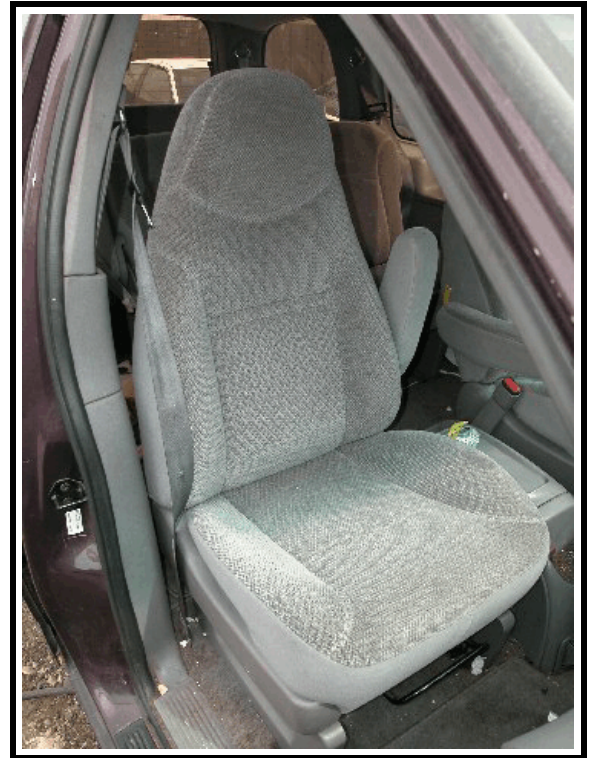
Figure 12. Front right passenger seat back
