Ford Safety Canopy Investigation / Rollover
Dynamic Science, Inc. / Case Number: DS04009
2003 Ford Expedition
California
May, 2004

1. Report No. DS04009	2. Government Accession No.	3. Recipient Catalog No.	
4. Title and Subtitle Ford Safety Canopy Investigation		5. Report Date July 11, 2005

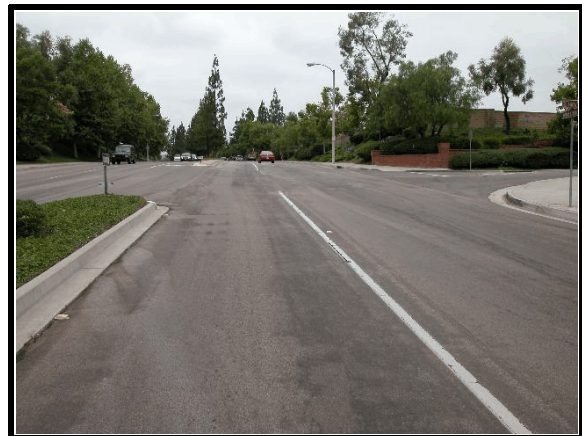
Figure 2. Approach of case vehicle to area of impact

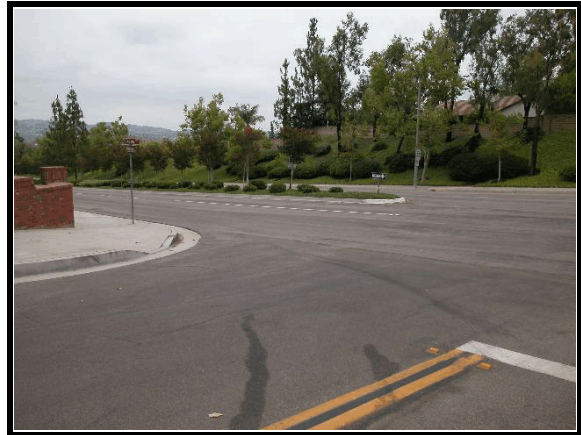
Figure 3. Driver's view from southbound roadway

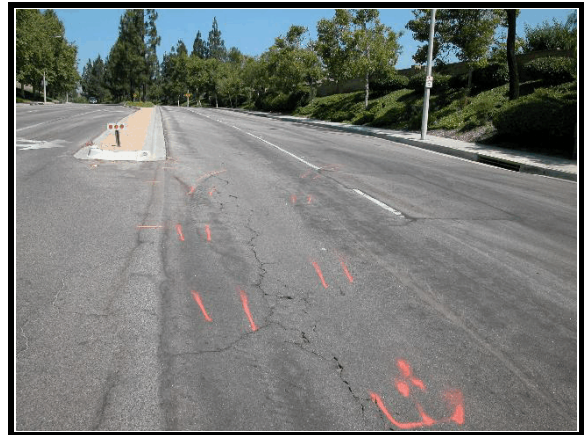
As the Expedition passed the Saturn it was struck in the right side (12RPLS1) by the front of the Saturn. The Expedition began a clockwise rotation. The vehicle rotated until it was facing at a 90 degree angle relative to its initial direction of travel. It appears that the Expedition tripped at this point. The vehicle rolled initially onto its left side and then continued rolling until it had completed five quarter turns and came to rest on the driver's side. During the rollover, the side air curtain deployed.

Figure 4. Area of rotation and vehicle overturning - case vehicle

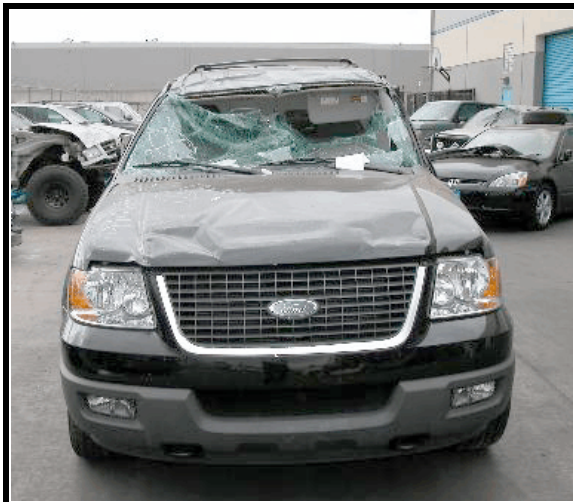
Damage Description: Moderate rollover damage to all planes. Direct contact includes the top of the hood and 30.0 cm (11.8 in) rearward along the roof from the top of the windshield. Glazing disintegrated on left side. Windshield cracked during rollover.

Figure 5. Front, Ford Expedition

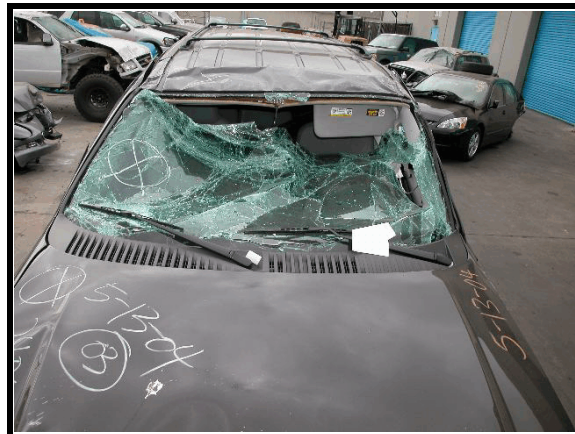
Figure 6. Top view, Ford Expedition

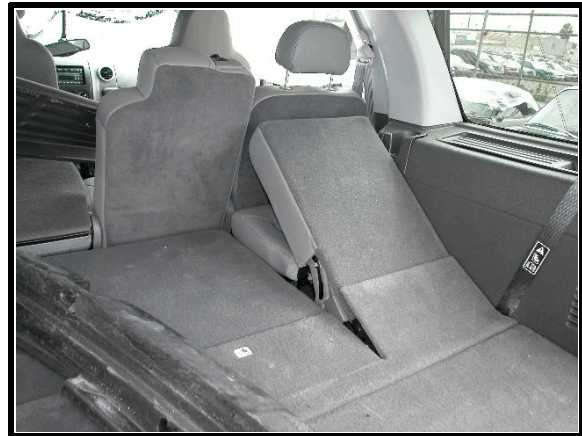
Interior damage to the Ford Expedition was minor and attributed to occupant contacts, passenger compartment intrusion, and artifacts from the safety curtain deployment. The windshield was fractured. The hole found at the time of the inspection was related to heat sag. The driver's and third row left side glass was disintegrated. There was vertical intrusion into the front right seating area from the A pillar and roof rail. The maximum intrusion was 4.0 cm (1.6 in). There was damage to the driver's arm rest and the driver's seat belt upper anchorage. This was most likely related to movements by the driver post-crash—he essentially stepped on these locations as he exited.

Figure 7. Overview of third row of seats

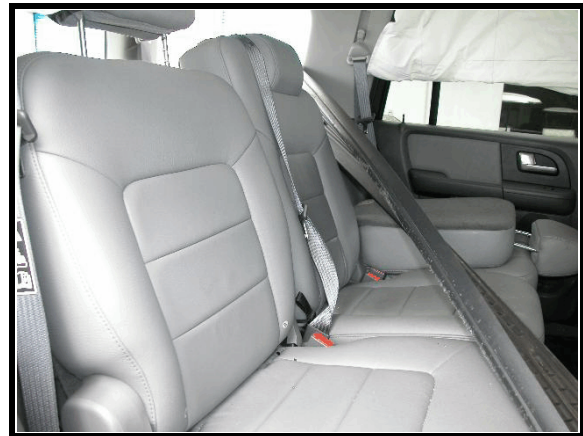
Figure 8. Overview of second row of seats

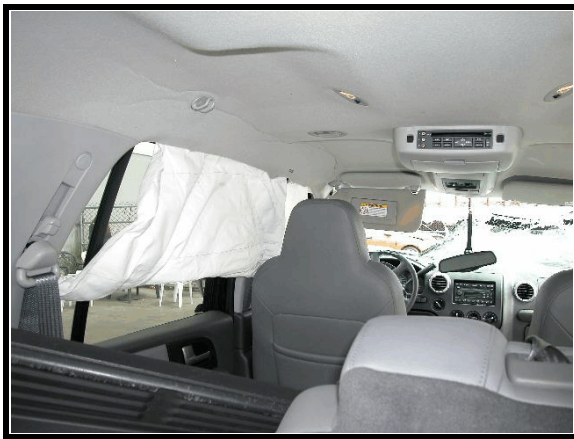
Figure 9. Left side curtain

Both the left and right side curtains deployed during the crash.

The curtains deployed downward from the roof cladding. The curtains are rectangular in shape and measured 135.0 cm (53.1 in) wide by 58.0 cm (22.8 in) high. They are attached to the A pillar by a single 45.0 cm (17.7 in) tether and to the C pillar by a 9.0 cm (3.5 in) tether. The distance from the front of the curtain to the mid point of the B pillar was 42.0 cm (16.5 in) and from the back of the curtain to that same point was 93.0 cm (36.6 in). Both side windows are essentially covered by the deployed air bag. There was no damage or occupant contact found on the right curtain. On the left side curtain there were road abrasions to the exterior of the curtain within the confines of the left front side glass area. The abrasions measured 33.0 cm (13.0 in) at the top left (as facing the left side of the vehicle), declining to 13.0 cm (5.1 in) at the bottom left.

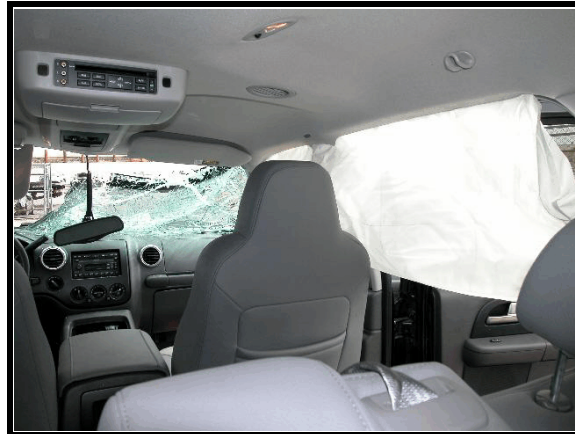
Figure 10. Right side curtain

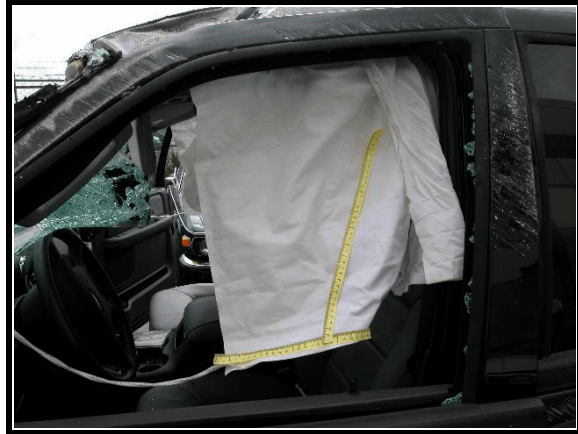
Figure 11. Exterior view of left side curtain

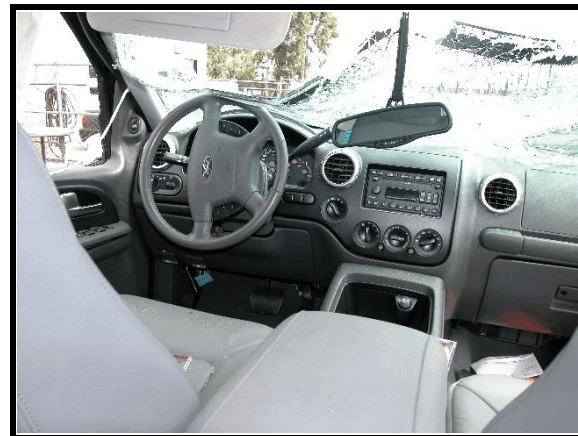
The Ford Expedition was equipped with a driver's front air bag and a front passenger's air bag. The driver's and front right passenger air bags did not deploy, nor would they have been expected to deploy in this crash configuration.

Figure 12. Non-deployed driver's air bag

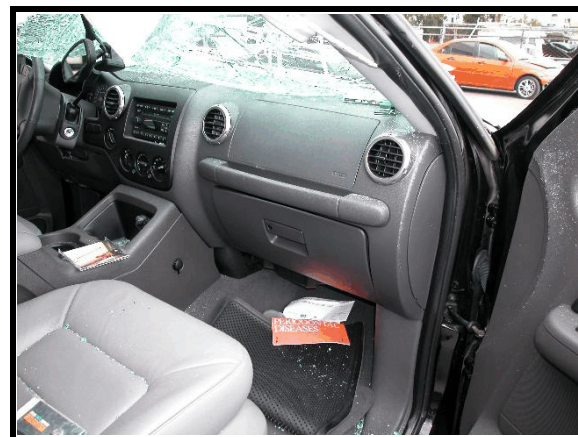
Figure 13. Non-deployed front right passenger's air bag
