Child Safety Seat Investigation / Vehicle to Vehicle
Dynamic Science, Inc. / Case Number: DS04021
2003 Nissan Altima
California
September, 2004

1. Report No. DS04021	2. Government Accession No.		3. Recipient Catalog No.	
4. Title and Subtitle Child Safety Seat Investigation			5. Report Date July 12, 2005

14. Sponsoring Agency Code	
15. Supplemental Notes				
16. Abstract This on-site investigation focused on a forward facing booster seat that was installed in the left rear position of a 2003 Nissan Altima. The Nissan Altima was occupied by a 48-year-old female restrained driver and a 4-year-old female who was seated in the booster seat. The booster seat was being used as a belt positioning booster and the vehicle lap and shoulder belt was in use. This two-vehicle crash occurred in September, 2004 at approximately 1108 hours in an urban area of southern California. The crash occurred at the approach to a four-leg intersection. The Nissan was struck in the rear by a Ford E-350 cutaway van. The driver of the Nissan sustained a head injury. The rear left occupant was fatally injured. The driver of the Ford E-350 did not report any injuries. The Nissan was pushed forward into the inte

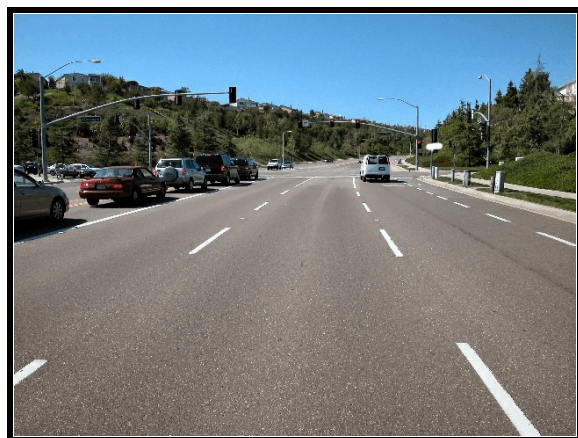
This two-vehicle crash occurred in September, 2004 at approximately 1108 hours in an urban area of southern California. The crash occurred at the approach to a four-leg intersection. The approaching seven lane roadway has a right hand curve with a positive 5 degree grade and a radius of 1314 m (4310 ft). The roadway is comprised of three westbound travel lanes, a left hand turn lane, and three eastbound travel lanes. The asphalt roadway was dry and free of any defects. The roadways are bordered by 21.0 cm (8.2 in) concrete curbs. The intersection is controlled by tri-color traffic signals that were functioning properly at the time of the crash. The speed limit is 80 km/h (50 mph). The ambient air temperature was 28 degrees C (82 degrees F).

Figure 2. Approach to area of impact (Northwest)

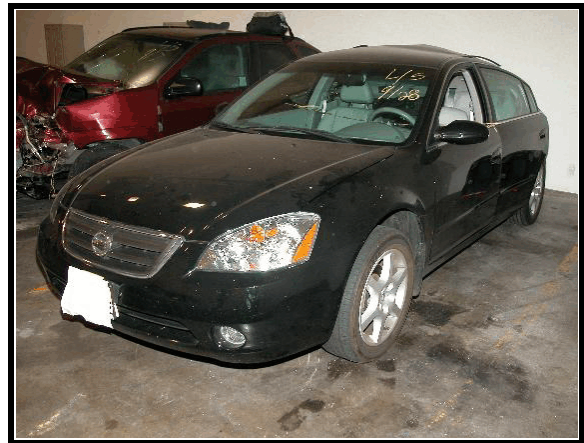
The front seating positions in the 2003 Nissan Altima were configured with leather covered bucket seats with adjustable head restraints. Both front seats were slightly reclined at the time of inspection. The rear seating positions were configured with a split bench seat with integral head restraints for the outboard positions.

Figure 3. Front left, Nissan Altima

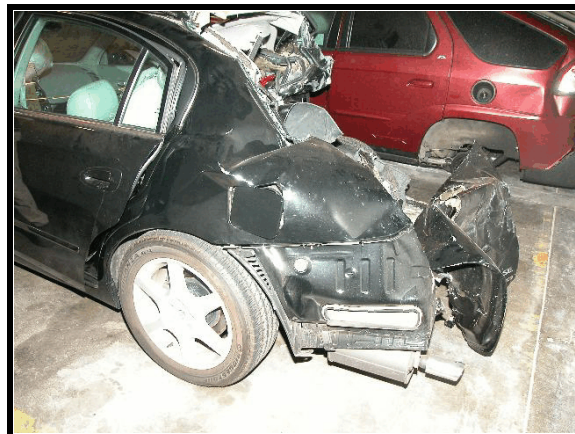
Damage Description:	Major rear end damage. Both right side doors jammed shut. Left rear door partially jammed shut. Trunk overridden. Crush to C pillar on right, as well as backlight frame. Backlight disintegrated. Wheelbase on left side shortened by 3.3 cm (1.3 in).	
CDC:	06BDAW6	
Delta V ⁴ :	Total	89-93 km/h (55-58 mph)
	Longitudinal	89-93 km/h (55-58 mph)
	Latitudinal	0 km/h (0 mph)
	Energy	Unknown

There was 152.0 cm (59.8 in) of direct contact to the rear end from the impact with the truck. The rear end was entirely overridden. The bumper and bumper backing bar were both separated from the rear mounting structure. The residual crush was measured at two locations in line with the bumper mounting brackets. A second set of measurements were taken above bumper at these locations. The averaged residual crush was as follows: C1=66.0 cm (25.9 in) and C2=69.0 cm (27.2 in). Additional measurements were taken along the backlight header. The residual crush at this location measured: C1=4.0 cm (1.6 in), C2=4.0 cm (1.6 in), C3=4.0 cm (1.6 in), C4=2.0 cm (0.8 in).

Figure 5. Left rear, Nissan Altima

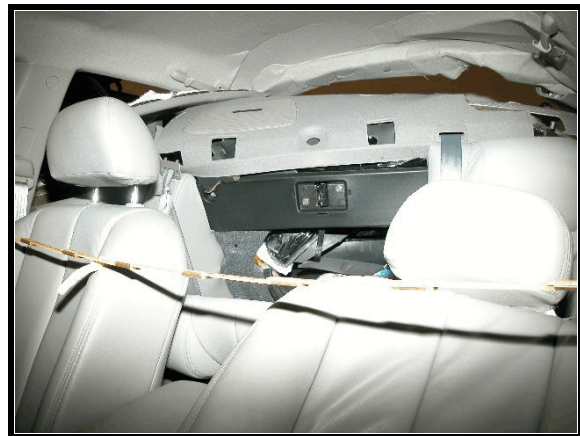
This Nissan Altima sustained interior damage from passenger compartment intrusion and occupant contacts. The second row seat back intruded from 63.0 cm (24.8 in) longitudinally on the right to 37.0 cm (14.6 in) on the left. There was intrusion of the backlight frame and the C pillar. The right rear and backlight glazing disintegrated due to damage. Both right doors were jammed shut. There was a skin contact to the back of the driver's seat.

Position	Intruded Component	Magnitude of Intrusion	Direction
LR	Rear seat back	37.0 cm (14.6 in)	Longitudinal
LR	Backlight	7.0 cm (2.8 in)	Longitudinal
LR	Driver's seat back	40.0 cm (15.7 in)	Longitudinal
MR	Top of backlight	8.0 cm (3.1 in)	Longitudinal
MR	Rear seat back	42.0 cm (16.5 in)	Longitudinal
RR	Rear seat back	63.0 cm (24.8 in)	Longitudinal
RR	C pillar	Unknown	Longitudinal
MR	Trunk latch assembly	Unknown	Longitudinal

Figure 6. Rear seat intrusion, Nissan Altima

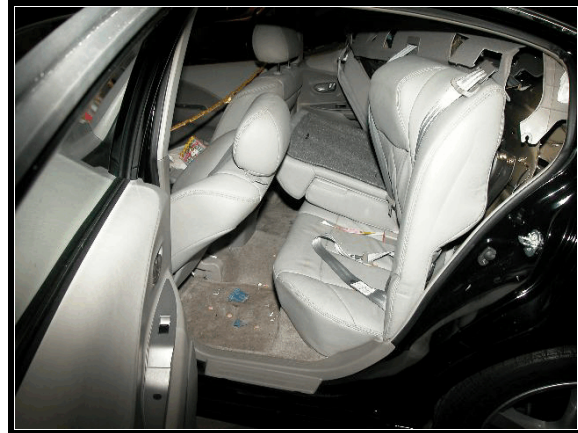
At impact, the seat was forced forward due to intrusion. The child safety seat back was stressed/bent at the top right and to the right middle. The rear left seat back had a post crash angle of 11 degrees forward from vertical.

Figure 7. Left rear seat position

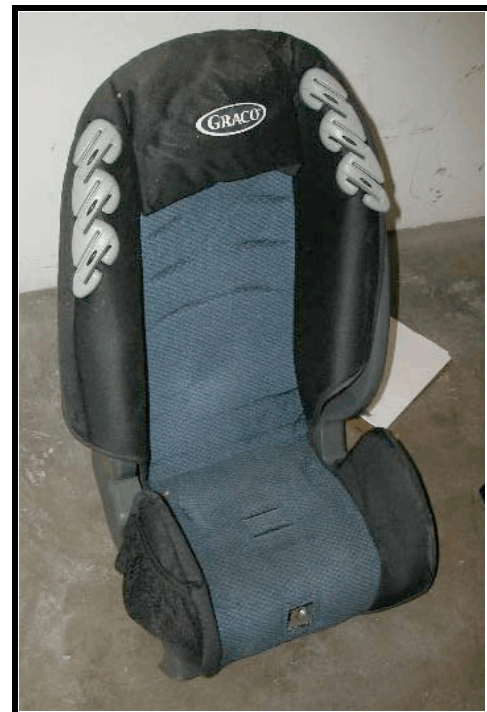
The 4-year-old female rear left occupant was seated in a GRACO Ultra CarGo Booster Car Seat 8487 (Manufacture date 07/21/2003). According to the manufacturer, the seat is designed to accommodate a child weighing between 9 kg (20 lbs) and 36 kg (80 lbs). For smaller children 14-18 kg (30-40 lbs), the seat is equipped with a 5-point harness. As the child grows 14-36 kg (30-80 lbs), the harness is removed and the car seat becomes a belt positioning booster which allows the child to use the vehicle combination lap and shoulder belt. The seat was being used as a belt positioning booster in this case. The child weighed 17 kg (37 lbs), making the use of the seat as a belt positioning booster appropriate. The child seat had been placed on the leather covered split bench seat that was equipped with folding backs. The seat bottom angle was 16 degrees from horizontal. The child was wearing the available lap and shoulder belt. The lap and shoulder belt was equipped with a switchable retractor and a sliding latch plate. It is believed that the seat belt was being used in the emergency locking mode. The belt was found in the spooled out (used) position.

Figure 8. GRACO Ultra CarGo Booster Car Seat 8487

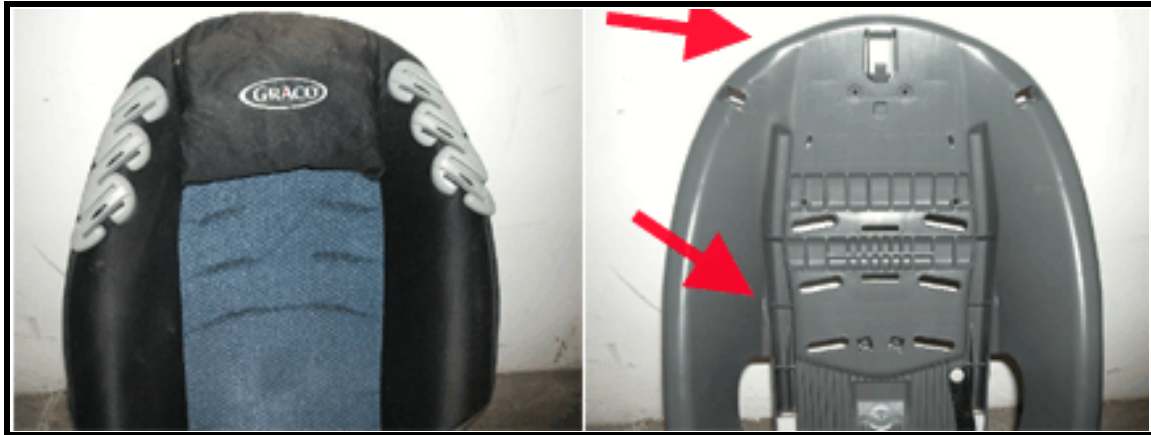
Figure 9. Booster seat with cover on and off. Right image locates stress marks.

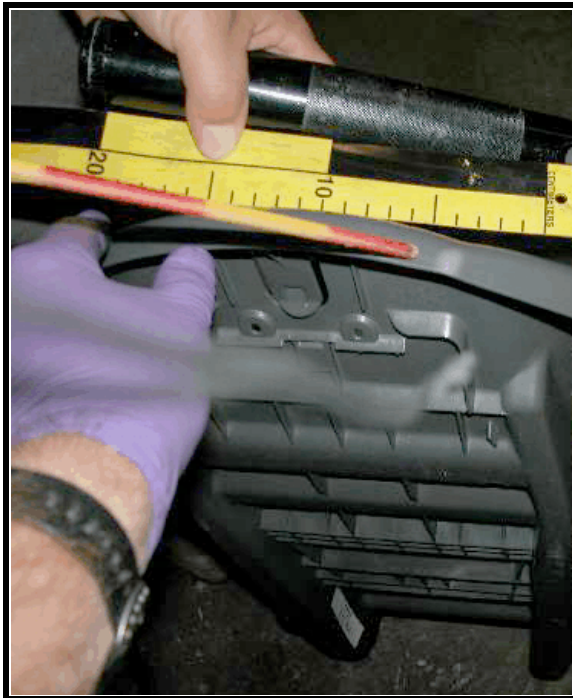
Figure 10. Close up view of top stress mark

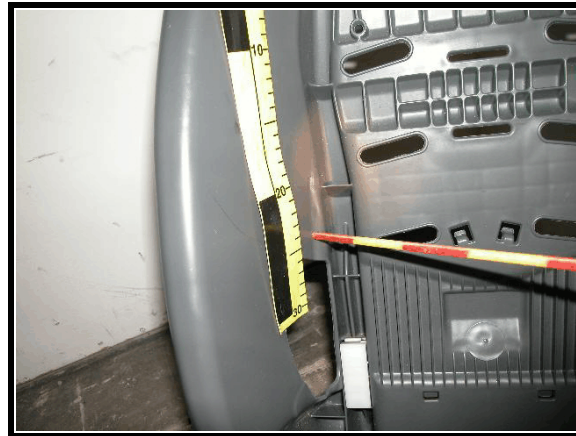
Figure 11. Close up of right seat back stress mark

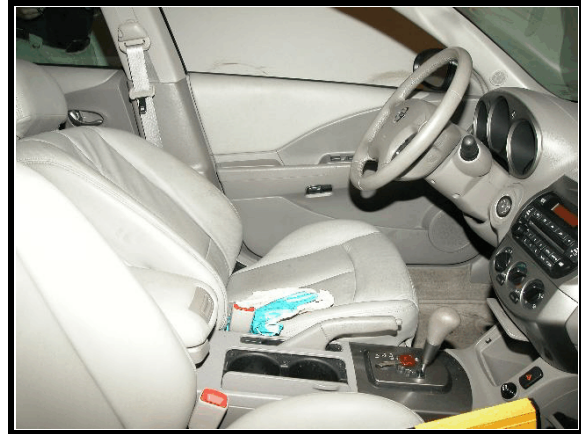
The 48-year-old female driver was seated in an upright posture and was restrained by the 3-point manual lap and shoulder belt. The leather covered bucket seat was adjusted to forward most track position. The adjustable head restraint was just above the bottom most position. At the time of inspection the seat back angle was 44.8 degrees and the seat bottom angle was 18.9 degrees. Her right foot was likely on accelerator with the left on the floorboard. At impact, the female driver initiated a rearward trajectory in response to the 180 degree direction of force. She loaded and deformed the seat back and head restraint with her head and back—causing contusions/abrasions to the posterior portion of her head, a concussion, and a cervical strain. After impact, she rebounded to some degree and came to rest upright in her seat. She was able to exit the vehicle on her own, but witnesses described her condition as “dazed”.

Figure 12. Driver's seat with deformed seat back
