**ON-SITE FRONTAL AIR BAG NON-DEPLOYMENT CRASH INVESTIGATION**

**VEHICLE: 2003 FORD CROWN VICTORIA POLICE INTERCEPTOR**

**CASE NO: CA04-024**

**CRASH DATE: APRIL, 2004**

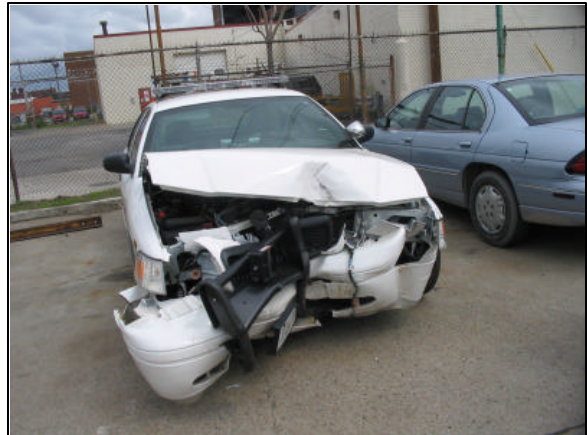
**Figure 1: Front view of the 2003 Ford CVPI.**

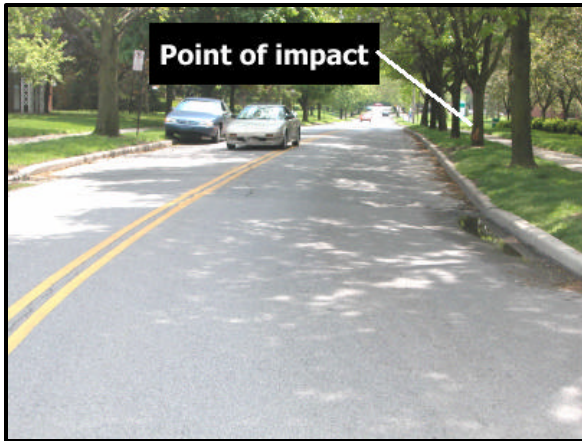
**Figure 3: Southbound trajectory view.**

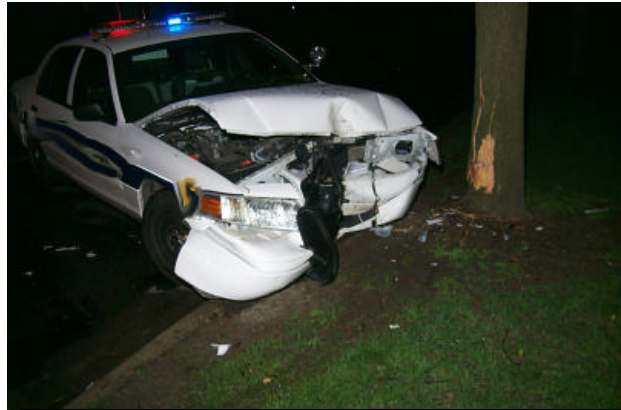
**Figure 2: Final rest position.**

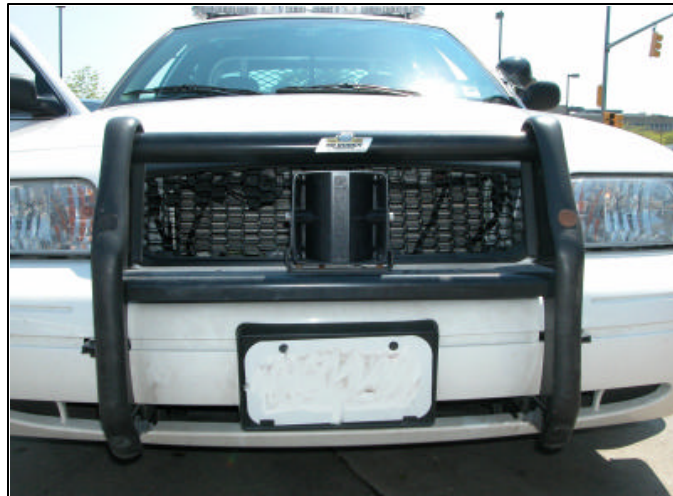
**Figure 4** is a front view of an exemplar Ford Crown Victoria Police Interceptor and aftermarket *Go Rhino!* push bumper. This exemplar Ford CVPI was also inspected during the on-site inspection. The push bumper consisted of a steel weldment that measured 74 cm x 58 cm (29 in x 23 in), width by height. The vertical uprights of the push bumper were joined together by a 5 cm (2 in) diameter cross tube at the top and by a 15 cm x 2.5 mm (6 in x 0.100 in), width by thickness, plate at the center. The push bumper was attached directly to the bumper reinforcement bar by two U-clamps manufactured from 6.4 mm (0.25 in) plate steel. Two horizontal slots were cut into the fascia to accommodate the attachment. All the push bumpers for the city police vehicles were installed by the *Go Rhino!* distributor.

**Figure 4: Exemplar Ford CVPI and push bumper.**

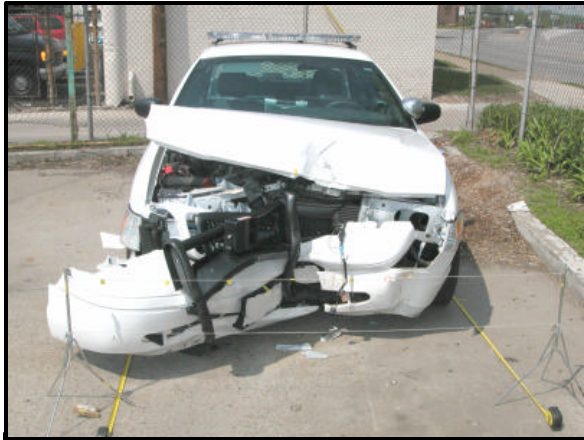
**Figures 5 and 6** are the front and left lateral views of the subject Ford. The front plane of the vehicle sustained 33.0 cm (13.0 in) of direct contact damage as a result of the tree impact. The direct damage began 36.8 cm (14.5 in) left of center on the left upright of the push bumper and ended 3.8 cm (1.5 in) left of center. The combined width of the direct and induced damage extended across the vehicle's entire 147 cm (58 in) frontal end width. The angular impact deformed the end of the left frame rail inboard. The residual location of the center of the bumper reinforcement bar was 16.8 cm (6.6 in) right of the vehicle's centerline. The direct contact damage on the hood measured 20 cm (8 in). The principle components damaged in the crash included the front bumper fascia and reinforcement bar, center grille, headlamp assemblies, hood, upper radiator support, radiator and air conditioner condenser. The right front fender shifted rearward causing a minor interference with the operation of the front right door. There was no measurable change in the wheelbase dimensions. The residual deformation measured

along the bumper reinforcement was as follows: C1 = 35.0 cm (13.8 in), C2 = 51.0 cm (20.1 in), C3 = 43.0 cm (16.9 in), C4 = 20.0 cm (7.9 in), C5 = 6.0 cm (2.4 in), C6 = 0. The Collision Deformation Classification (CDC) was 10-FYEN-2. The total Delta V calculated by the Barrier Algorithm of the WINSMASH model was 20.3 km/h (12.6 mph). The longitudinal and lateral delta V components were -13.0 km/h (-8.1 mph) and 15.5 km/h (9.6 mph), respectively. Although the results of the WINSMASH reconstruction appeared reasonable (relative to the stored RCM data), the results were considered borderline because the aftermarket push bumper was involved in the direct damage and its mounting to the bumper reinforcement bar effected the crush profile and crush parameters of the vehicle.

**Figure 5: Front view of the Ford CVPL.**

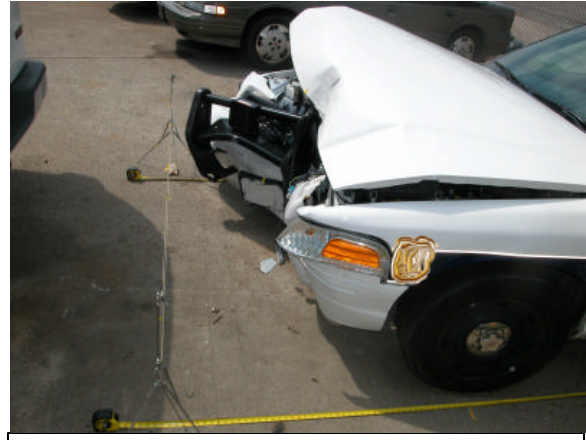
**Figure 6: Left lateral view.**

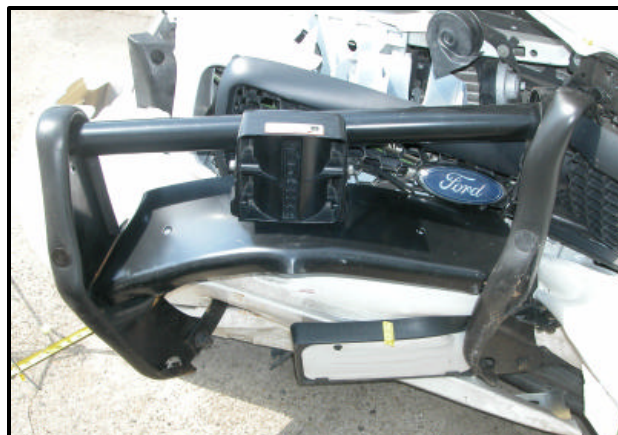
**Figure 7** is a view of the residual damage to the push bumper. Direct contact to the tree was noted on the left upright and the upright deformed (twisted) inboard. The center plate of the push bumper buckled vertically and was slightly bowed. Other than the above noted damage, the push bumper was intact. The force of the impact was transmitted through the push bumper mounting points to the bumper reinforcement. The bumper structure deformed rearward and right indicative of the 10 o'clock direction of the impact.

**Figure 7: Close-up of the deformed push bumper.**

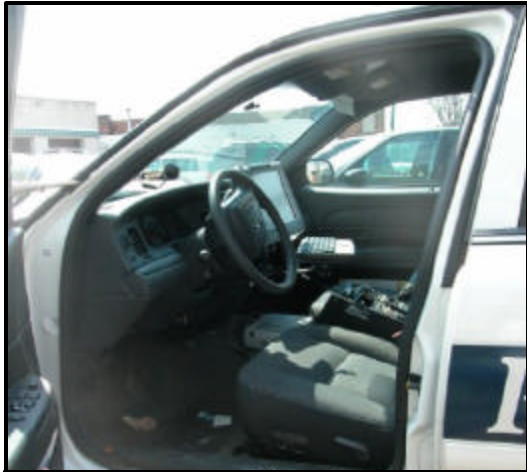
The only interior damage to the Ford consisted of the displacement of center mirror from its mount as a result of an interaction with the front right occupant. There were no noted contacts or deformations to the respective bolsters. There was no movement of the steering column shear capsules or steering wheel rim deformation.

The driver seat was located in a full rear track position. The seat back angle measured 15 degrees aft of vertical. The horizontal distance from the seat back to the steering wheel hub measured 63.5 cm (25.0 in). The driver's manual safety belt was not in use at the time of the crash. The restraint was stowed in the retractor at inspection and the retractor was operational. The retractor pretensioner had not fired. Examination of the restraint webbing identified indicators of historical use.

**Figure 10: Left interior view.**

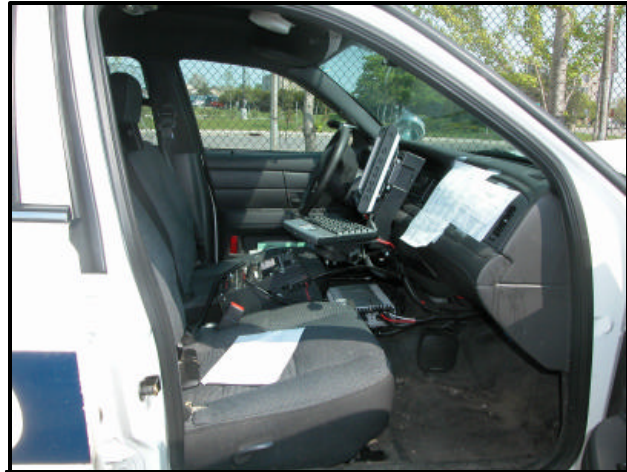
The front right seat was located in a full rear track position and its seat back angle measured 15 degrees. The horizontal distance from the seat back to the leading edge of the instrument panel measured 82.6 cm (32.5 in). The front right passenger was unrestrained at the time of the crash. Upon inspection, the restraint was stowed in the retractor and the retractor was operational. The retractor pretensioner had not fired. Historical use indicators were identified on the restraint upon examination.

**Figure 11: Right interior view.**
