**CALSPAN REMOTE ADAPTIVE CONTROL-EQUIPPED VEHICLE CRASH
INVESTIGATION**

NASS/SCI COMBO CASE NO: 2005-12-018B

VEHICLE: 1996 CADILLAC DEVILLE

CRASH DATE: JANUARY 2005

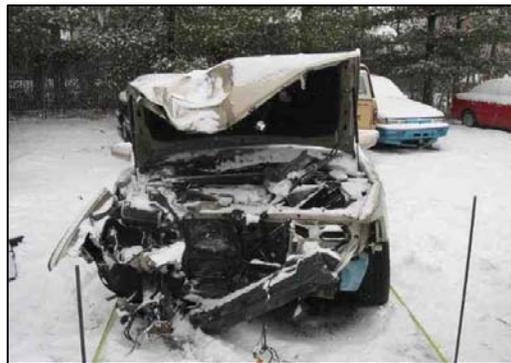
Figure 1 - Damaged 1996 Cadillac DeVille

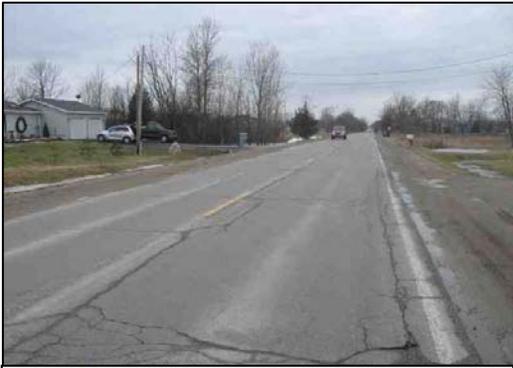
The 63-year old male driver of the Cadillac was traveling in a westerly direction on the two-lane roadway (**Figure 2**). The Cadillac drifted to the left and across the centerline before departing the left roadside (**Figure 3**). Neither the NASS inspection nor the police investigation revealed any evidence indicative of pre-crash avoidance measures.

Figure 2 – Westbound approach of Cadillac Deville.

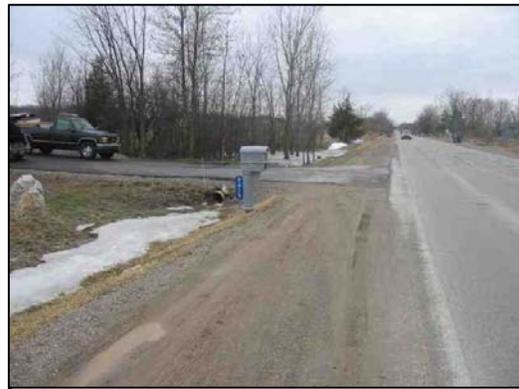
Figure 3 - Area of road departure.

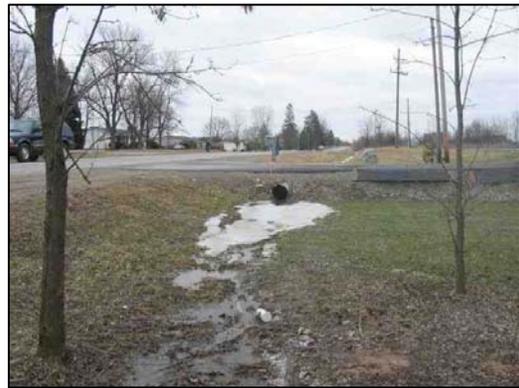
As the Cadillac departed the roadway, it impacted a mailbox located 3 m (9.8') outboard of the roadway with its frontal plane. The vehicle then entered a shallow ditch that was approximately 5 m (1.5') in depth. The shallow ditch ascended to a driveway where a culvert was located adjacent and perpendicular to the driveway. The culvert pipe was 45 cm (18") in diameter and protruded from the bank. The front plane impacted and overrode the culvert and continued in a forward trajectory. The vehicle vaulted forward across the driveway and returned to its wheels prior. The vehicle then impacted a 32 cm (13") diameter tree located 22 m (72') west of the driveway with the front right area of the vehicle. **Figure 4** illustrates the path of travel of the Cadillac from the road departure to the impacted hardwood tree.

Figure 4 – Look back at approach.

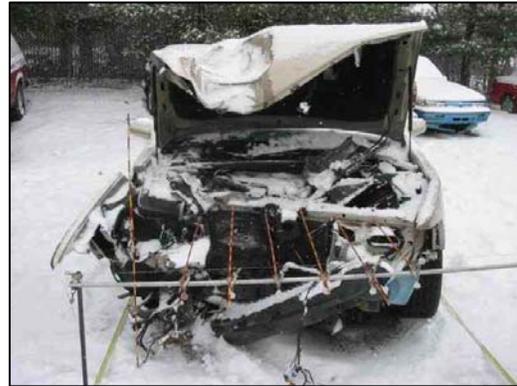
The 1996 Cadillac DeVille sustained moderate damage as a result of the impact with the hardwood tree (**Figure 5**). The maximum crush was located approximately 25 cm (10") right of the vehicle's centerline and measured 51 cm (20.1") in depth. The direct contact began at the front right bumper corner and measured 48 cm (18.9") in length. The Field-L measurement extended across the full width of the bumper beam and was an SCI revised 115 cm (45.3") in length. The crush profile was measured to the bumper beam and then raised to the upper radiator support. The averaged crush measurements were as follows: C1 = 0 cm, C2 = 17 cm (6.7"), C3 = 22 cm (8.7"), C4 = 37 cm (14.6"), C5 = 38 cm (15"), C6 = 27 cm (10.6"). The Collision Deformation Classification (CDC) was 12-FZEW-2.

Figure 5 - Frontal view of damaged Cadillac DeVille.

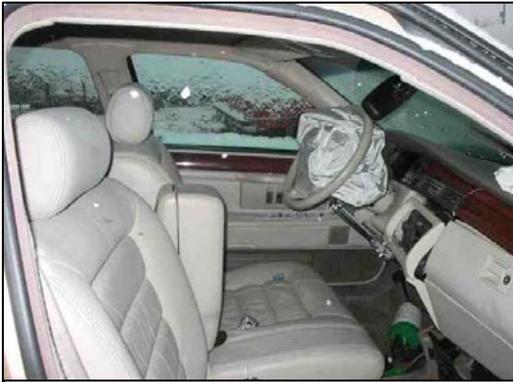
Occupant contact was noted in both frontal seating positions of the vehicle. The driver loaded through the deploying air bag into the steering assembly, displacing the column upward (**Figure 6**). Transfer evidence was present on the driver's air bag; however, the NASS investigation made no determination as to what type of transfer was present. The driver loaded through the air bag deforming the right half of the steering wheel rim 8 cm (3.2"). The driver loaded the push/pull handle of the adaptive control unit with his left knee deflecting the handle into the padded instrument panel where the component left a circular indentation (**Figure 10**). Energy was translated down the adaptive control linkage into the brake pedal and the pedal bent and released this loading force. The driver also loaded the left knee bolster evidenced by scuffing.

Figure 6 - Driver's area.

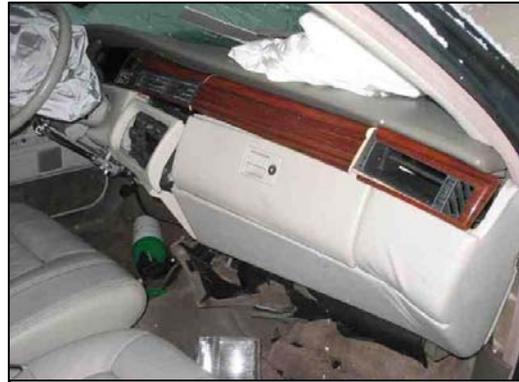
Figure 7 - Contact knee bolster.

His left knee impacted the knob of the adaptive driving hand control. This contact displaced the knob into the knee bolster, deforming the bolster panel. As a result of this contact, the driver sustained a left knee abrasion.

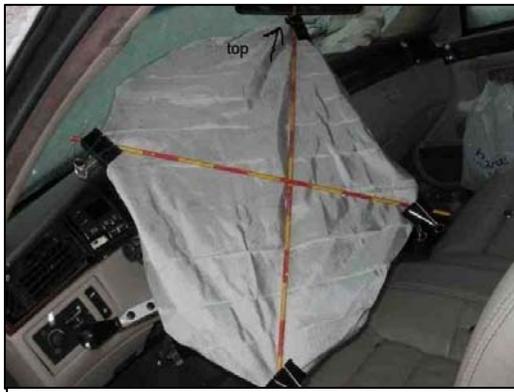
The driver's air bag deployed through symmetrical I-configuration cover flaps. Each cover flap measured 10 cm (3.9") in length and 10 cm (3.9") in height. The deployed driver's air bag measured 62 cm (24.4") in diameter in its deflated state (**Figure 8**). The NASS investigator was able to identify an unspecified transfer from occupant interaction on the air bag membrane. The investigation did not specify the precise location of this engagement. The air bag was reportedly not tethered and was vented by two ports located in the 3 o'clock and 9 o'clock positions.

Figure 8 - Deployed driver's air bag.

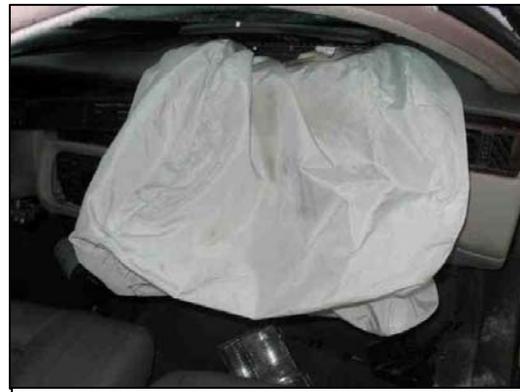
The front right passenger's air bag deployed through a top-mount single cover flap that measured 36 cm (14.2") horizontally and 18 cm (7.9") vertically. The deployed front right air bag measured 47 cm (18.5") horizontally and 55 cm (21.7") vertically in its deflated state. The air bag was tethered by two internal straps in an unspecified location. The air bag contained no vent ports. The NASS investigator was able to identify an unspecified transfer from occupant interaction on the air bag membrane. The investigation did not specify the precise location of this engagement; however, in a review of images, a possible contact transfer is present in the center of the air bag (**Figure 9**).

Figure 9 - Deployed front right passenger's air bag.

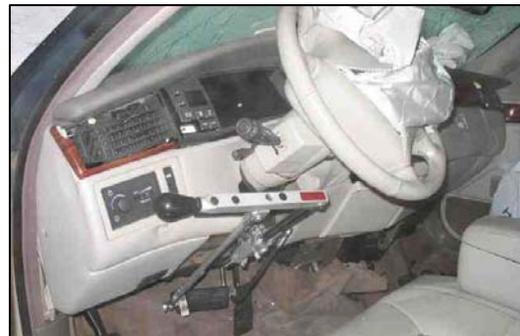
The 1996 Cadillac DeVille was equipped with adaptive hand controls for throttle and braking functions (**Figure 10**). The mechanical system was a left-hand operated push/pull system mounted to the left side lower instrument panel and linked to the OEM brake and accelerator pedals.

Figure 10 - Adaptive hand controls and indented instrument panel.

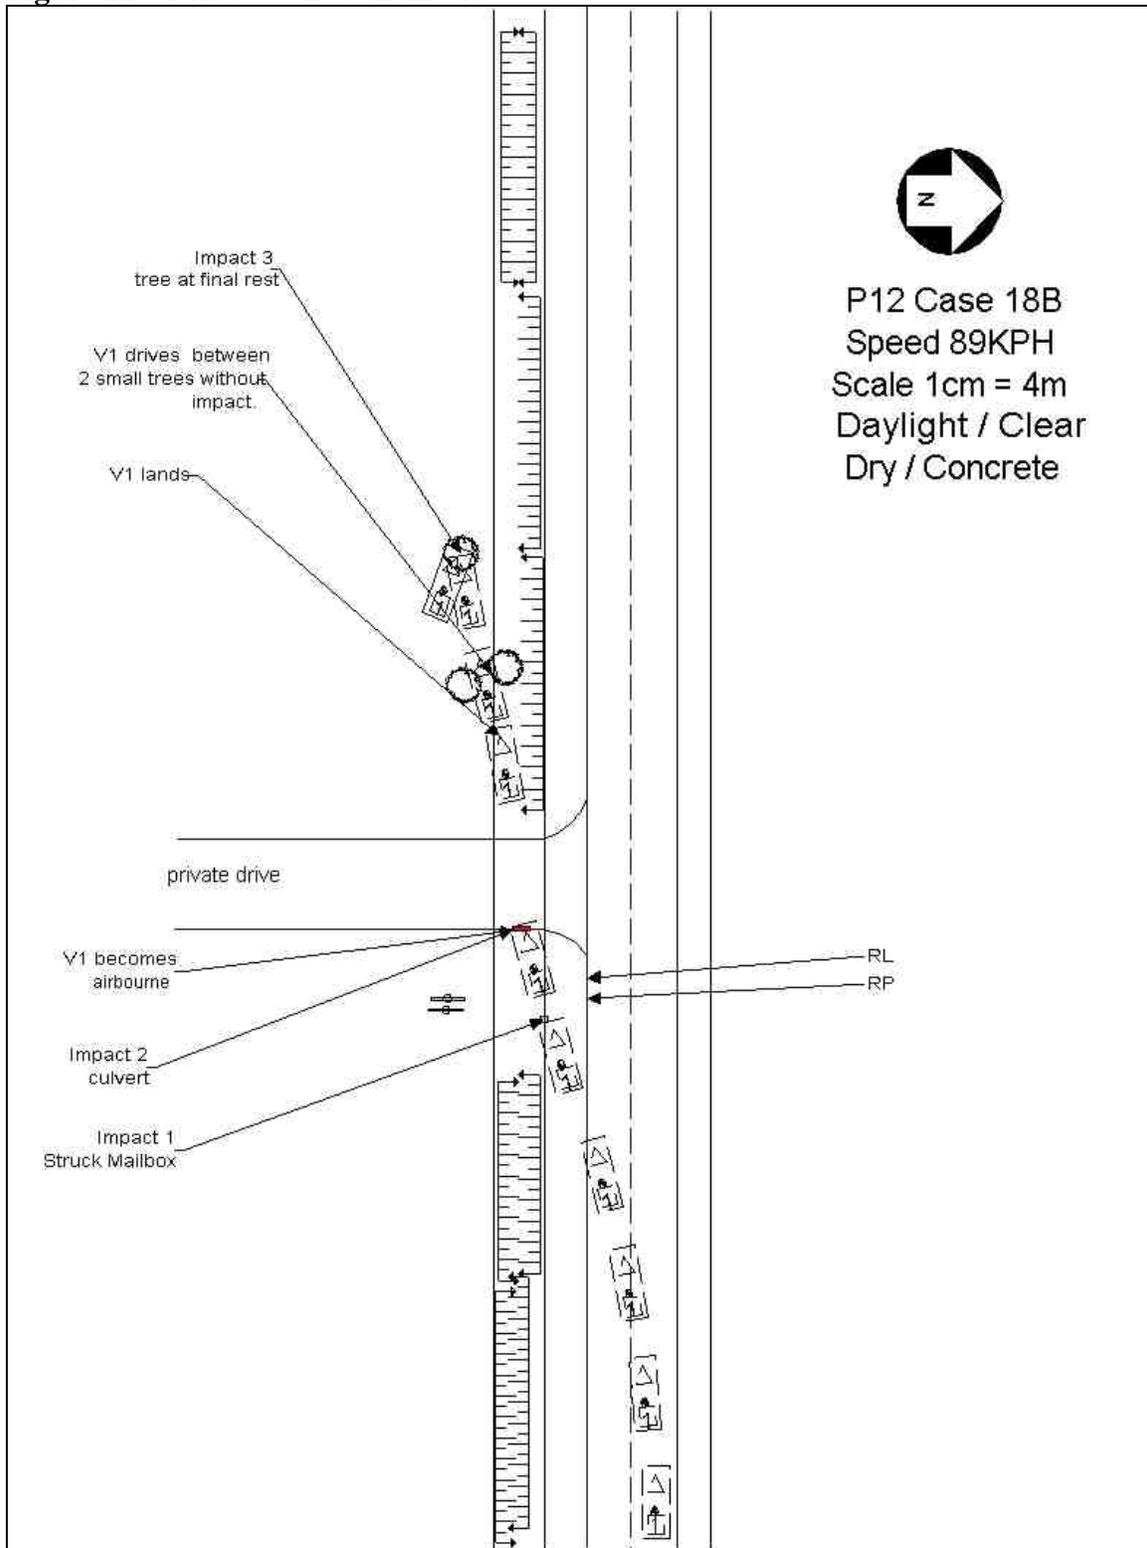
Figure 11 – NASS Scene Schematic

asphalt and was delineated by painted broken yellow lines. The east and westbound lanes were 3.1 m (10.2') and 3.4 m (11.2') in width respectively. The road surface was dry and there were no adverse weather conditions reported at the time of the crash. The road was bordered by natural growth and scattered private homes. The south roadside consisted of a dirt shoulder adjacent to a grassy slope that descended into a shallow ditch. The ditch was approximately 0.5 m (1.5') in depth. The shallow ditch ascended to a driveway where a culvert was located adjacent and perpendicular to the driveway. The culvert protruded approximately 45 cm (18") from the ground. The mouth of the asphalt driveway was 6.5 m (21.3') in width. Several large diameter trees were located within the vicinity of the crash site and the contacted tree was placed 9 m (29.5') outboard of the south edge of the roadway and 22 m (72') west of the driveway. The struck hardwood tree measured 33 cm (13") in diameter. The posted speed limit was 89 km/h (55 mph). The scene schematic is included as **Figure 11** at the end of this narrative report.

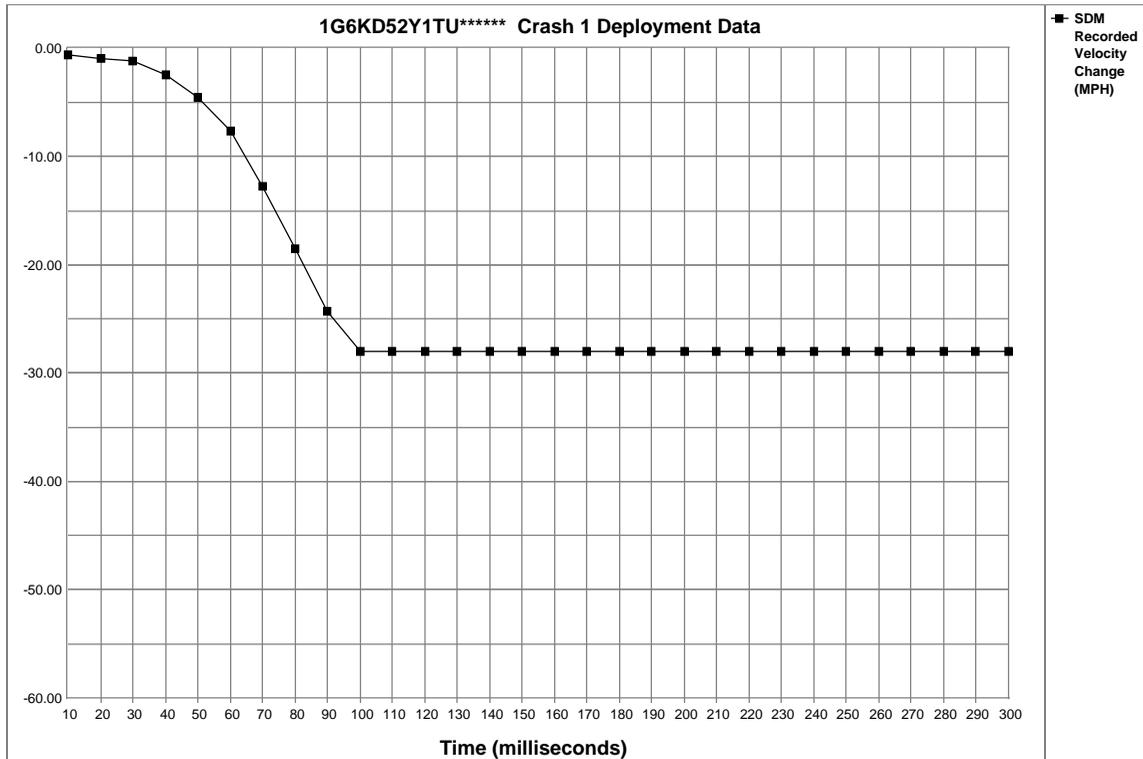
SIR Warning Lamp Status	OFF
Driver's Belt Switch Circuit Status	BUCKLED
Ignition Cycles At Deployment	12292
Ignition Cycles At Investigation	12293
Time From Algorithm Enable to Deployment Command Criteria Met (msec)	22.5
Time Between Non-Deployment And Deployment Events (sec)	.48

Time (milliseconds)	10	20	30	40	50	60	70	80	90	100	110	120	130	140	150
Recorded Velocity Change (MPH)	-0.55	-0.88	-1.21	-2.41	-4.50	-7.68	-12.73	-18.54	-24.24	-27.97	-27.97	-27.97	-27.97	-27.97	-27.97
Time (milliseconds)	160	170	180	190	200	210	220	230	240	250	260	270	280	290	300
Recorded Velocity Change (MPH)	-27.97	-27.97	-27.97	-27.97	-27.97	-27.97	-27.97	-27.97	-27.97	-27.97	-27.97	-27.97	-27.97	-27.97	-27.97

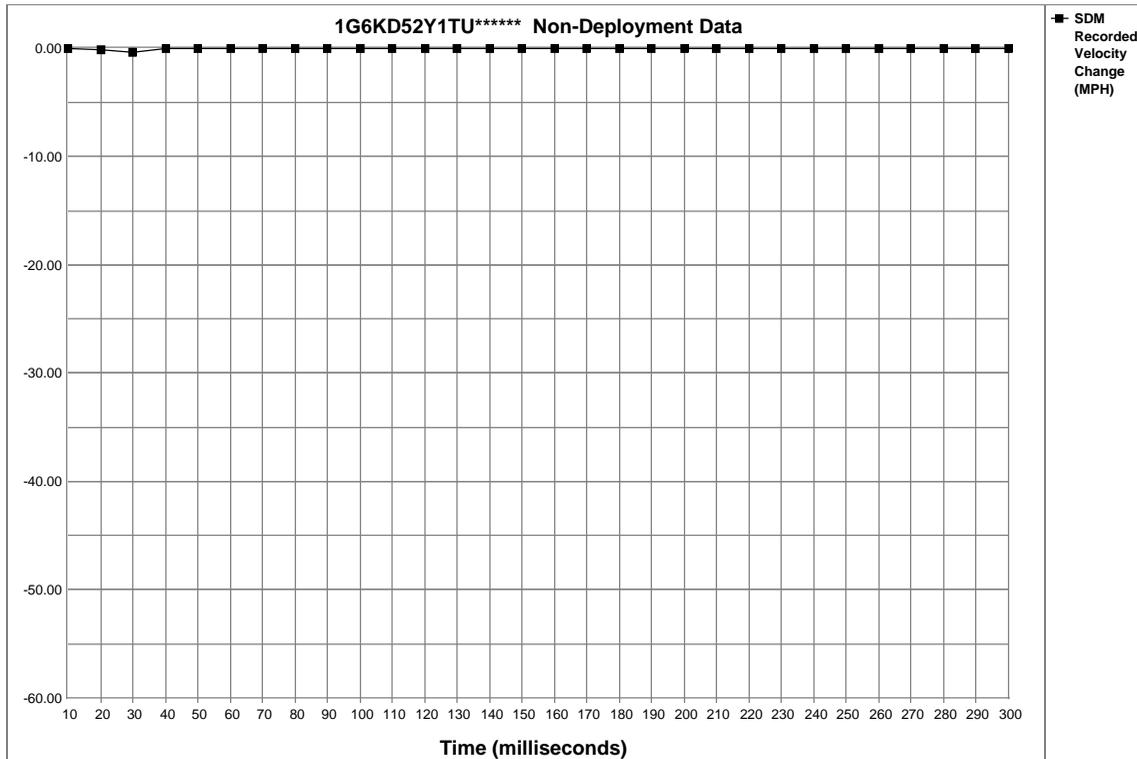
SIR Warning Lamp Status	OFF
Driver's Belt Switch Circuit Status	BUCKLED
Ignition Cycles At Non-Deployment	12292
Ignition Cycles At Investigation	12293
Algorithm Enable to Maximum SDM Recorded Velocity Change (msec)	0
Maximum SDM Recorded Velocity Change (MPH)	-0.55
A Deployment was Commanded Prior to this Event	No

Time (milliseconds)	10	20	30	40	50	60	70	80	90	100	110	120	130	140	150
Recorded Velocity Change (MPH)	0.00	-0.11	-0.33	0.00	0.00	0.00	0.00	0.00	0.00	0.00	0.00	0.00	0.00	0.00	0.00
Time (milliseconds)	160	170	180	190	200	210	220	230	240	250	260	270	280	290	300
Recorded Velocity Change (MPH)	0.00	0.00	0.00	0.00	0.00	0.00	0.00	0.00	0.00	0.00	0.00	0.00	0.00	0.00	0.00
