**ON-SITE AIR BAG RELATED CHILD FATALITY INVESTIGATION
CALSPAN CASE NO: CA05-028**

**VEHICLE – 1997 JEEP CHEROKEE
LOCATION – GEORGIA
CRASH DATE – APRIL 2005**

| <p>4. <i>Title and Subtitle</i> On-Site Air Bag Related Child Fatality Investigation Vehicle: 1997 Jeep Cherokee Location: Georgia</p> | | <p>5. <i>Report Date:</i> July 2005</p> | |

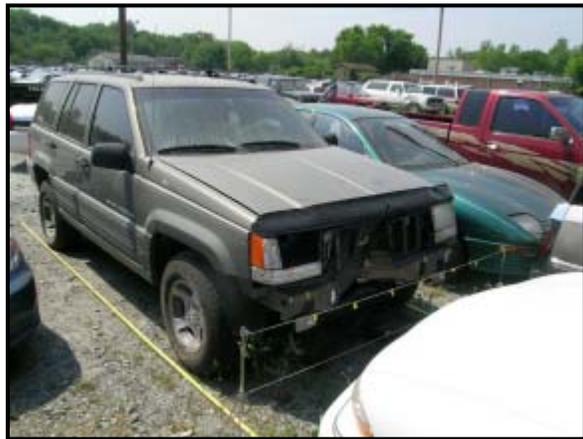
Figure 1: 1997 Jeep Cherokee front right view.

This on-site investigation focused on the crash dynamics and fatal injury sources of a 3 year old female seated in the front right position of a 1997 Jeep Cherokee, **Figure 1**. The Jeep Cherokee was equipped with a frontal air bag system that consisted of driver and front right passenger air bags. The air bags deployed as a result of a frontal impact with a 99 cm x 99 cm (39 in x 39 in) brick column that supported an overhang to a building located adjacent to a parking lot. The child was initially seated on a Cosco Ambassador backless booster seat and improperly restrained by only the lap portion of the vehicle's manual 3-point safety belt system. However, as the Jeep neared its destination, the child released the safety belt and attempted to exit the vehicle prior to its coming to a full stop. The child moved forward off the seat and was positioned in-close proximity to the front right passenger air bag module. The driver became distracted by the pre-crash actions of the child precipitating the crash. At impact, the child suffered multiple thoracic injuries as a result of her interaction with the deploying air bag resulting in her death. The driver of the Jeep was not injured in the crash.

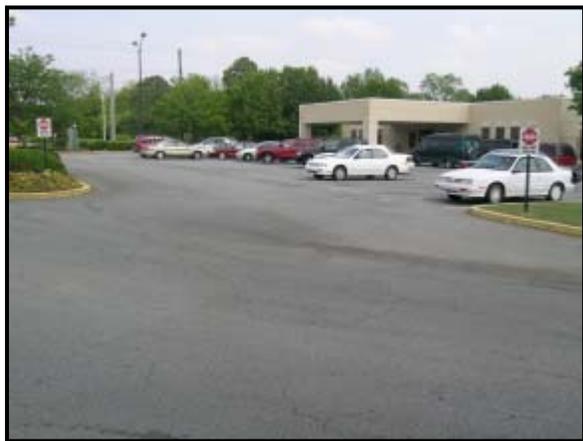
Figure 2: Trajectory view at the parking lot entrance.

private business was located on the south side of the parking lot. Two brick columns supported a 9.8 m (32.0 ft) long overhang that extended from the building and covered its entrance. The brick columns measured 99 cm x 99 cm (39 in x 39 in) and were approximately 3.6 m (12 ft) tall. The west-most brick column was the point of impact. **Figure 2** is a southeast trajectory view along the Jeep's path of travel at the point where the vehicle entered the parking lot. **Figure 3** is a view of the point of impact.

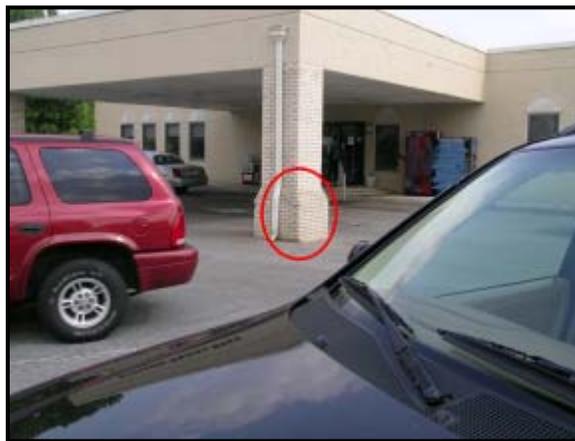
Figure 3: View of the POI (highlighted).

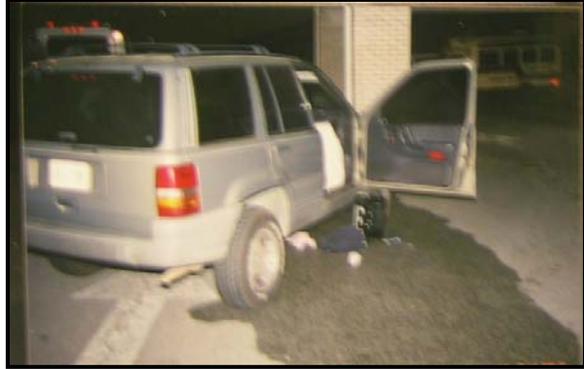
During the driver's distraction, the Jeep continued its forward trajectory and struck the brick column. The approximate distance from the entrance of the parking lot to the point of impact was 27 m (90 ft). The crash occurred with the center aspect of the Jeep's frontal plane impacting the corner of the brick column. The brick column was not damaged in the crash. The impact halted the vehicle's forward momentum and the Jeep came to rest. The delta V of the impact calculated by the Damage Algorithm of the WINSMASH model was 16.9 km/h (10.5 mph). The final rest position of the Jeep was documented by the police investigation, **Figure 4**. The distance between the front plane of the Jeep and the column measured 2.7 m (9.0 ft). It was

probable the Jeep rolled backward to this location after the impact; this final rest location was not associated to rebound. There was no evidence of pre-impact braking observed during the police investigation or SCI scene inspection. A schematic of the crash is attached to the end of this narrative report as **Figure 13**.

Figure 4: Jeep final rest position.

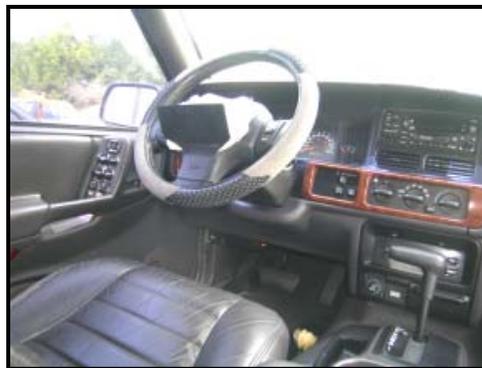
Figure 7 is a view of the driver's position. There was no deformation of the three-spoke steering wheel rim. The tilt steering wheel was adjusted to the full up position. There was no displacement of the steering column's shear capsules. There was no occupant contact to the driver's knee bolster.

Figure 7: Driver's position.

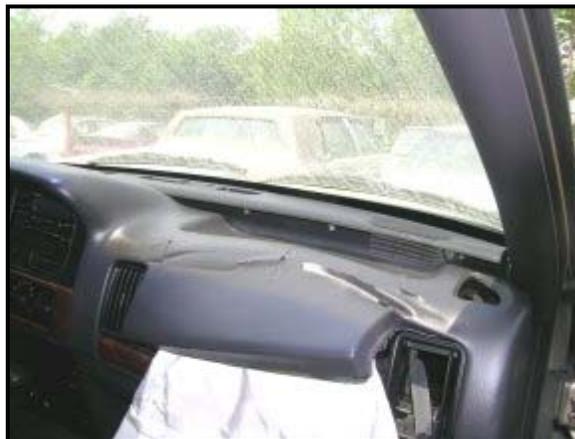
Inspection of the right aspect of the instrument panel revealed evidence of an impeded air bag deployment. Refer to **Figure 8**. The cavity in the right aspect of the instrument panel that housed the passenger air bag module was deformed due to an over-pressurization. The forward position of the child obstructed the normal deployment path of the air bag resulting in a partial expansion of the air bag within the module. Two linear cracks were observed in the vinyl instrument panel as a result of the deformation. The cracks were located 2.5 cm (1.0 in) and 21.1 cm (8.3 in) right of the inboard edge of the module flap, respectively. The centermost crack radiated forward 23 cm (9 in) to the lower aspect of the windshield. The outboard air conditioner/heater vent louver was also deformed during the impeded deployment. The top surface of the trim panel located immediately below the air bag module was abraded by the air bag during the altered deployment.

Figure 8: Right aspect of the instrument panel.

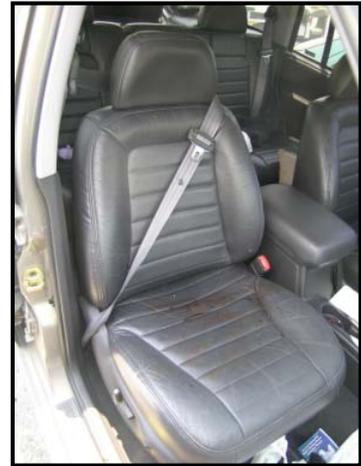
The front right passenger restraint consisted of a light-weight locking latch plate, continuous loop webbing, adjustable D-ring, and ELR retractor. The webbing was extended from the retractor upon initial inspection and the shoulder portion of the webbing was looped behind the back of the front right seat, **Figure 9**. The D-ring was adjusted to its lowest position. The position of the webbing was consistent with only the lap portion of the restraint being used by the child occupant. This improper use was confirmed during an interview with the driver. The driver stated that she placed the child in the front right position and only utilized the lap portion of the restraint. She reported that the shoulder portion of the restraint came across the child's neck; therefore she placed it behind the seat. She further stated, that prior to the crash, the child unbuckled the restraint and attempted to exit the vehicle prior to the crash. An inspection of the restraint's webbing and the friction surfaces of the hardware was unremarkable for crash related evidence, consistent with its non-use at the time of the crash.

Figure 9: Front right passenger seat and restraint.

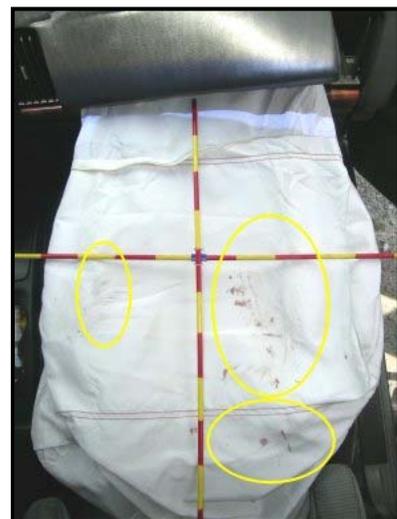
The front right passenger air bag module was a mid-mount design located in the right aspect of the instrument panel. Refer to **Figure 10**. The module cover flap was rectangular and measured 36.3 cm x 10.2 cm (14.3 in x 4.0 in), width by height, respectively and was hinged along its top aspect. There was no evidence of occupant contact to the cover flap. The cover flap rotated open upon deployment; however, the forward position of the child altered the deployment path of the air bag at the inboard aspect of the module. The deploying air bag was deflected to the right resulting in the asymmetrical opening of the flap and the over-pressurization of the module. Inspection of the front right passenger air bag membrane revealed indications of its impeded deployment as well. The dimensions of the

Figure 10: Top surface of the deflated front right passenger air bag.

deflated air bag measured 46 cm x 51 cm (18 in x 20 in), width by height, and the air bag extended 46 cm (18 in) rearward from the vertical face of the instrument panel. The top, face, and bottom surfaces of the air bag exhibited areas of black vinyl transfer related to frictional contact with the interior surfaces of the module during the impeded deployment. The expanding air bag also contacted and abraded the forward aspect of the booster seat (refer to the Booster seat section of this report below).

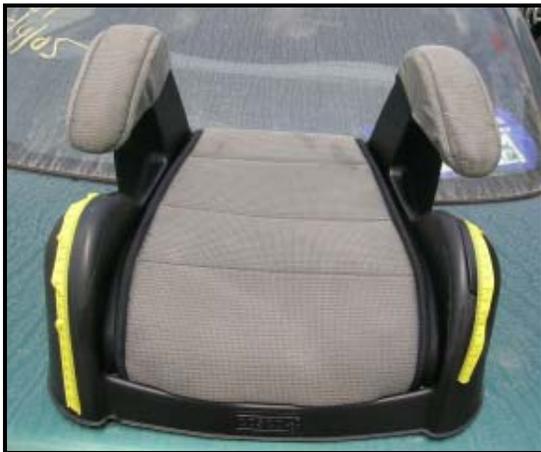
Prior to the crash, the 3 year old front right passenger was seated in a Cosco Ambassador backless booster seat. The seat was identified by the model number 22-296-WAL and was manufactured on 07/26/2004. The seat was rated for children over 1 year of age, 74 cm to 145 cm (29 in to 57 in), and 14 kg to 45 kg (30 lb to 100 lb). The manufacturer’s labels were still attached to the seat and the instruction manual was found in the front right foot well. At the time of the inspection, the seat was found in the second row interior. Inspection of the seat revealed the leading edges of the seat (outboard the cushion) were abraded by the expansion of the front right passenger air bag. The lengths of the left and right abrasions, measured along the circumference of the seat, were 21 cm (8.3 in) and 22 cm (8.7 in), respectively. Refer to **Figure 11**. The inspection of the seat was otherwise unremarkable. **Figure12** is an interior view of the front right seat and the reconstructed at-crash position of the booster seat.

Figure 11: Cosco Ambassador BBS.
