Remote Passenger Air Bag Related Child Fatality Investigation/ Vehicle to Object  
Dynamic Science, Inc. / Case Number: DS06008  
1997 Ford F150 SuperCab Pickup  
Washington  
March 2002

1. Report No. DS06008	2. Government Accession No.		3. Recipient Catalog No.	
4. Title and Subtitle Remote Passenger Air Bag Related Child Fatality Investigation			5. Report Date June 1, 2006

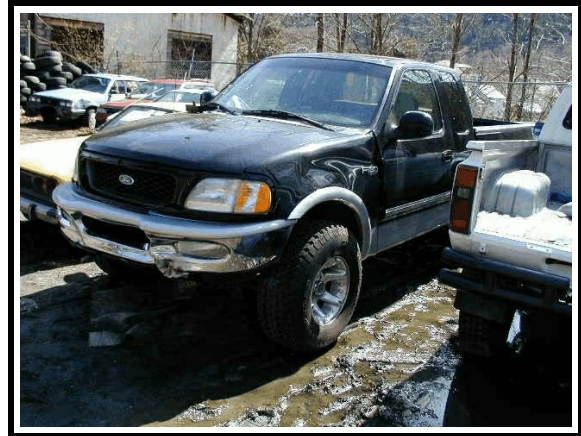
**Figure 1.** Front/Left - 1997 Ford F150 SuperCab

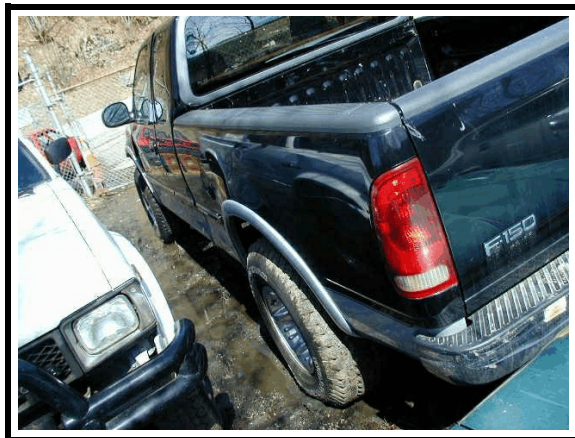
The 1997 Ford F-Series pickup was equipped with Goodyear Wrangler AT/S LT305/70R16 tires. The auto manufacturer's recommended tire size for the front and rear was LT245/75R16. The left rear tire was significantly under-inflated at the time of the inspection. The specific tire information is as follows:

Position	Measured Pressure	Vehicle Manufacturer Recommended Pressure	Restricted	Damage
LF	279 kPa (40 psi)	276 kPa (40 psi)	No	None
LR	97 kPa (14 psi)	276 kPa (40 psi)	No	None
RR	303 kPa (44 psi)	276 kPa (40 psi)	No	None
RF	293 kPa (42 psi)	276 kPa (40 psi)	No	None

**Figure 3.** Left rear tire under-inflated at inspection

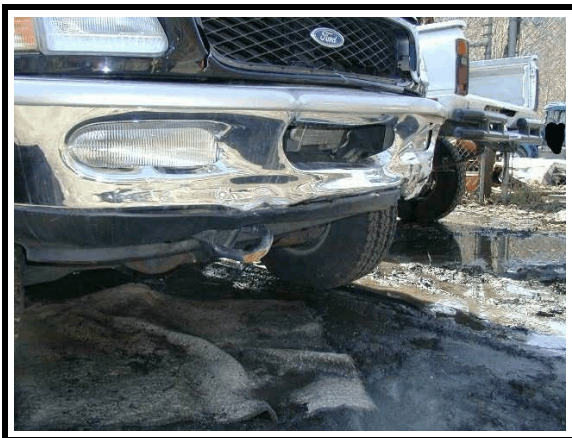
**Damage Description:** The 1997 Ford F150 sustained light front end damage as a result of the impact with the snowbank. The case vehicle sustained 130.0 cm (51.2 in) of direct damage along the front bumper, beginning 50.0 cm (19.7 in) right of center and extending to the left front bumper corner. There was no integrity loss and the three doors remained closed and operational. Six crush measurements were documented along the front bumper as follows: C1=10.0 cm (3.9 in), C2=11.0 cm (4.3 in), C3=9.0 cm (3.5 in), C4=5.0 cm (2.0 in), C5=5.0 cm (2.0 in), C6=2.0 cm (0.8 in).

**Figure 4.** Closer view of damage to right front bumper

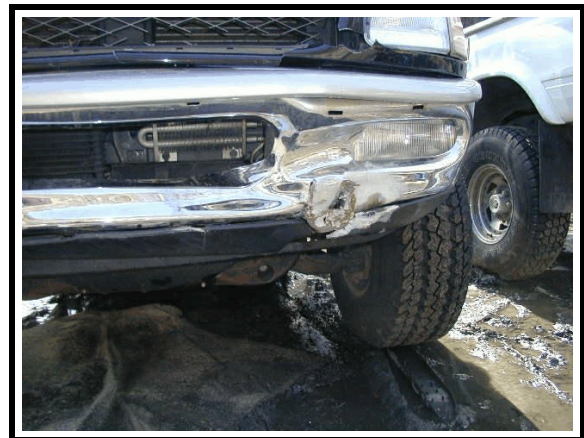
**Figure 5.** Closer view of damage to left front bumper

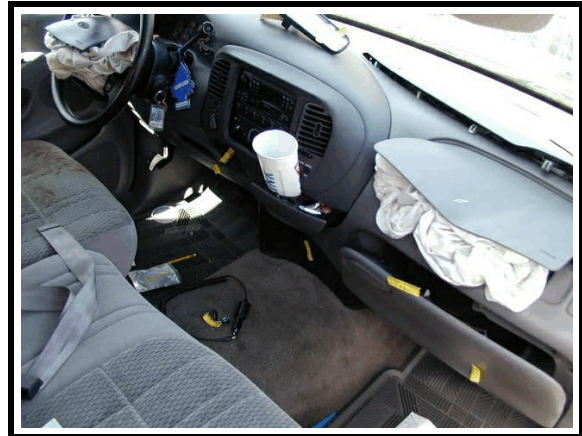
There was a scuff to the driver's knee bolster due to occupant contact. The center section of the instrument panel was deformed and the rearview mirror was broken off its base. A cup holder mounted in the center of the instrument panel appeared to have been moved and the cup in the holder was deformed, but this may have occurred post-impact. The right A pillar and glove compartment door were scuffed and the right instrument panel was cracked, most likely due to occupant contact. The back of the driver's integral head restraint was deformed due to contact from the second row left seat passenger. There was blood found on the driver and passenger air bags, the front row center lap belt, the left and center front row seat backs and seat cushions, as well as the left sill area. There was no intrusion and no integrity loss. The three side doors remained closed and operational. The windshield was in place, but was cracked on the right side due to occupant contact. There was no other glazing damage.

**Figure 6.** Damage/Occupant contacts to the instrument panel

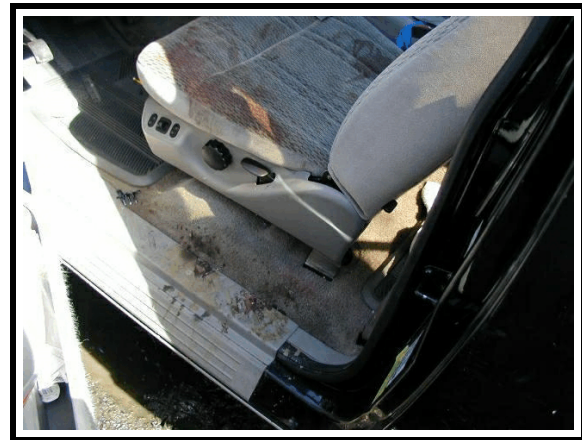
**Figure 8.** Blood in driver's area - from fatally injured front center occupant

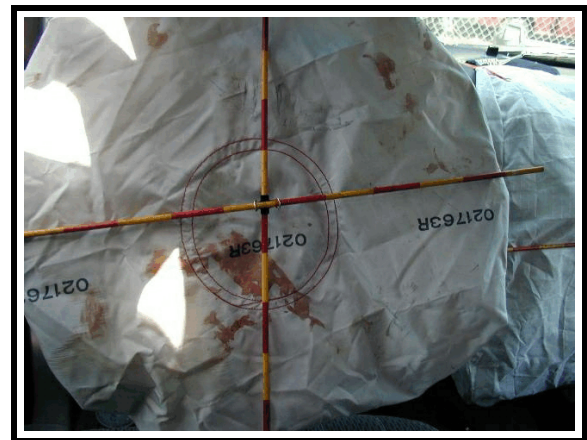
The driver's air bag was mounted in the center of the steering wheel hub. The driver's tilt steering wheel was set between the center and full down tilt positions. The air bag module had an H configuration. The top flap measured 20.0 cm (7.9 in) wide by 20.0 cm (7.9 in) high. The bottom flap measured 19.0 cm (7.5 in) wide by 8.0 cm (3.1 in) high. The air bag was circular in shape and in its deflated state, measured 58.0 cm (22.8 in) in diameter. There were black cover flap deployment streaks located in the center left section and the upper right quadrant. There was blood in the center section and on the left side of the air bag face. On the back of the air bag, there were black deployment streaks at the 8 o'clock and 11 o'clock locations. There were bloodstains at the 1 to 2 o'clock positions. The air bag had two internal tethers and no vent ports. There was no damage to the air bag module cover flaps.

Figure 10. Driver air bag

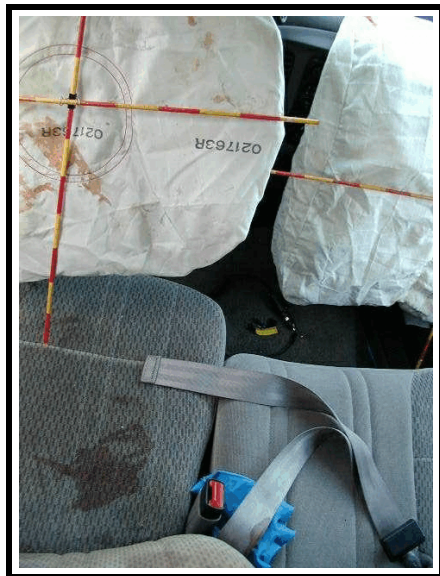
**Figure 13.** View of front center seat in relation to the deployed driver and passenger air bags

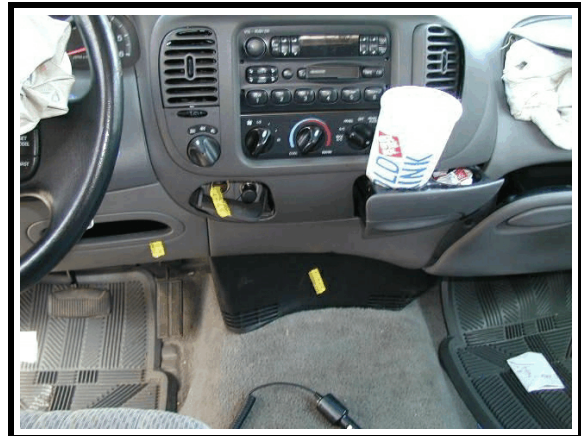
**Figure 15.** Possible occupant contacts - center instrument panel and below

At impact, the driver and front right passenger air bags deployed. The passenger air bag is equipped with an On/Off switch that was in the “On” position at the time of the crash. This passenger initiated a forward trajectory towards the 1 o’clock direction of force and likely loaded the safety belt and engaged the deployed passenger air bag with his face and head, resulting in severe head injuries. Based on the abrasive injuries to this passenger’s face and neck, it would appear that the air bag fully engaged his face and forced his head rearward. This hyperextending motion likely caused the spinal contusion . His feet and/or lower legs appear to have contacted the plastic cover located below the center instrument panel, deforming it.

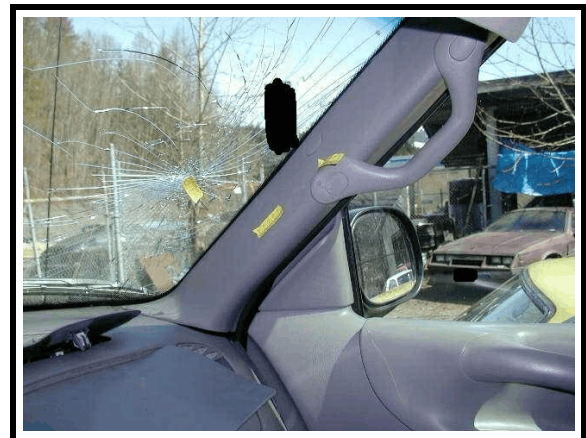
This passenger initiated a forward trajectory toward the 12 o’clock direction of force and likely loaded the safety belt and engaged the deployed passenger air bag with his/her face. This occupant’s knees appear to have contacted the glove compartment door, leaving scuffs. This occupant’s right hand and wrist appear to have been pushed upward due to the deploying passenger air bag, cracking the windshield and scuffing the right A pillar. This passenger’s lower right arm appears to have contacted the right instrument panel, cracking it. It is not known if this occupant was injured or if he/she received any medical treatment.

**Figure 16.** Possible occupant contacts to windshield and right A pillar
