**CALSPAN ON-SITE CHILD AIR BAG RELATED FATALITY CRASH
INVESTIGATION**

CALSPAN CASE NO: CA06-015

VEHICLE: 1994 PONTIAC GRAND PRIX

CRASH DATE: JUNE 2006

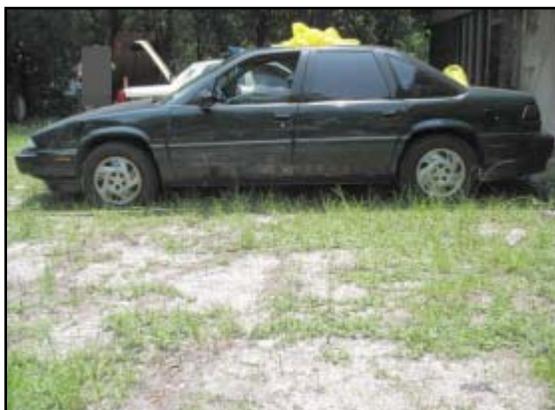
Figure 1. 1994 Pontiac Grand Prix subject vehicle.

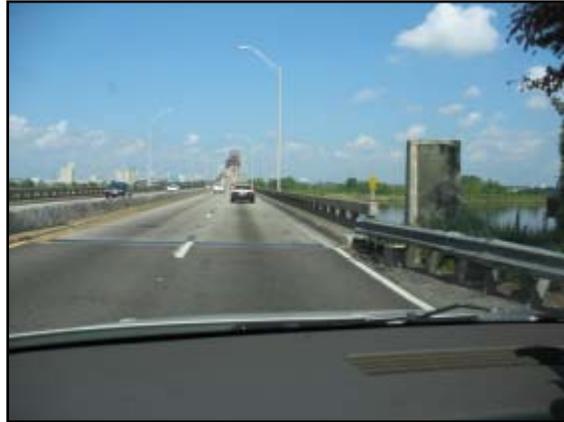
The crash occurred on a straight segment of road with a long positive grade for westbound travel (**Figure 2**). The driver of the Pontiac was operating the vehicle westbound on the right lane. Reportedly, a 1993 Geo Metro was stalled on the right lane. The driver of a 2002 Ford Ranger observed the stalled vehicle and stopped behind the Geo. The driver of a Honda was operating the vehicle westbound on the right lane and was unable to stop. The front of the Honda Civic struck the rear of the stopped Ford. The driver of the Pontiac stated to the SCI investigator that

Figure 2. Pontiac's pre-crash approach.

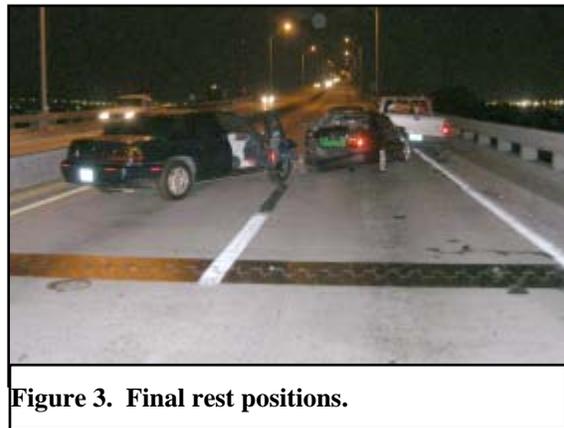
Figure 3. Final rest positions.

The corner impact displaced the Honda in a clockwise (CW) direction as it came to rest straddling the outboard travel lane behind the Ford Ranger. The Pontiac rotated CW into the inboard westbound travel lane, coming to rest diagonal to the inboard lane. **Figure 3** is an on-scene image of the vehicles at final rest.

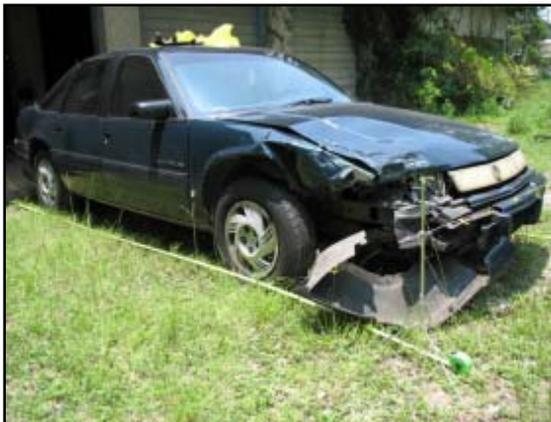
The 1994 Pontiac Grand sustained minor severity frontal damage as a result of the impact with the Honda (**Figures 4 and 5**). Maximum crush was 9 cm (3.5”), located at the right

Figure 4. Overall view of the frontal damage.

corner of the front bumper beam. The direct contact damage consisted of abrasions, dents, and fracturing of the bumper fascia, hood, and the right front fender. The direct contact damage began 36 cm (14") right of the vehicle's centerline and extended 31 cm (12.3") to the right bumper corner. The impact deformed the bumper beam resulting in a combined induced and direct damage length (Field L) of 135 cm (53"). Six equidistant crush measurements were documented at this level and were as follows: C1 = 0 cm, C2 = 0 cm, C3 = 0 cm, C4 = 0 cm, C5 = 1 cm (0.4"), C6 = 9 cm (3.5"). Additionally, crush was documented at the leading edge of the right front fender which was 22 cm (8.8"). Damage components included the hood, front bumper fascia and beam, right headlamp and the turn signal assembly. The Collision Deformation Classification (CDC) for this impact was 12-FREE-3.

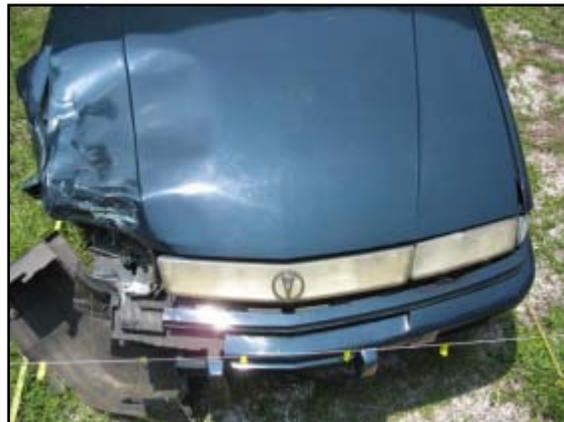
Figure 5. Overhead view of the crush profile

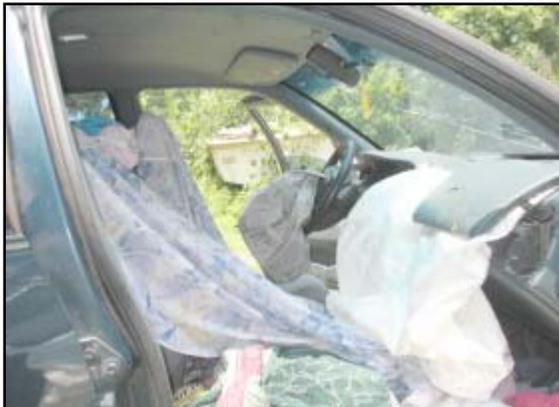
The interior of the Pontiac sustained interior damage that was attributed to air bag deployment, and occupant contacts. The driver stated to the SCI investigator that she was in the process of moving. The vehicle contained several personal items that consisted of clothing, large storage container, and food items that were scattered throughout the vehicle. **Figures 6 and 7** are overall views of the interior. The instrument panel exhibited damage from previous sun and heat exposure. The sun damage consisted of several cracks to the top of the instrument panel and front right air bag cover flap. Both air bags deployed as designed from the respective modules. The cover flap of the front right air bag contacted and fractured the windshield. The expanding air bag contacted the rear view mirror, which deflected it to the left and contacted and fractured the windshield. Also, the mirror glass was fractured from the contact with the front right air bag. The air vent, that was located on the right end of the right instrument panel was separated from probable contact with the expanding air bag as it was displaced by the out-of-position child passenger. Additionally, the headliner fabric contained several tears and stains that were not related to the crash.

The occupant contact points consisted of a scuff mark to the face of the glove compartment door from one of the front occupants. A smudge mark was present on the center rear edge of the right front air bag cover. The interior surfaces of the Pontiac were soiled which hampered the identification of minor occupant contact points. Furthermore, the front and rear seating surfaces were covered with sheets at the time of the crash and SCI inspection. This crash did not result in a reduction of the occupant space.

Figure 6. Overall view of the interior front row.

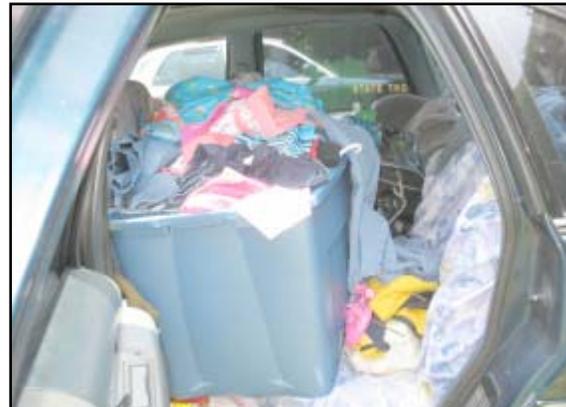
Figure 7. Overall view of the rear seating area.

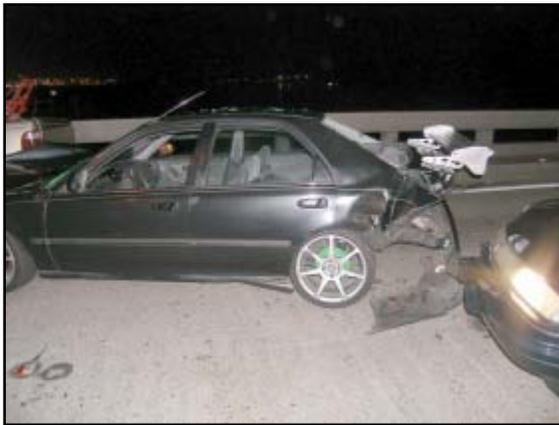
The 1992 Honda Civic was relocated prior to the SCI investigation; therefore, it was not inspected. The damage assessment was estimated from the police images **Figures 8 and 9**. The Honda sustained moderate severity frontal damage from the impact with the Ford Ranger.

The Honda sustained moderate severity damage to the rear from the impact with the Pontiac. The direct contact damage began left of the vehicle’s centerline and extended to the rear left bumper corner. Maximum crush occurred outboard of the rear left bumper corner. Due to the Pontiac underriding the rear of the Honda, the left rear axle was engaged and deflected forward resulting in a left side wheelbase reduction. The CDC for this impact was 06-BZEW-2.

Figure 8. Resultant damage to the Honda.

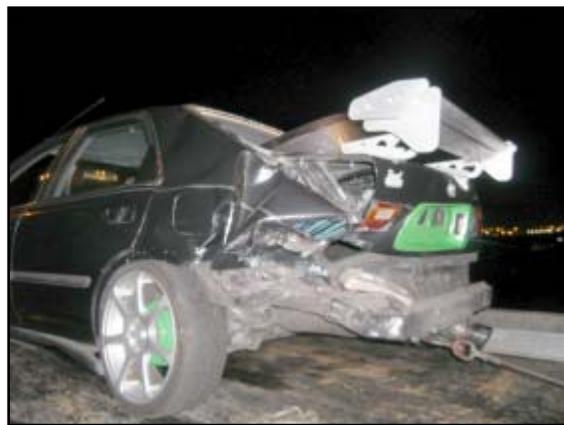
Figure 9. Damage to the rear of the Honda.

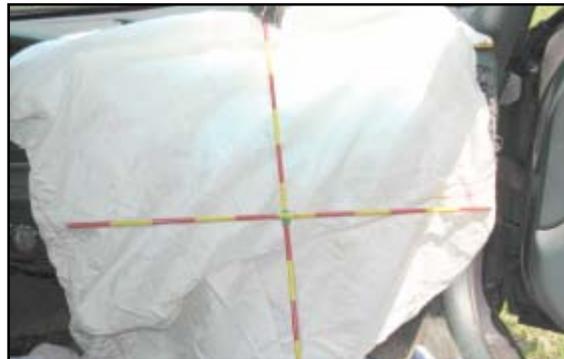
Figure 10. Deployed front right air bag.

The front right passenger air bag was a top-mount design, incorporated into the right instrument panel (**Figure 10**). A single cover flap concealed the bag, which measured 53 cm (21”) in width at the top and narrowed to 38 cm (15”) in width at the rear edge. The cover flap measured 28 cm (11”) in height. The exterior vinyl of the cover flap was cracked at numerous locations from prior sun/heat exposure. Additionally, a smudge was present on the center rear edge of the cover flap from possible occupant contact.

The air bag membrane measured 61 cm (24”) in width and 58 cm (23”) in height. The bag was tethered by a single wide band tether that extended across the full the width and was sewn to the face of the membrane. The air bag was vented by two vent ports on the side panels at the 11 and 1 o’clock positions. The maximum rearward excursion of this bag at the midpoint measured 41 cm (16”). Vinyl transfers were noted on the face of the membrane at the 11 and 8 o’clock sectors. No occupant contact points were noted to the air bag; however, two areas of body fluid that measured less than 1 cm (0.4”) were noted on the face of the membrane at the 5 o’clock sector. The air bag was free of damage.

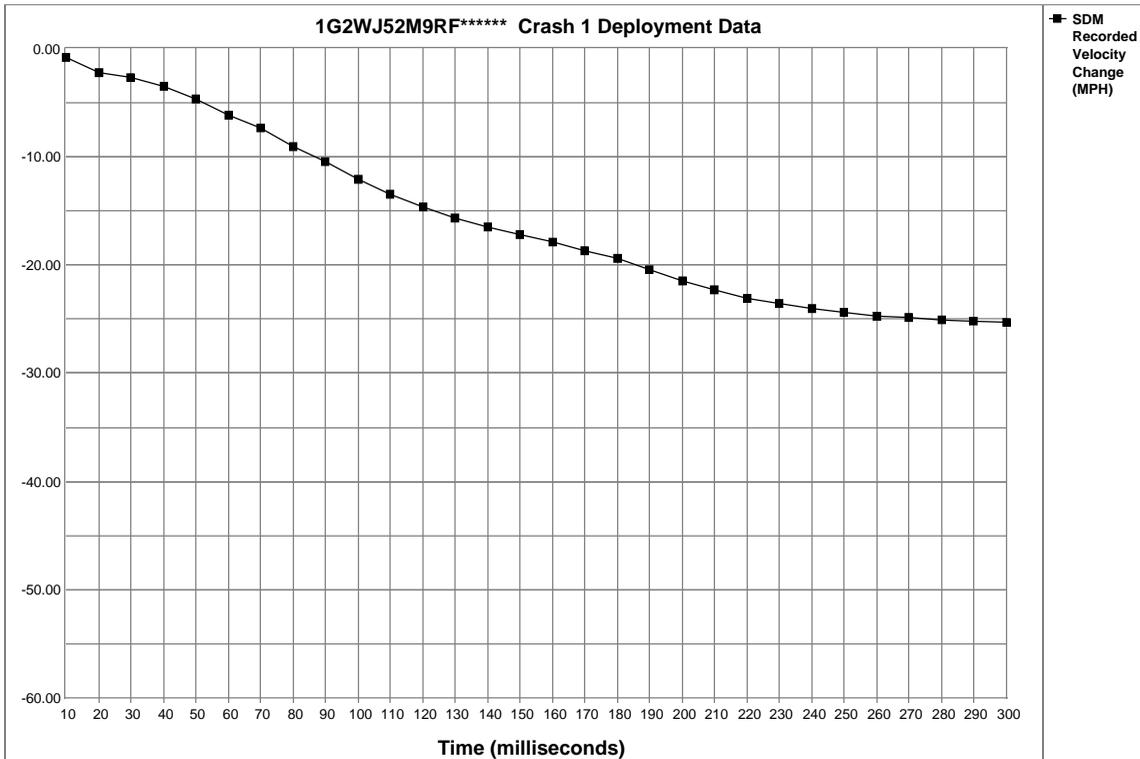
The 1994 Pontiac Grand Prix was equipped with a Sensing and Diagnostic Module (SDM) that had EDR capabilities. The SDM was located under the right front seat. The EDR was downloaded directly from the SDM using the Vetronix Crash Data Retrieval tool with software version 2.8 during this on-site investigative effort. The EDR printout is included in this report as **Attachment A**. The EDR data indicated the driver’s safety belt was not buckled at the time of Algorithm Enable (AE). The EDR recorded a maximum delta-V was -41 km/h (-25.3 mph) at 300 milliseconds of AE. The frontal air bag system was commanded to deploy at 166.25 milliseconds. This first generation EDR

Time (milliseconds)	10	20	30	40	50	60	70	80	90	100	110	120	130	140	150
Recorded Velocity Change (MPH)	-0.77	-2.19	-2.63	-3.51	-4.61	-6.14	-7.35	-9.00	-10.42	-12.07	-13.49	-14.59	-15.69	-16.46	-17.22
Time (milliseconds)	160	170	180	190	200	210	220	230	240	250	260	270	280	290	300
Recorded Velocity Change (MPH)	-17.88	-18.65	-19.42	-20.40	-21.50	-22.27	-23.04	-23.59	-24.02	-24.35	-24.68	-24.79	-25.01	-25.23	-25.34
