Remote Not in Traffic Surveillance Back Over Investigation / Vehicle to Pedestrian  
Dynamic Science, Inc. / Case Number: DS06032  
1990 Chevrolet Silverado 4x4 Club Cab Pickup  
Washington  
March 2006

1. Report No. DS06032	2. Government Accession No.		3. Recipient Catalog No.	
4. Title and Subtitle  Remote Not in Traffic Surveillance Back Over Investigation			5. Report Date May 11, 2007

**Dynamic Science, Inc.**  
**Crash Investigation**  
**Case Number: DS06032**

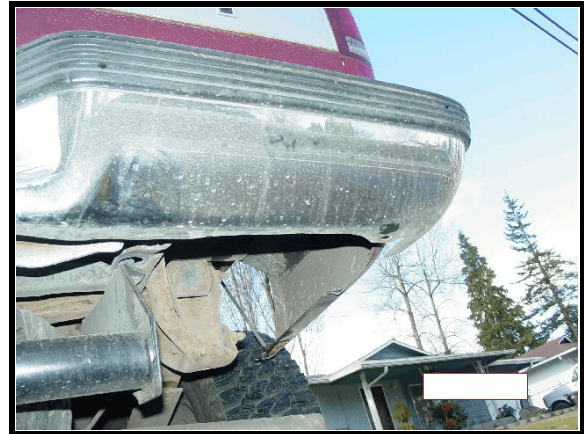
**Figure 7.** Close up of scuff/dust erasure to right side of rear bumper

There was no damage to the Chevrolet Silverado. The only indication of a possible contact was a scuff/erasure of dust on the right hand side of the rear bumper, just to the right of the license plate. This does not appear to be related to this incident.
