Not In Traffic Surveillance Remote Back Over Investigation / Vehicle v. Pedestrian
Dynamic Science, Inc. / Case Number: DS07013
1998 Chevrolet Blazer
Utah
March 2007

1. Report No. DS07013	2. Government Accession No.		3. Recipient Catalog No.	
4. Title and Subtitle Not In Traffic Surveillance Back Over Investigation			5. Report Date October 4, 2007

**Dynamic Science, Inc.
Crash Investigation
Case Number: DS07013**

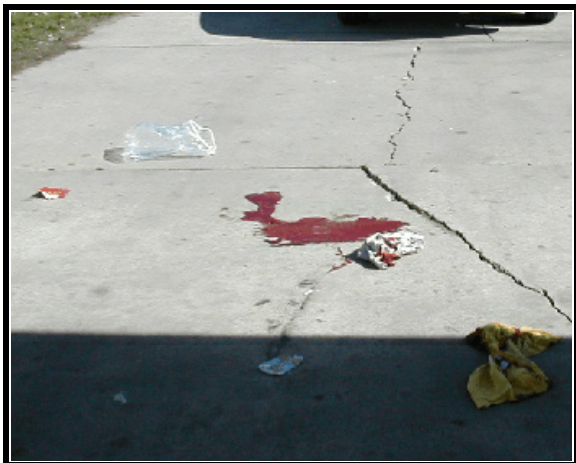
Figure 4. Drag path

As the driver began backing the vehicle, the right portion of the rear bumper contacted and knocked down the child. It appears that the vehicle had traveled 0.6-0.9 m (2-3 ft) before this first impact. The vehicle had only traveled a short distance and, based on an acceleration rate of 4.8 fps^2 , had speed of less than 8 km/h (5 mph). The vehicle continued backing and the right rear tire rolled over the child's back/torso after traveling approximately 0.9 m (3.0 ft). The driver felt that she had run over something at this point—possibly a skateboard—with the right rear tire. The vehicle continued backing and traveled approximately 2.7 m (9.0 ft) before the front right tire engaged the left side of the child's head. There was a 122 cm (48 in) pattern of hair on the driveway leading to the final resting position of the child's head (see Figures 4 and 5). The driver kept backing up an additional 6.1 m (20.0 ft) until she saw the child lying in front of the vehicle in the driveway and stopped the vehicle.

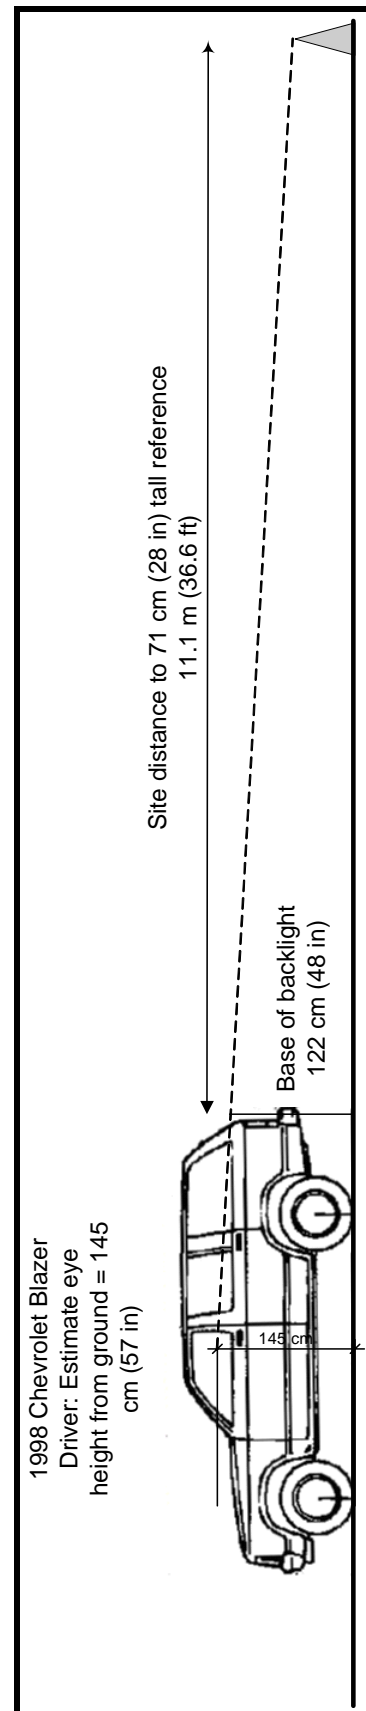
Figure 8. Nominal visibility diagram

The driver's eye height was determined using the anthropometric seated eye height measurements for a 50th percentile male and the seat height the exemplar vehicle. Based on the driver's height and the height of the base of the backlight, a scaled diagram was drawn and line was extended rearward until it intersected the 71 cm (28 in) reference object.

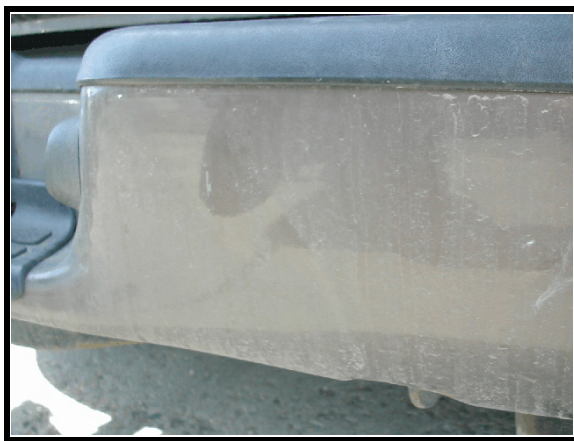
Figure 9. Contact to right rear bumper

Police officers noted that the rear bumper of the Blazer was covered in a light covering of road dust. There was a section of the bumper where the road dust had recently been rubbed off. This section was approximately 30.5 cm (12.0 in) in from the edge of the right side toward the middle of the rear bumper. There was a 7.6-10.2 cm (3.0-4.0 in) section of road dust missing from this section of the bumper.

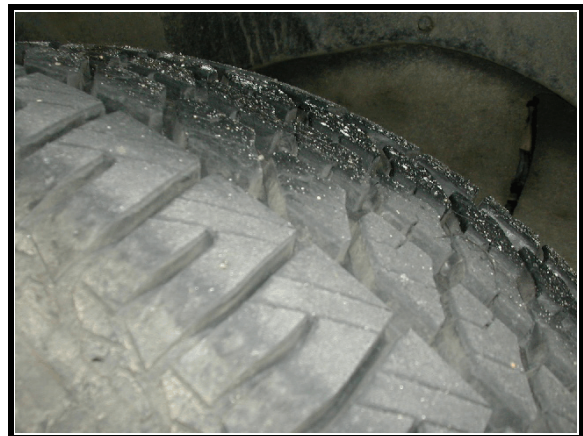
Figure 10. Oily substance found on right front tire tread

There were several hairs found on the right front tire which matched the hair color of the injured child. There was also an oily substance found on the tread area that appeared to have come from the child's skin as the tire rolled over him.
