**CALSPAN REMOTE HYPERTHERMIA INVESTIGATION**

**SCI CASE NO.: CA07-017**

**VEHICLE: 2005 HONDA PILOT**

**NOT-IN-TRAFFIC SURVEILLANCE**  
**CALSPAN REMOTE HYPERTHERMIA INVESTIGATION**  
**SCI CASE NO.: CA07-017**  
**VEHICLE: 2005 HONDA PILOT**  
**LOCATION: VIRGINIA**  
**DATE: MARCH 2007**

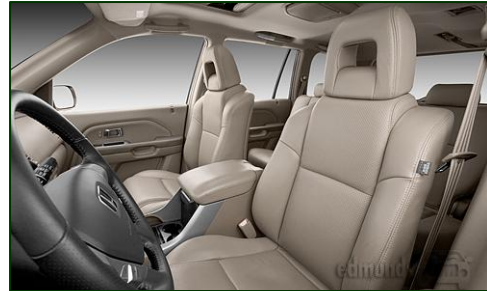
**Figure 2. View of the driver's position and interior configuration in an exemplar vehicle.**

The involved vehicle in this case was a 2005 Honda Pilot EX, four door sport utility vehicle. The Honda was equipped with eight-passenger seating with three rows of seats in a 2-3-3 configuration. **Figure 2** is an interior view of the driver's position in of exemplar Honda Pilot. The Honda Pilot EX was black in color with a beige leather

interior. The Pilot was identified by Vehicle Identification Number (VIN) 5FNYP18695B (production number deleted). The Pilot was equipped with deep tinted privacy glass at the rear doors, quarter windows, and backlight glazing. The police stated that the vehicle was not equipped with a sunroof. The door windows were power activated and all windows were reported as closed by the investigating officer for the duration of this incident.

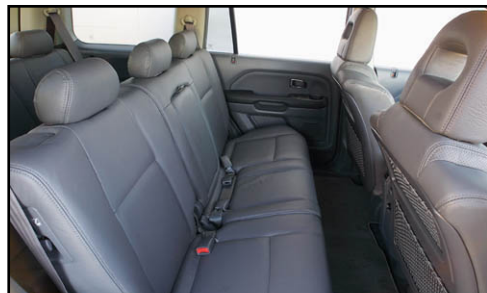
**Figure 3. Second row seat configuration of an exemplar Honda Pilot.**

On the morning of this incident, the case occupant's father reinstalled the rear-facing infant seat in the rear left position of the Pilot. The case occupant was placed in the CSS in the rear left position and presumably secured in the seat with the integral harness system. **Figure 3** is a view of the second row seat in an exemplar Honda Pilot. The parents entered the Honda Pilot with the mother driving. On this morning, the father required a ride to work, as he had loaned his vehicle to a family member following a traffic crash. This task added approximately five minutes to the driver's normal commute to work that involved a stop at the babysitter's residence.
